**RESTORATION WORKS AT SUMHURAM
(ARCHAEOLOGICAL PARK OF KHOR RORI)
(Sultanate of Oman)
CAMPAIGN February-March 2016**

**Technical Report
06th February – 24th March 2016**

RESTORATION WORKS AT HAMR AL-SHARQIYA

Technical Report
06th February – 24th March 2016

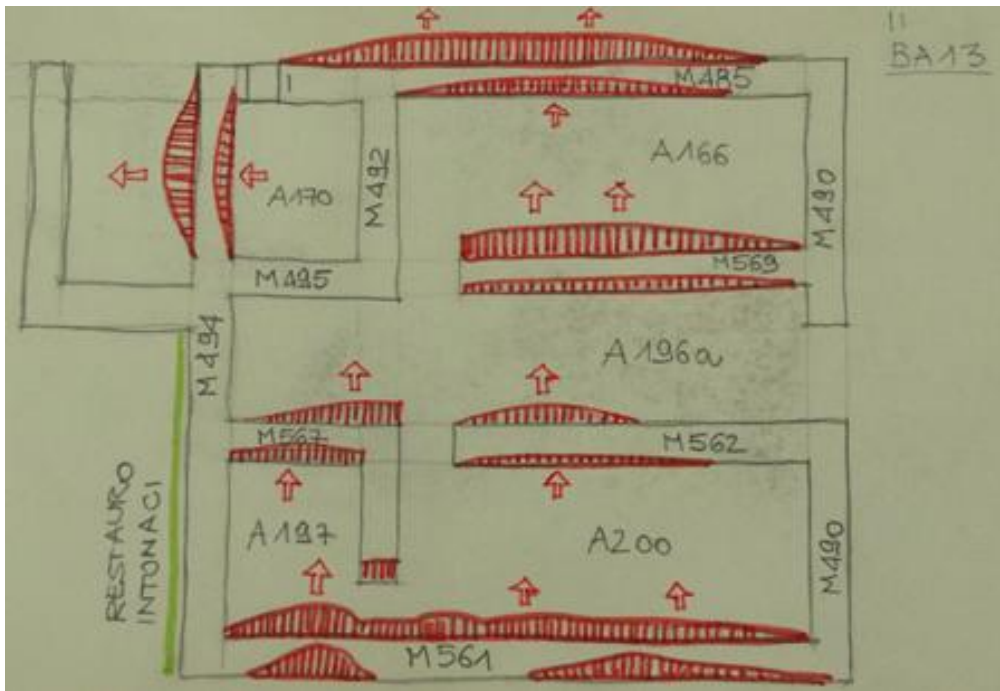
Sketch area BA13. Plan with collapsing walls

The building had a large part of the walls collapsed. The restoration was done by giving the priority to the walls on the tourist route and then those inside. The work is proceeded with the disassembly of some parts of the masonry, the cleaning and the replacement with the same stones as not to alter the original shape.

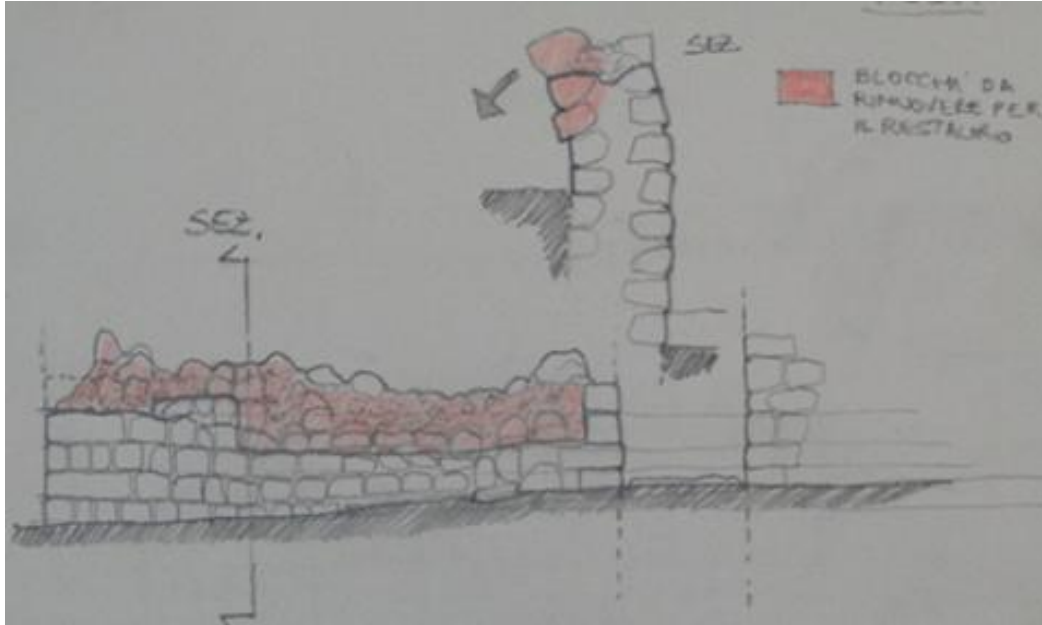
M635, south facing wall. Stones to remove highlighted with hatch

The restoration was done by giving the priority to the walls on the tourist route. The work is proceeded with the disassembly of some parts of the masonry, the cleaning and the replacement with the same stones as not to alter the original shape.

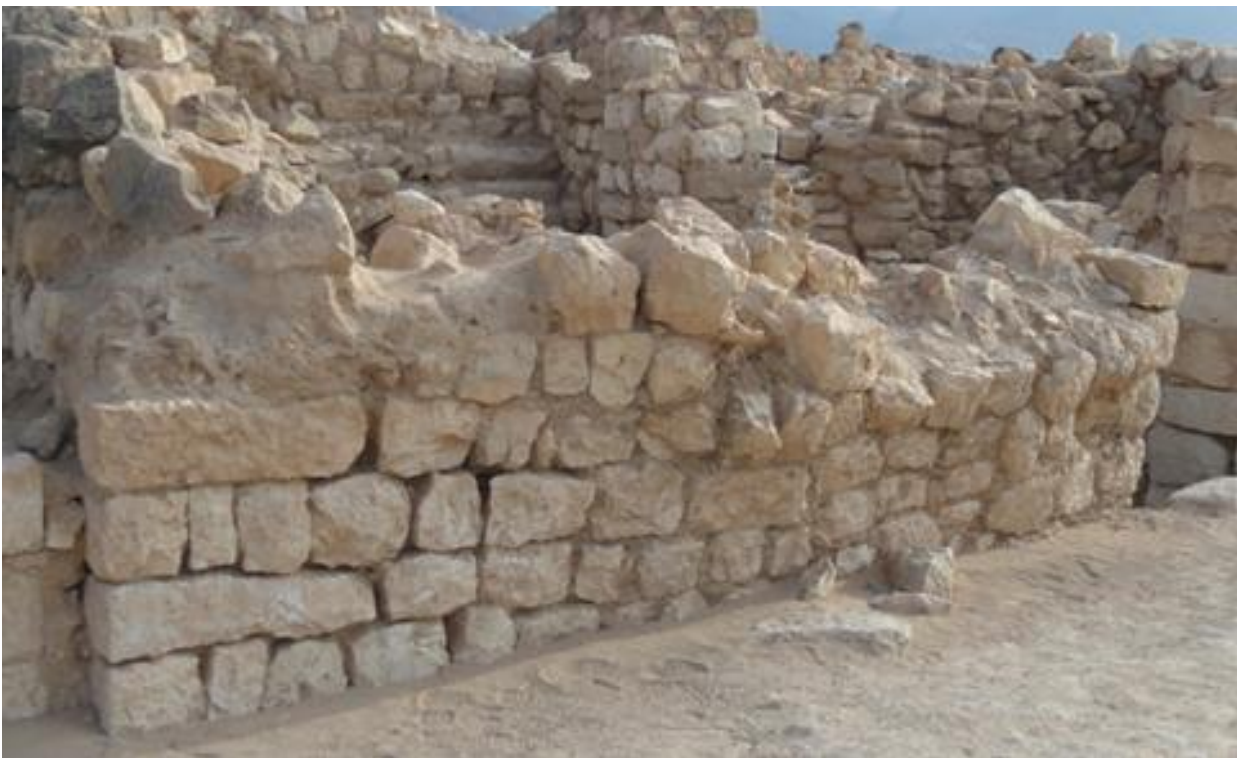
M635, south front wall, before the restoration.

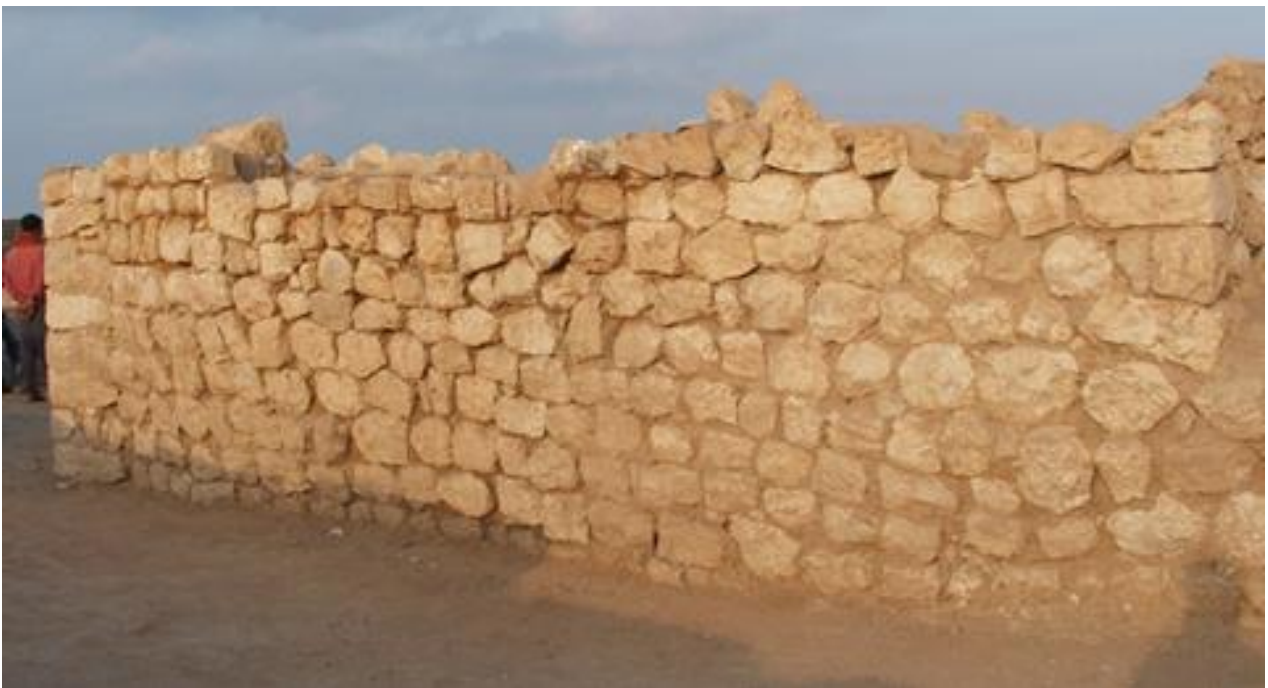
M484, east front wall, after the restoration.

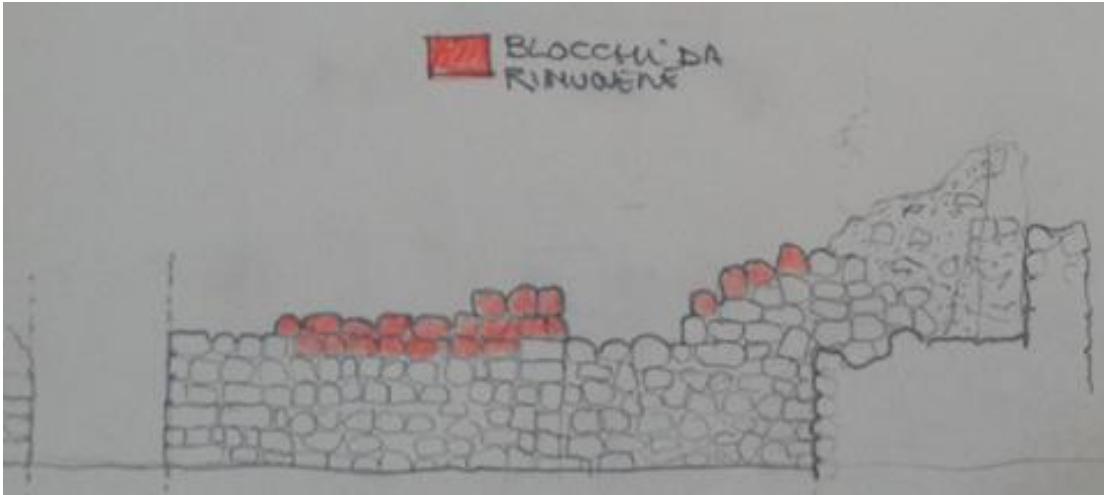
M581, south front wall. Stones to remove highlighted with hatch

The restoration was done by giving the priority to the walls on the tourist route. The work is proceeded with the disassembly of some parts of the masonry, the cleaning and the replacement with the same stones as not to alter the original shape.

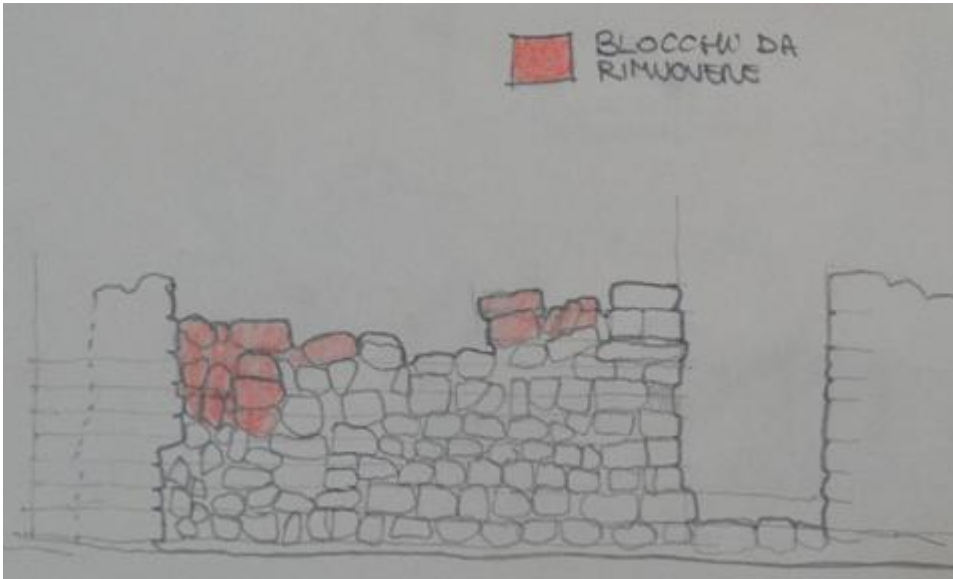
M70, south front wall. Stones to remove highlighted with hatch

The restoration was done by giving the priority to the walls on the tourist route. The work is proceeded with the disassembly of some parts of the masonry, the cleaning and the replacement with the same stones as not to alter the original shape.

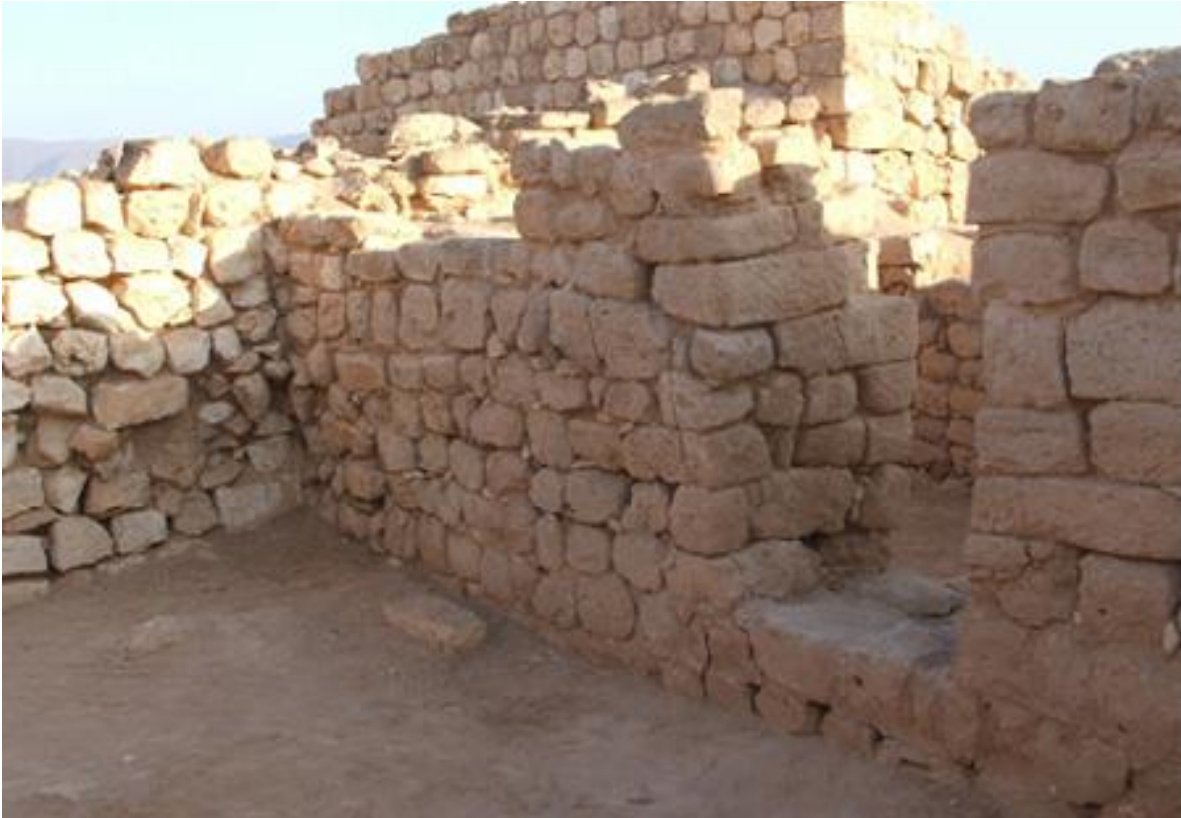
M70, south front wall, after the restoration.

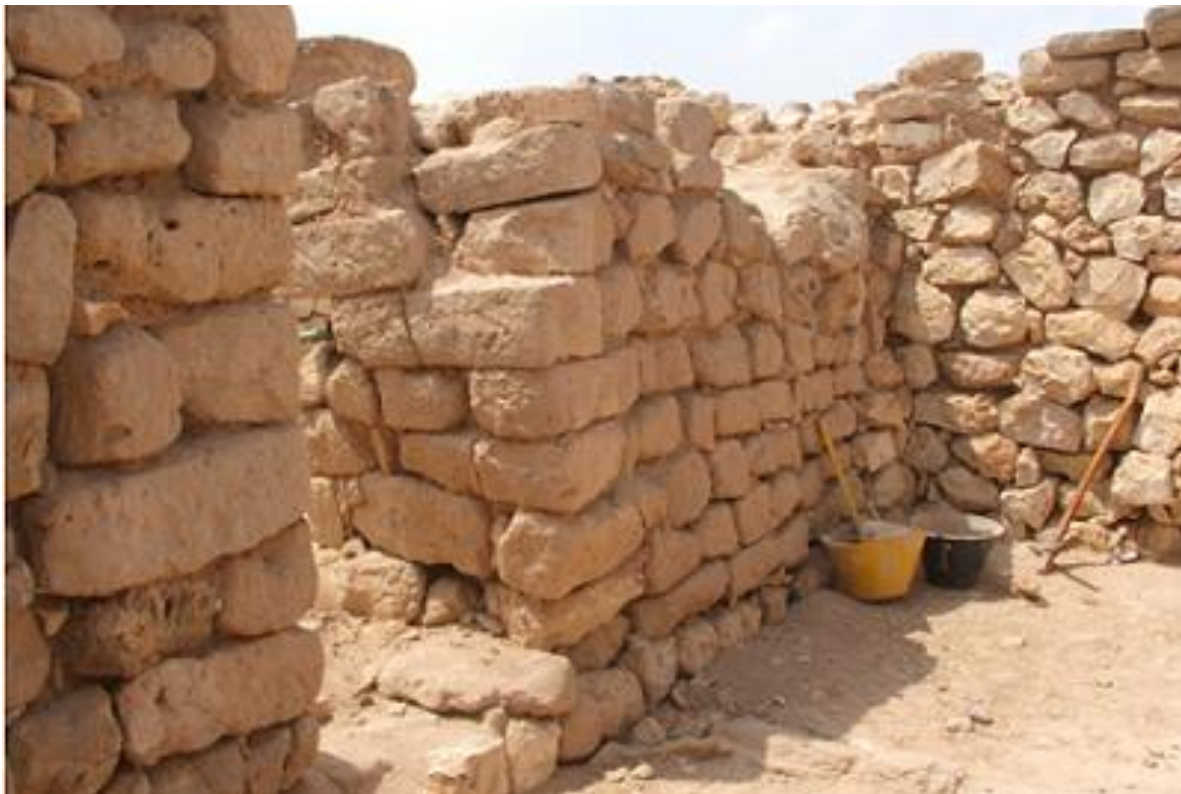
M70, south front wall, before the restoration.

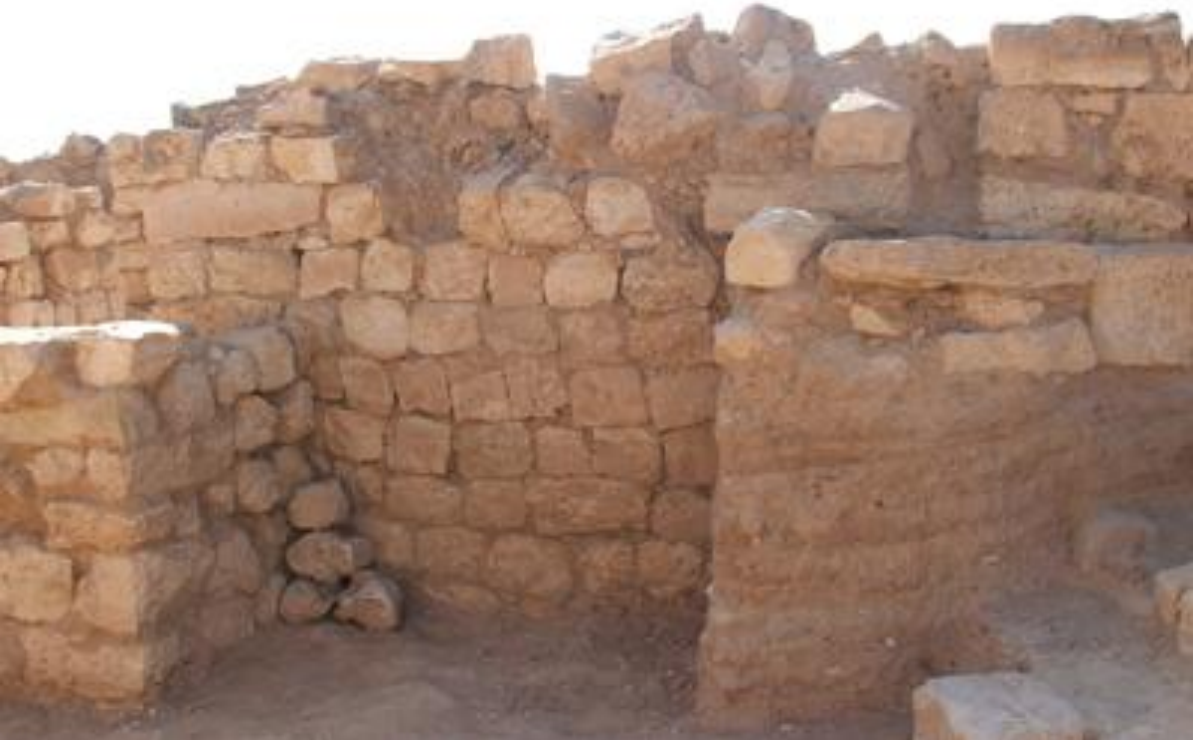
M521, west front wall, before the restoration

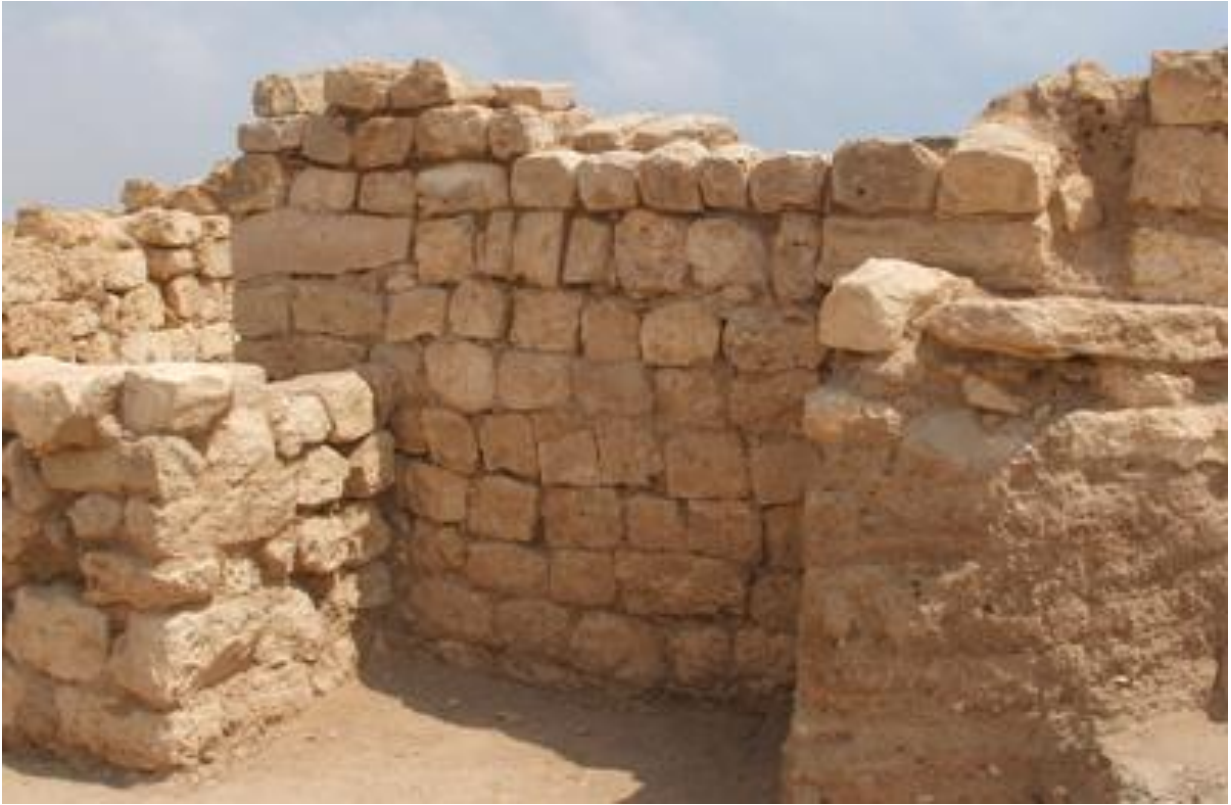
M521, west front wall, after the restoration

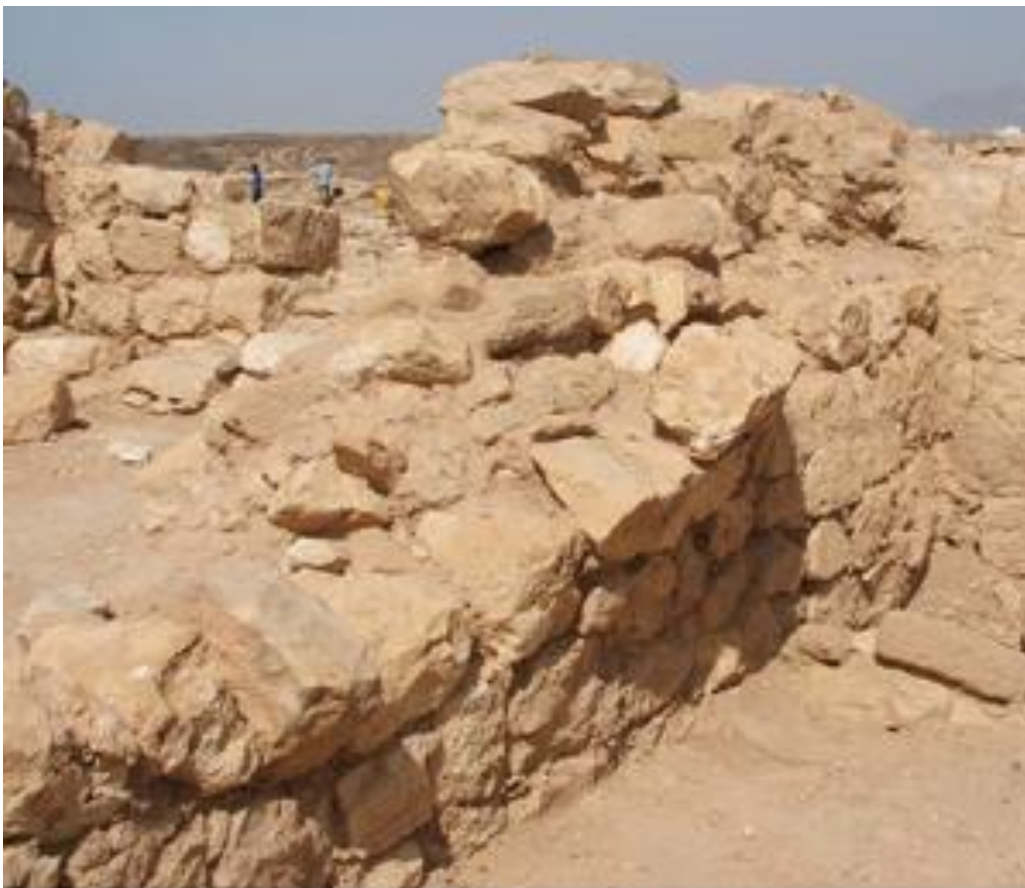
M529, north front wall, before the restoration

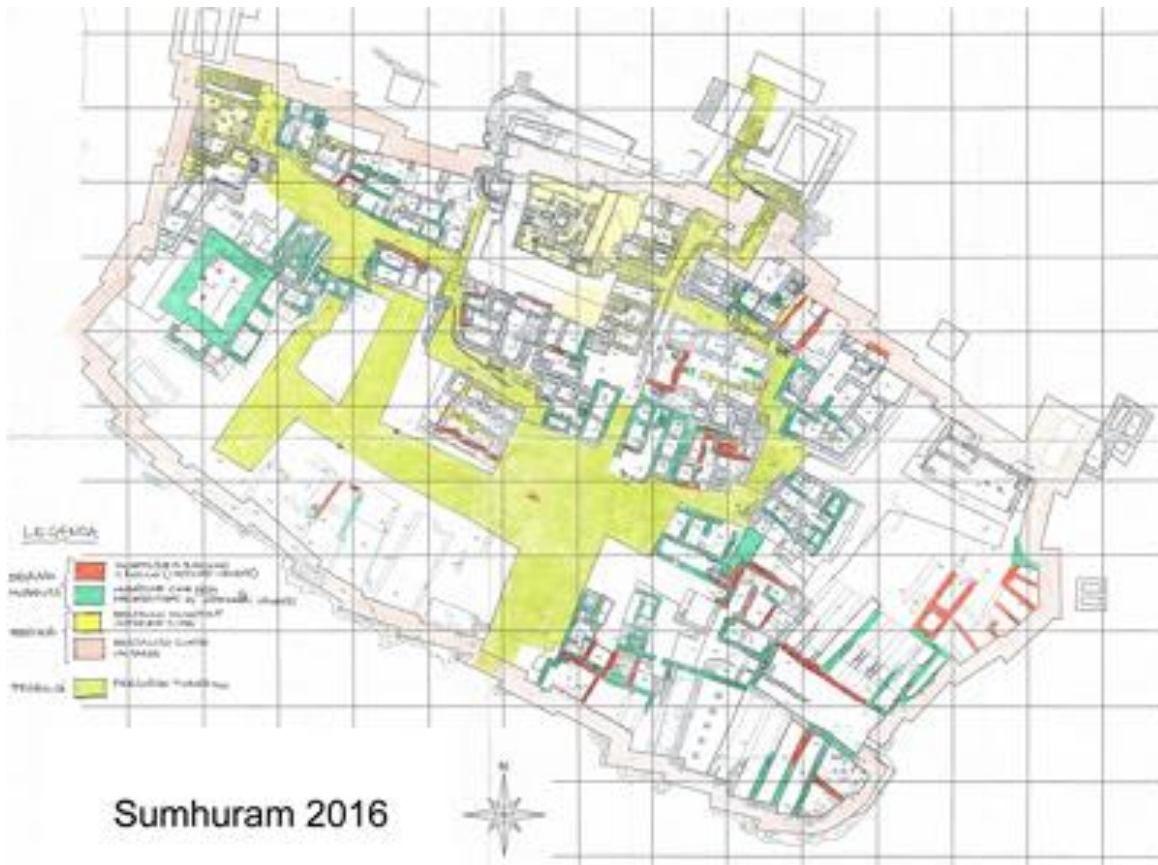
The risk map is useful to the identification of risk masonry collapse (red) and then to the most urgent restoration. Green degraded walls that do not require urgent action, in yellow walls restored, light green the visit route. The risk map allows the defining of guidelines aimed to further restoration planning.

Plan with a risk collapse highlighted walls

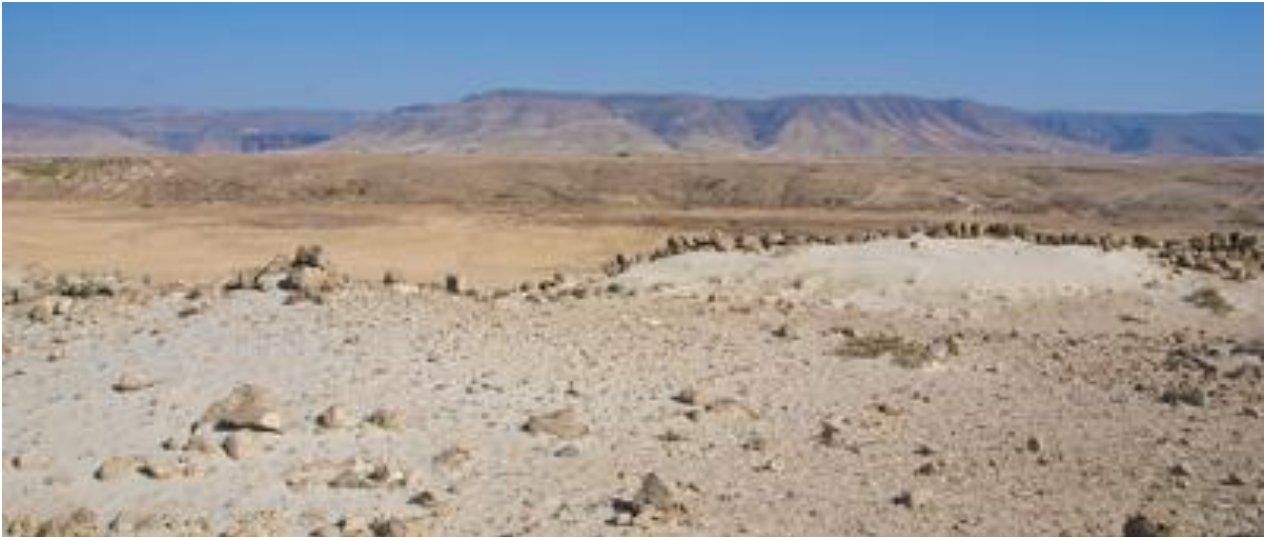
Along the east wall alternating zones of collapse and evident and well preserved areas. Near the tower there was a big crash and the wall is almost completely collapsed.

East wall in bad condition

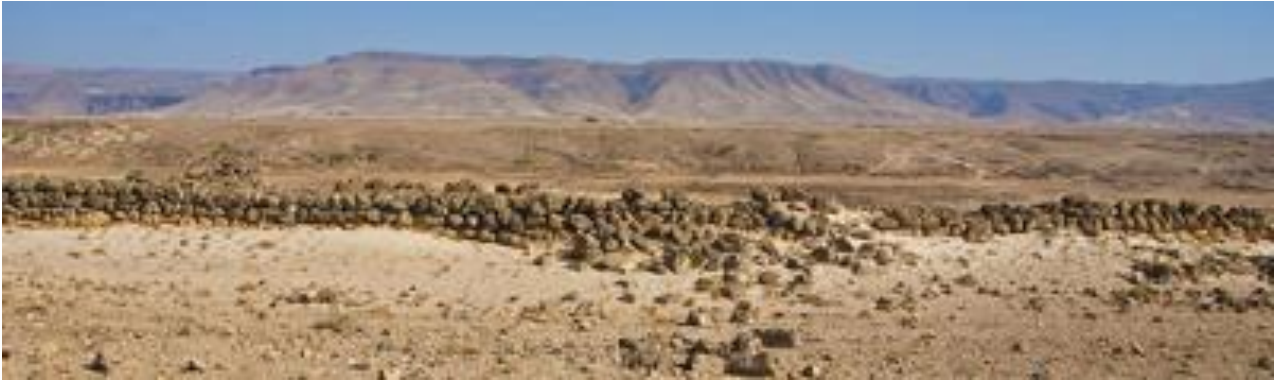
Along the west wall alternating zones of collapse and evident and well preserved areas. Near the tower there was a big collapse and the opening of a passage of recent construction.

West wall in bad condition

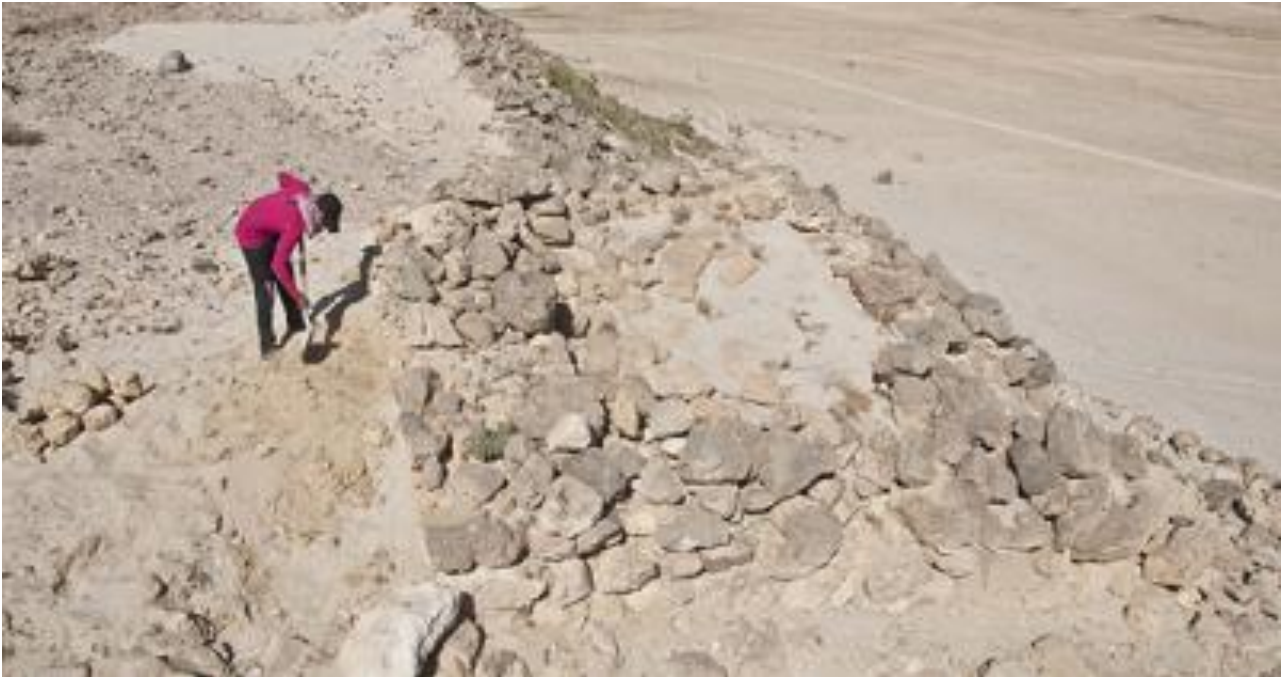
The west tower is in poor condition, there are many collapses and many unsafe and unstable stones.

West tower, east side

It is necessary a step of removing the stones of collapse, a consolidation of unstable stones, a thorough cleaning and finally restore four front walls with the restoration of the original part.

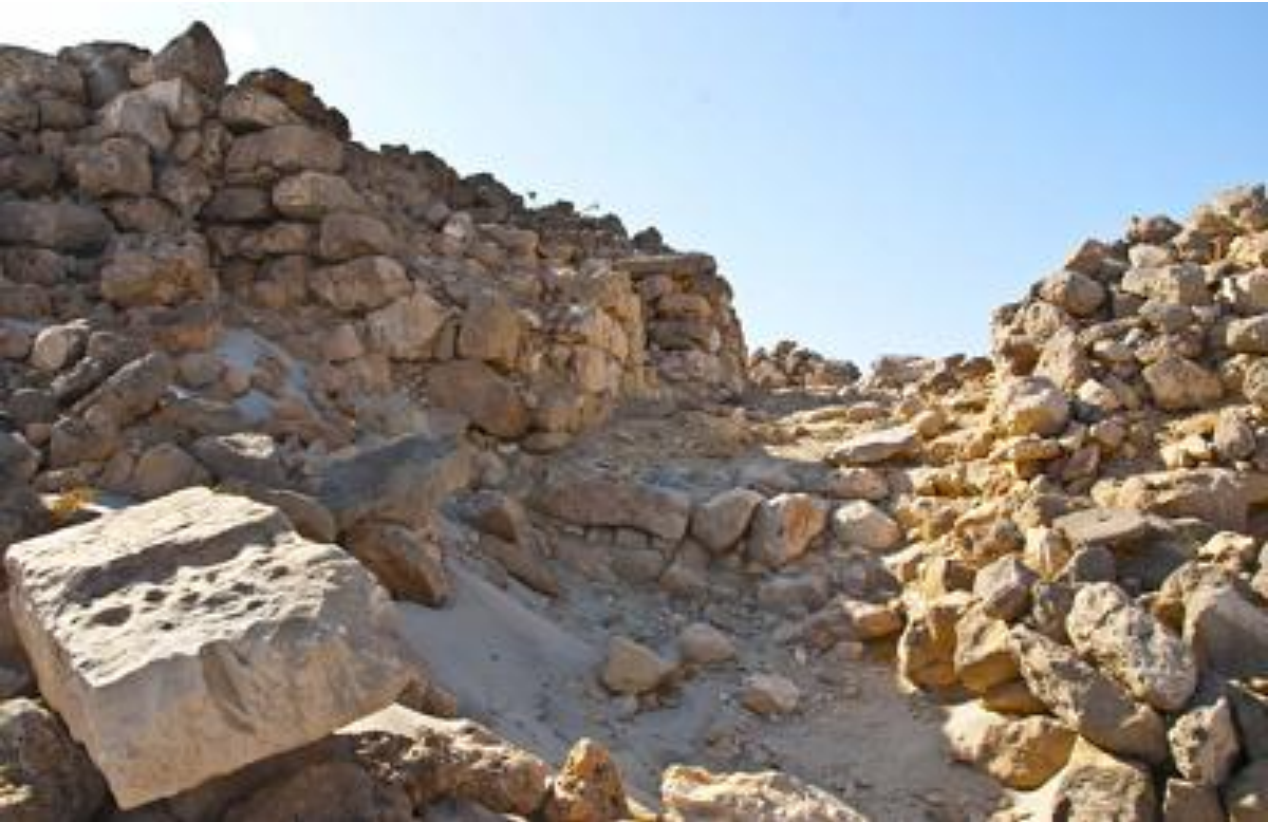
Principal door north side before restoration

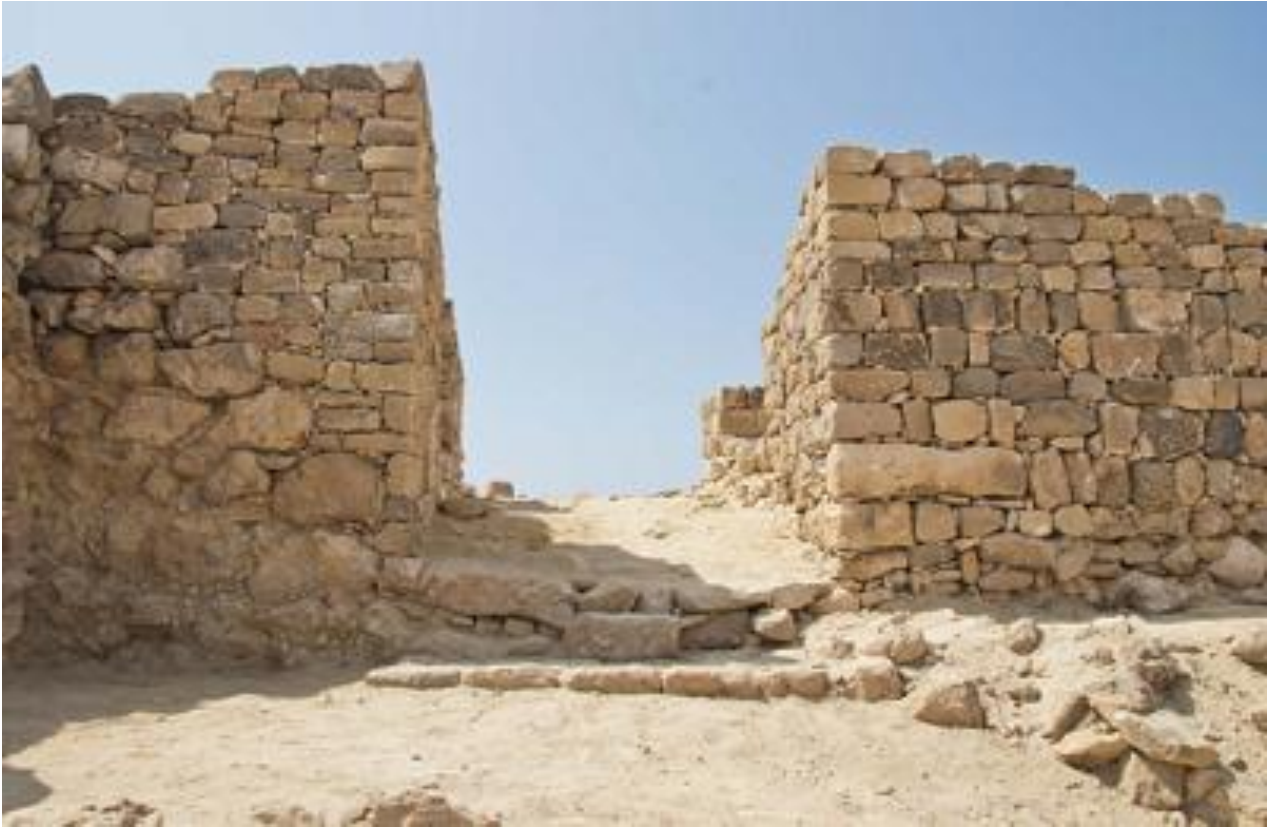
Principal door north side after restoration

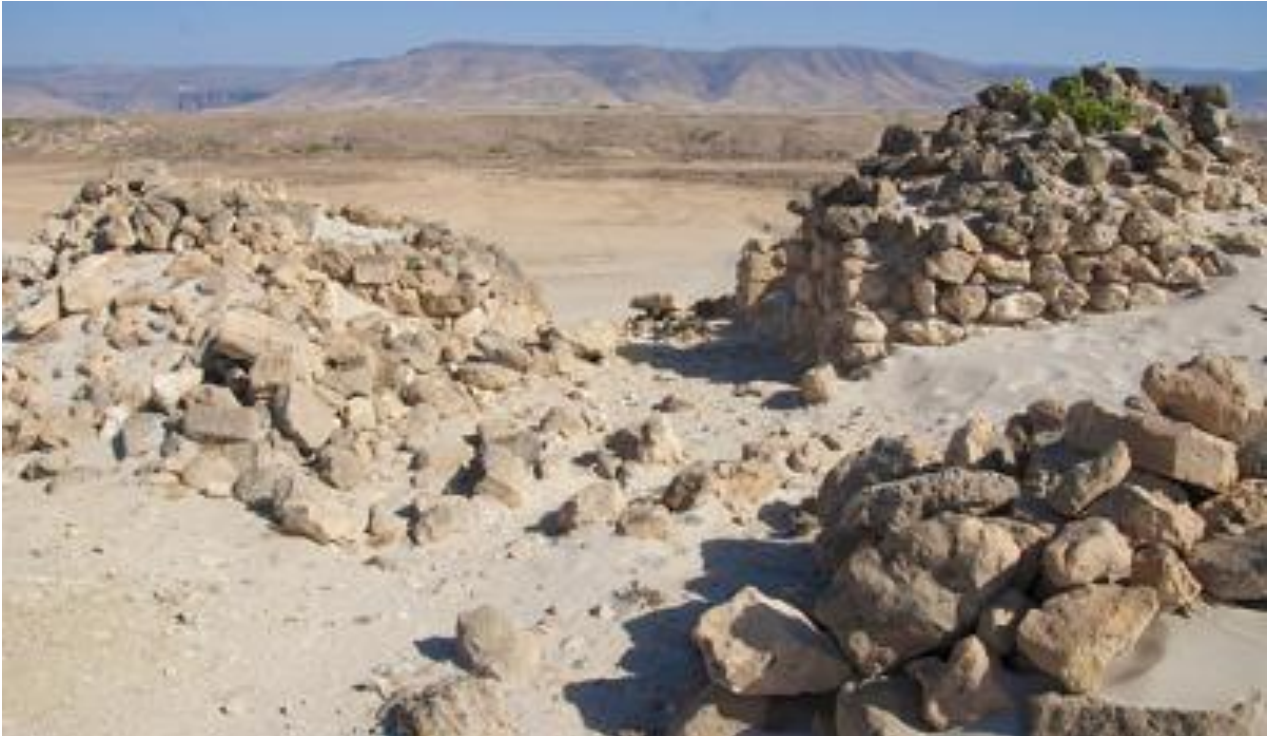
Principal door south side before restoration

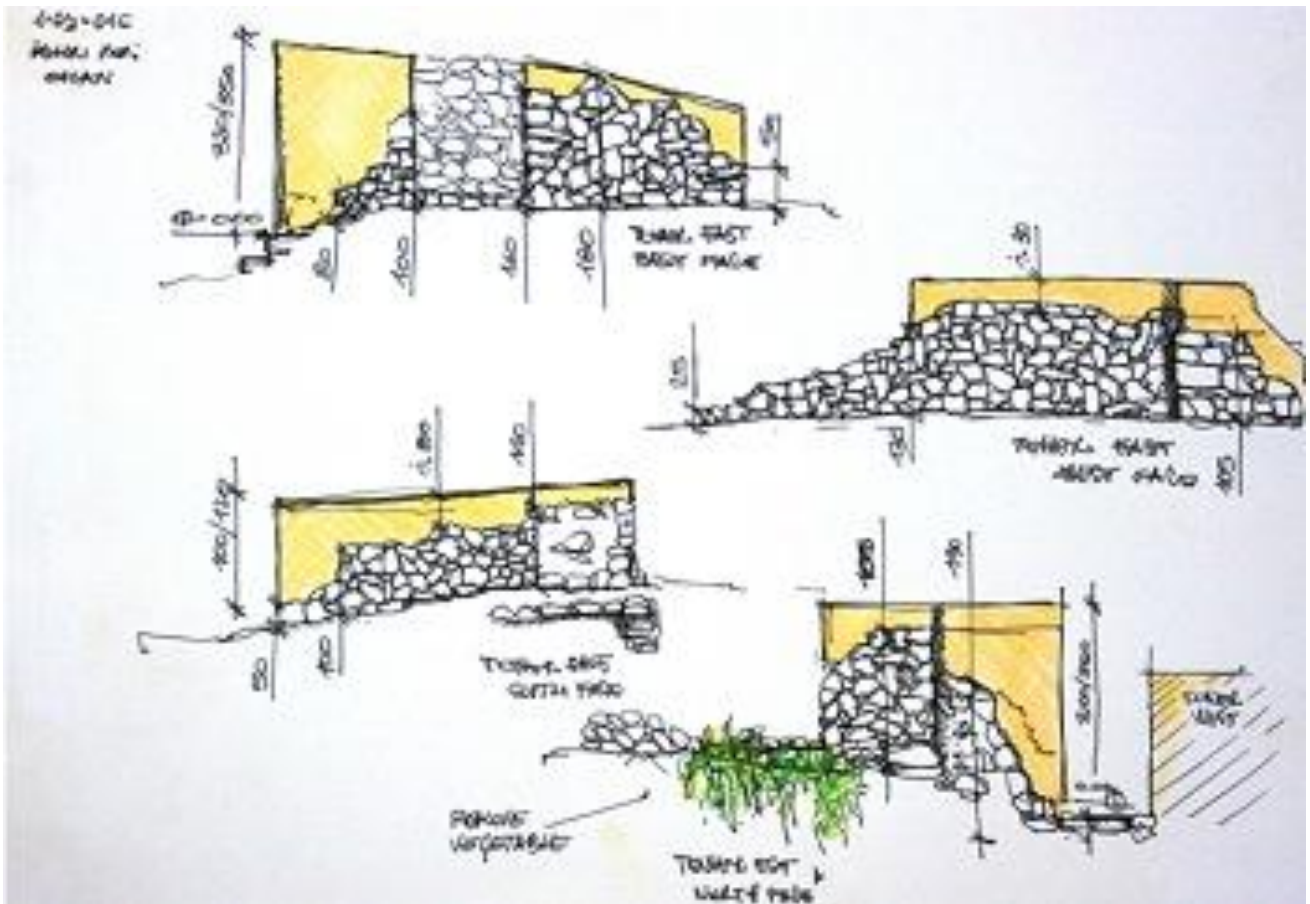
Project for east tower

The restoration of the tower was carried out using the technique of dry wall , with a filling of different grain of stones and ground.

The ground and sand present on the sides of the tower removed to allow cleaning and consolidation of the original stone.

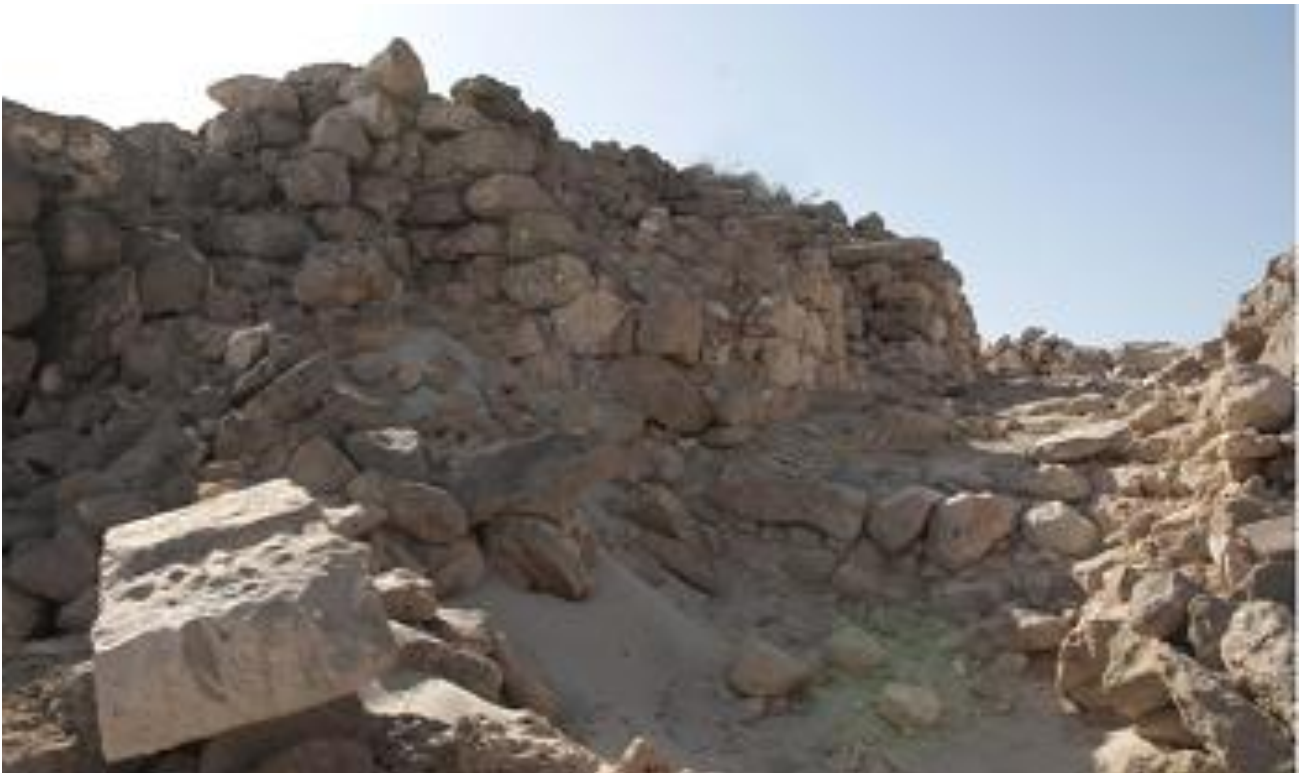
View north-west side before restoration

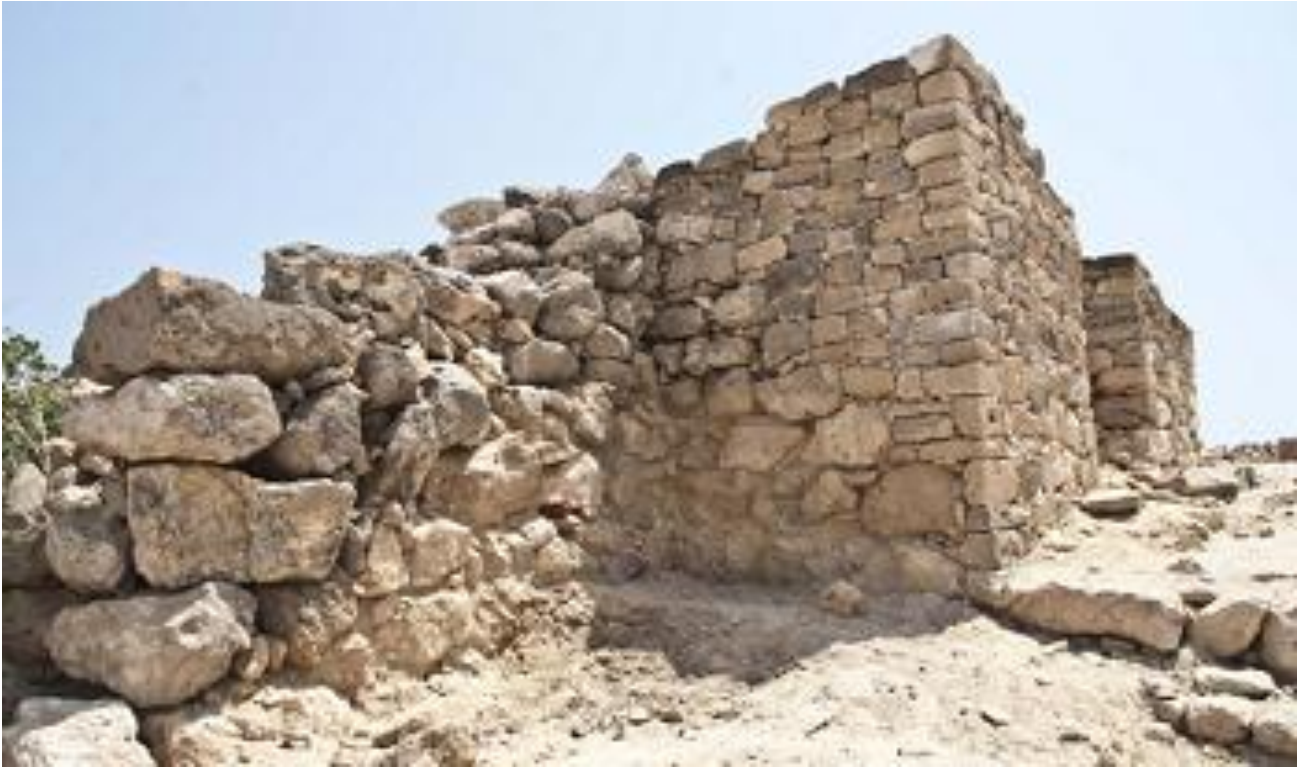
View north side after restoration

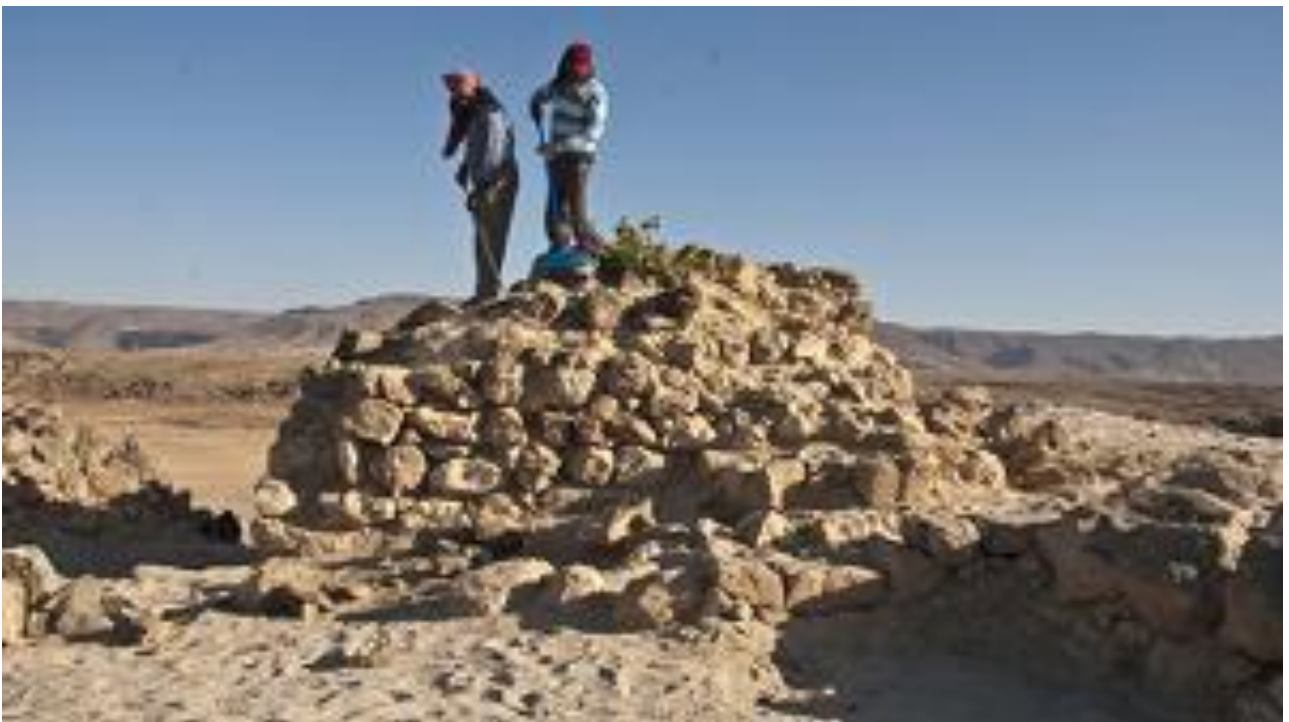
View south side before restoration

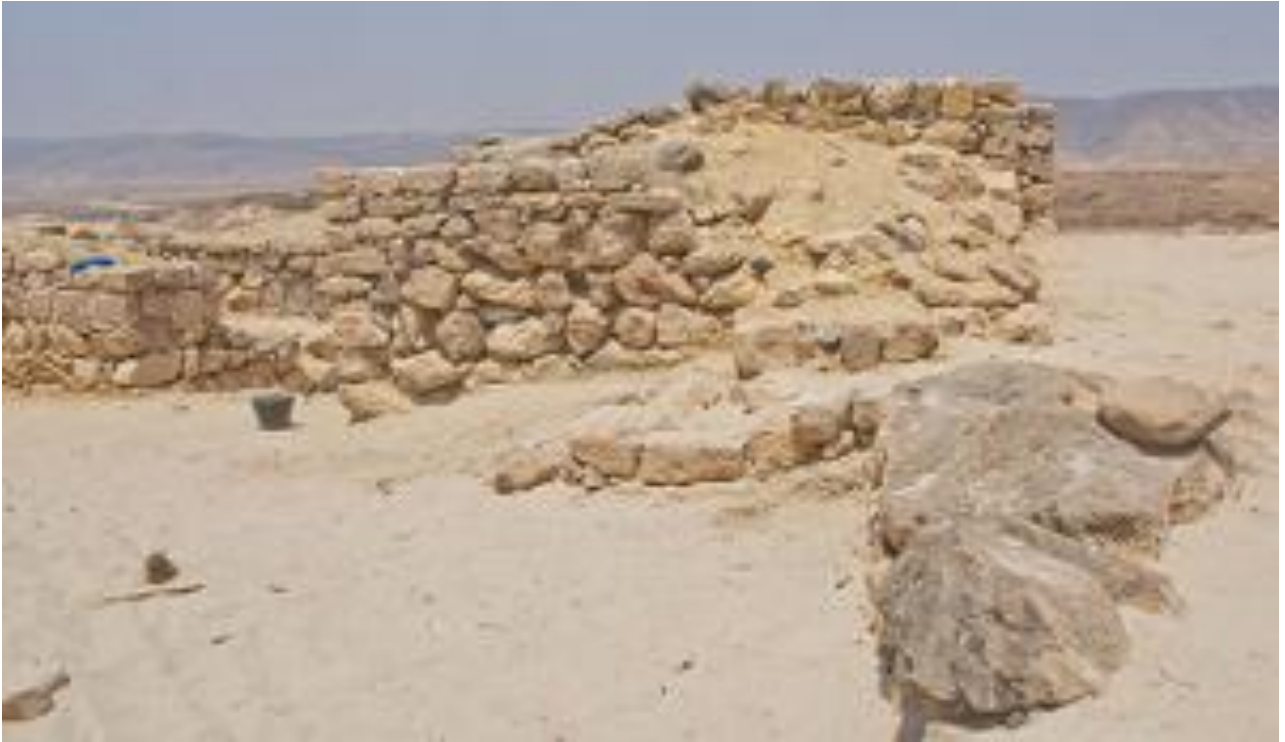
View south side after restoration

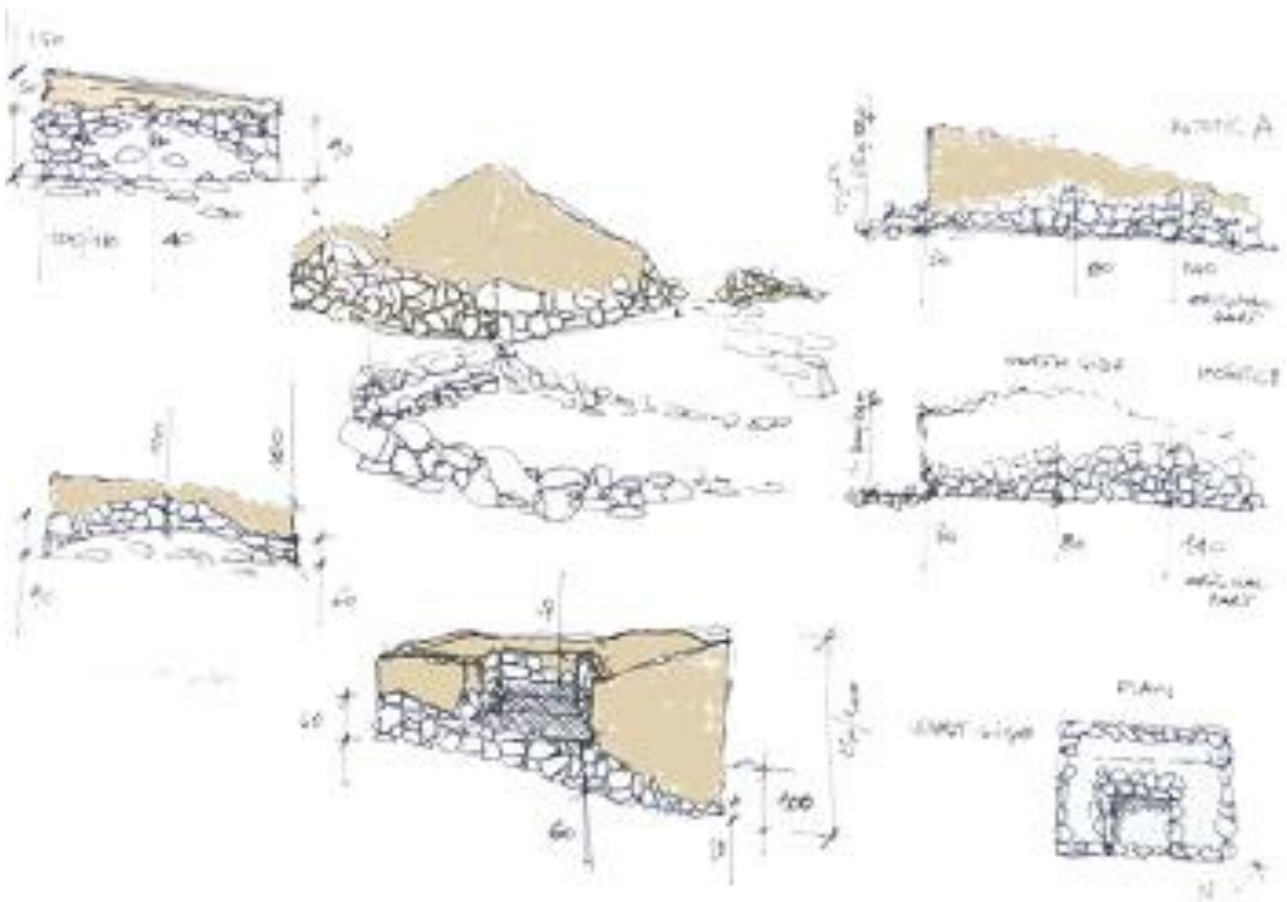
Project for west tower

The restoration of the tower was carried out using the technique of dry wall , with a filling of different grain of stones and ground.

The ground and sand present on the sides of the tower removed to allow cleaning and consolidation of the original stone.

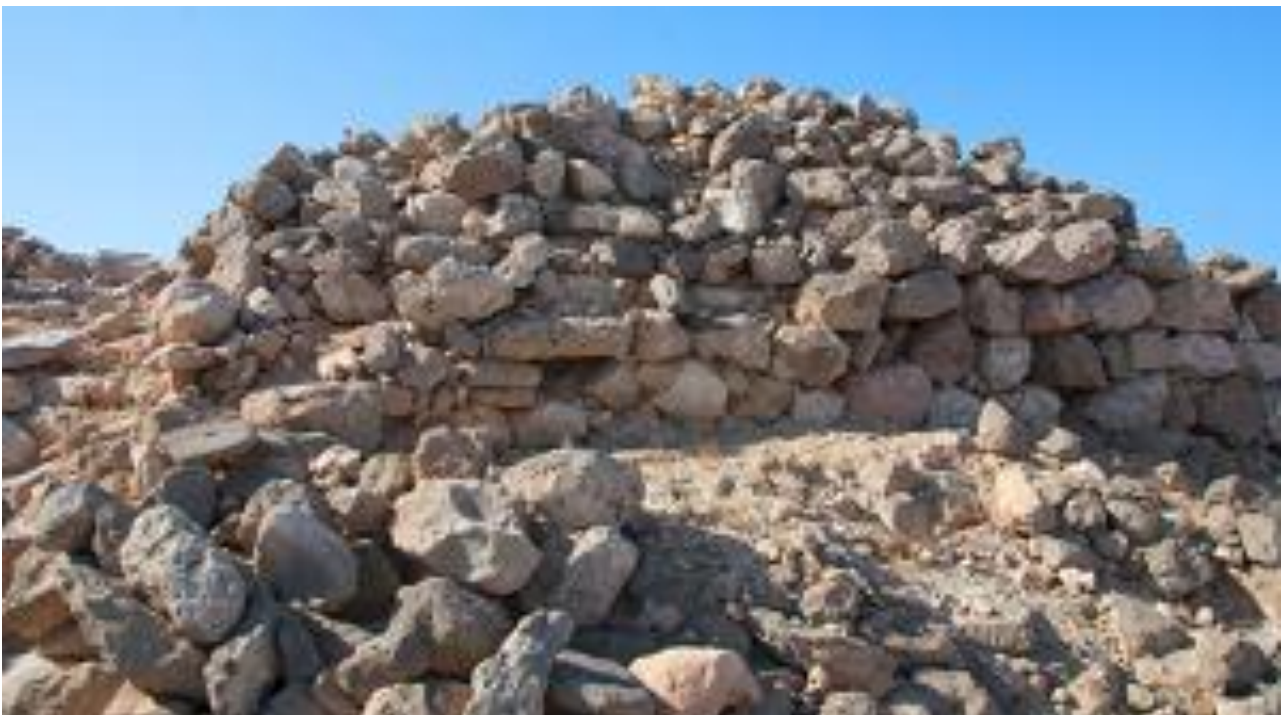
North side before restoration
