**RESTORATION WORKS AT SUMHURAM
(ARCHAEOLOGICAL PARK OF KHOR RORI)
(Sultanate of Oman)
CAMPAIGN February-March 2016**

**Technical Report
06th February – 24th March 2016**

RESTORATION WORKS AT HAMR AL-SHARQIYA

Technical Report
06th February – 24th March 2016

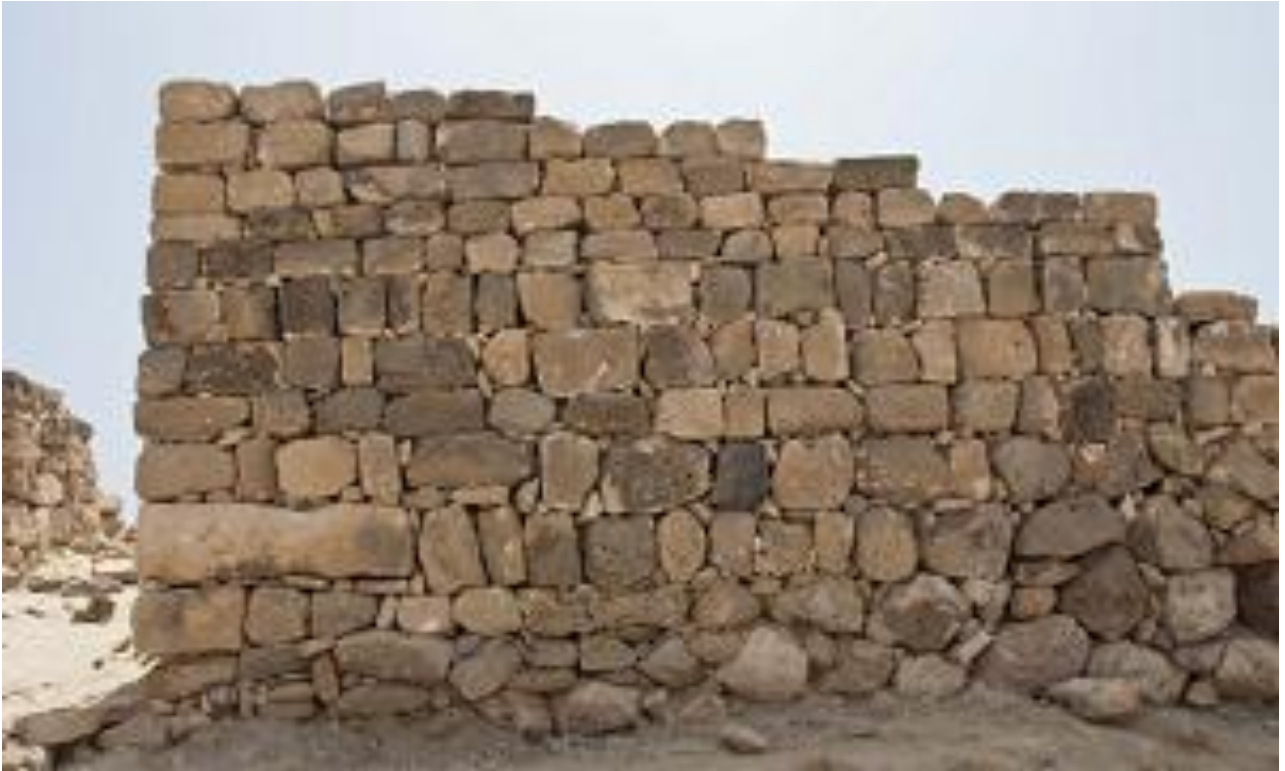
North side after restoration

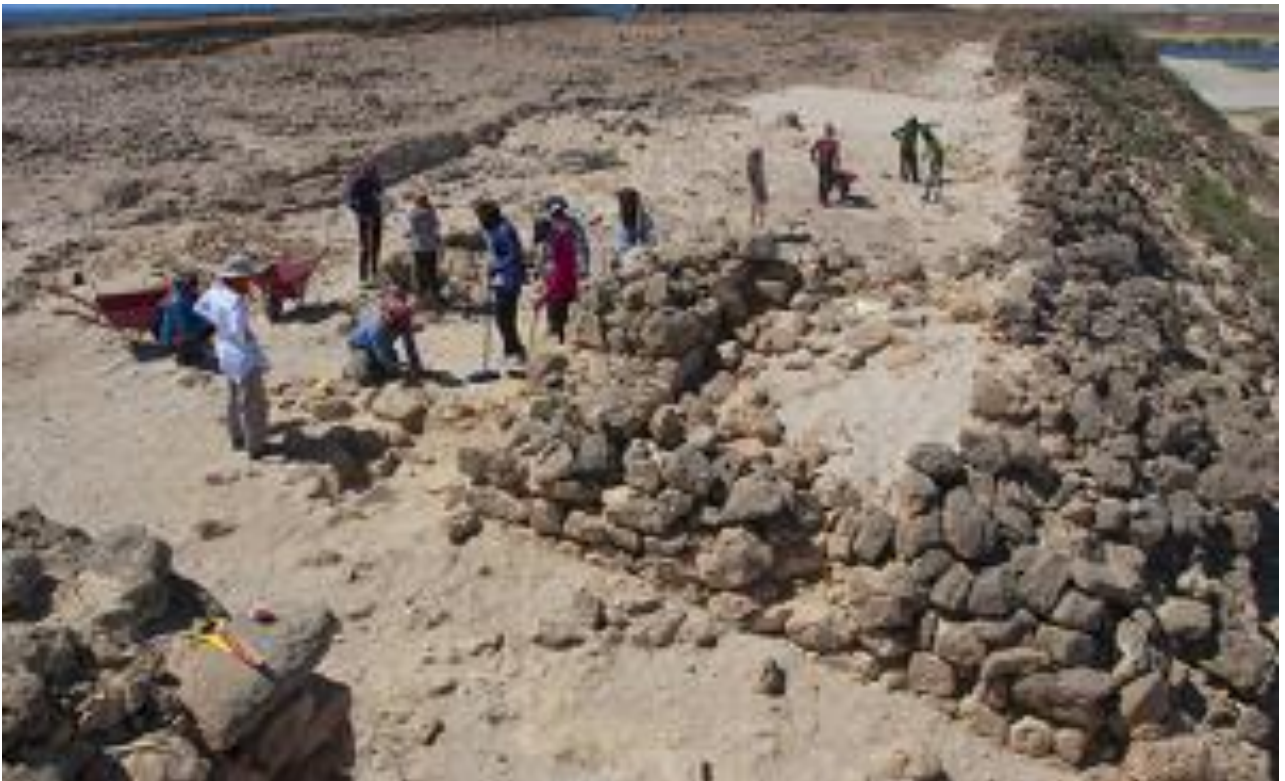
West side before restoration

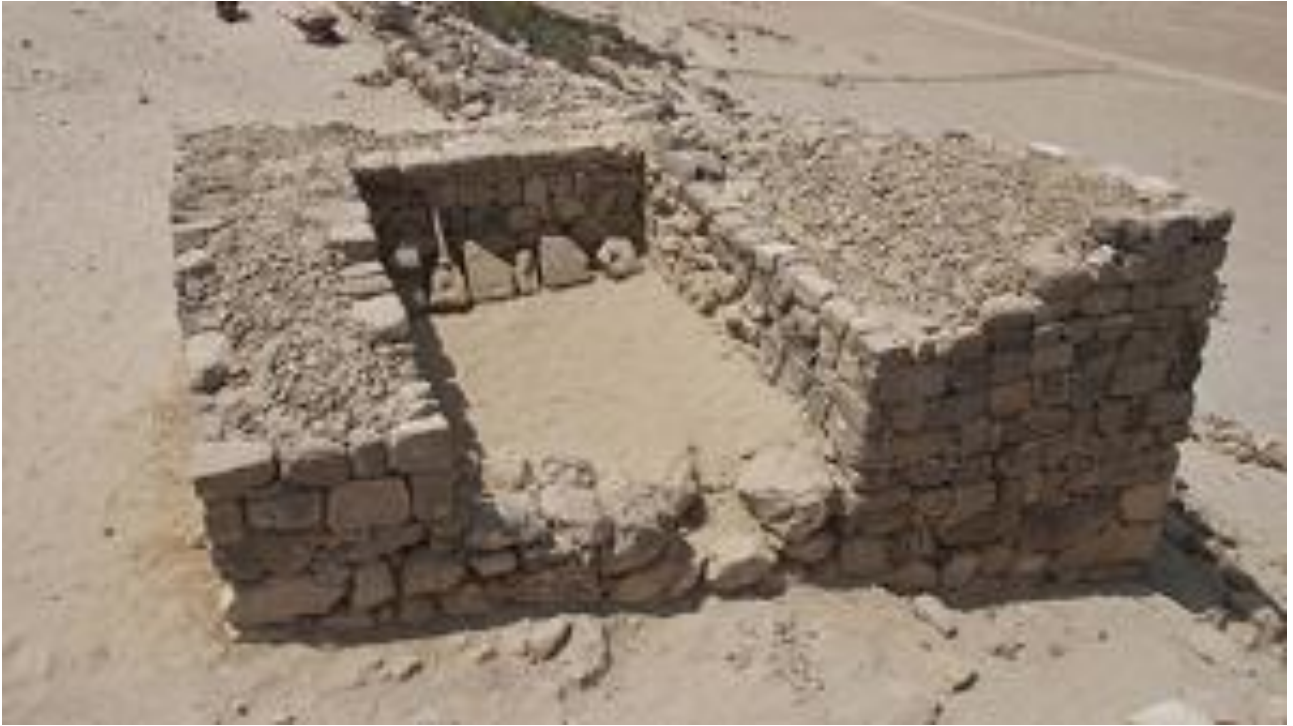
West side after restoration

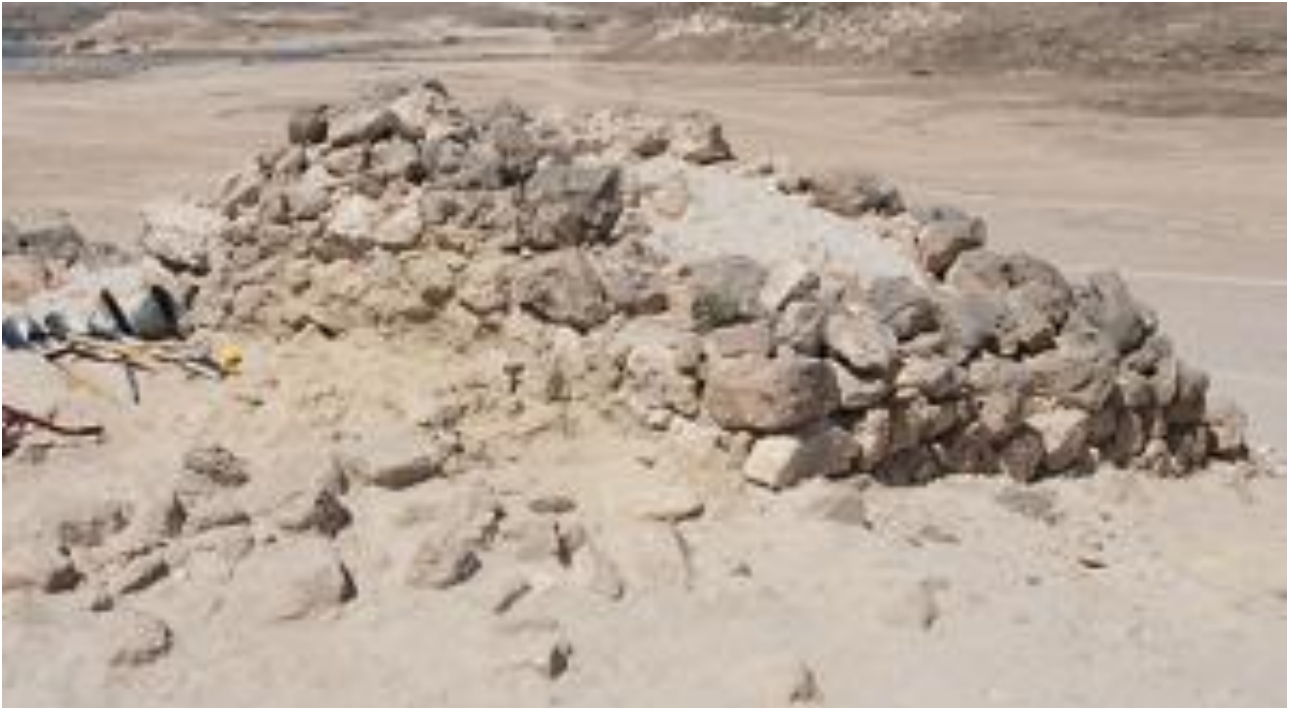
South side before restoration

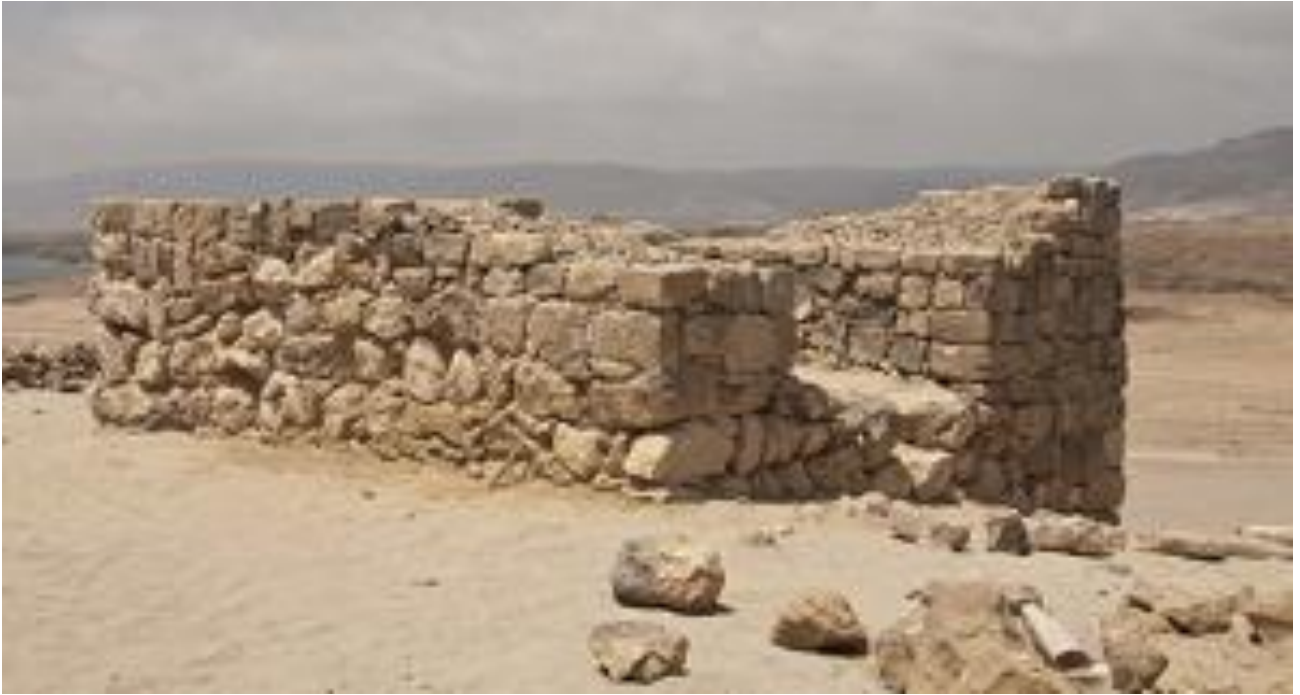
South side after restoration

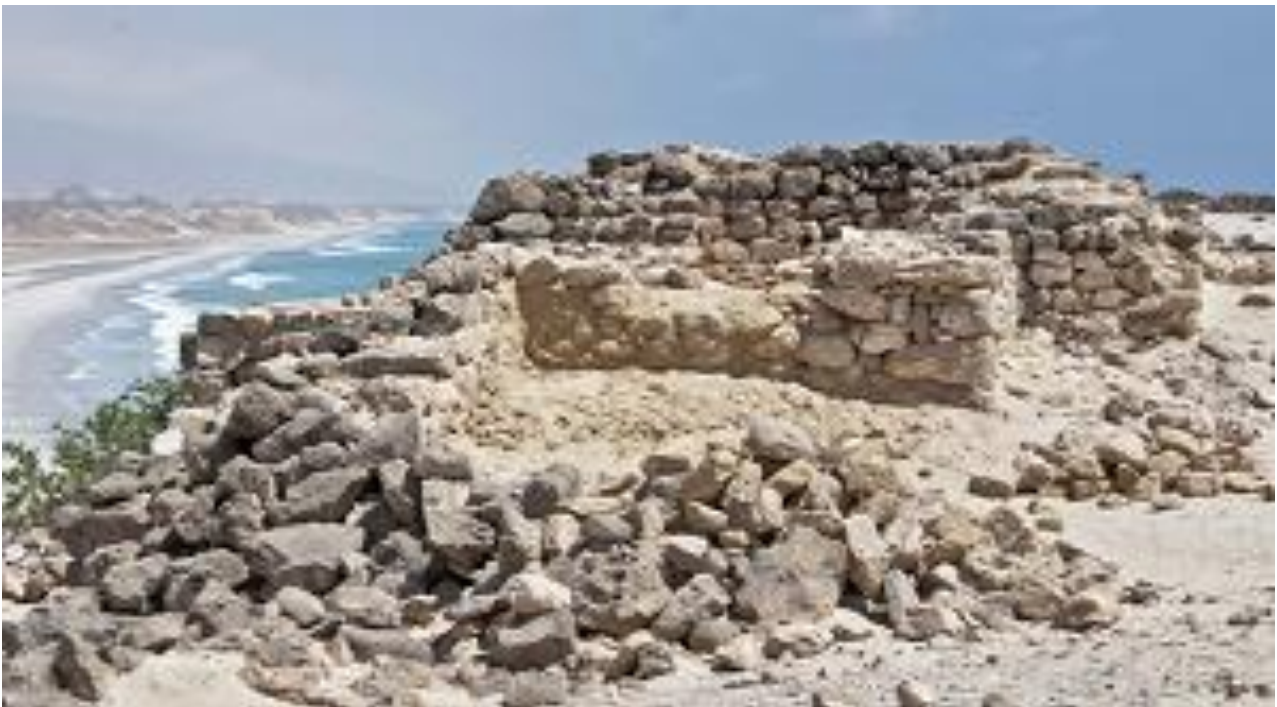
East side before restoration

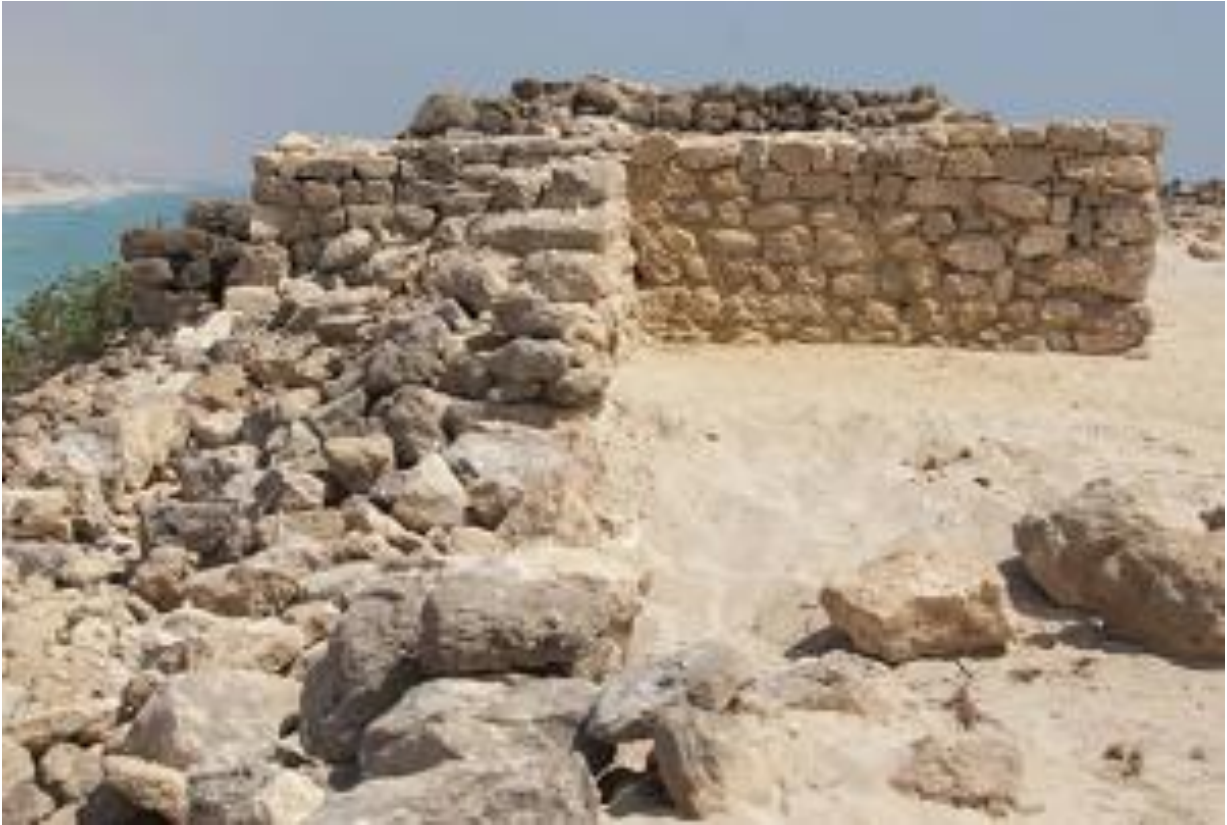
East side after restoration

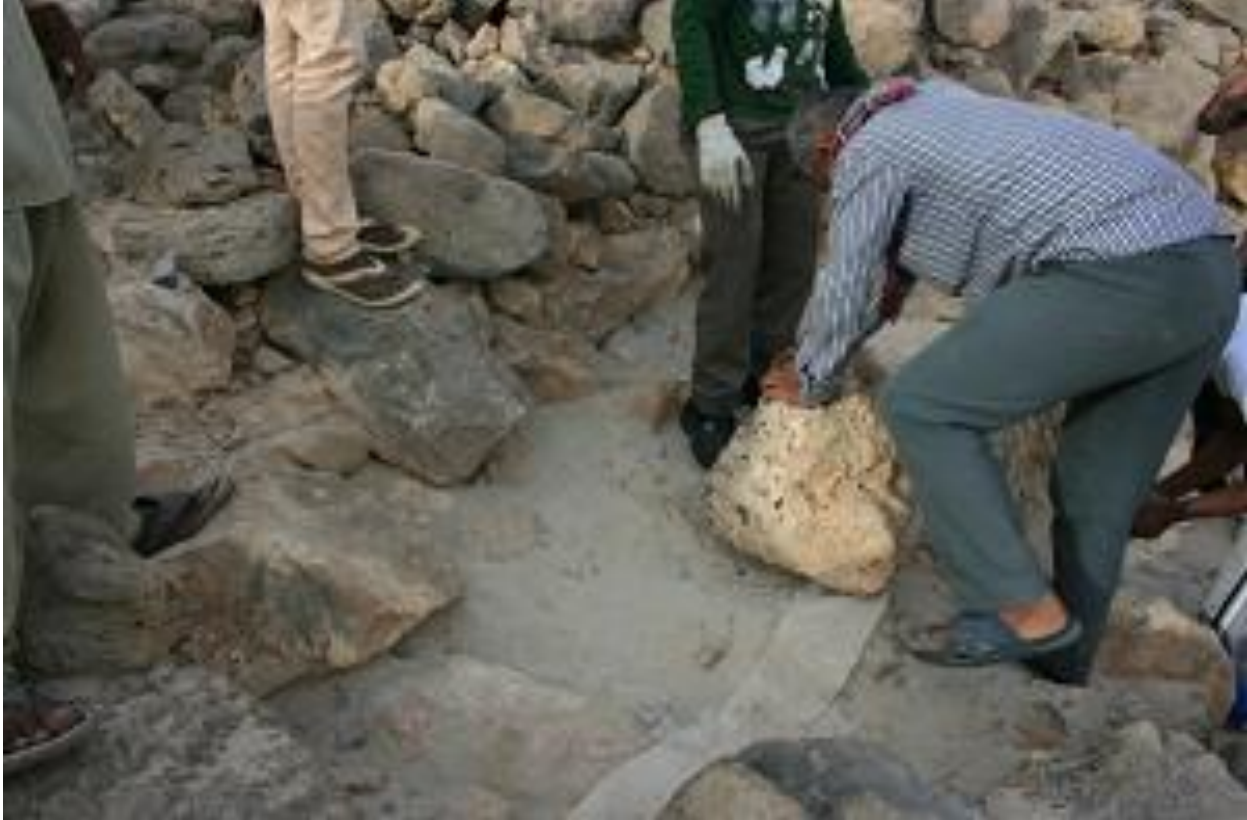
Consolidation of basement

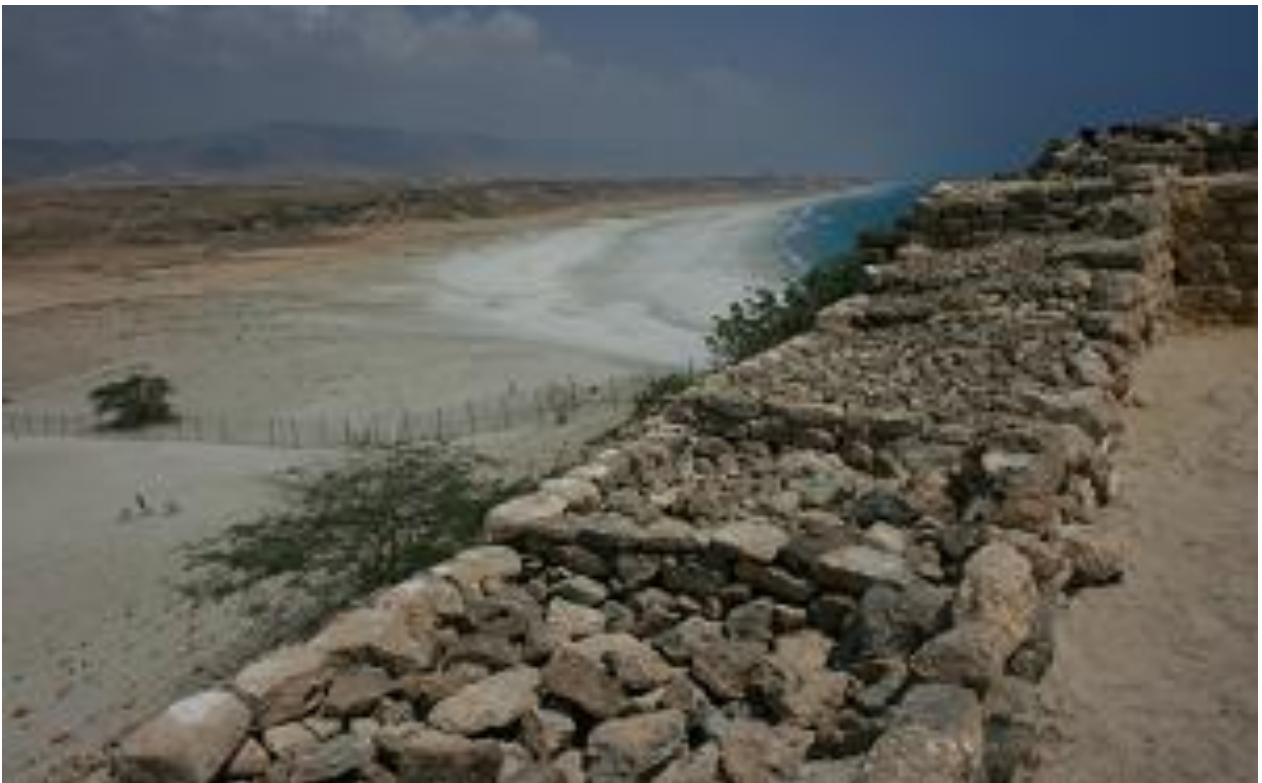
Terraced steps, in accordance with the existing southern front

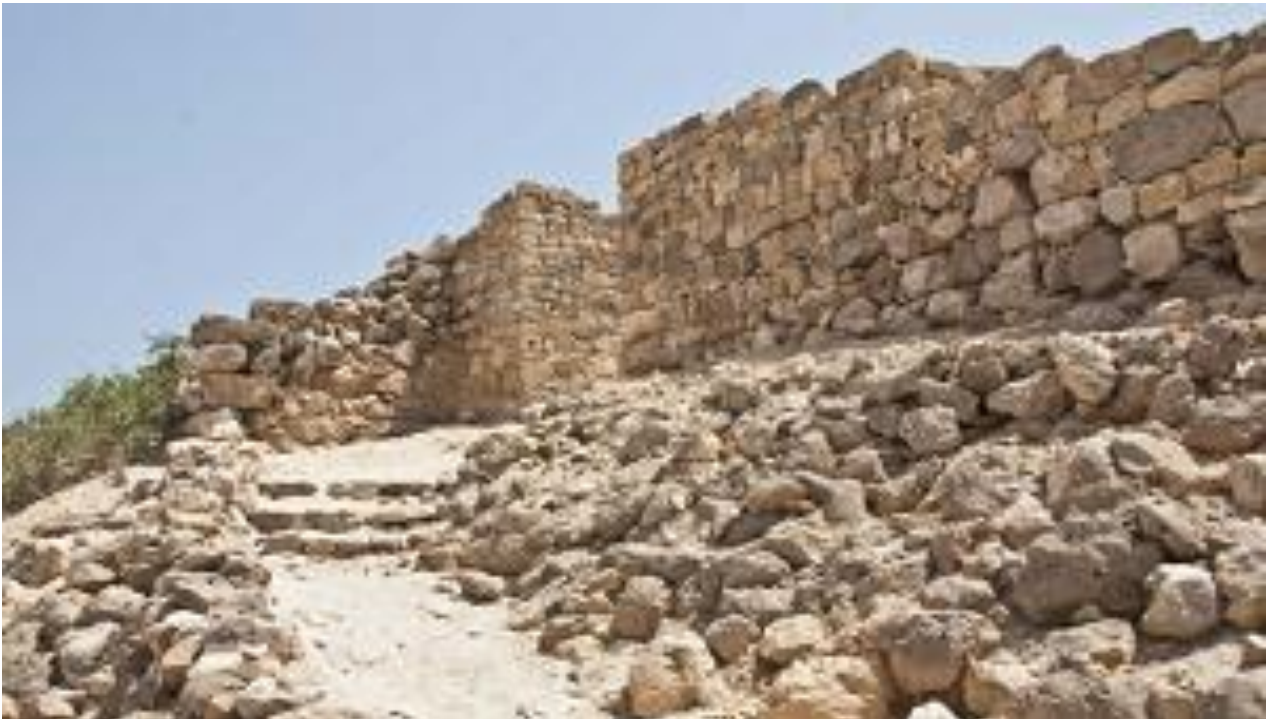
North side before cleaning
