Restoration report

**RESTORATION WORKS AT SUMHURAM
(ARCHAEOLOGICAL PARK OF KHOR RORI)
(Sultanate of Oman)
CAMPAIGN SUM16B (November-December)**

Technical Report
12th November – 7th December 2016

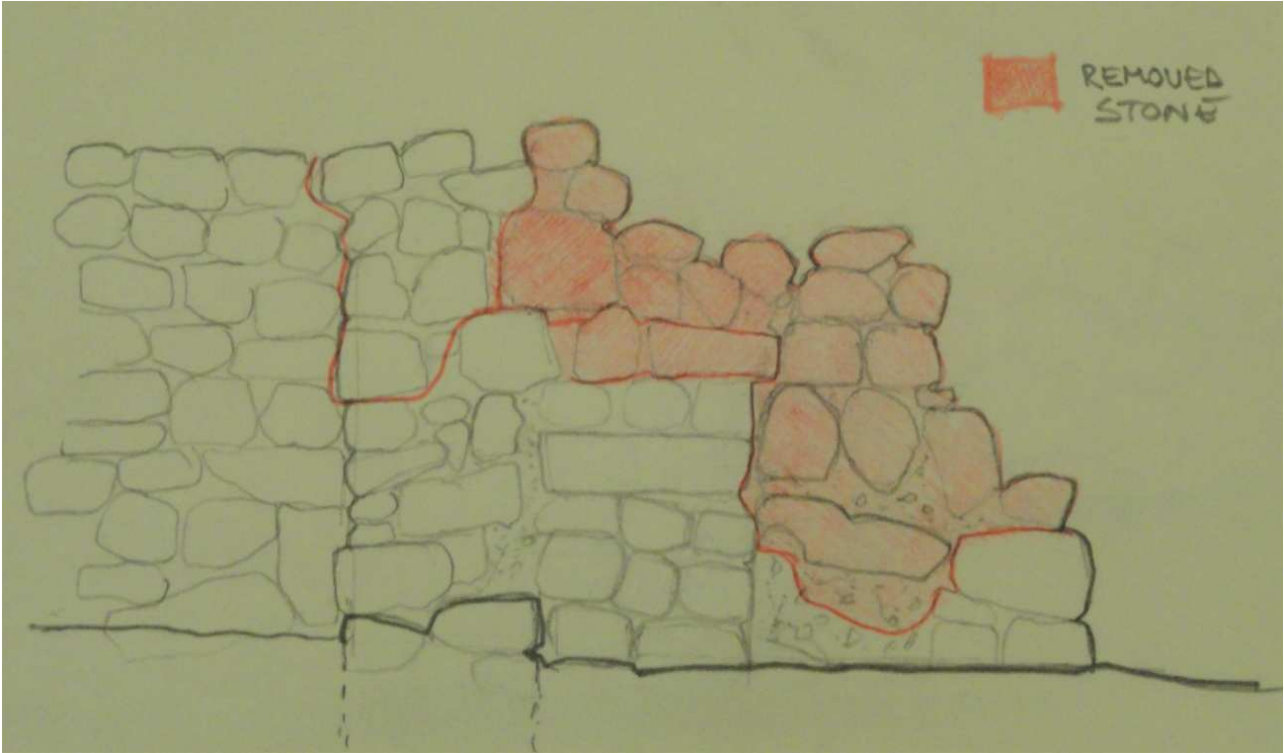
The work is proceeded with the disassembly of some parts of the masonry, the cleaning and the replacement with the same stones as not to alter the original shape. The wall had vertical fractures that could result in the collapse.

Sketch of the wall M572. Stones to remove highlighted with hatch

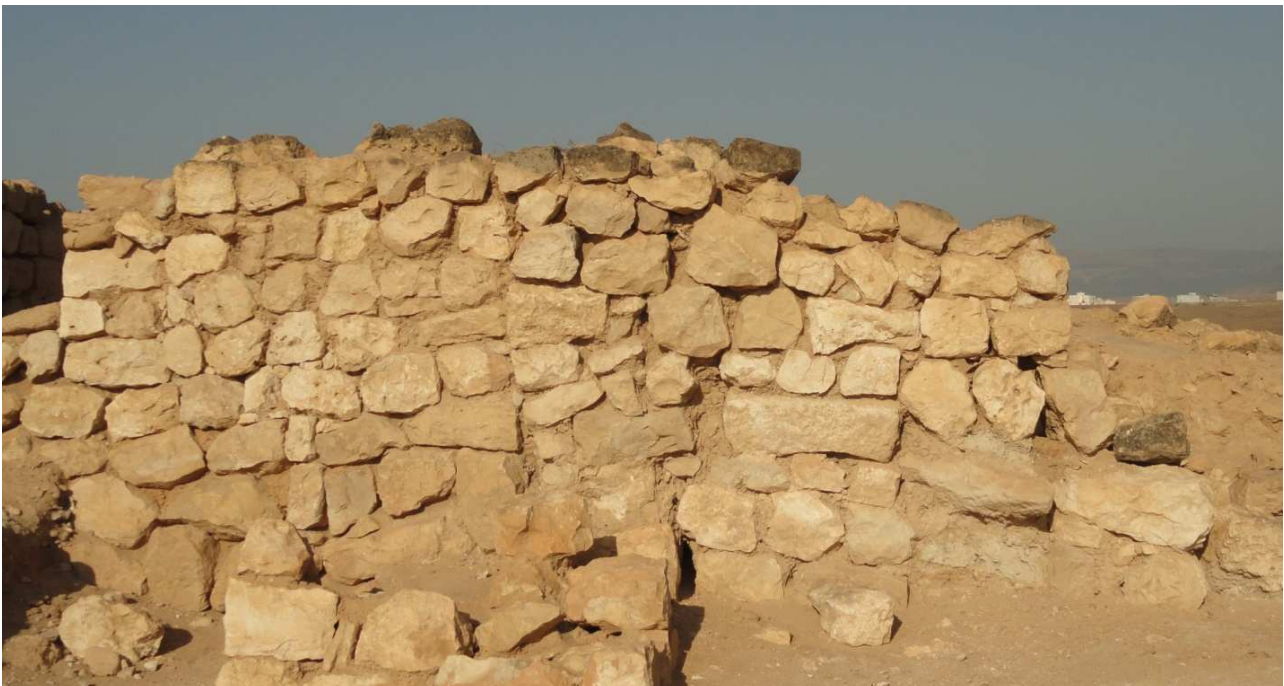
M572, East front wall, before the restoration.

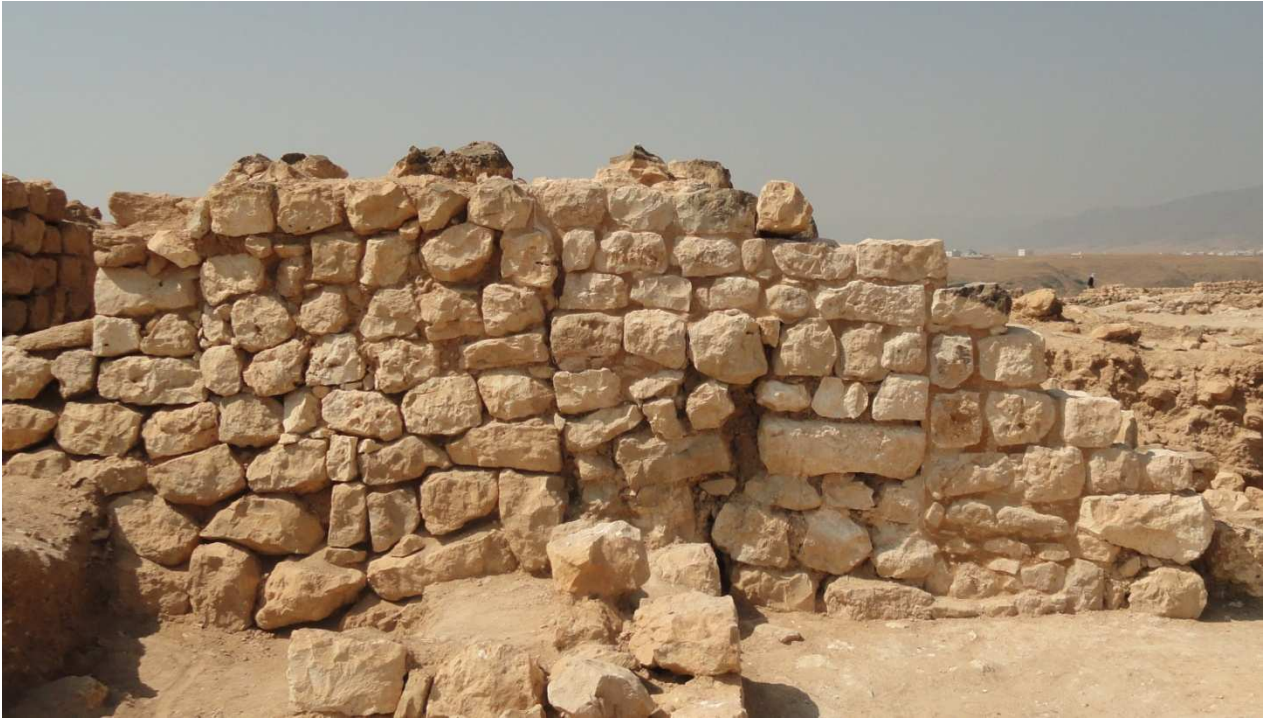
M572, East front wall, after the restoration.

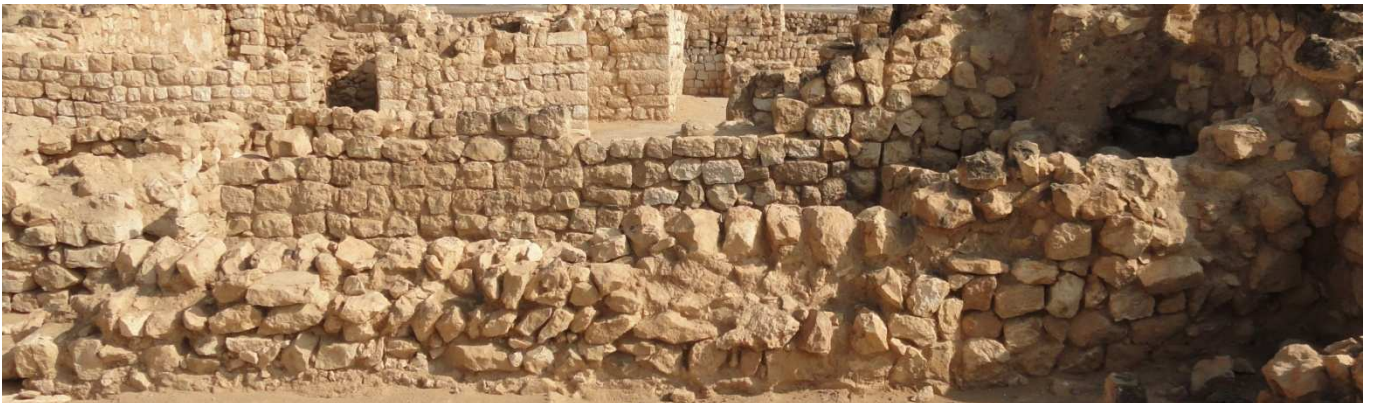
The work is proceeded with the disassembly of some parts of the masonry, the cleaning and the replacement with the same stones as not to alter the original shape. Restoration has affected only the south facade of the wall.

M582, South front wall, before the restoration.

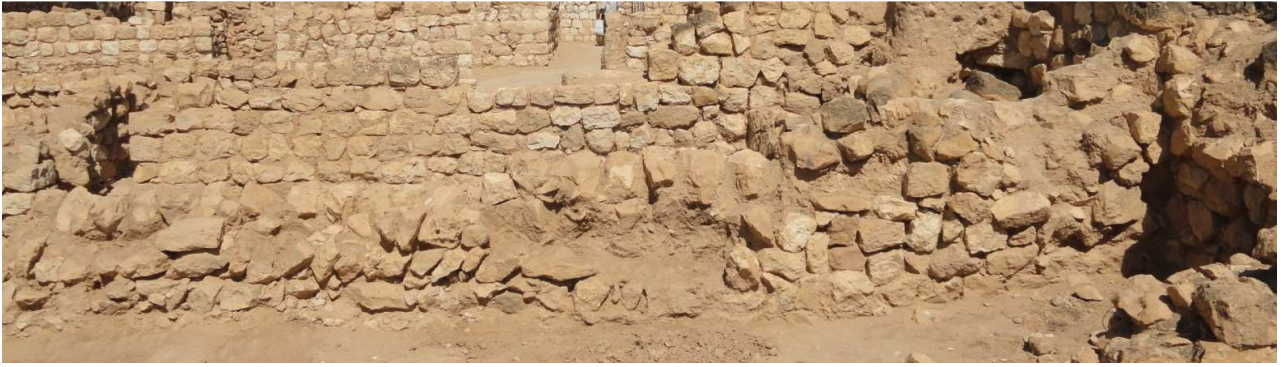
M582, South front wall, during the cleaning work .

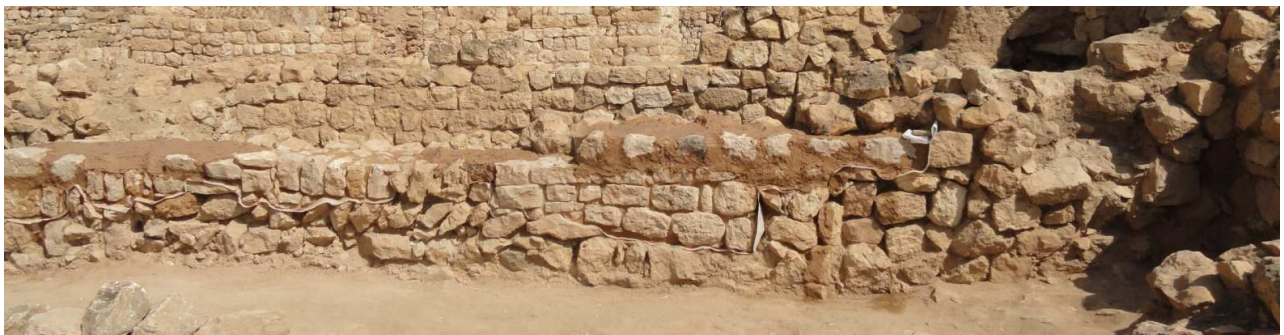
M582, South front wall, during the restoration work.

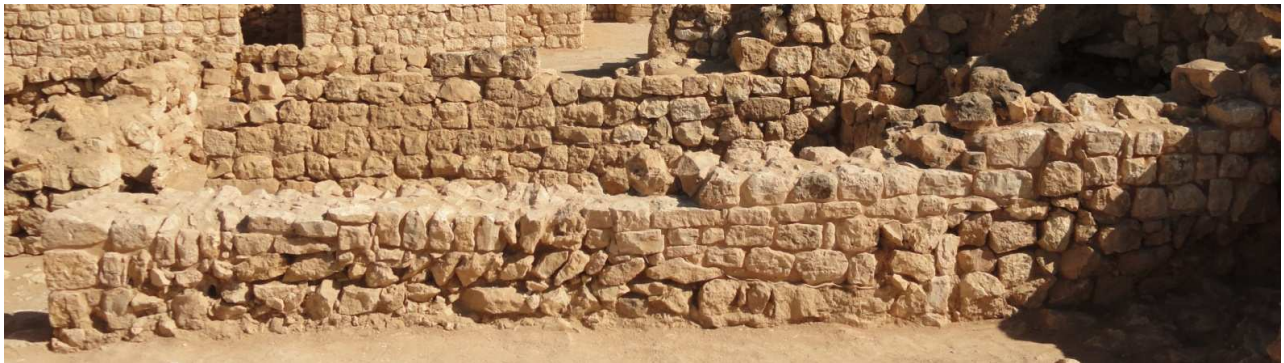
M582, South front wall, after the restoration.

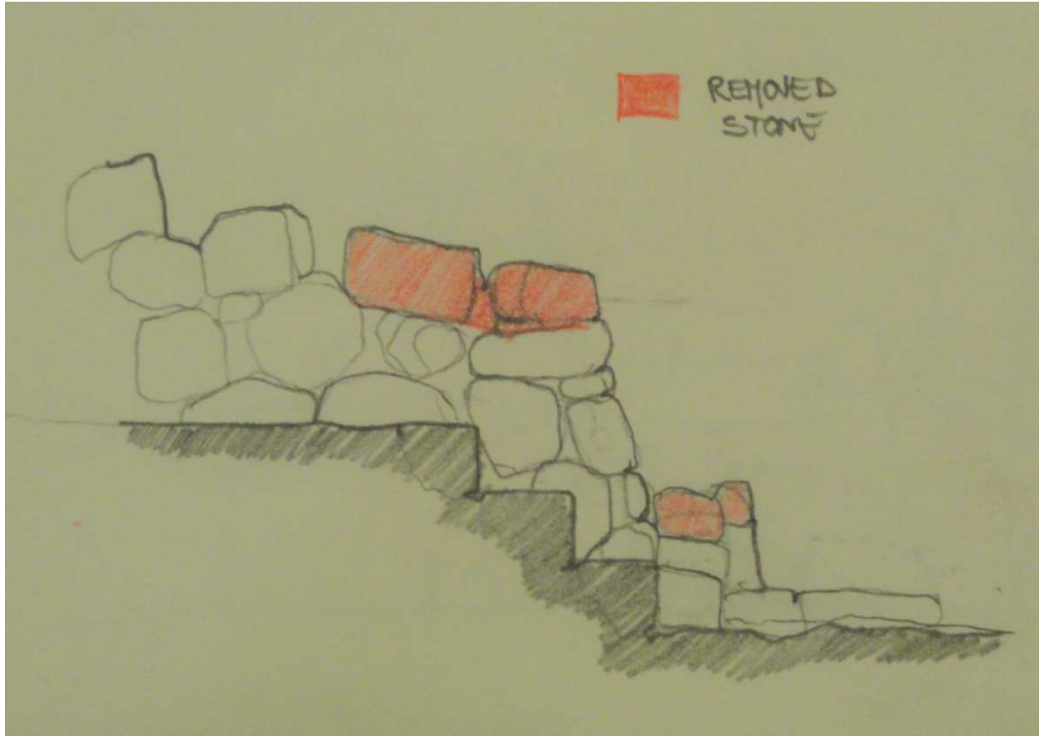
The stones in the upper part of the wall had collapsed, the work is proceeded with the disassembly of some parts of the masonry, the cleaning and the replacement with the same stones as not to alter the original shape.

Sketch of the wall M16. Stones to remove highlighted with hatch

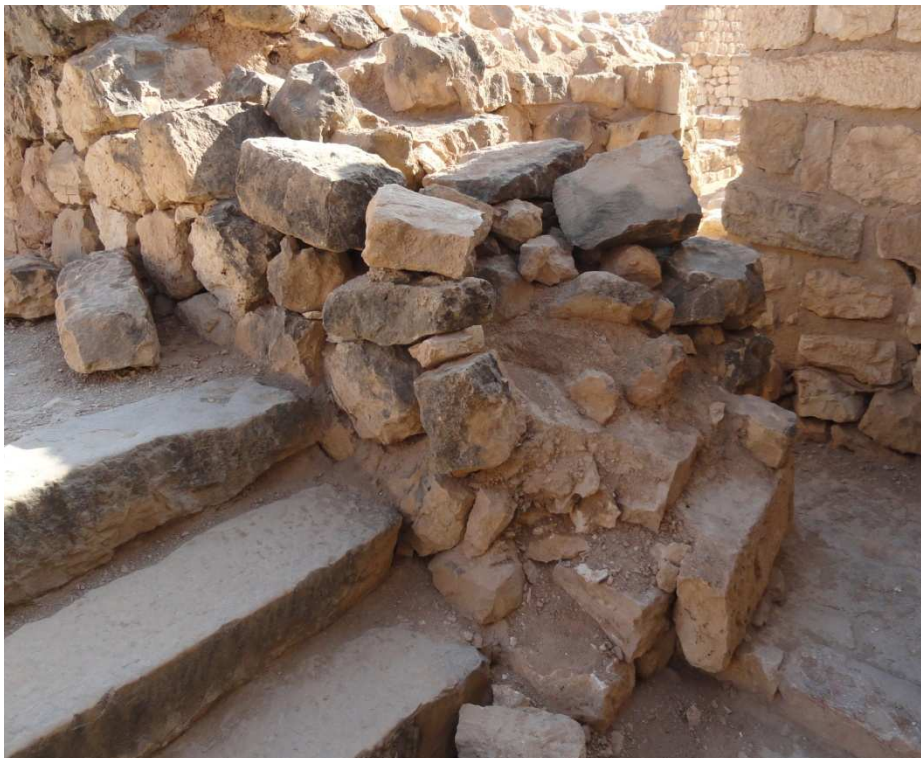
M16, West front wall, before the restoration.

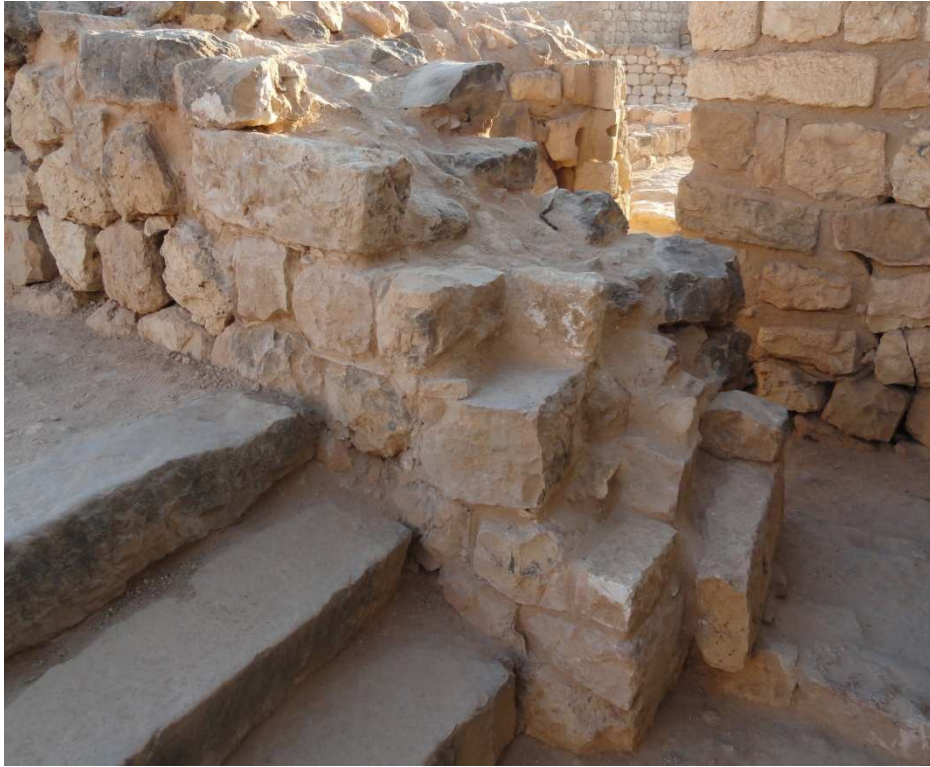
M16, West front wall, after the restoration.

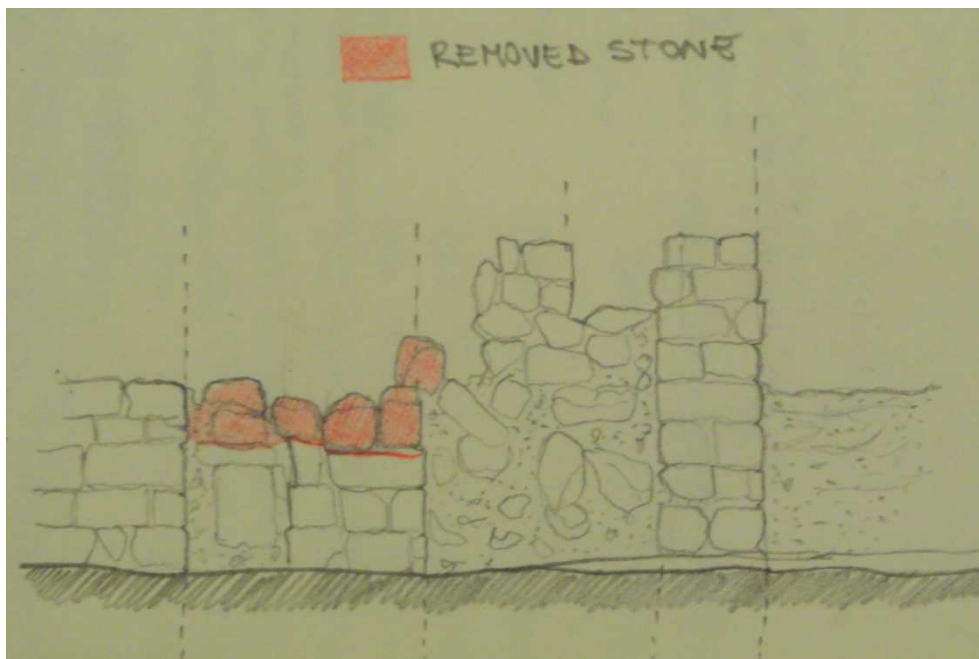
The work is proceeded with the disassembly of some parts of the masonry, the cleaning and the replacement with the same stones as not to alter the original shape. Restoration has affected only the north facade of the wall.

Sketch of the wall M485. Stones to remove highlighted with hatch

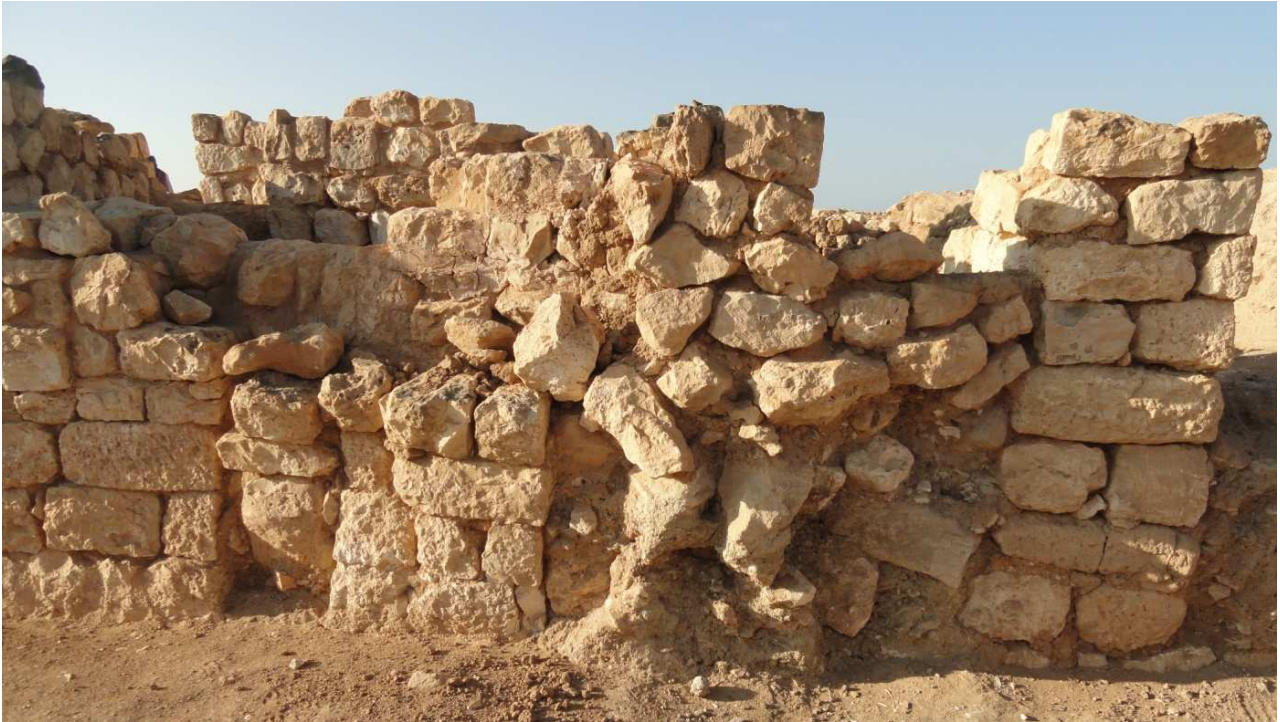
M485, North front wall, before the restoration.

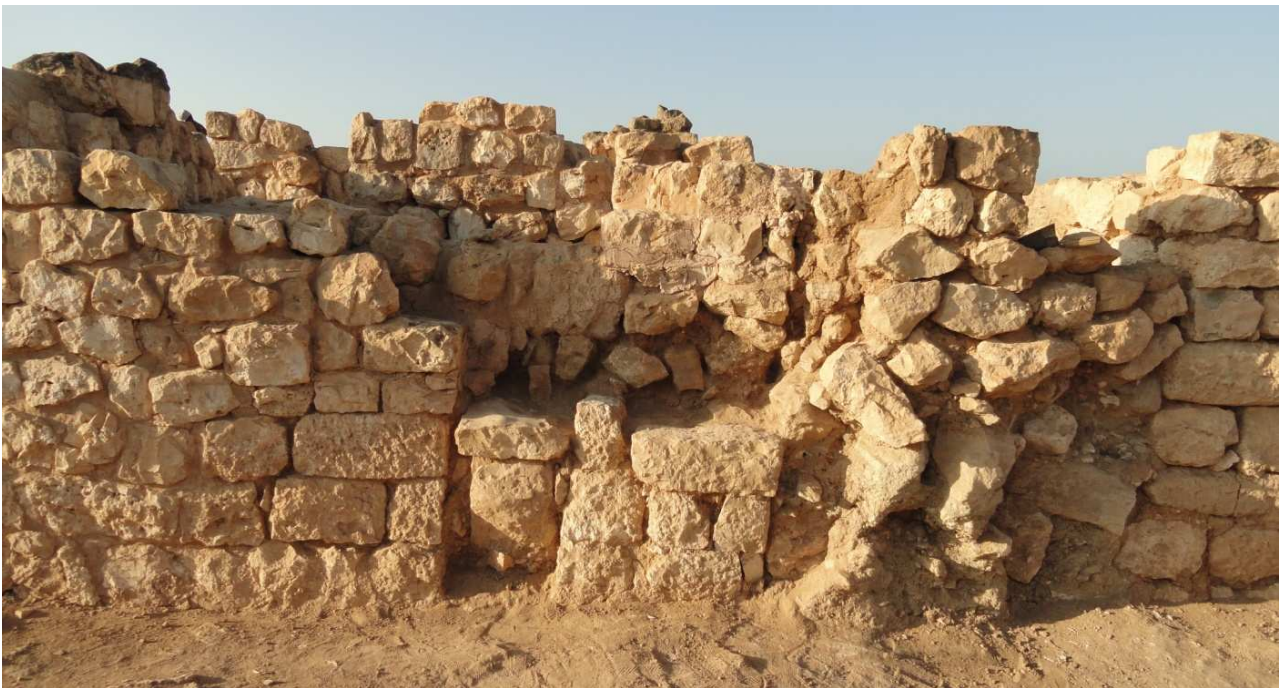
M485, North front wall, during the cleaning work.

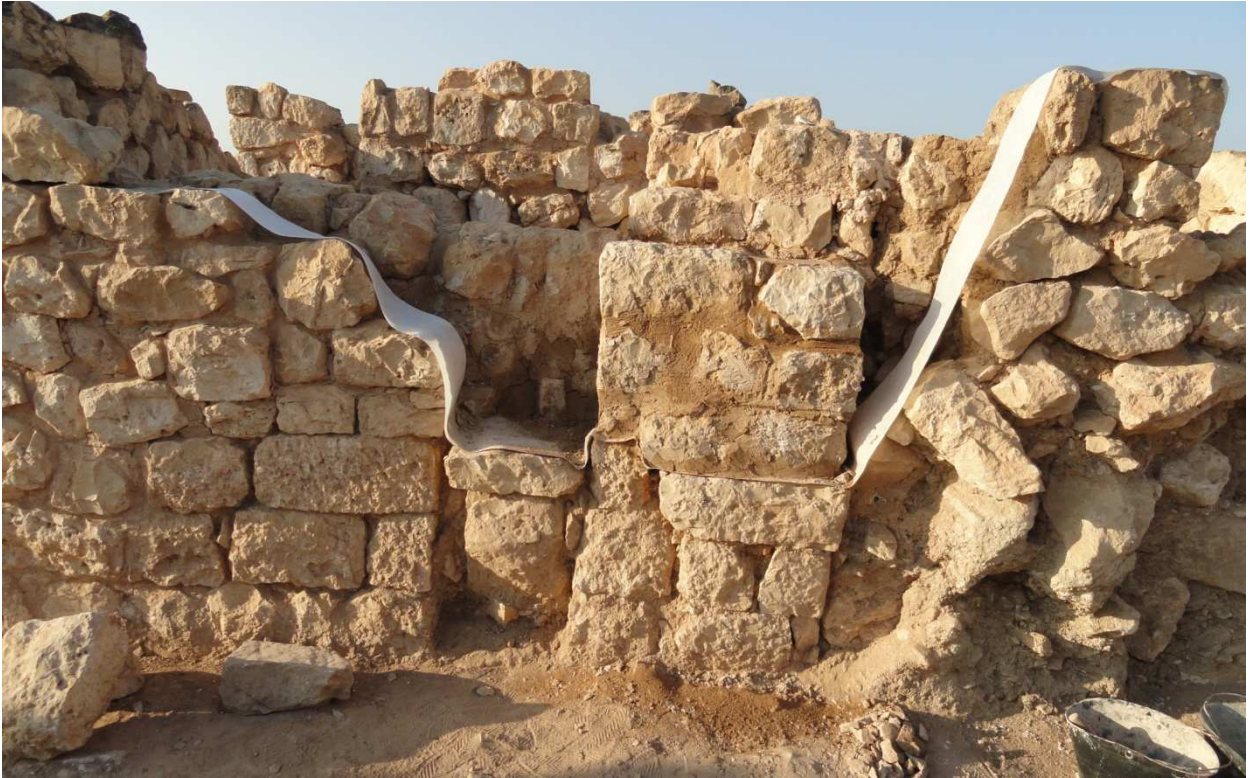
M485, North front wall, during the restoration work.

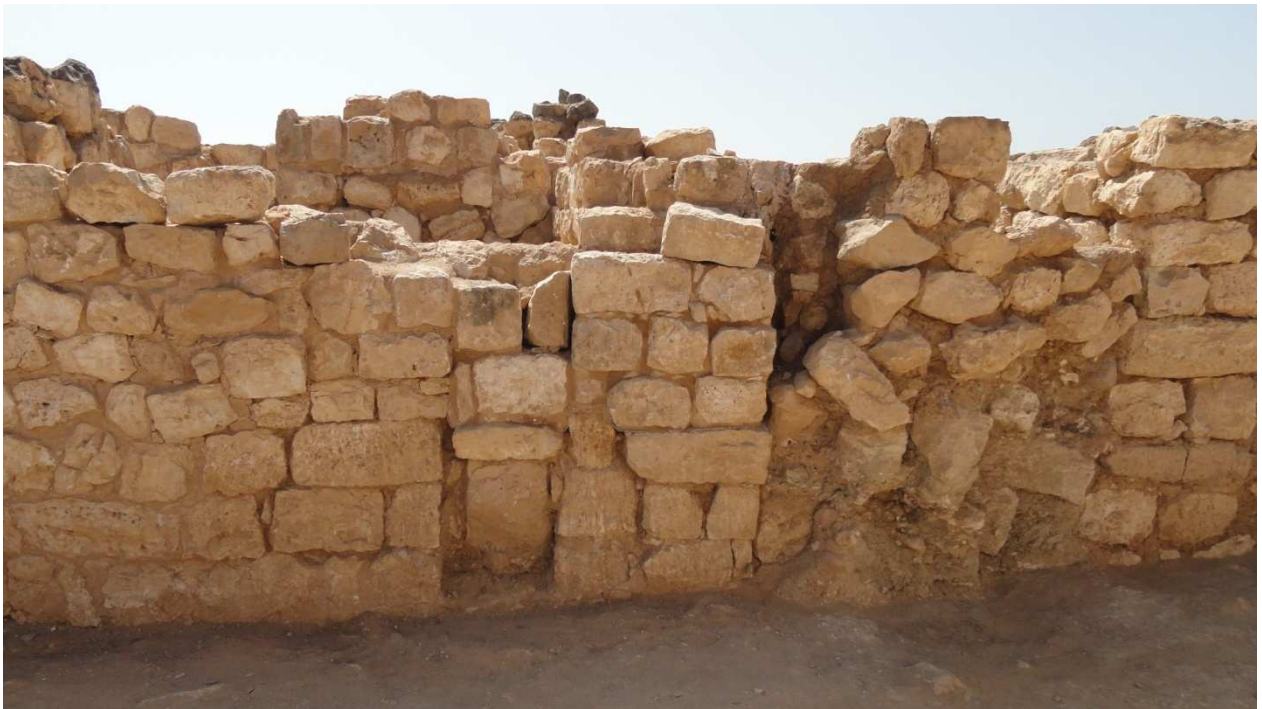
M485, North front wall, after the restoration.

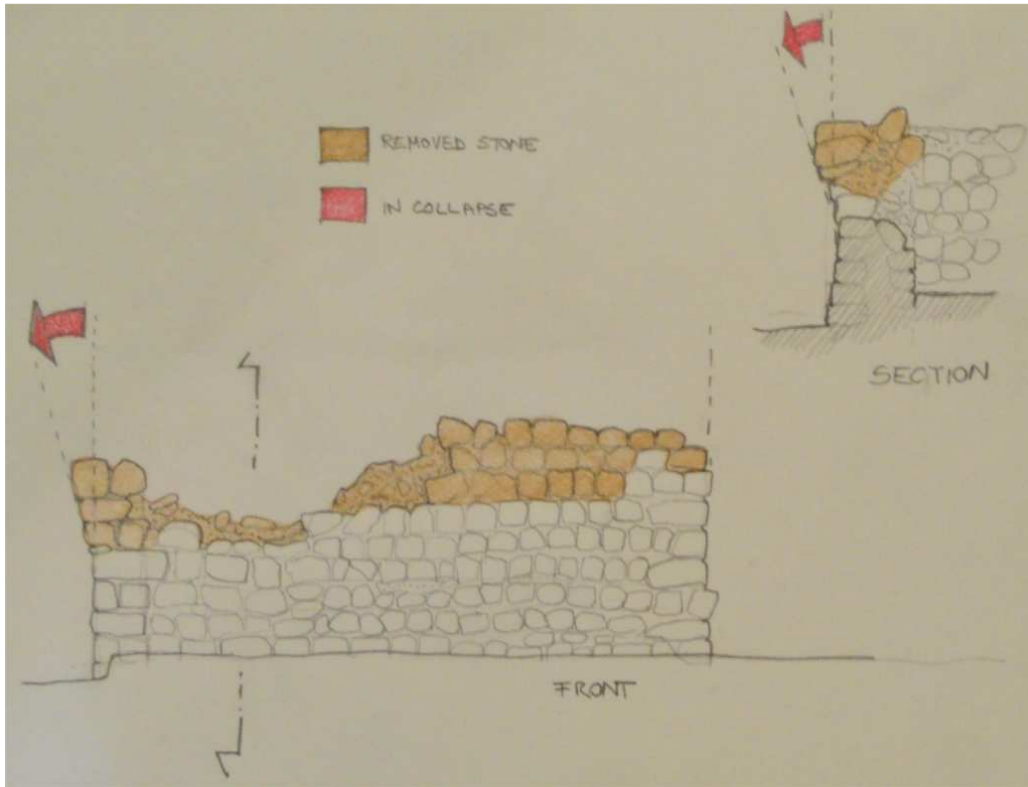
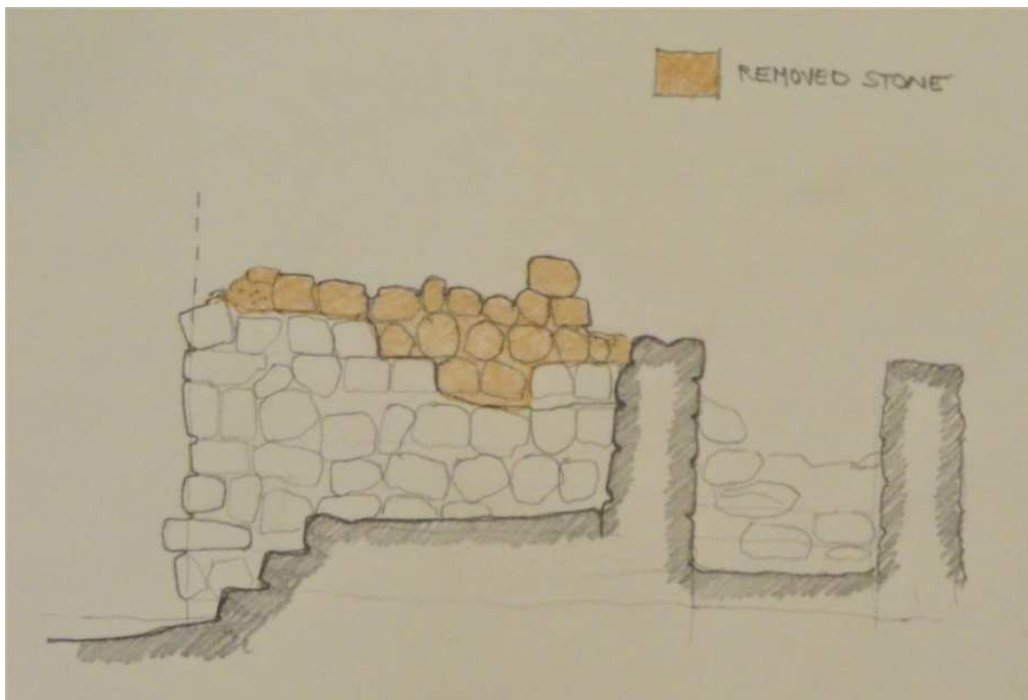
The wall is one of the main tourist routes in the direction of the temple, the upper part was in grave state of near collapse. The work is proceeded with the disassembly of some parts of the masonry, the cleaning and the replacement with the same stones as not to alter the original shape.

Sketch of the wall M290-274. Stones to remove highlighted with hatch

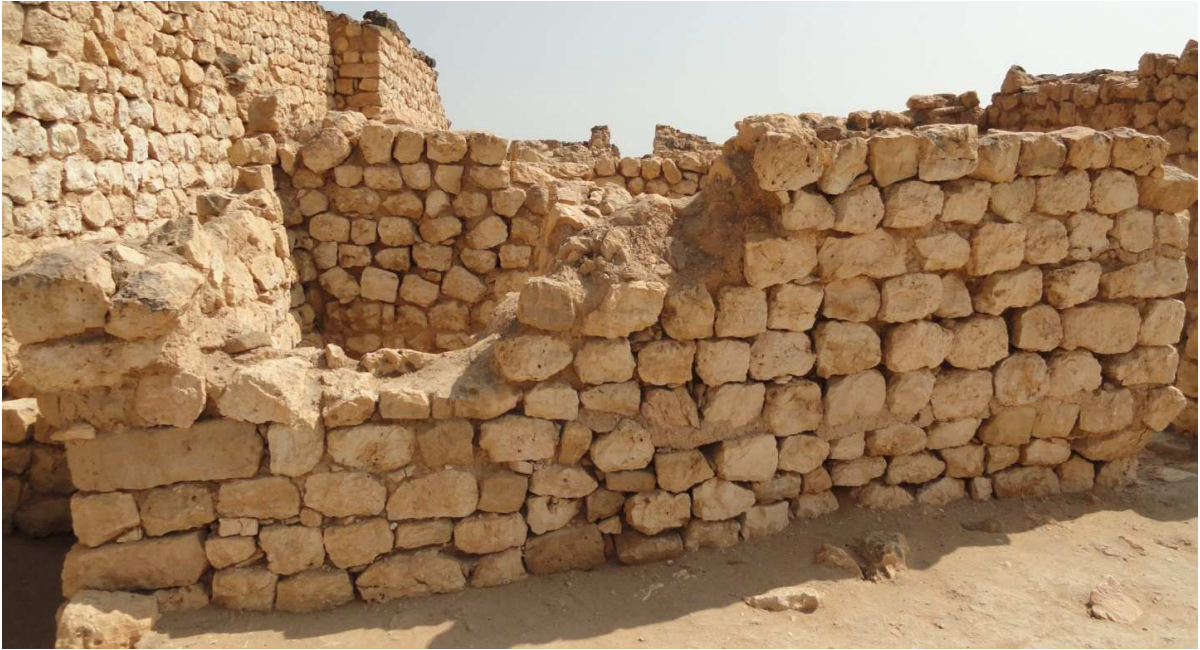
M290-274, West front wall, before the restoration.

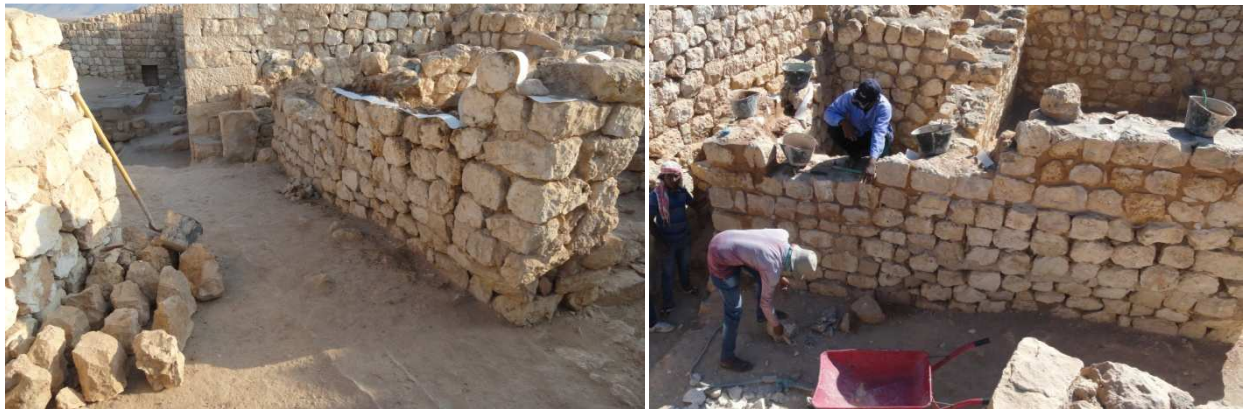
M290-274, West front wall, during the restoration work.

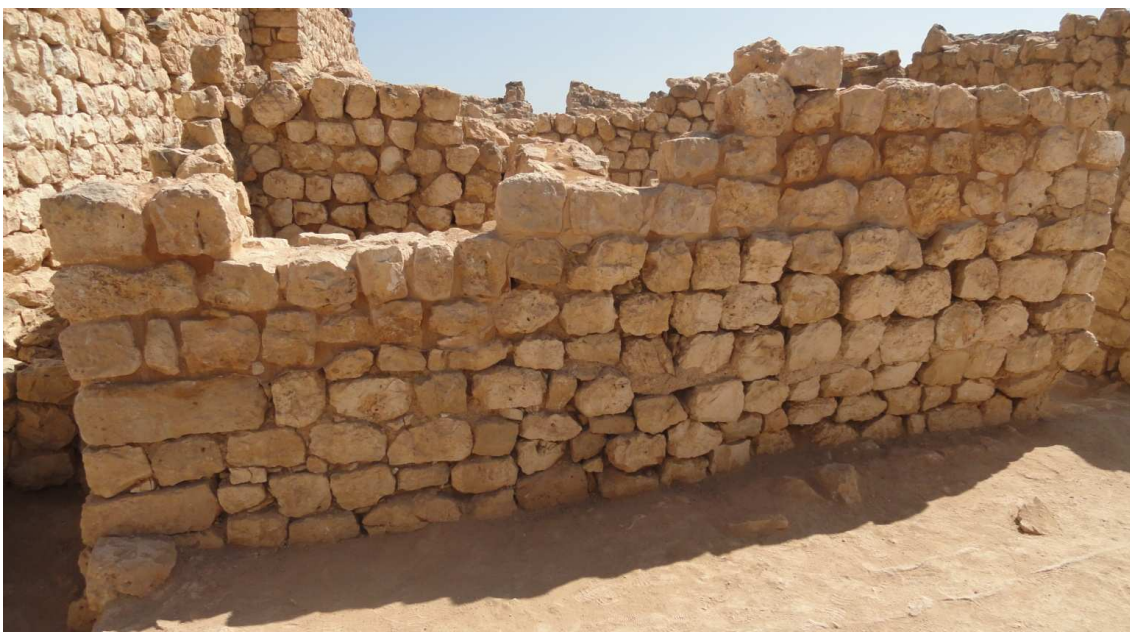
M290-274, West front wall, after the restoration.

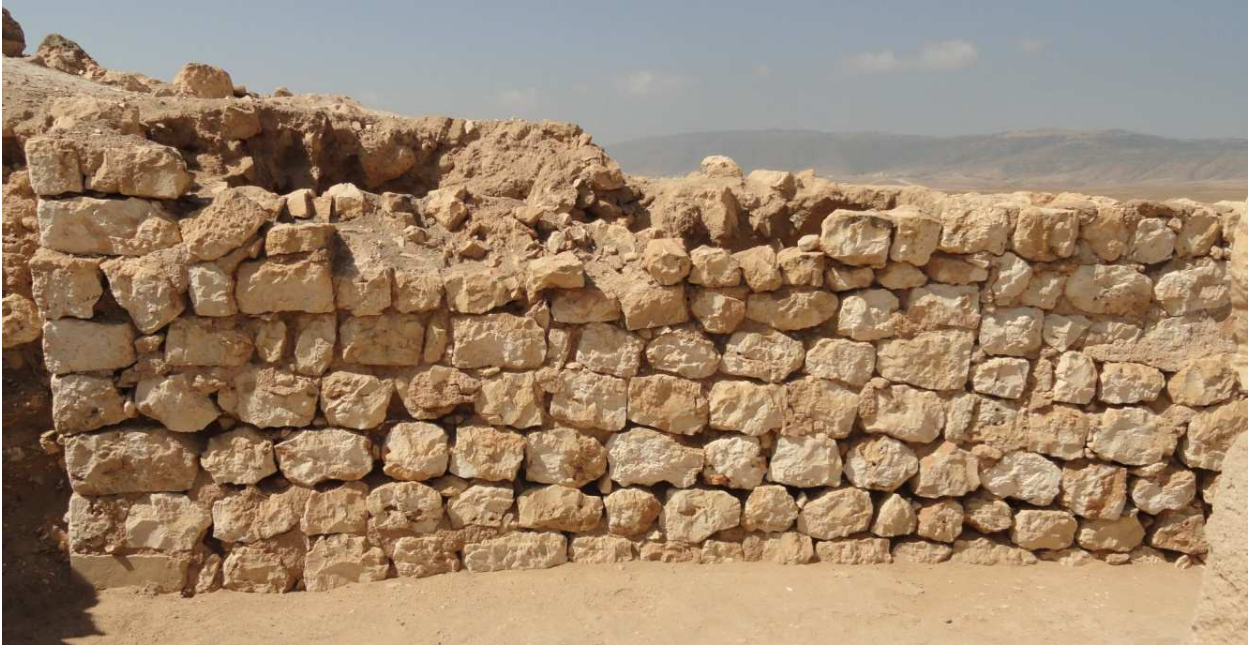
The wall is one of the main tourist routes in the direction of the temple, the upper part was in grave state of near collapse. The work is proceeded with the disassembly of some parts of the masonry, the cleaning and the replacement with the same stones as not to alter the original shape

M464, East front wall, before the restoration.

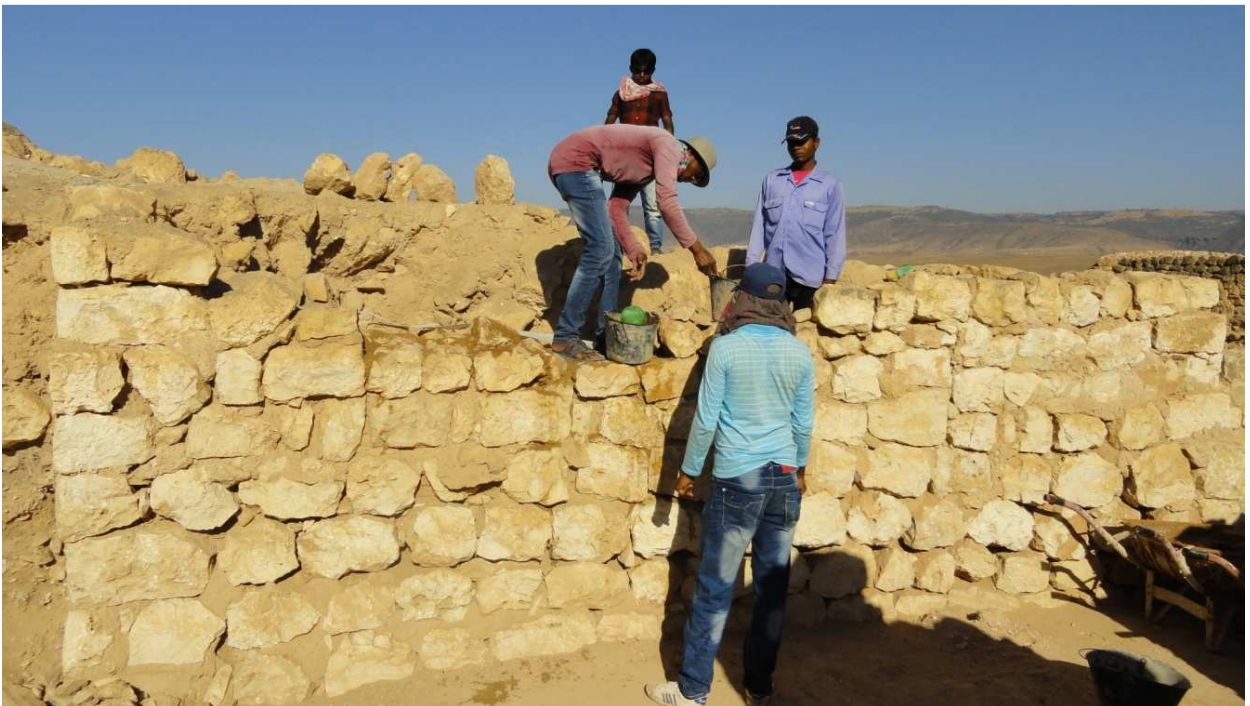
M464, East front wall, during the work.

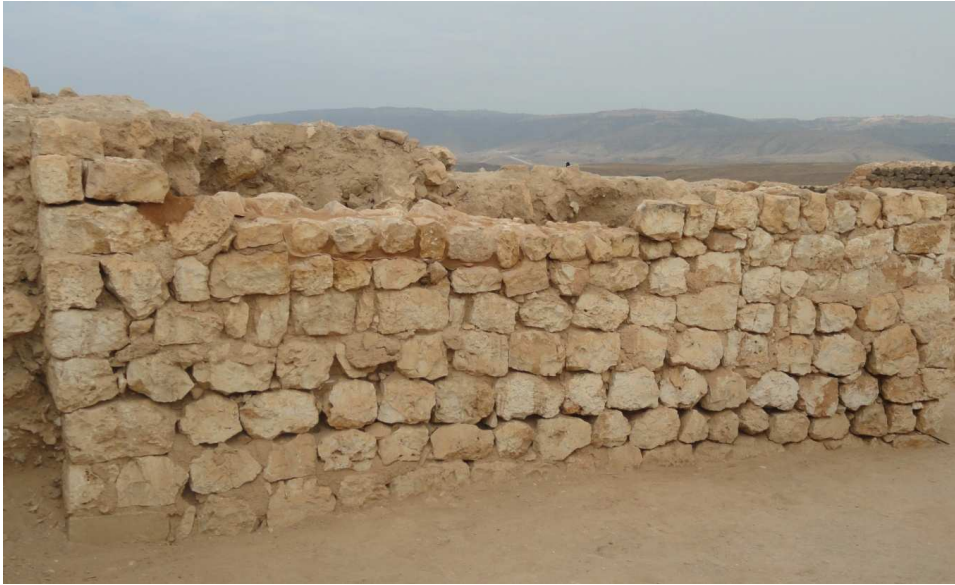
M464, East front wall, after the restoration.

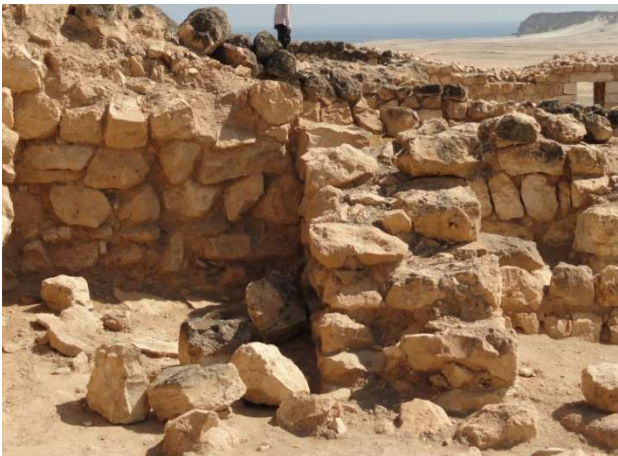
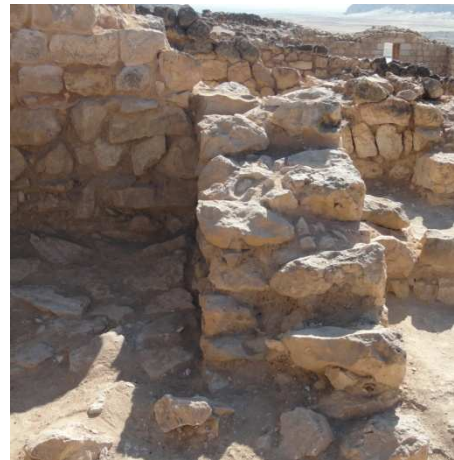
Endeavored the methodology for the restoration of this wall is different from other interventions, having no particular problems of stability, we carried out the filling of the mortar joints on the top of the wall. This method could be a method to be employed on all the walls that have the same degradation.

M578, before and after the restoration.

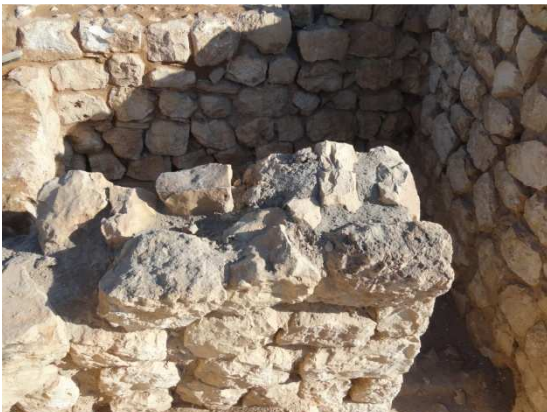
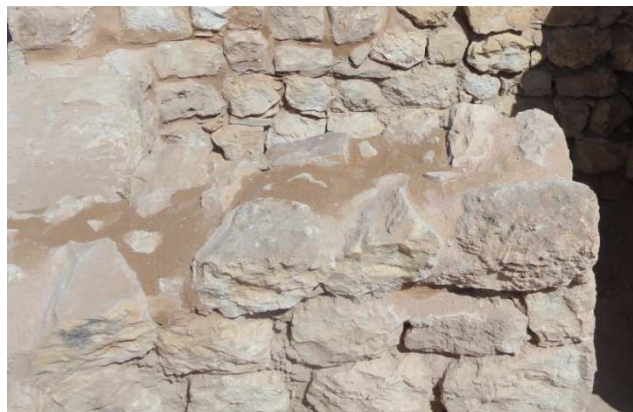
M400, before and after the restoration.

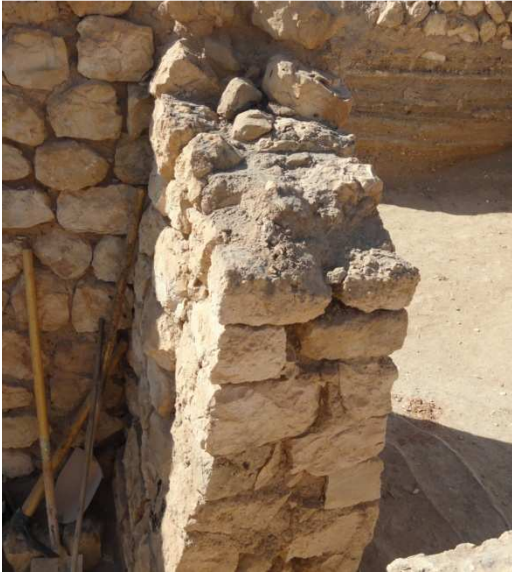
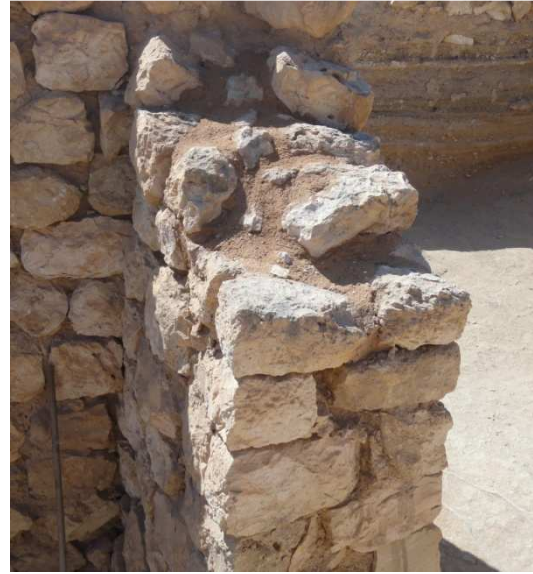
M290, before and after the restoration.

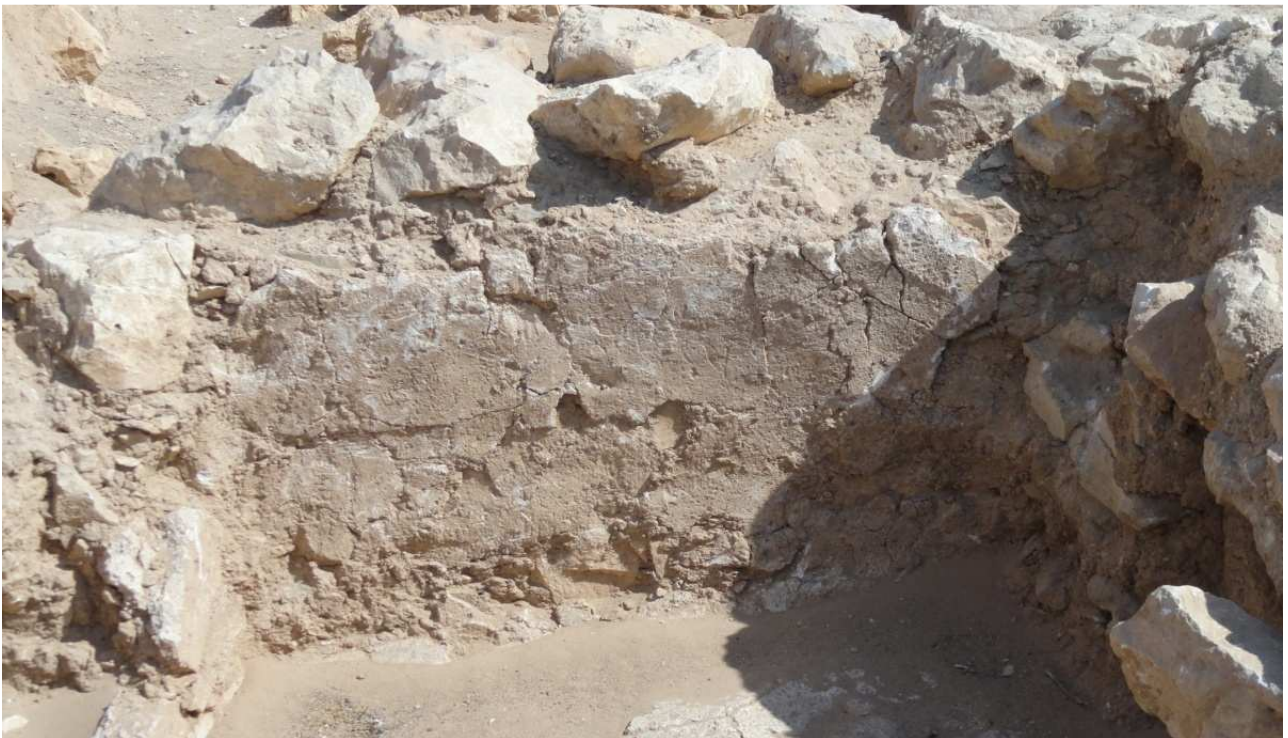
During the restoration of the walls we have personally run the consolidation of the plaster wall of an environment dug in October 2016, it is probably a basin. Execution phases: cleaning with brushes and water, laying of a new mortar in the edges.

South wall, façade. before the restoration

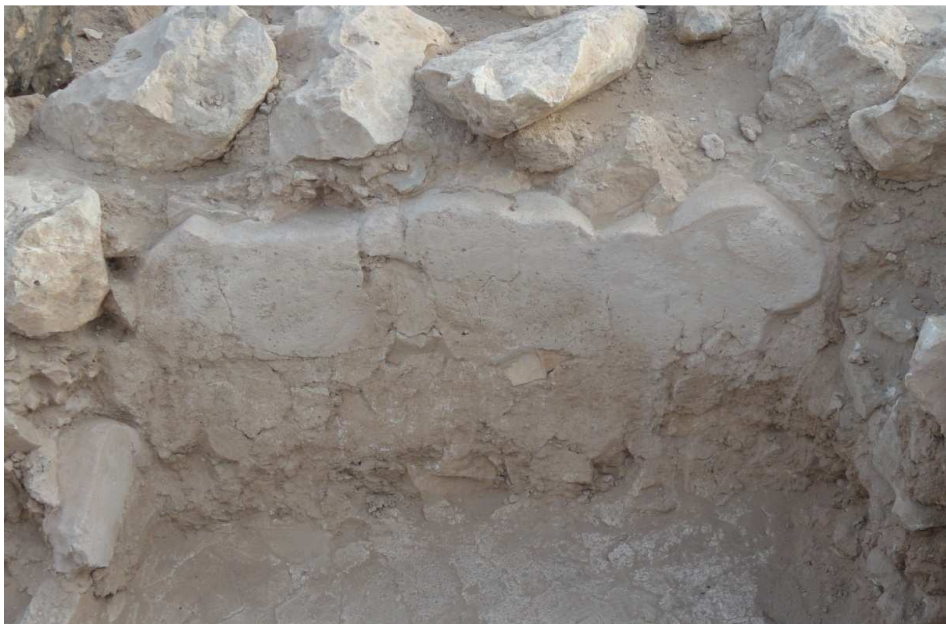
South wall, façade. after the restoration

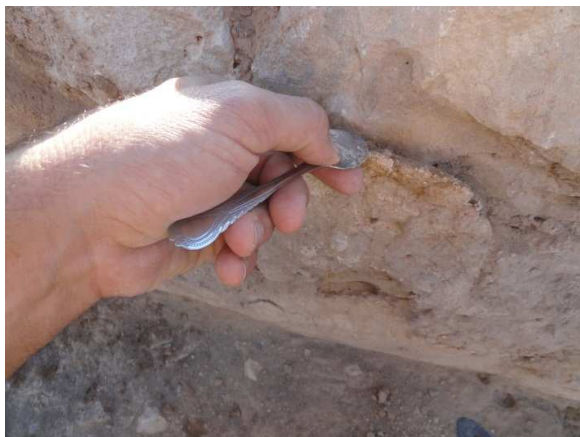
Dust removal

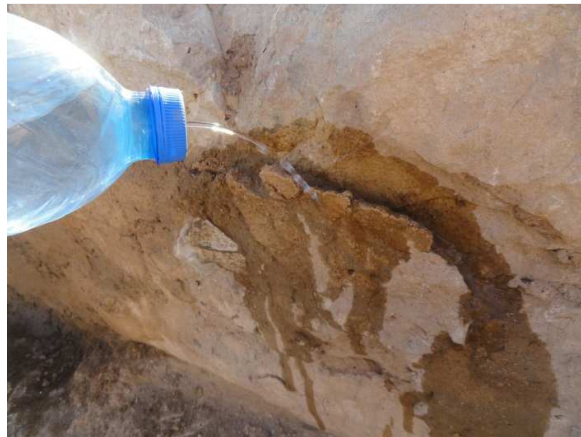
Cleaning

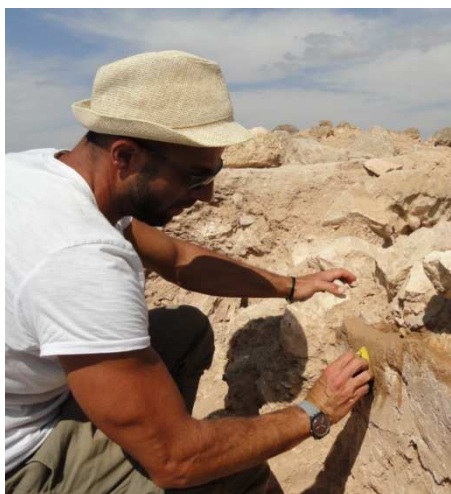
Laying of new plaster

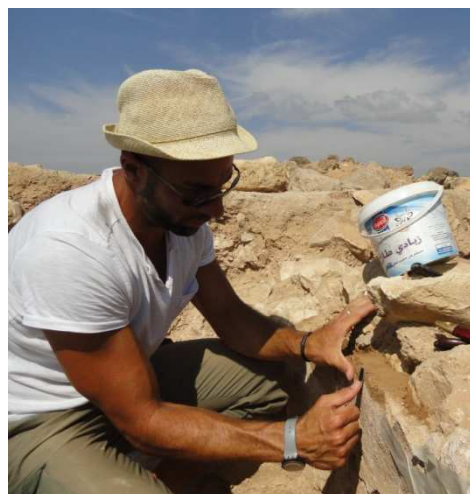
Setting of new plaster
