**RESTORATION WORKS AT SUMHURAM  
(ARCHAEOLOGICAL PARK OF KHOR RORI)  
(Sultanate of Oman)  
CAMPAIGN October-December 2017**

**Technical Report**  
**16<sup>th</sup> October – 14<sup>th</sup> December 2017**

**Michele Chimienti – Emiliano Mura**  
**ARCHITECTS**

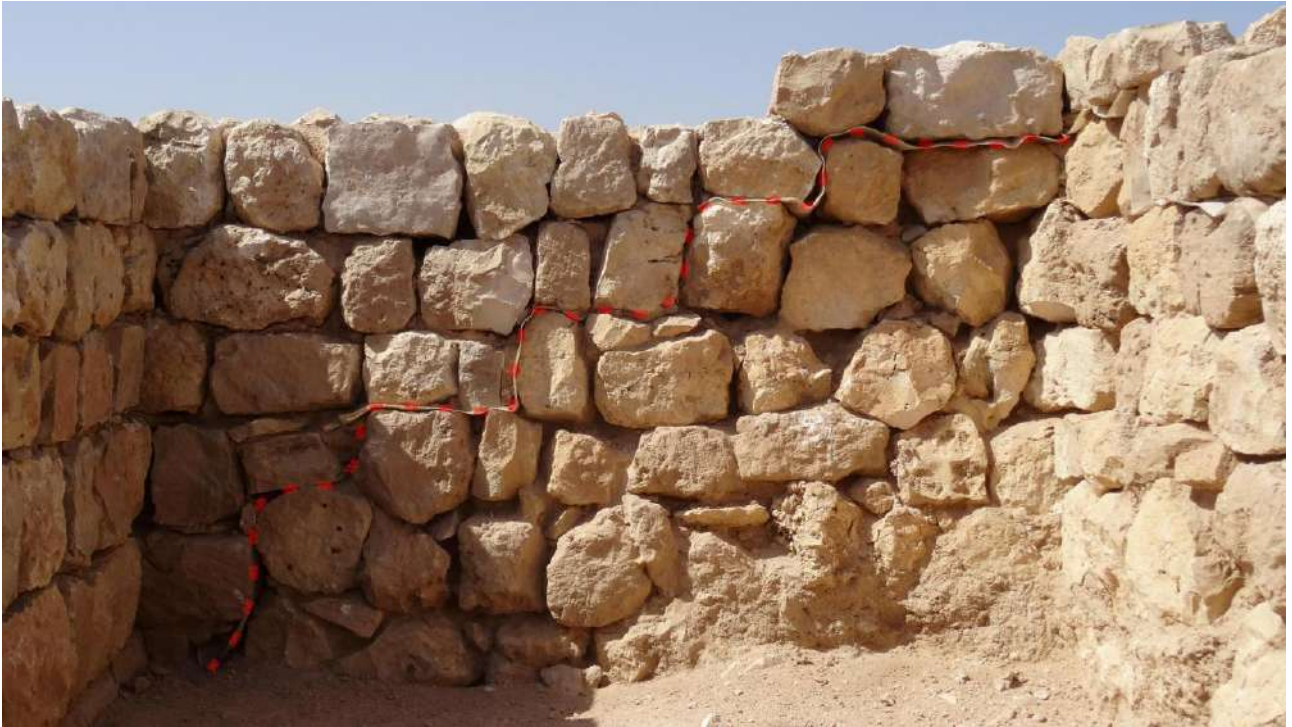
*Fig. 3 – New (on the left) and old (on the right) masonry texture. Building BA12, wall M185.*

All restored and reconstructed masonry sections were built in accordance with the original construction technology, using stone blocks from the site and mortar with local sand as inert. Stone blocks were chosen to be as much similar as possible to those of the original parts, both in size, shape and color. The wall texture of the restored and reconstructed portions was set up with very retracted mortar in order to homogenize new rebuilt sections with the surrounding built environment (Fig. 3).

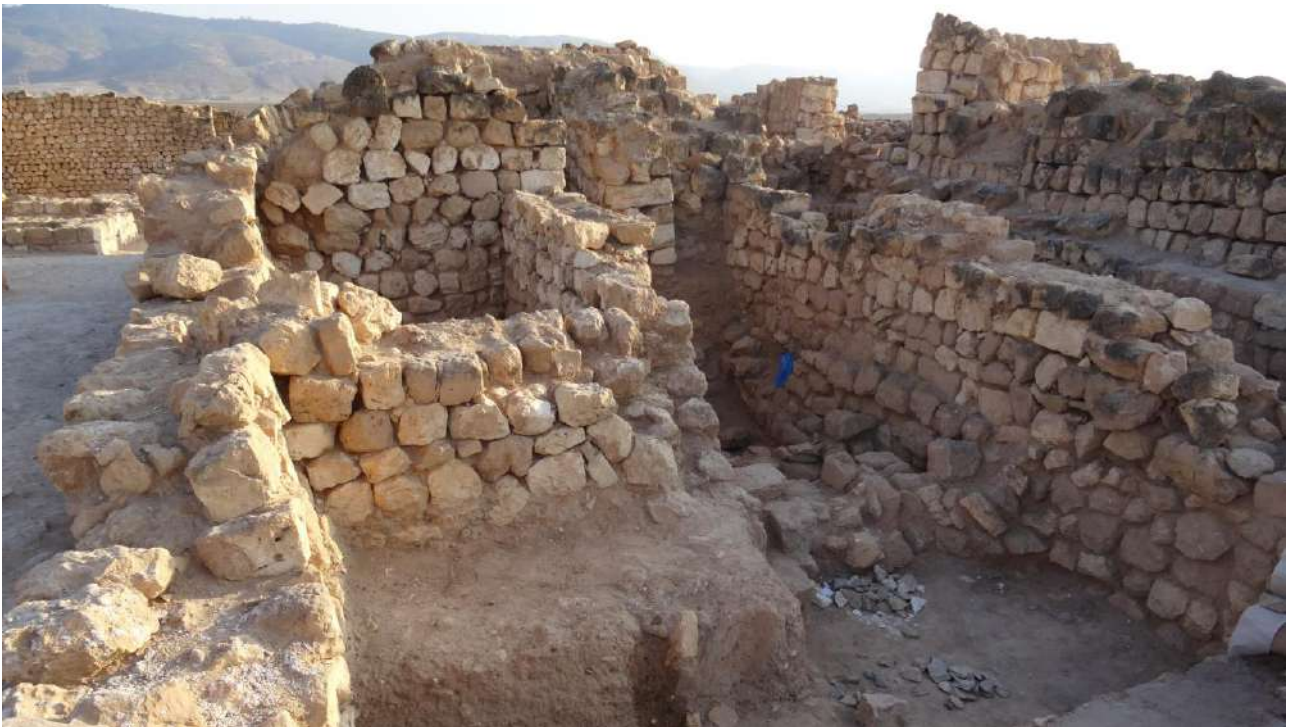
Before the restoration, the corner between the walls M541 and M542 was almost completely collapsed, especially the south and east faces. Before rebuilding the corner, the unstable stones were removed to have a solid foundation for new wall sections. Moreover, as explained in the introduction, the upper surface of the support was abundantly wet and a geotextile layer was placed above the original masonry. The upper surface of the new corner and of the masonries M541 and M542 was reshaped to make it similar to the surrounding ruins, and not similar to that of a new wall (Figs. 8).

*Fig. 7b – BA12 before the restoration work (view from SW).*

The first part of the Mission concerned the restoration of part of BA12. In particular, it was rebuilt the corner between the walls M541 and M542, the upper part of the the walls M541 and M542, the western part of the wall M554 and the southern part of the wall M185, and it was disassembled and reconstructed the upper part of the southern area of the wall M550 (Figs. 7).

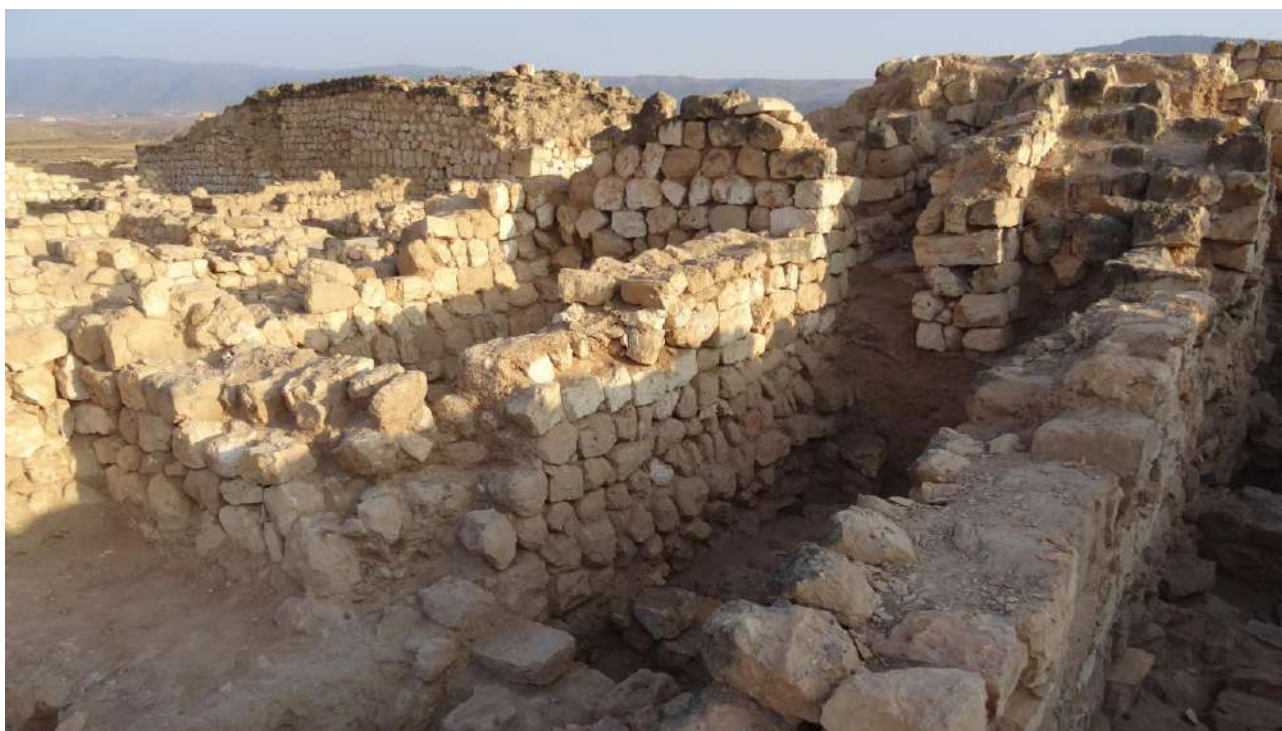
*Fig. 7d – BA12 before the restoration work (view from SE).*

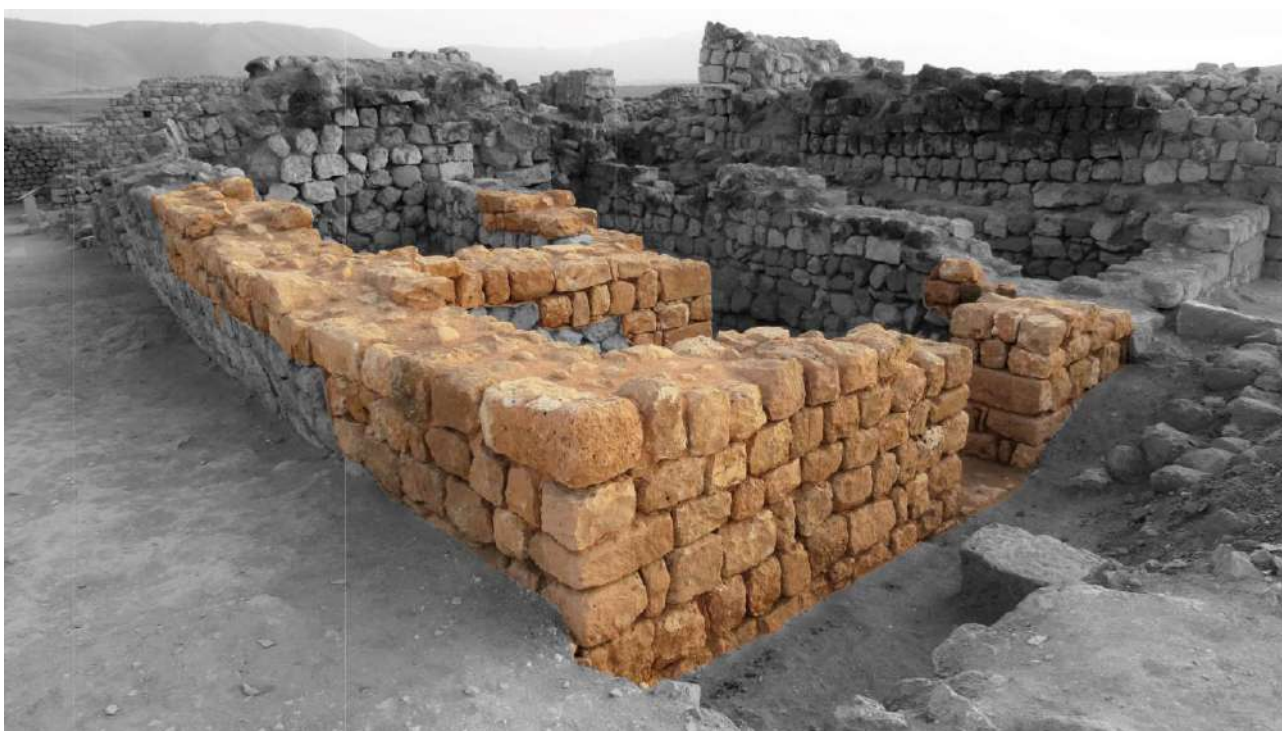
*Fig. 7f – Details of restoration works of BA12 (view from SW).*

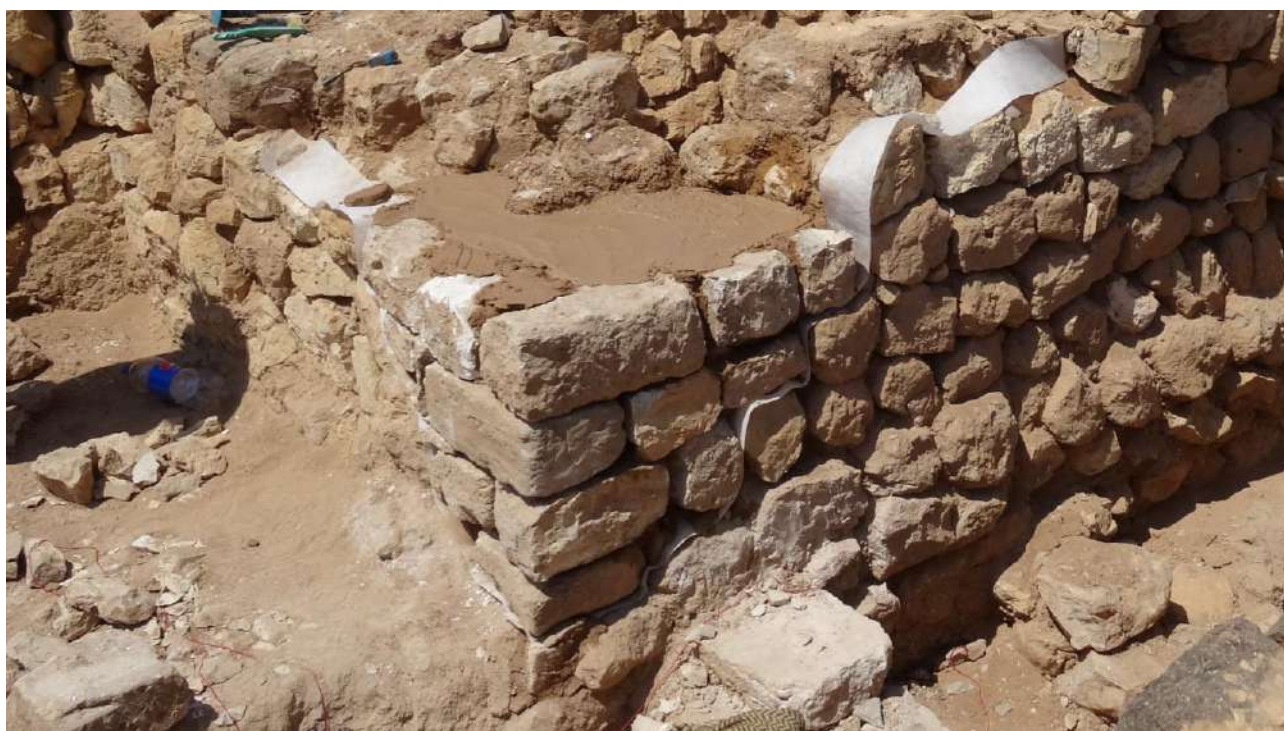
*Fig. 8b – BA12, corner between M541 and M542 during the restoration works.*

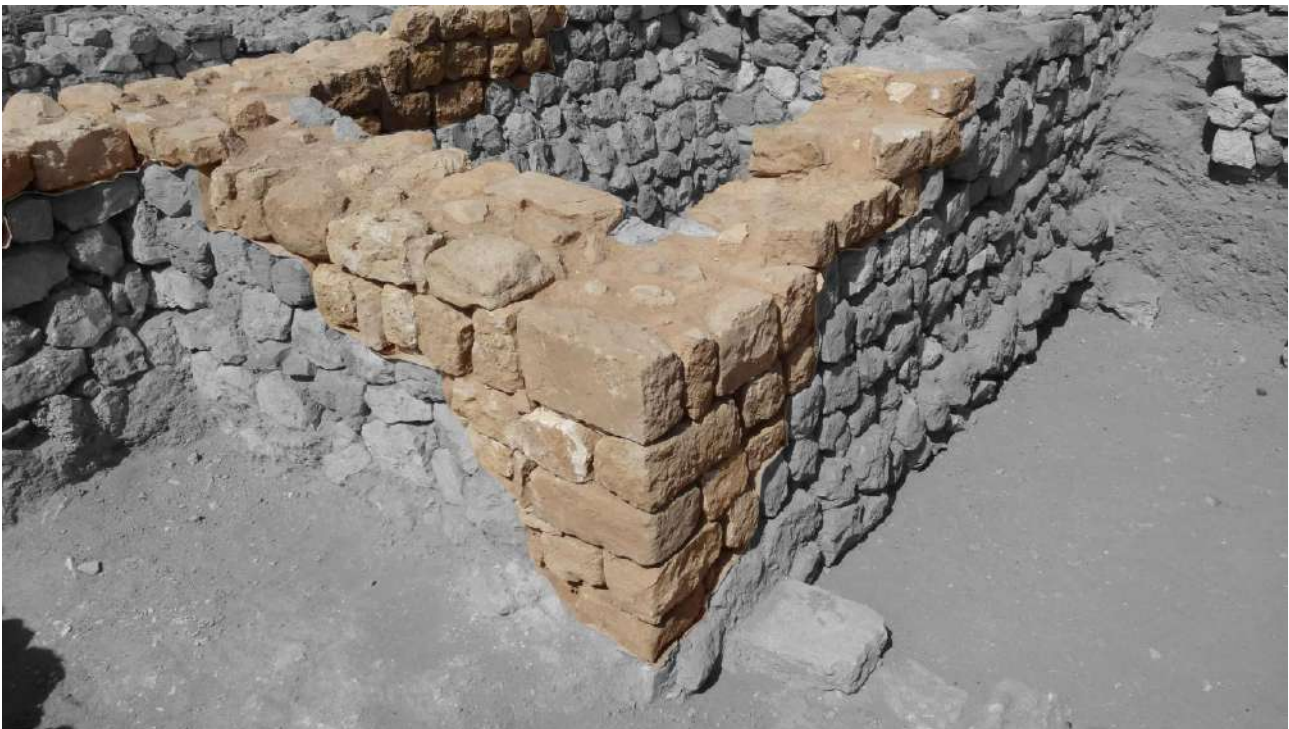
*Fig. 8d – BA12, details of restoration works of the corner between M541 and M542 (view from SE).*

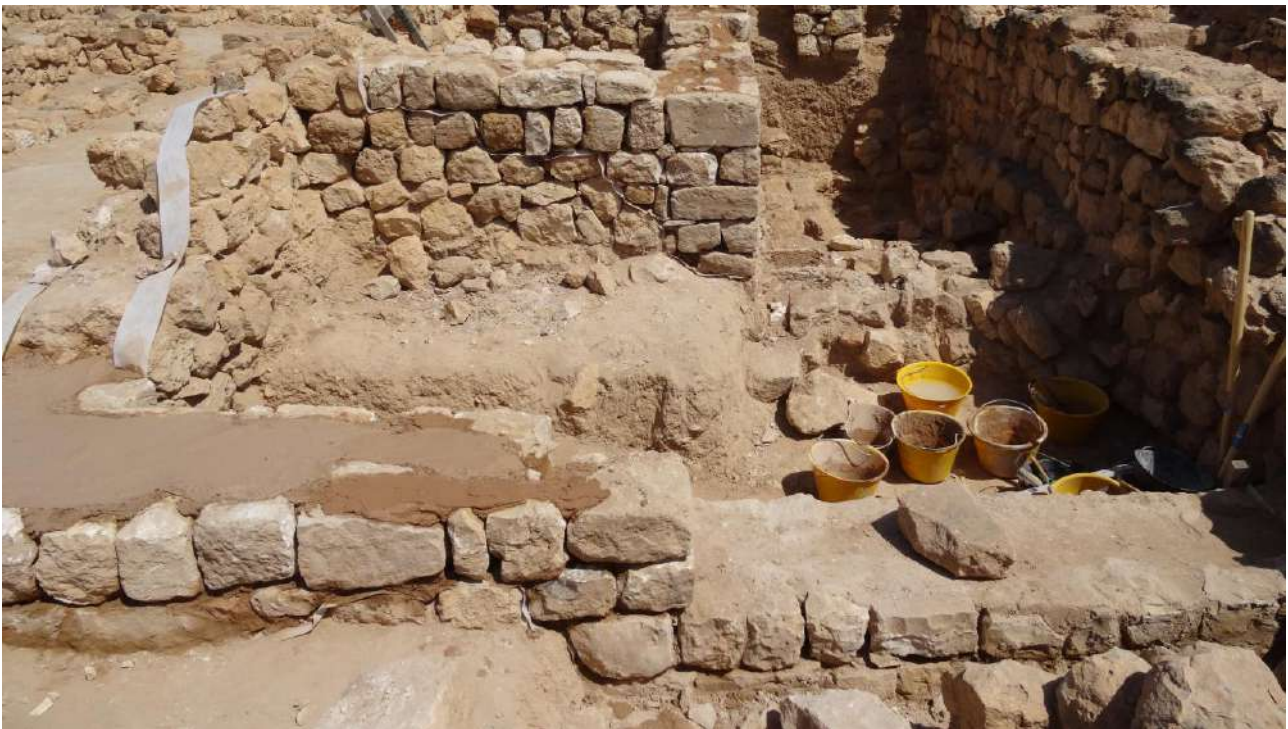
*Fig. 9b – BA12, wall M554 and corner between walls M554 and M185 during the restoration works.*

Afterwards, it was rebuilt the wall M554, between the alignments M185 and M550, and the southern part of the wall M185. In order to avoid future subsidences and cracks in the new masonry, the foundation plan was placed about 50 cm below the countryside plan. To reinforce the foundation of the wall, the first two rows were realized with plentiful mortar in joints. Following to the indications of Mr. Sedov, in the middle of the reconstructed part of the wall M554 it was made an opening of about 85 cm (Figs. 9).

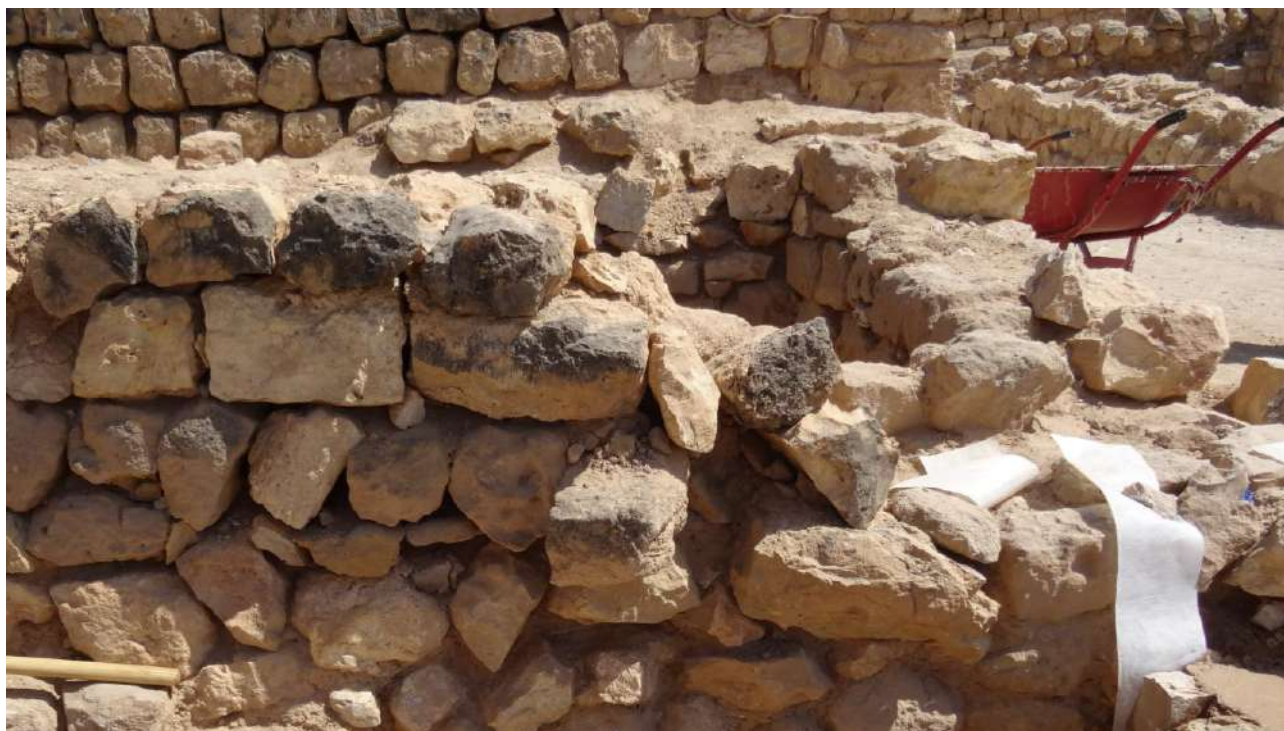
*Fig. 10a – BA12, southern part of the wall M550 before the restoration works.*

Subsequently, the top of the southern end of the wall M550 was disassembled and reconstructed (Figs. 10).

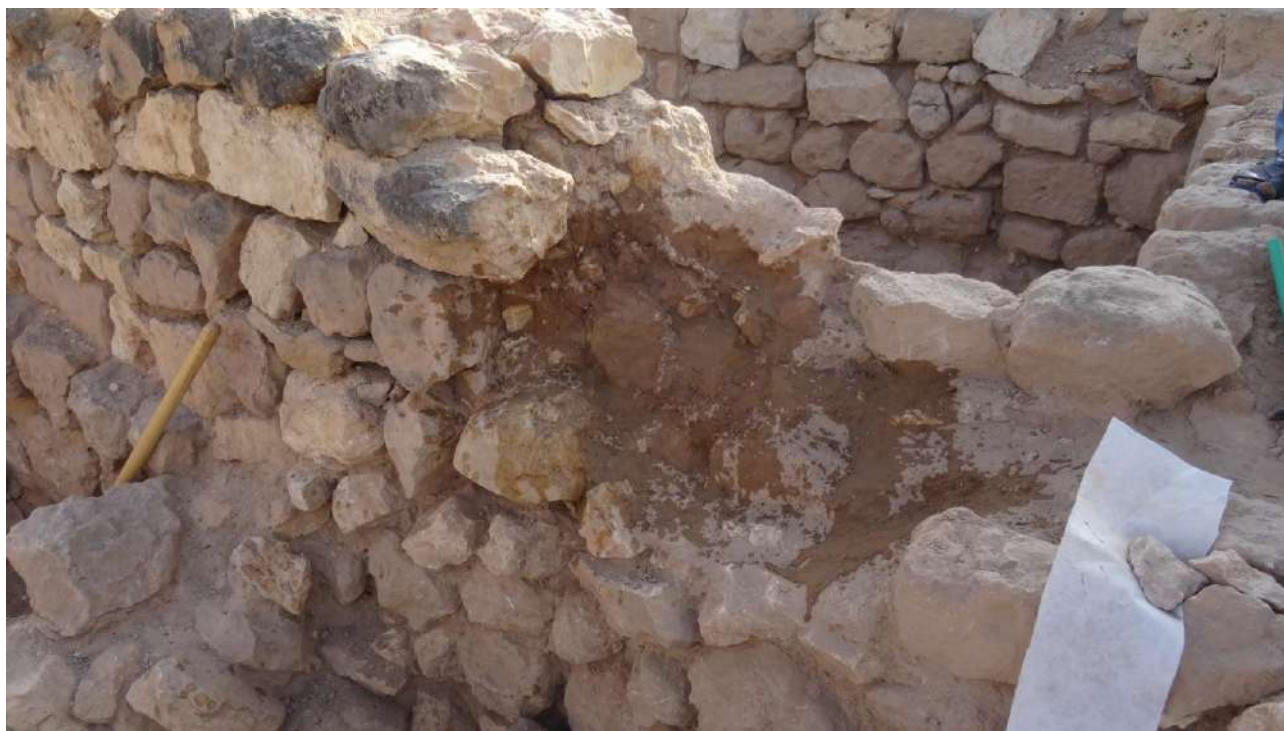
*Fig. 10b – BA12, southern part of the wall M550 during the restoration works.*

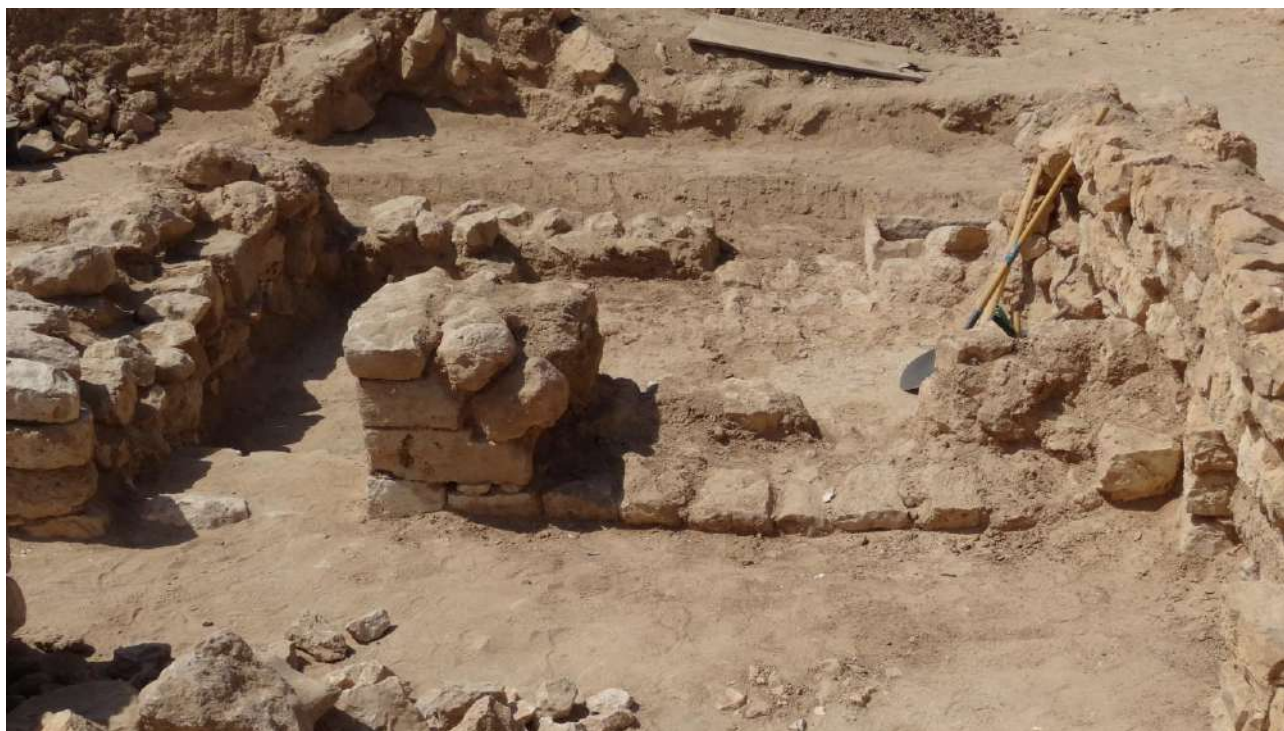
At first it was restored the wall M645. While the south corner was in good condition, the central part of the wall was widely collapsed. After removing the unstable stones and positioning the geotextile layers, the wall was rebuilt by shaping the top surface as ruin to connect the height of the wall M646 with that of the south end, that was substantially intact (Figs. 12).

*Fig. 12a – BB4, wall M645 before the restoration work (view from E).*

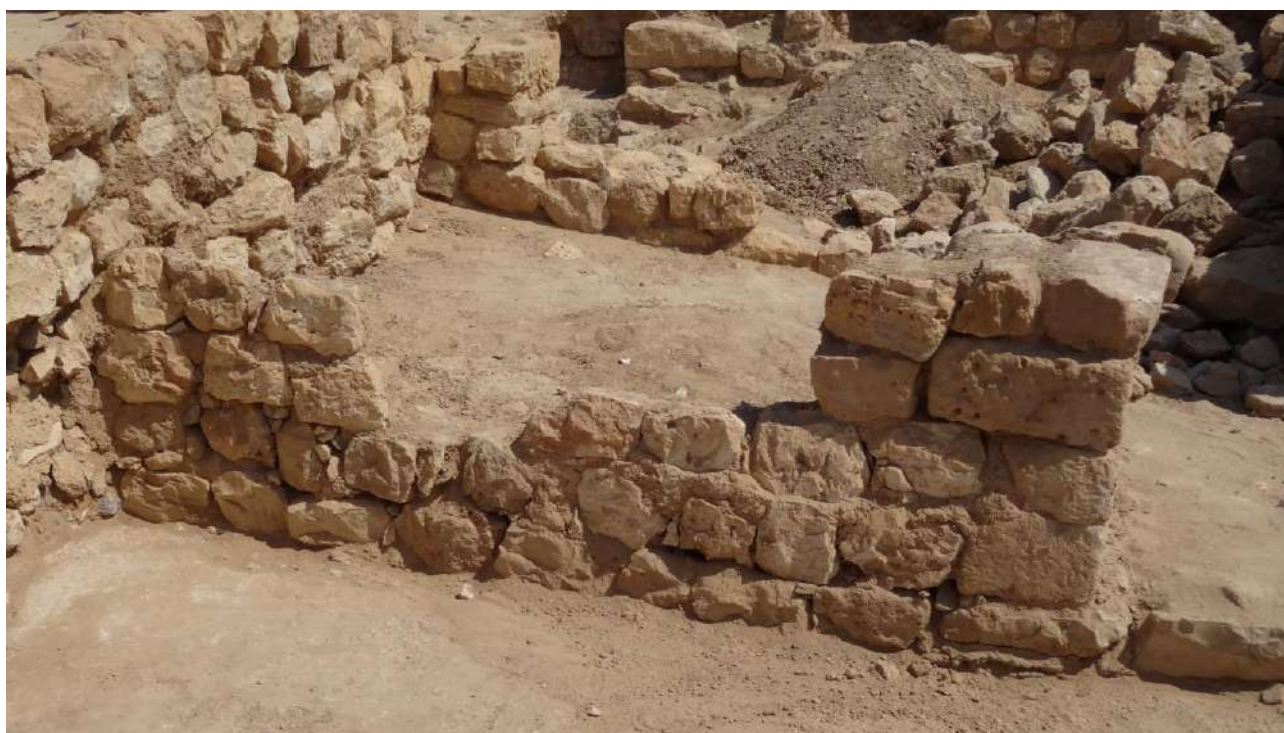
*Fig. 12b – BB4, wall M645 before the restoration work (view from W).*

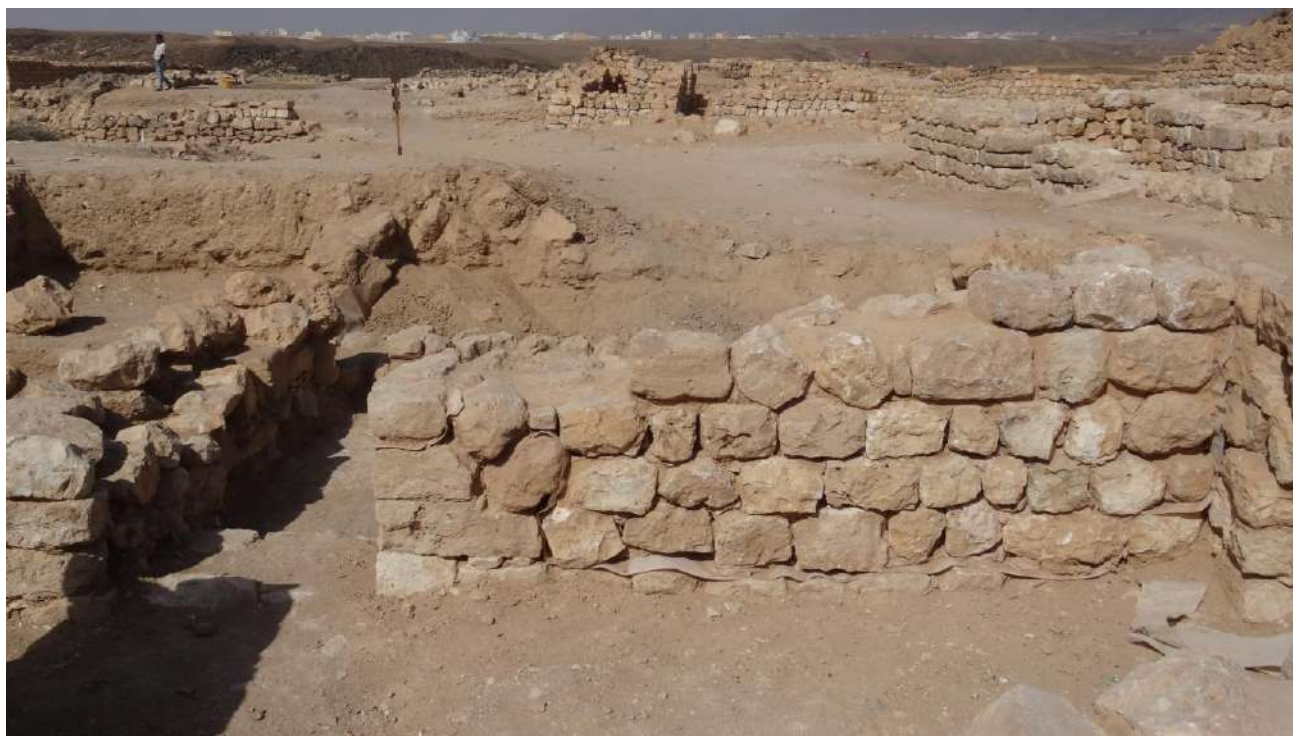
*Fig. 12c – BB4, wall M645 after the restoration works (view from E).*

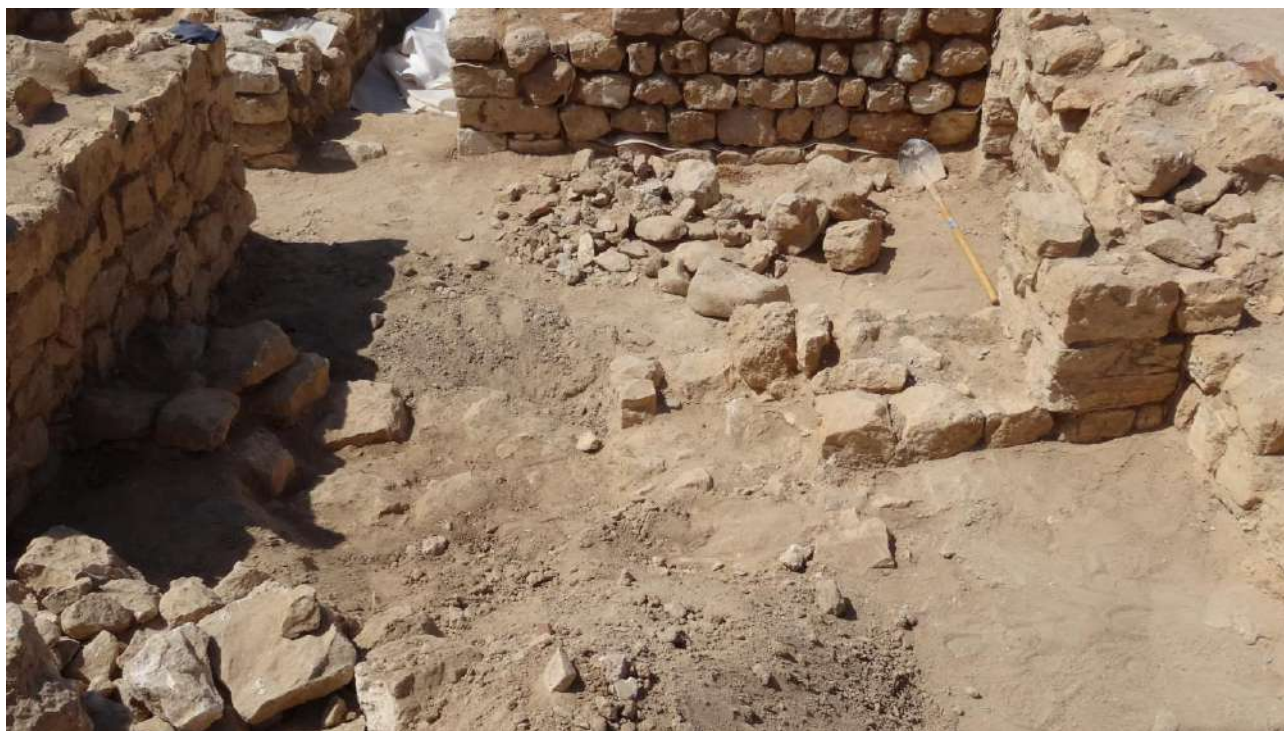
Afterwards it was rebuilt the wall M653. The southern half of the wall was almost completely collapsed, with the exception of the first row of stones. Therefore it was possible to create the door in its original position, though there was a doubt jamb near the north transversal wall M646. Before rebuilding the masonry, the unsafe stones were removed and the geotextile layer was placed (Figs. 13).

*Fig. 13a – BB4, wall M653 before the restoration work (view from E).*

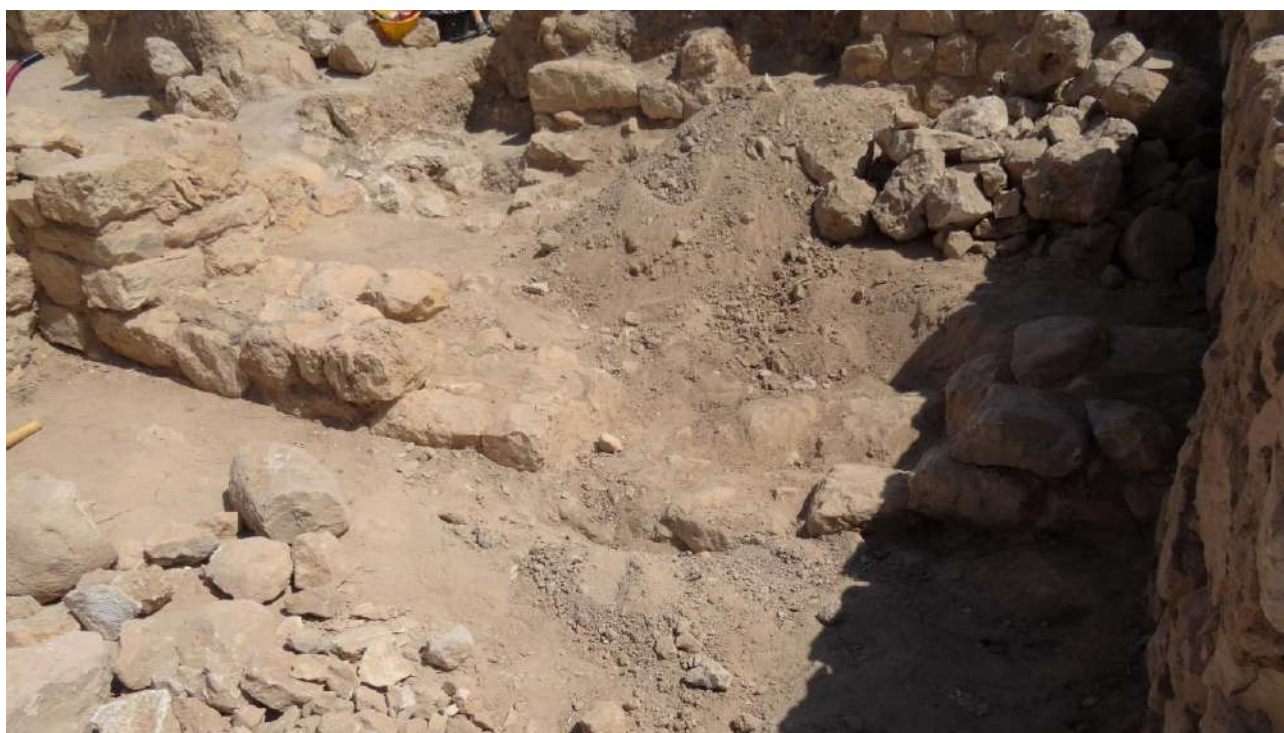
*Fig. 13b – BB4, wall M653 before the restoration work (view from W).*

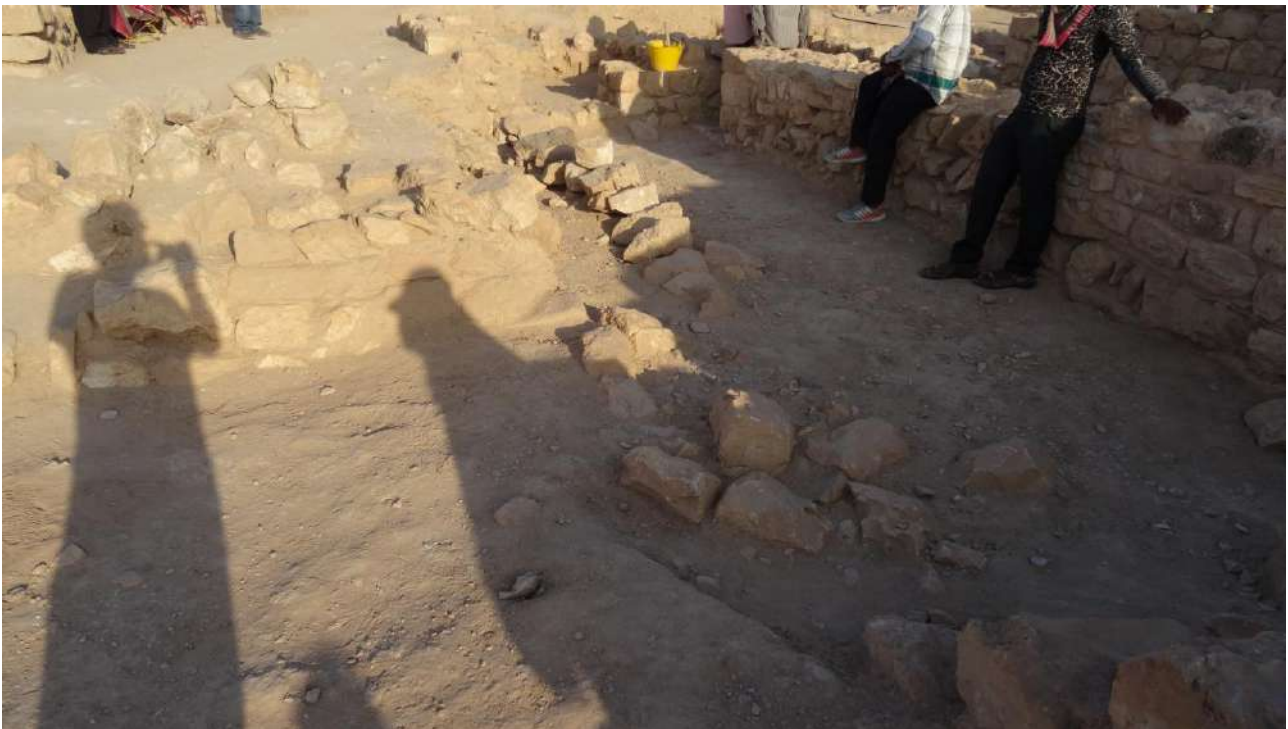
*Fig. 14b – BB4, wall M578 before the restoration work (view from SE).*

During the restoration of the walls M645 and M653, it was also reconstructed the wall M578 between the alignments M698 and M235. After digging to find a solid surface on which to base the wall, all the first row was laid. From the second row on, the rows were interrupted to make an opening in the east part of the wall. Having no trace of the location of that door, it was created in the middle of the room to access (Figs. 14).

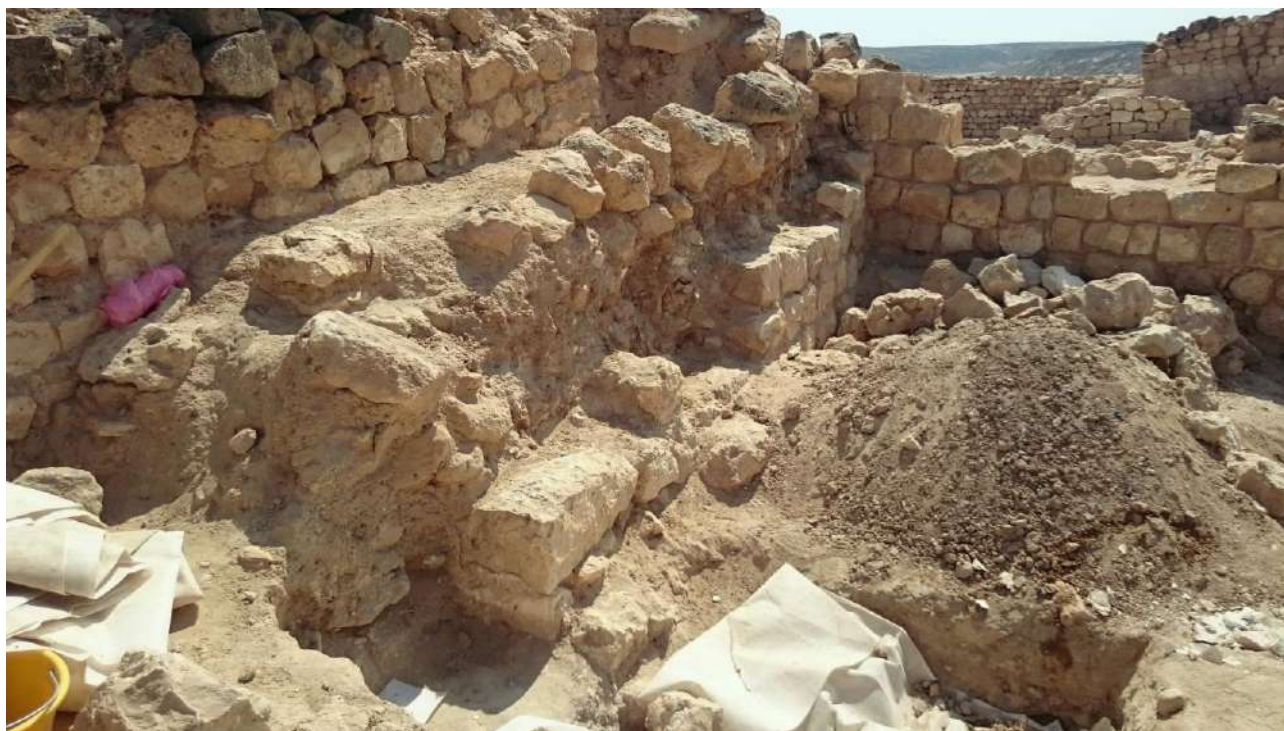
Later on, it was restored the corner between the walls M644 and M646, the east end of the wall M646 and all the wall M644. While the corner was completely collapsed, the two walls were at least detectable, with the wall M644 that kept only the first rows of the inner face, while the outer face was 2 meters high. Since from the state of the places it was unclear what was the planimetric shape of the corner, at first it was digged a survey in order to find its foundations and to deduce its shape. With the help of the archaeologists present on the site it was deduced that this was a concave angle (i.e. a W shape). To avoid losing track of the above-mentioned planimetry, the first rows were immediately reconstructed until the high of the wall M646 and of the inner face of the wall M644. After that, the rocking stones of the wall M644 were removed. At this point, the walls M644 and M646 were built simultaneously, with upward trend from west to east and from north to south (Figs. 15).

*Fig. 15a – BB4, wall M644 before the restoration works (view from NW).*

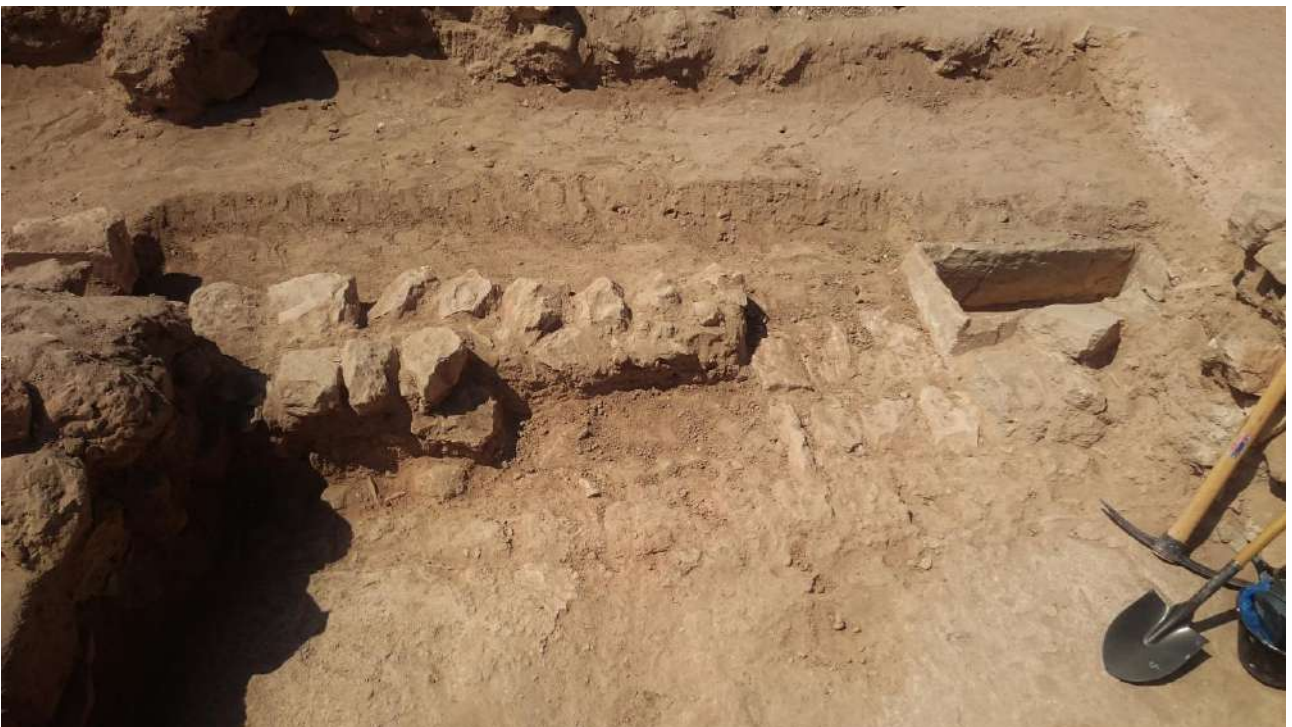
Simultaneously with the aforementioned restoration works, it was dugged around the west border wall between the walls M581 and M646 to discover its foundation or the bedrock. During the excavation a stone basin was found outside the northwest corner of the building. Moreover, it appeared that the masonry consisted of three different faces: the east one in raw earth bricks and the western two in stones. However, analyzing the remains of the three wall faces, it seemed that the exterior stone face was out of the shape of the building, that was perfectly defined by the well preserved northwestern corner. Therefore, it was supposed that originally there were two different masonry: the building boundary wall, made by two faces (the inner in bricks and the exterior in stones), and an exterior wall, made by one stone face. Watching carefully the exterior face, it was noted that some stones adjacent to the stone basin were remarkably smooth. It was therefore conjectured that this was the threshold of an opening. However, the fact that this threshold wasn't present even in the most internal masonry (the two-faced wall) suggested that the two walls were built in two different periods. In order to clarify the situation, it was excavated a width of about 1 m and a depth of about 30 cm on the west of the wall in question, but nothing was found. Therefore, according with Mr. Sedov and with the archaeologists present on site, it was decided to postpone the restoration to a next mission, after enlarging the survey. In any case it was disassembled and temporarily reconstructed the north-west corner that was in precarious equilibrium conditions (Figs. 16).

*Fig. 16d – BB4, west border wall between walls M581 and M646 during the excavation (view from E). It is possible to note the presence of the three wall faces.*

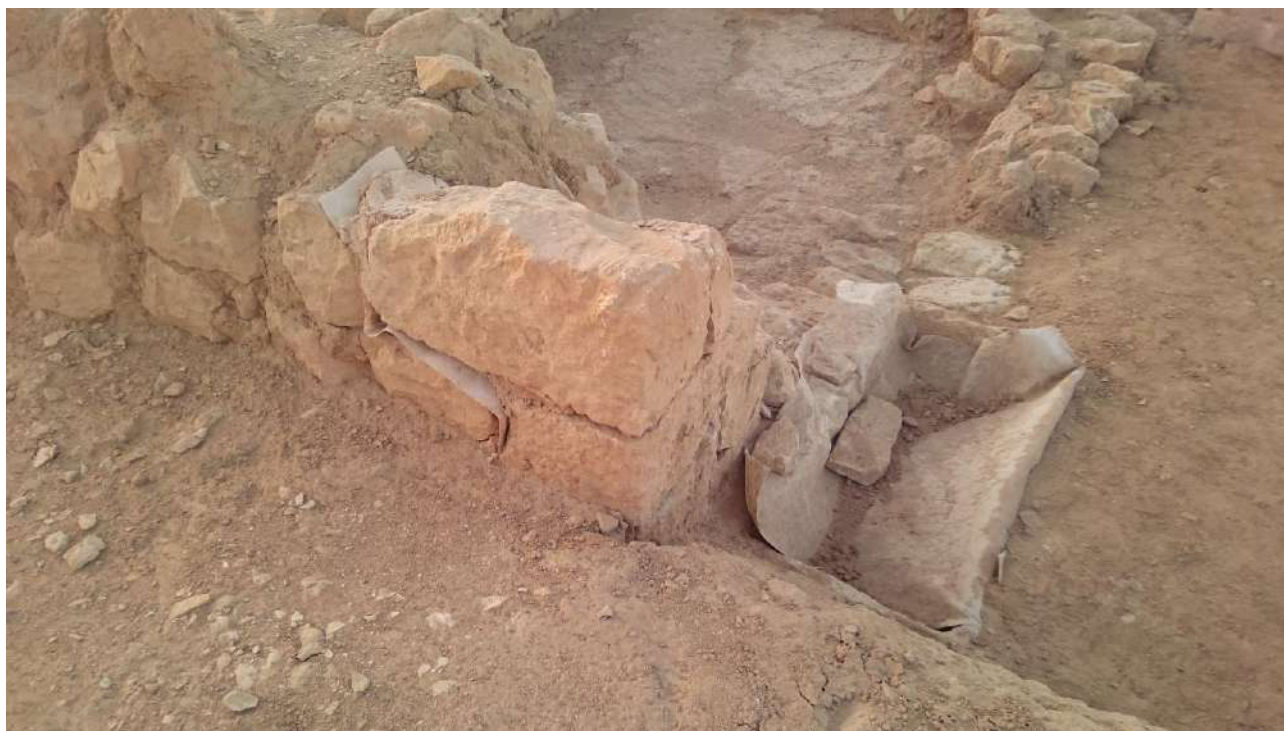
*Fig. 16g – BB4, north-west corner after the restoration works.*

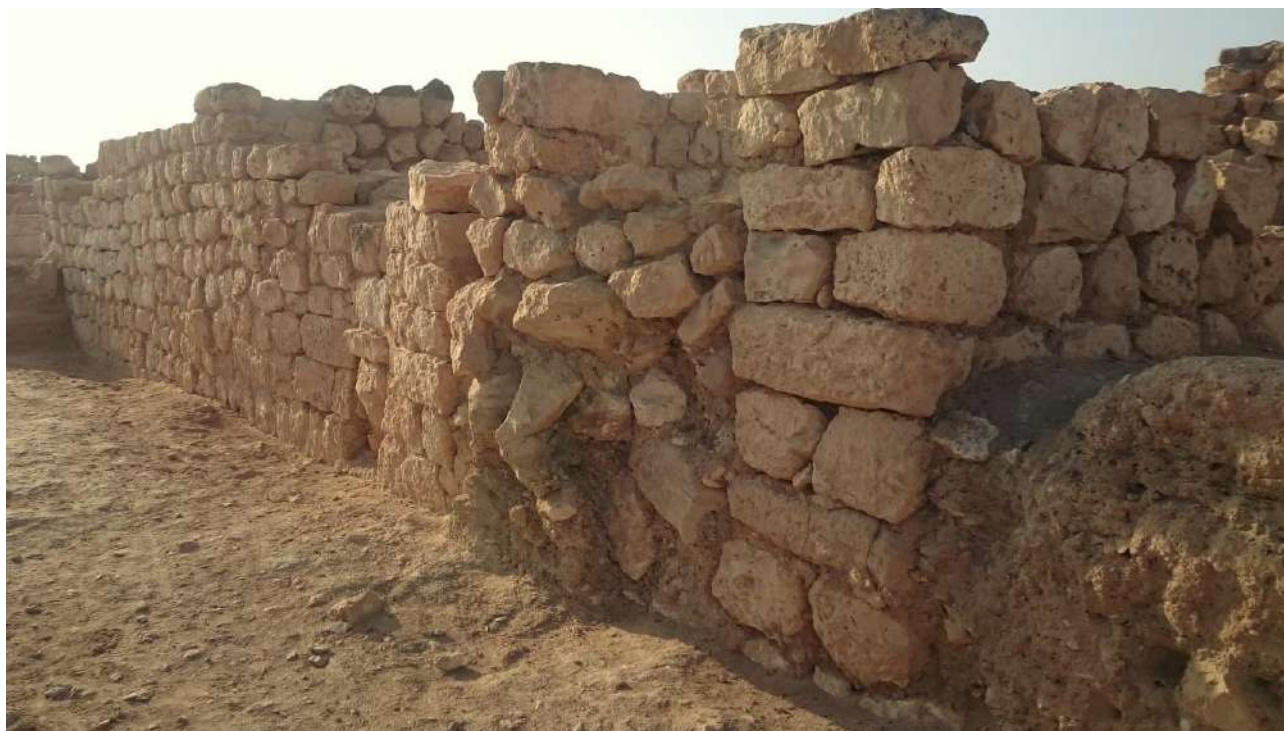
Before the restoration works, the wall M656 appeared in precarious equilibrium conditions, showing an evident collapse towards the north. Therefore, for the safety of tourists, the aforementioned wall was disassembled and rebuilt with the same stones. Moreover, in agreement with the archaeologists present on site, the wall was rebuilt lower to facilitate a future disassembly of the same in order to investigate thoroughly the environment of BA13 closed by the wall M656 and the road at north of it (Figs. 18).

*Fig. 18a – BA13, wall M656 before the restoration works (view from NW).*

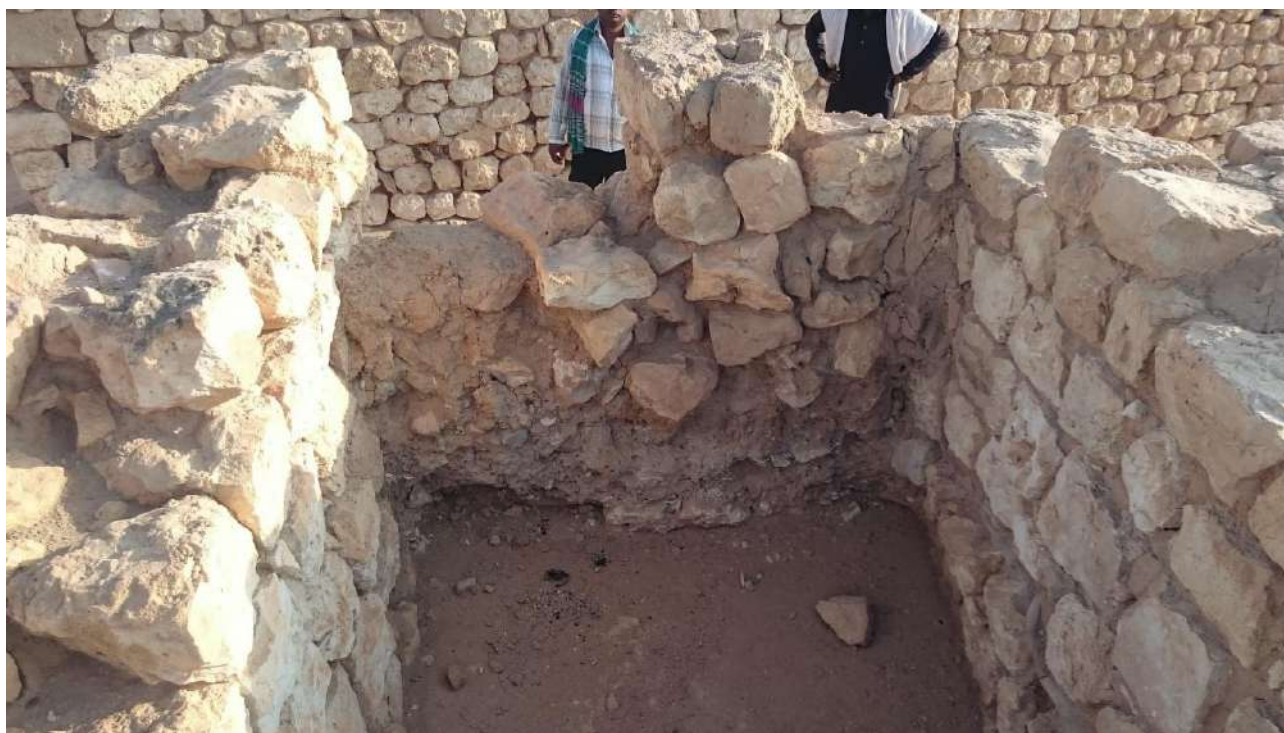
*Fig. 18b – BA13, wall M656 before the restoration works (view from S).*
