## **RESTORATION OF BF3**

*Restoration works at the Archaeological Park of Khor Rori (Sultanate of Oman)  
Diary of activities (October-December 2017)*

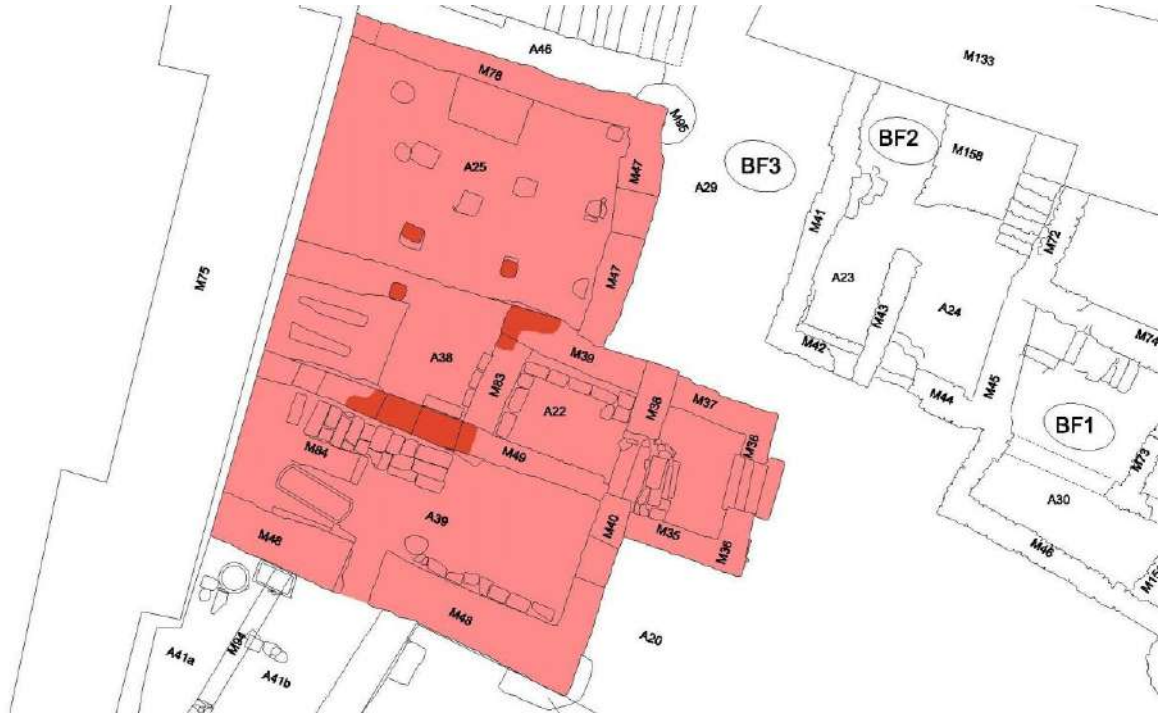
The last part of the mission was dedicated to the restoration of BF3, the temple of Sumhuran. In particular, they were restored the wall M49 with the access to the temple, the corner between the walls M39 and M83, and the bases of the columns inside the temple (Figs. 19).

*Fig. 19a – BF3 plan with highlighted the restored walls.*

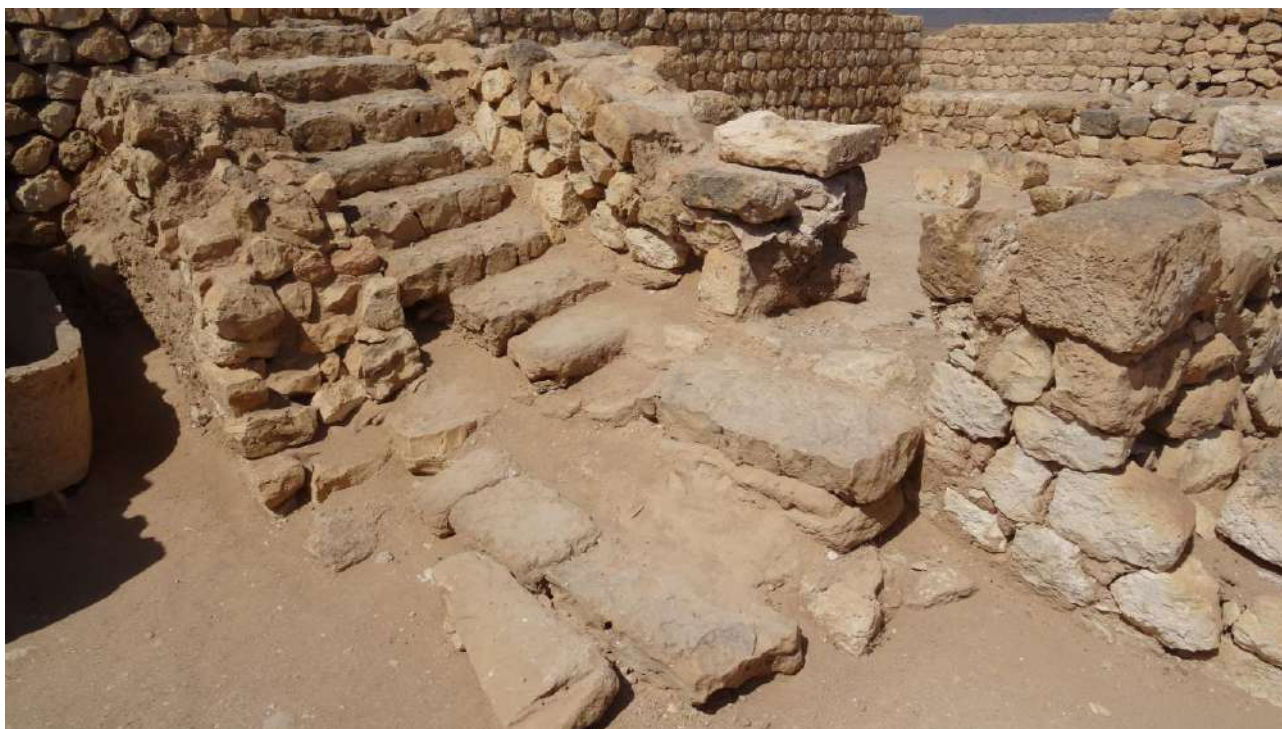
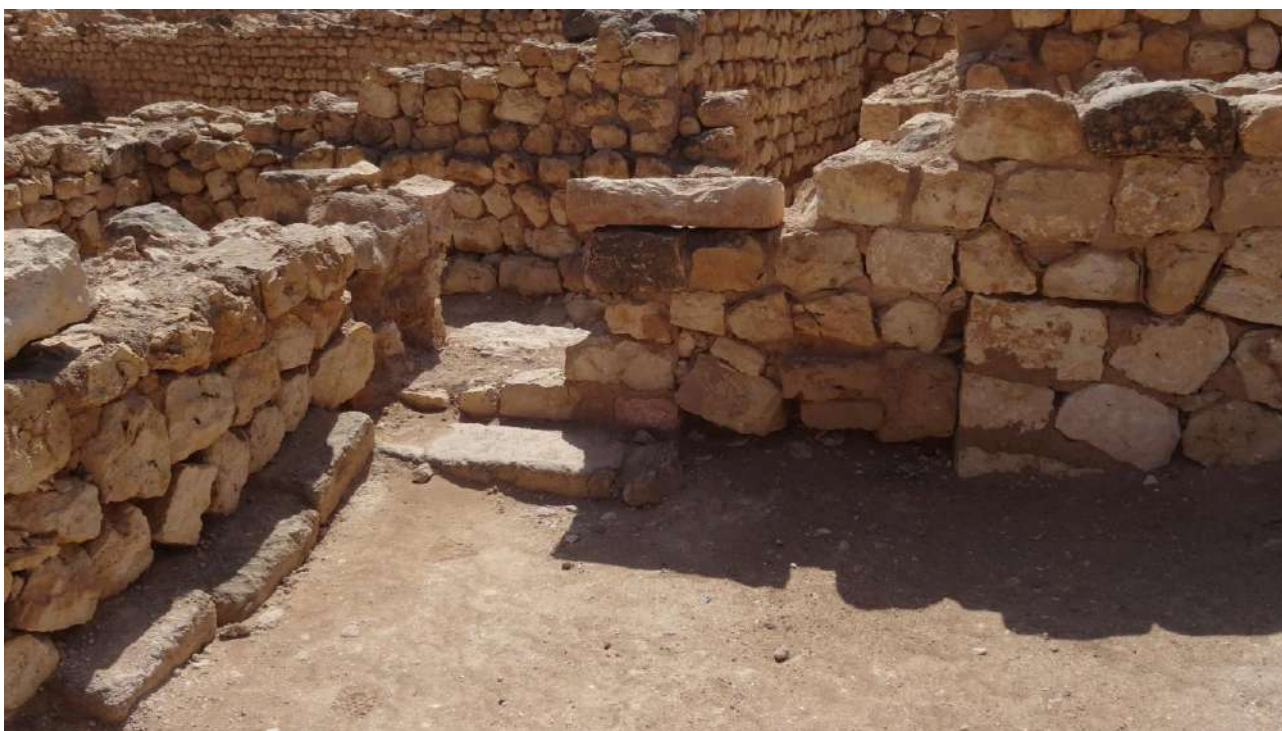
At first it was restored the entrance to the temple. At the beginning of the mission the wall M49 had a breach rather than an opening near the wall M83. The purpose of the restoration work was to close the breach (evidently not original) and open the closed passage on the west, highlighted by the well-shaped side jambs. Therefore, the closed door was reopened and subsequently the breach in the wall was mended (Figs. 20).

*Fig. 20a – BF3, wall M49 before the restoration works (View from SE).*

*Fig. 20b – BF3, wall M49 before the restoration works (View from N).*

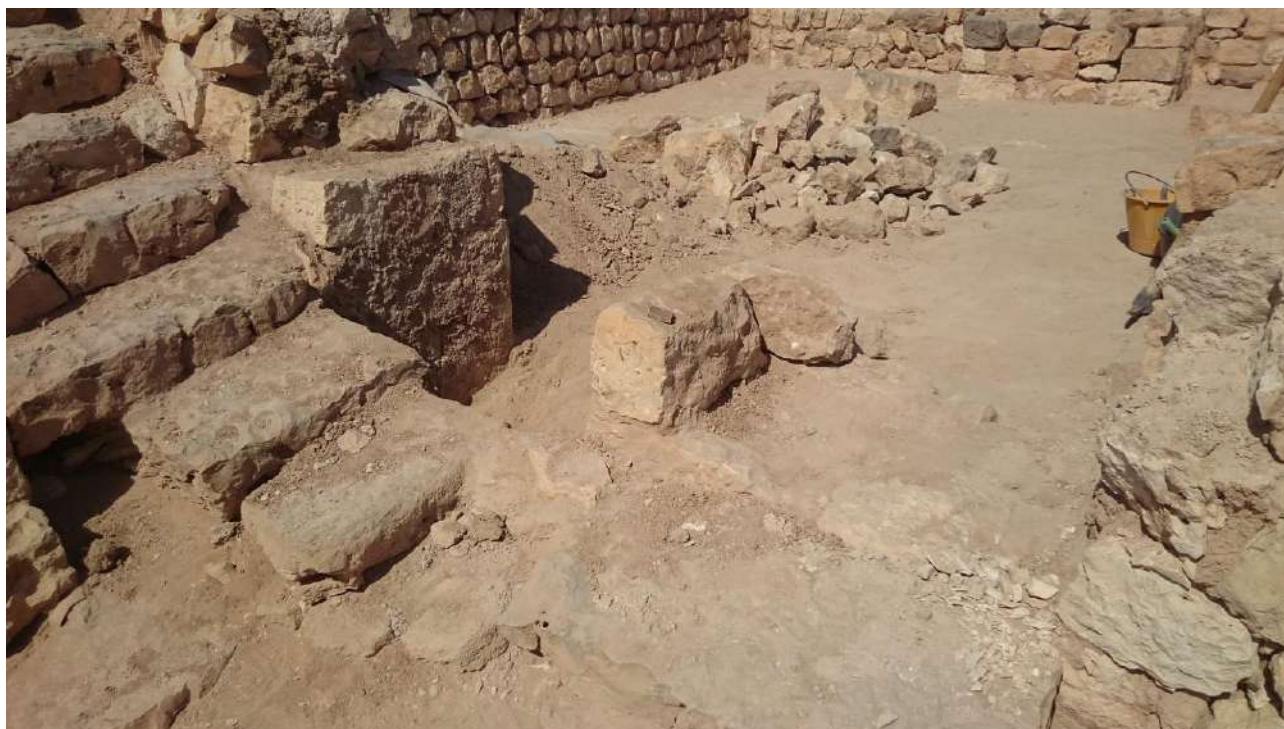
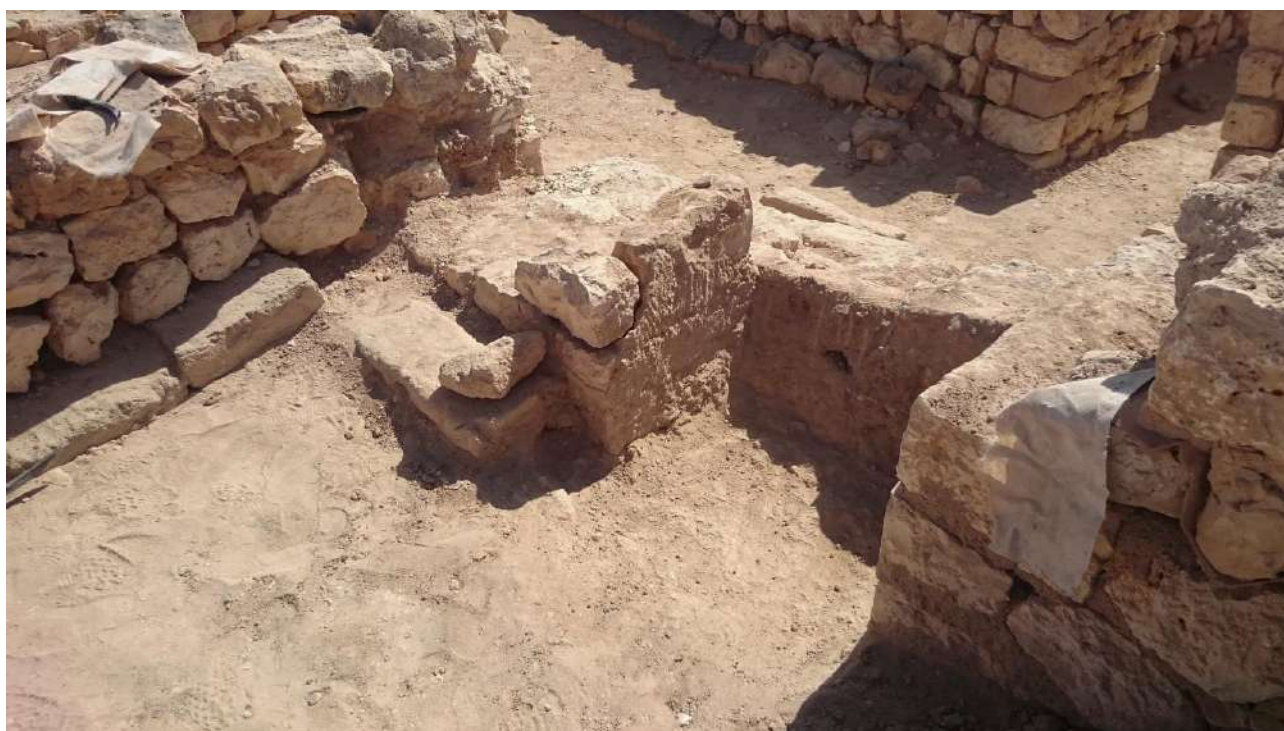
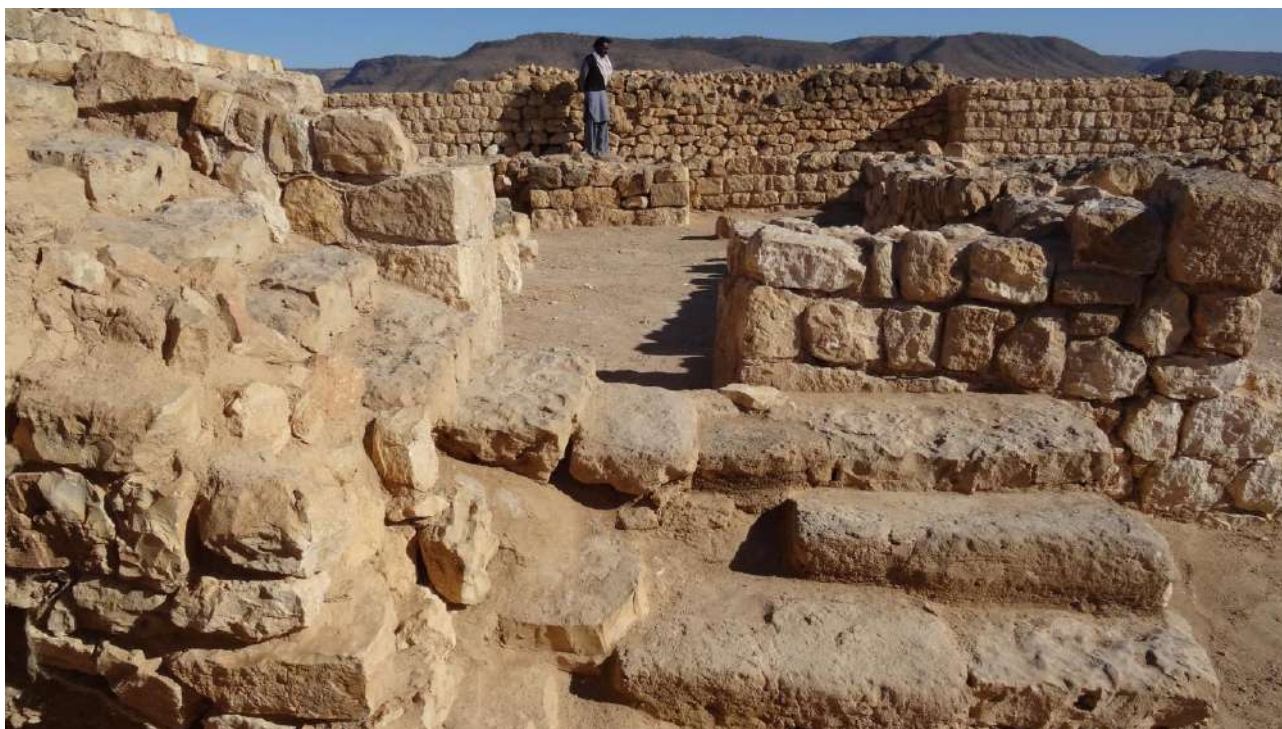
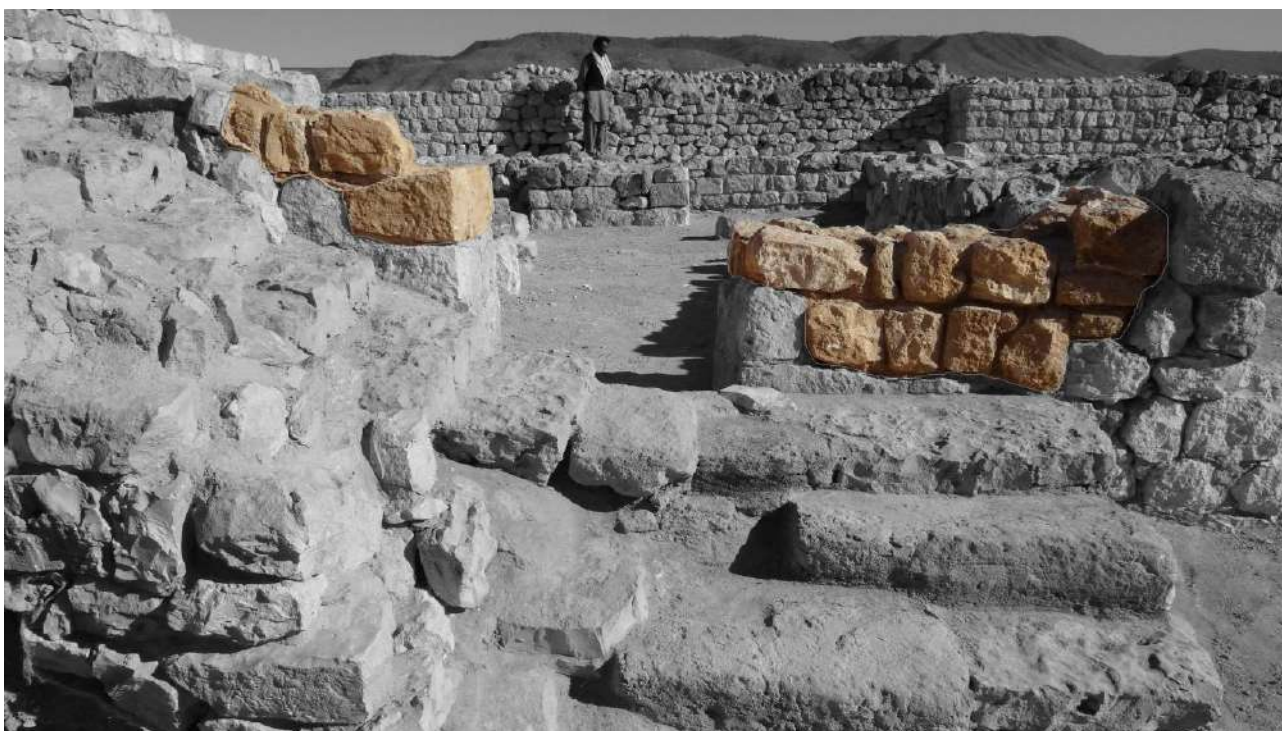
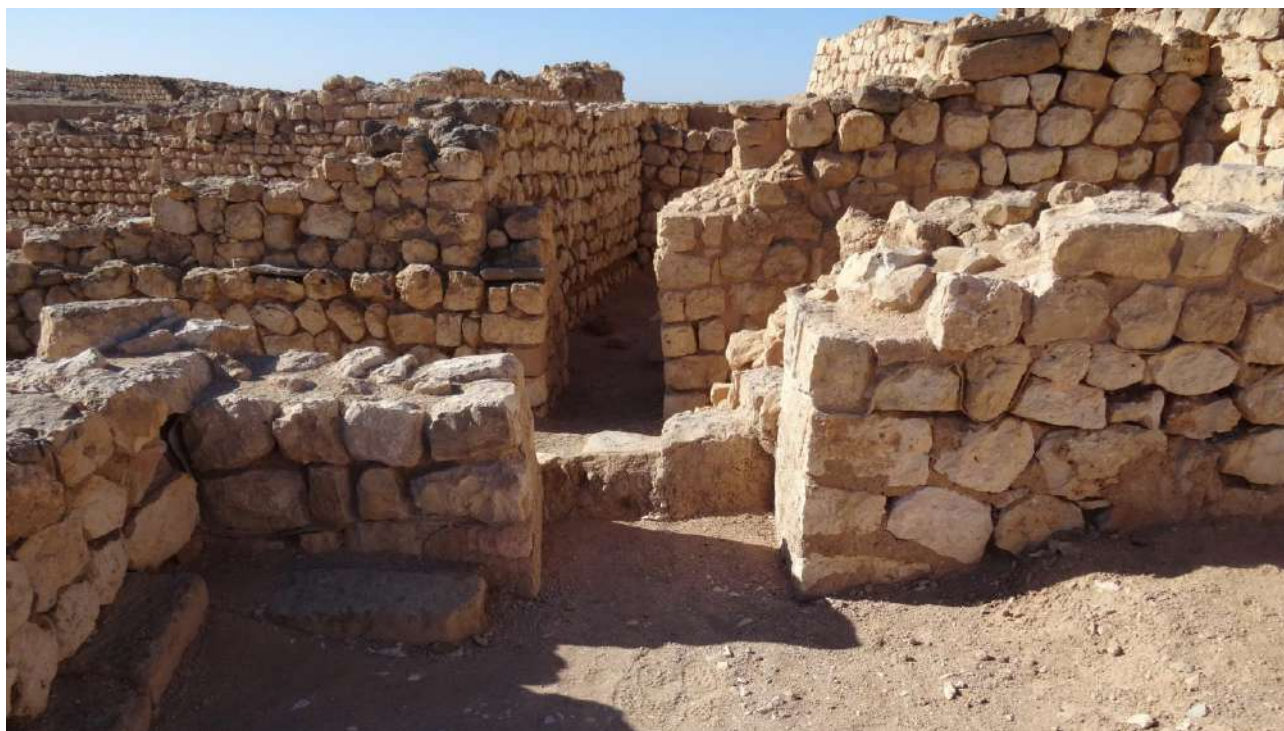
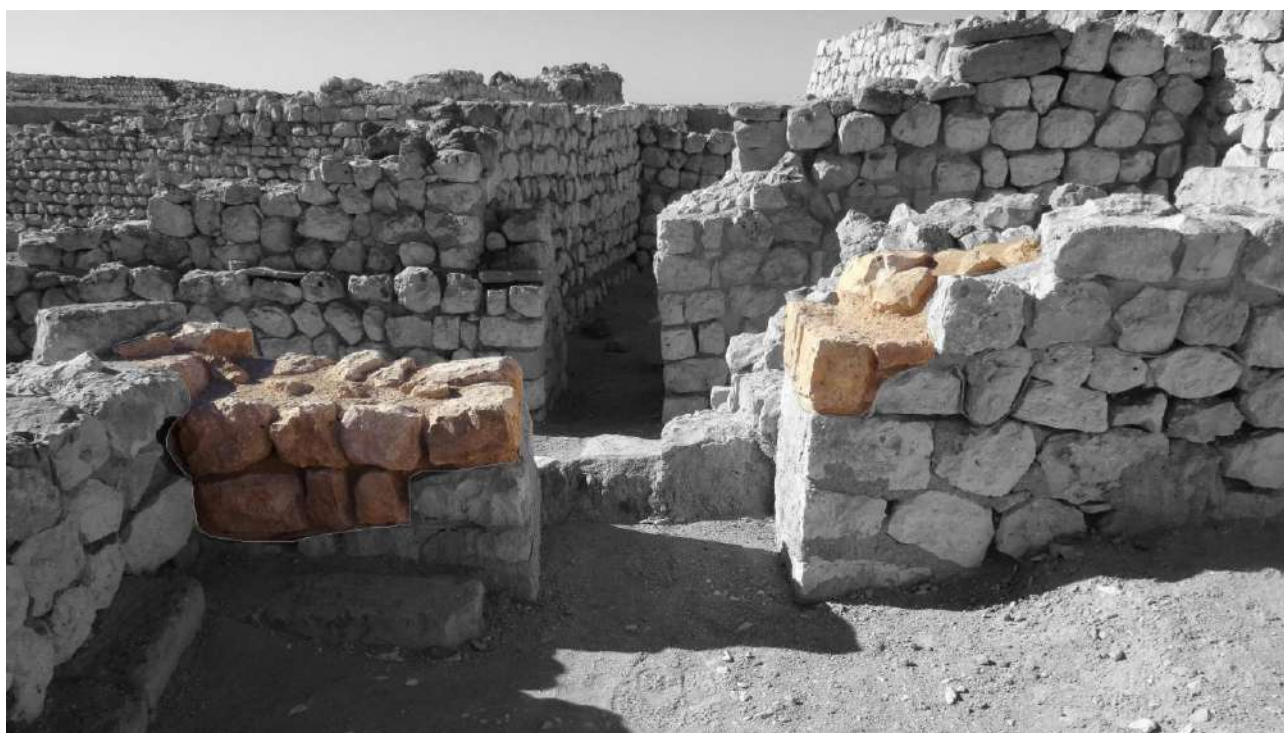
*Fig. 20c – BF3, wall M49 during the restoration works (View from SE).*

*Fig. 20d – BF3, wall M49 during the restoration works (View from NW).*

*Fig. 20e – BF3, wall M49 after the restoration works (view from S).*

*Fig. 20f – BF3, details of the restoration works of the wall M49 (view from S).*

*Fig. 20g – BF3, wall M49 after the restoration works (view from N).*

*Fig. 20h – BF3, details of the restoration works of the wall M49 (view from N).*

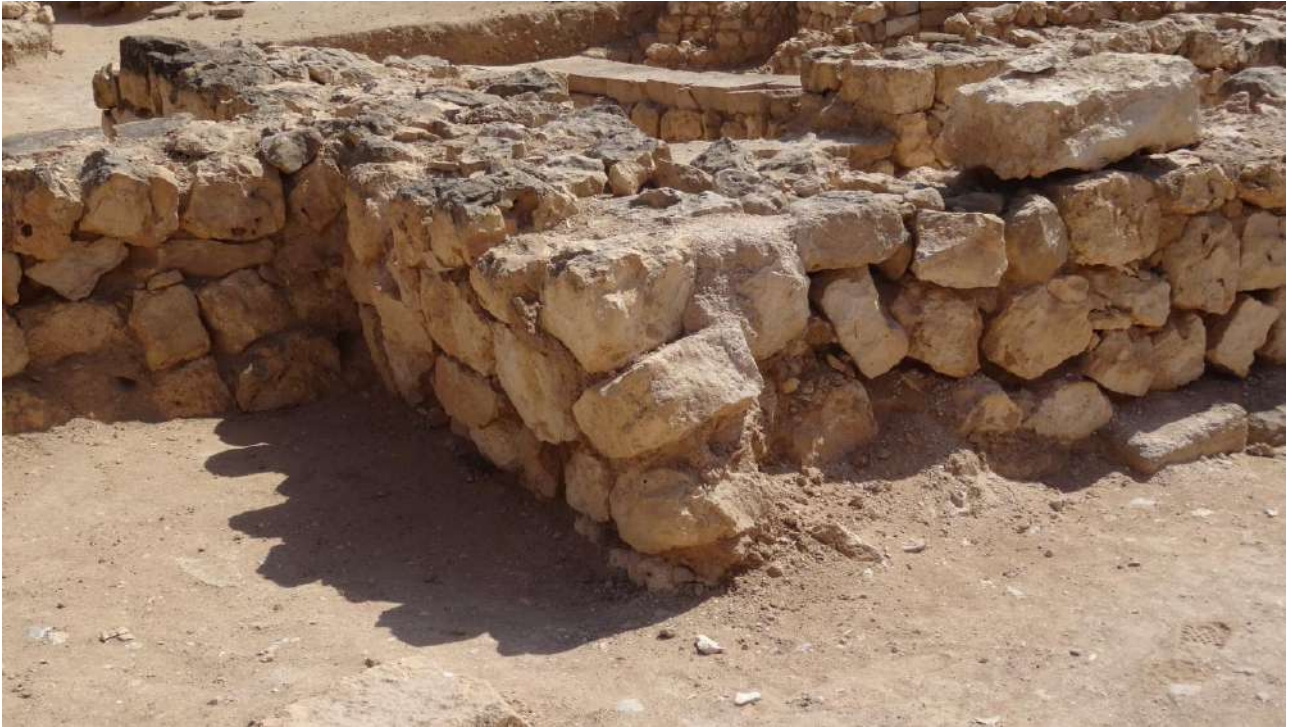
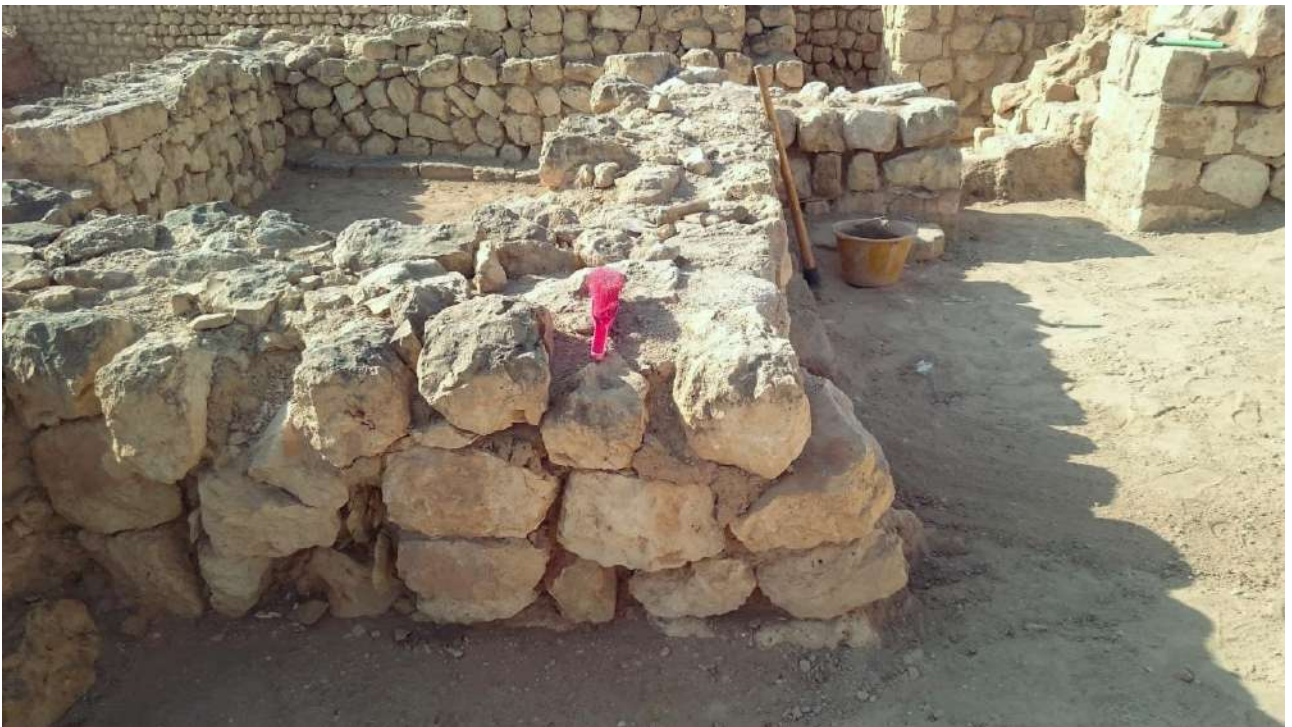
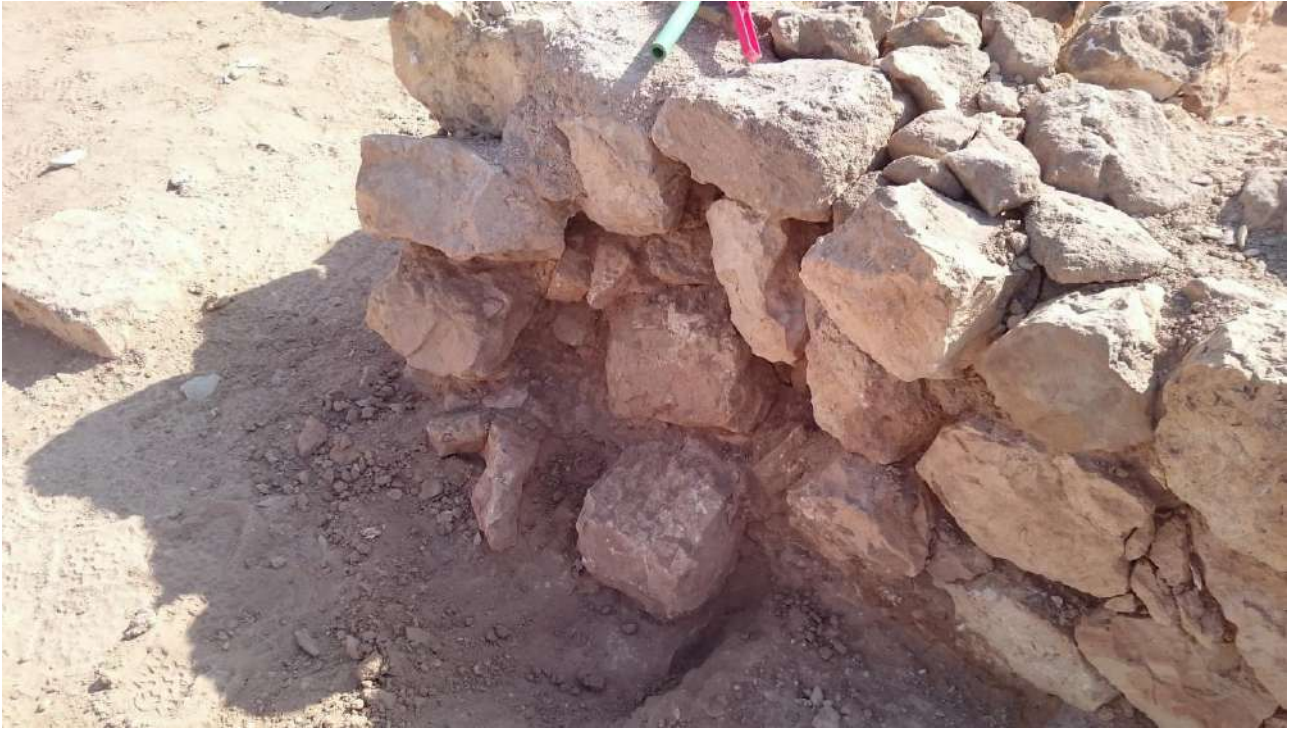
Subsequently the north-west corner between the walls M39 and M83 was restored. The north face of the M39 wall appeared to be heavily bulged, while the west face of the M83 wall was very disjointed. Analyzing the situation of this last face, it was noted that in reality it was a cut created in the wall M39, that probably continued towards the west. In fact, this face showed broken stones in elevation and in the foundation the wall continued to the west. In any case, following the indications of Mr. Sedov, the corner between M39 and M83 has been restored, leaving however a trace of the M39 wall that continues west keeping the beginning of the first row. The wall texture of this corner has been voluntarily disrupted so as to homogenize it to the adjacent walls (Figs. 21).

*Fig. 21a – BF3, corner between walls M39 and M83 before the restoration works (view from NW).*

*Fig. 21b – BF3, corner between walls M39 and M83 before the restoration works (view from N).*

*Fig. 21c – BF3, corner between walls M39 and M83 before the restoration works (view from SW).*

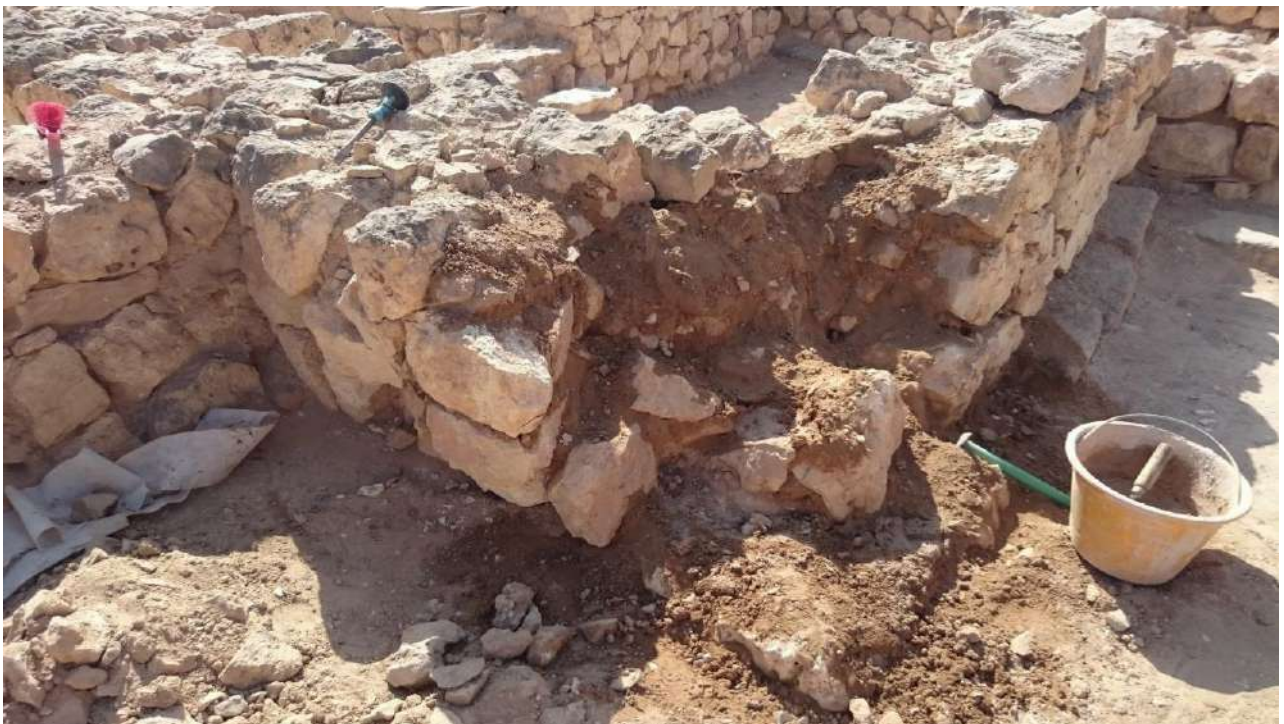
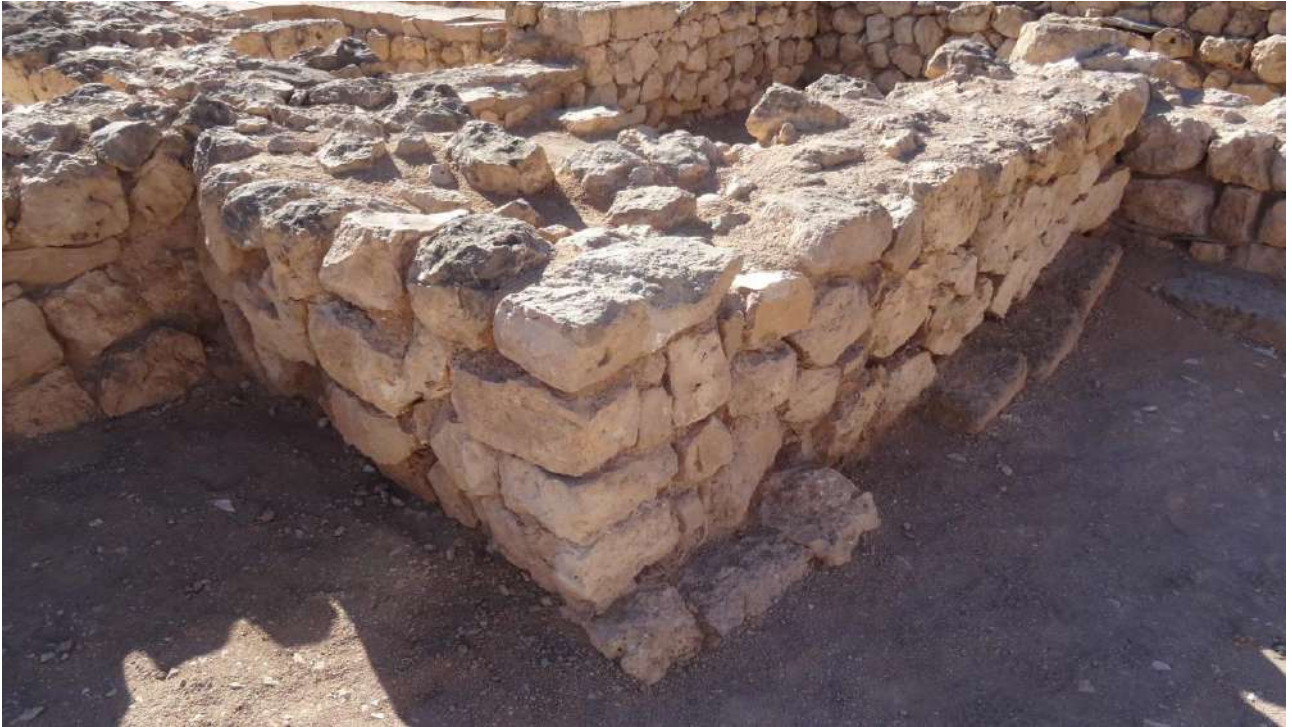
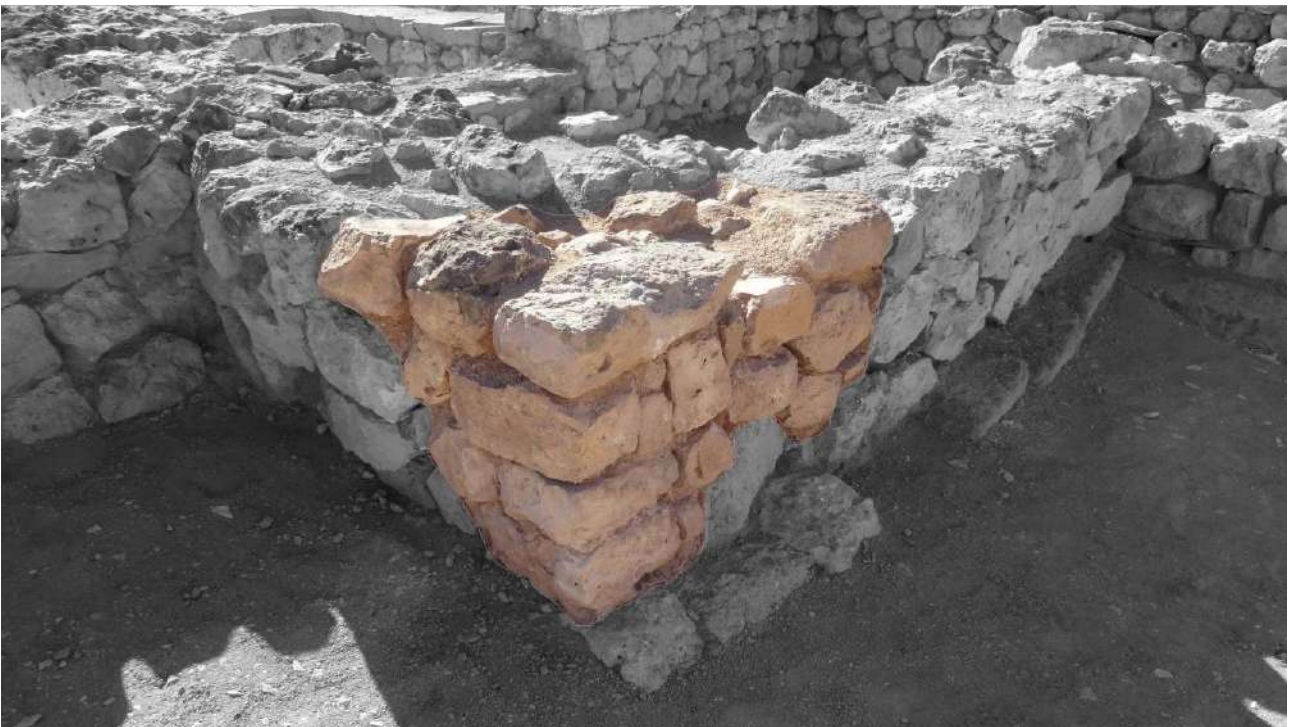
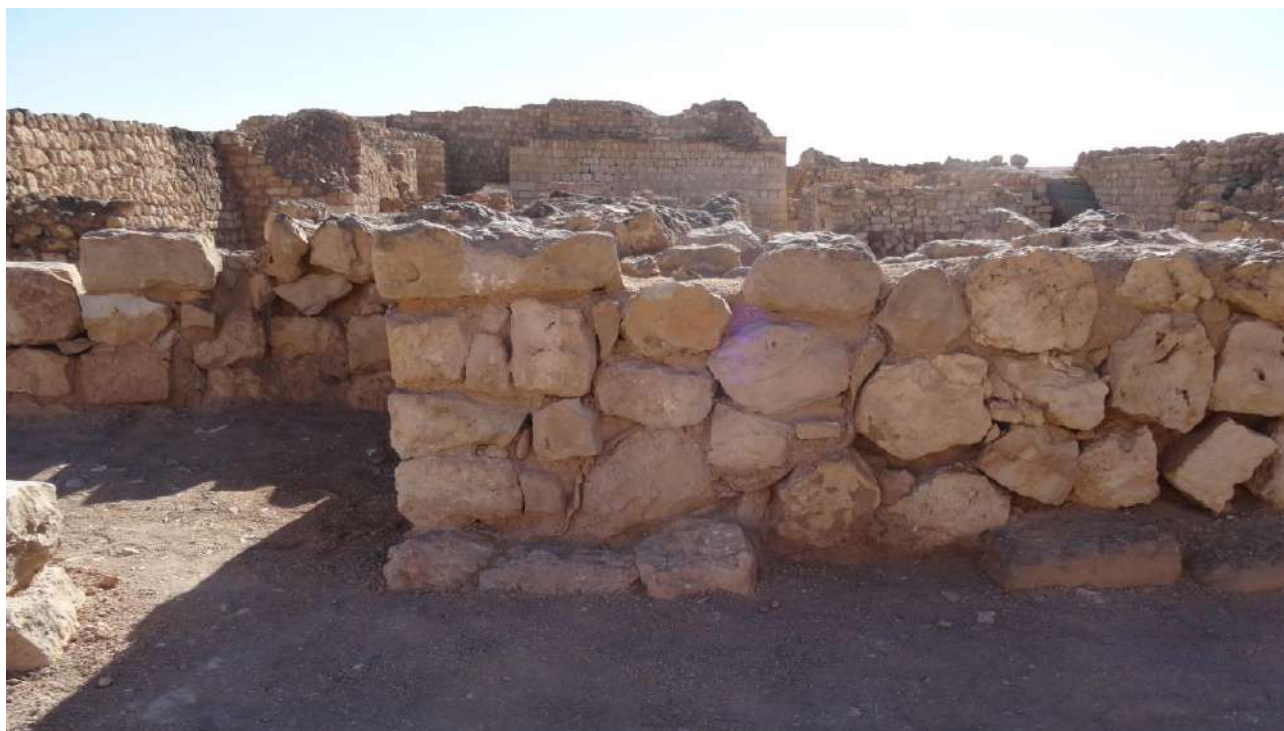
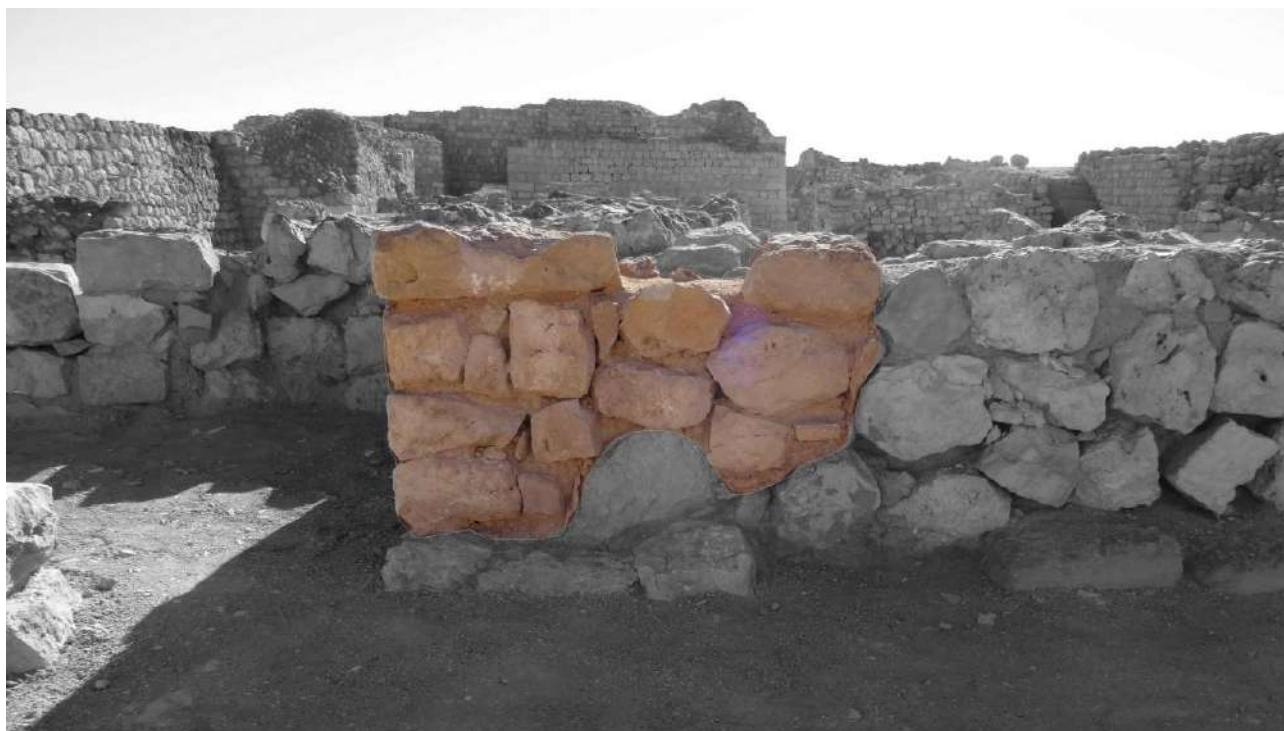
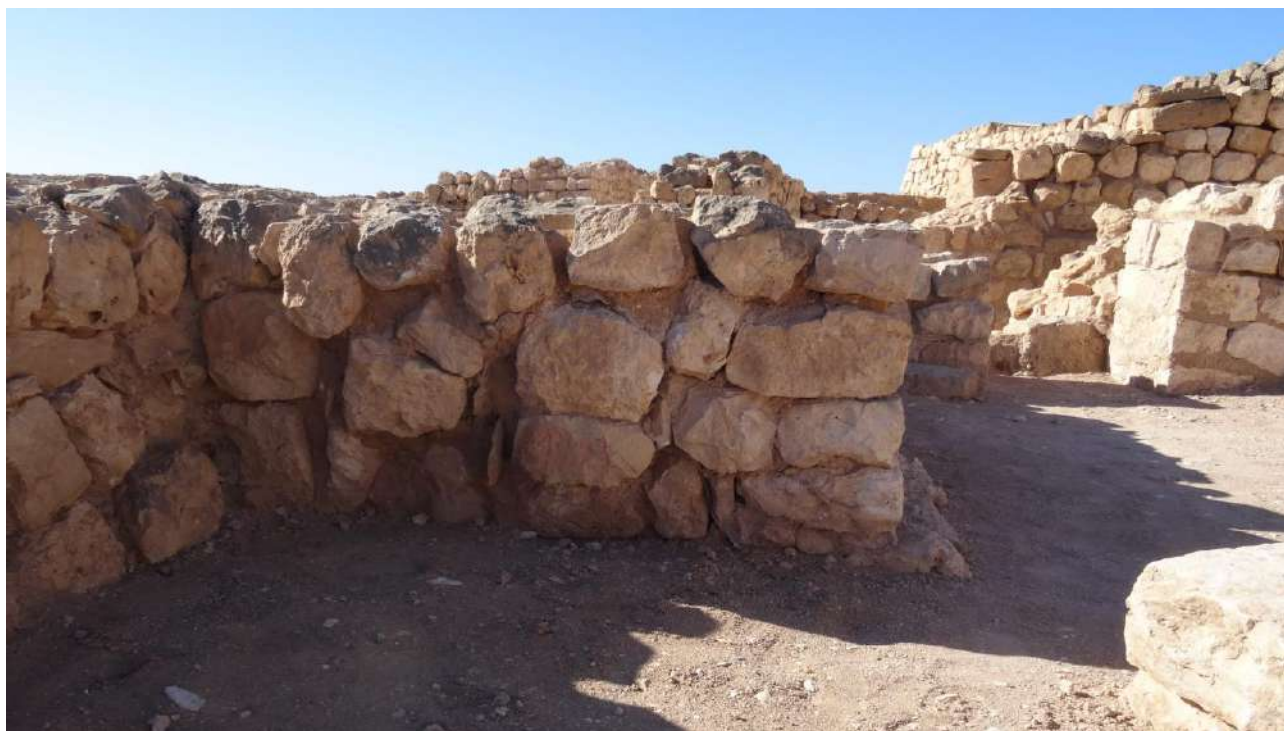
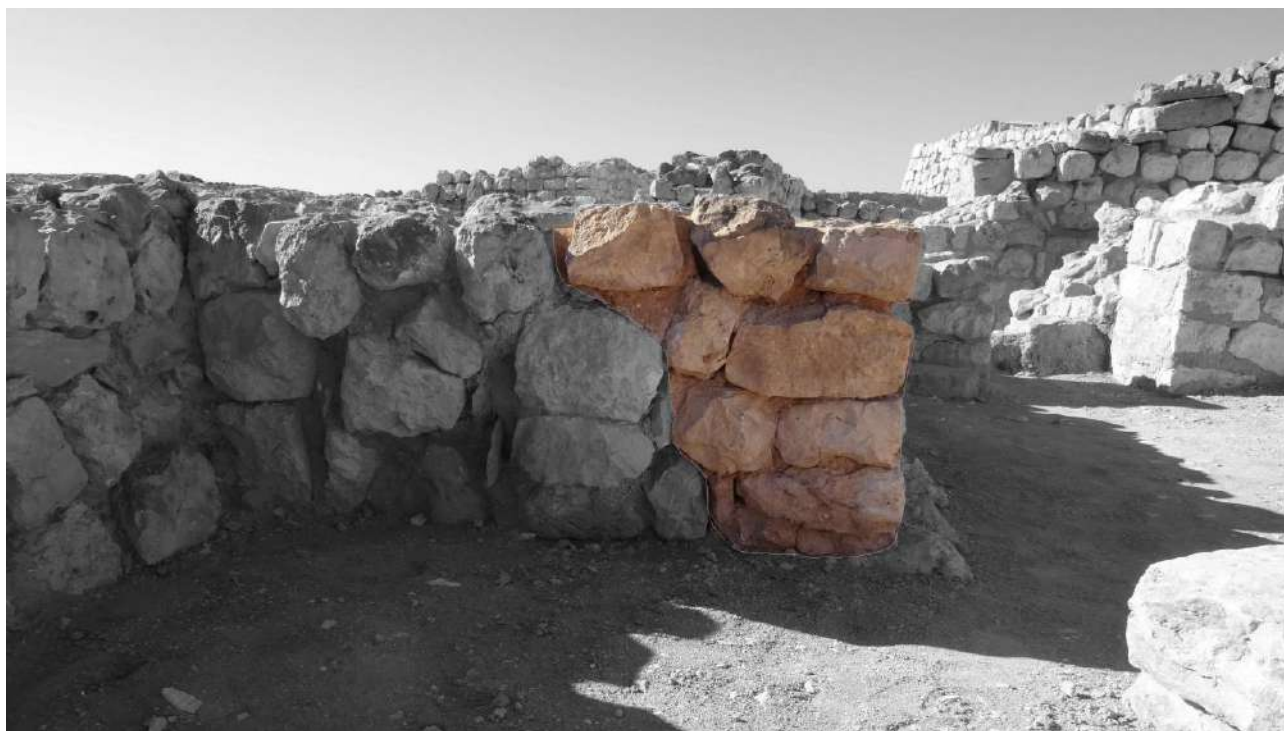
*Fig. 21d – BF3, corner between walls M39 and M83 during the restoration works (view from NW).*

*Fig. 21e – BF3, corner between the walls M39 and M83 after the restoration works (view from NW).*

*Fig. 21f – BF3, details of the restoration works of the corner between the walls M39 and M83 (view from NW).*

*Fig. 21g – BF3, wall M83 after the restoration works (view from W).*

*Fig. 21h – BF3, details of the restoration works of the wall M83 (view from W).*

*Fig. 21i – BF3, wall M39 after the restoration works (view from N).*

*Fig. 21j – BF3, details of the restoration works of the wall M39 (view from N).*

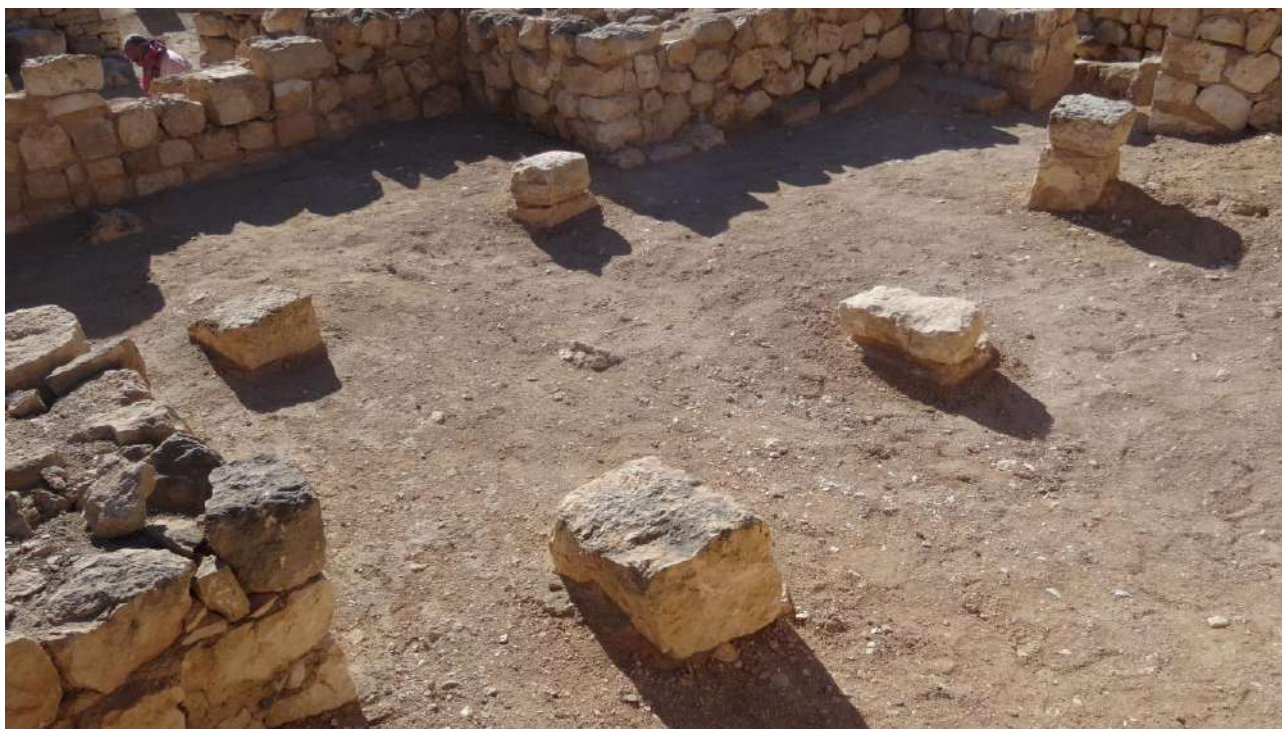
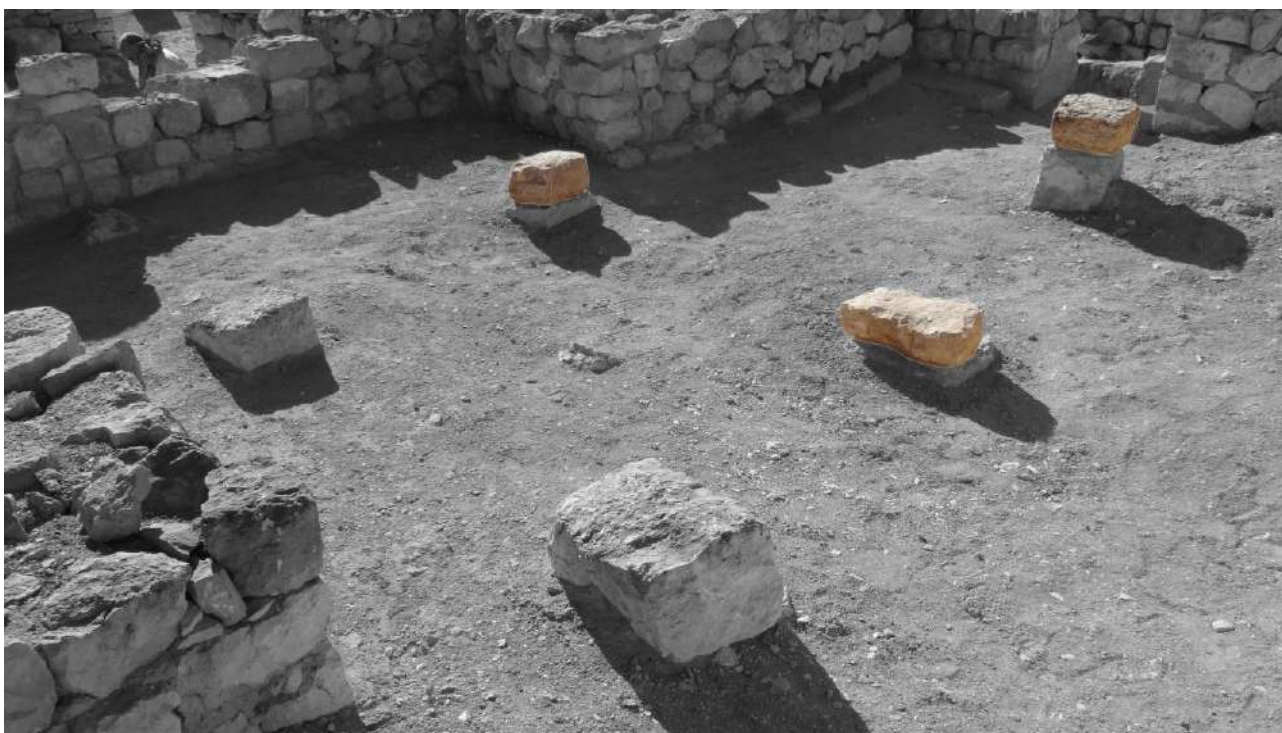
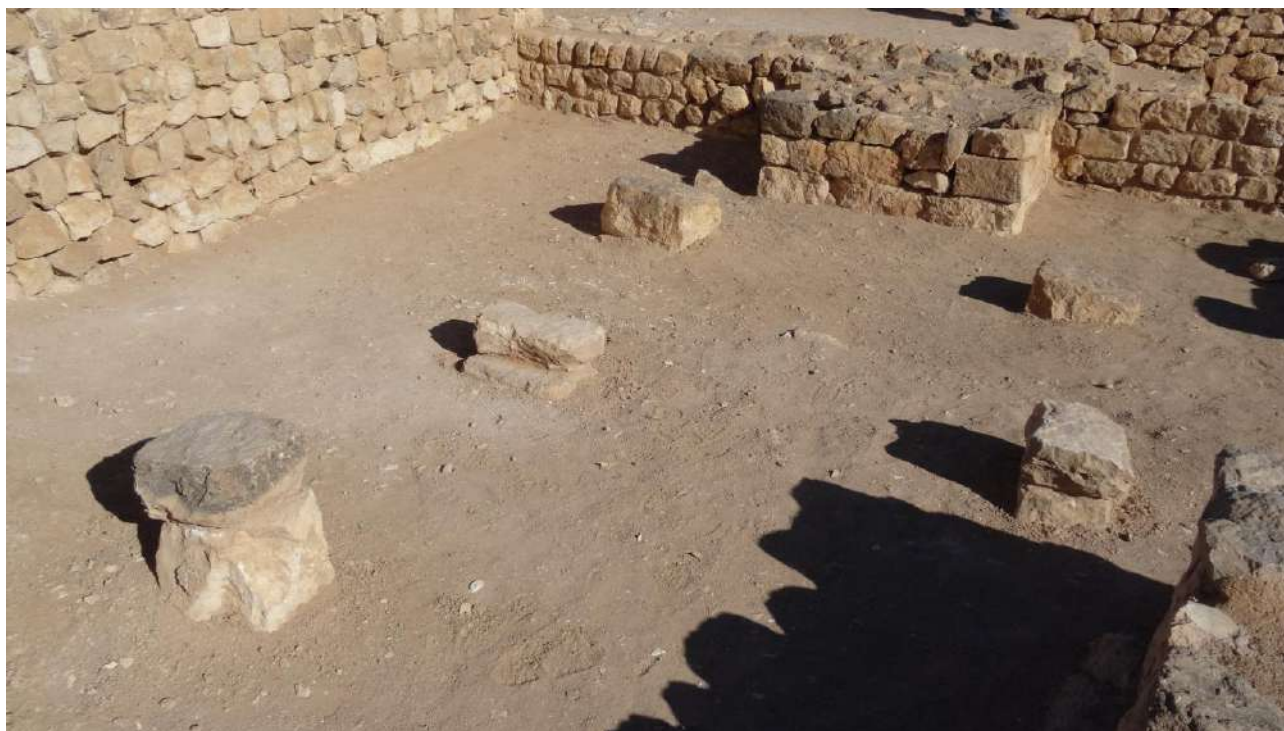
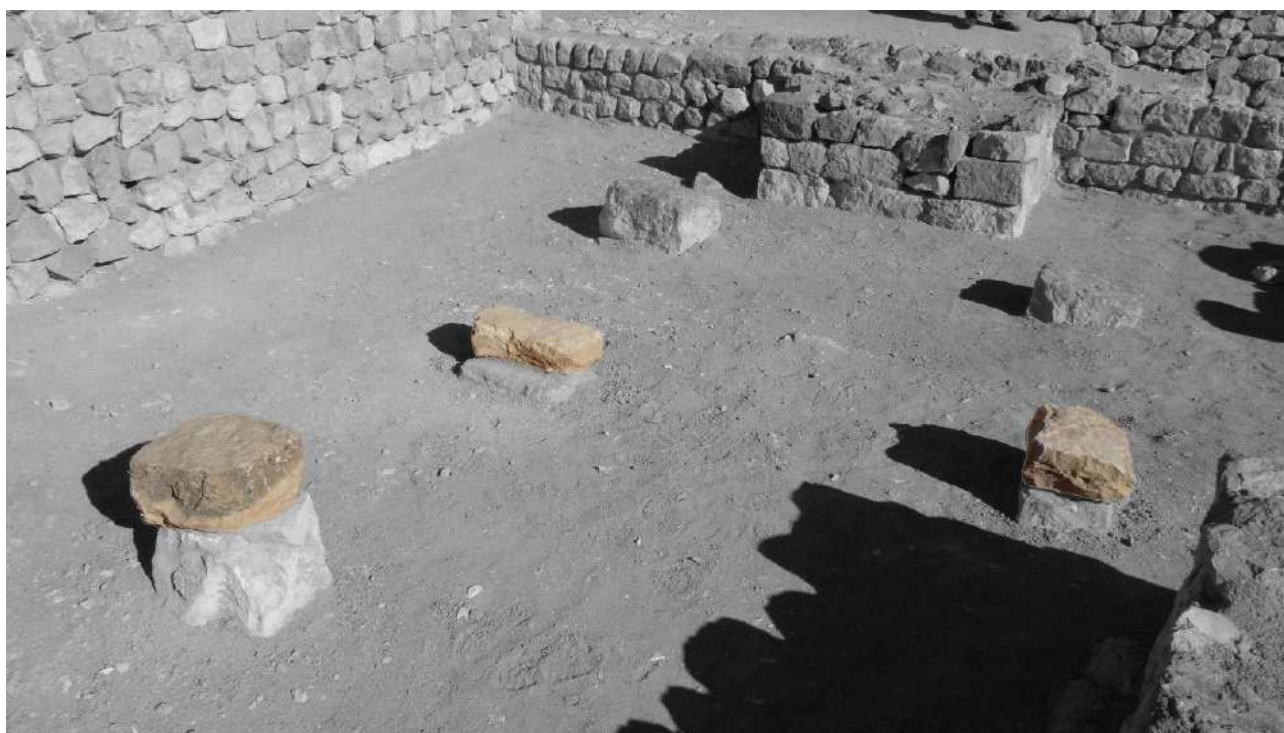
*Fig. 22a – BF3, columns of the temple after the restoration works (view from NW).*

*Fig. 22b – BF3, details of the restoration works of the columns of the temple (view from NW).*

*Fig. 22c – BF3, columns of the temple after the restoration works (view from SE).*

*Fig. 22d – BF3, details of the restoration works of the columns of the temple (view from SE).*

Finally, the bases of some columns have been restored. In particular, especially for those columns whose bases were barely legible because almost at the same level than the ground, stone blocks were added to make the plan of the temple cell more legible (Figs. 22).
