## **RESTORATION OF BF3**

*Restoration works at the Archaeological Park of Khor Rori (Sultanate of Oman)  
Diary of activities (October-December 2017)*

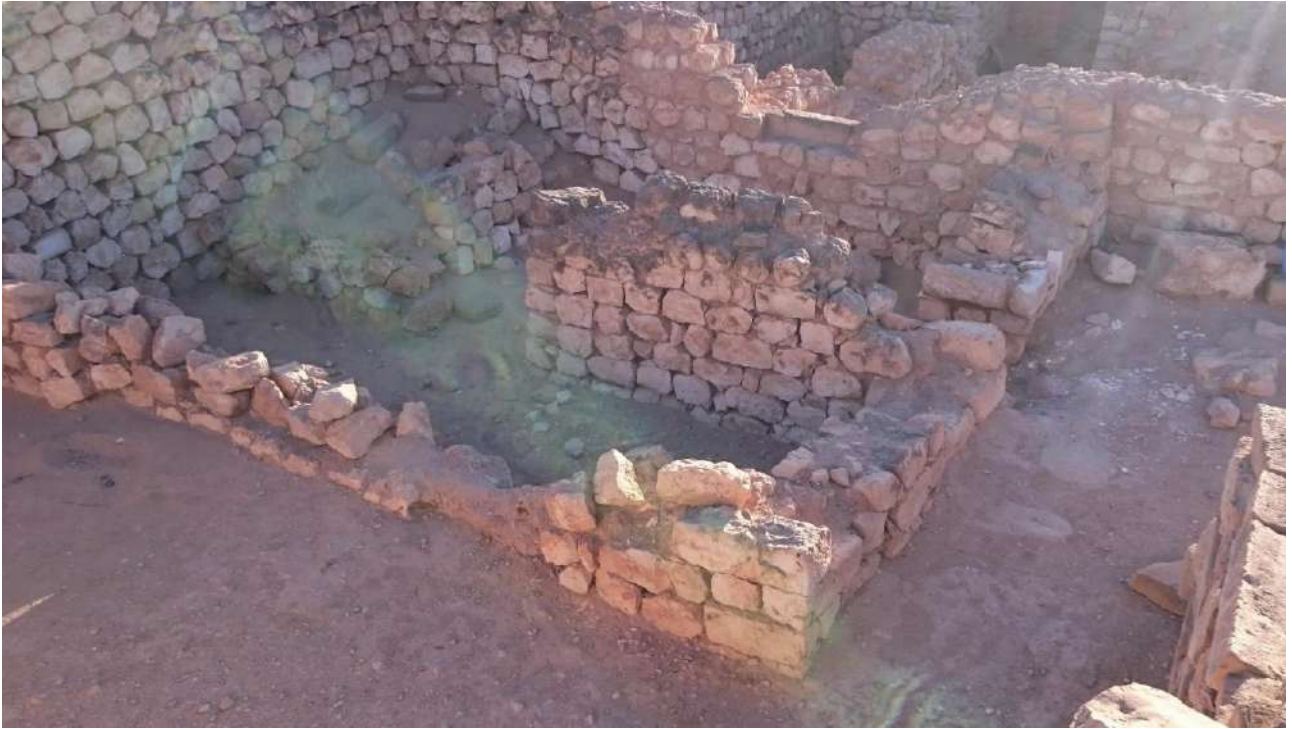
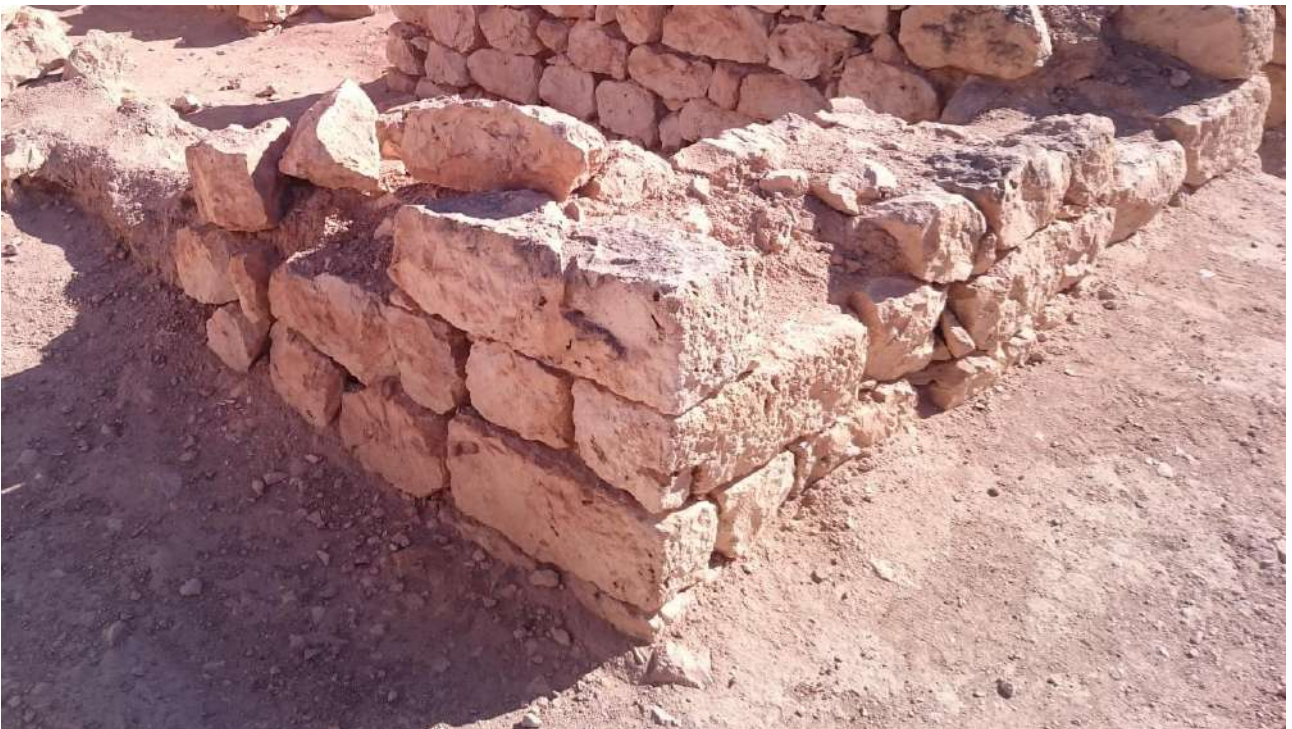
Before restoration, the corner had the upper row very badly put, with some blocks missing or in precarious equilibrium conditions. Therefore, unstable stones were removed, the surface was cleaned up and the ridge of the walls was recomposed (Figs. 24).

*Fig. 24a – BF2 before the restoration works (view from SW).*

*Fig. 24b – BF2, corner between walls M41 and M42 before the restoration works (view from SW)*

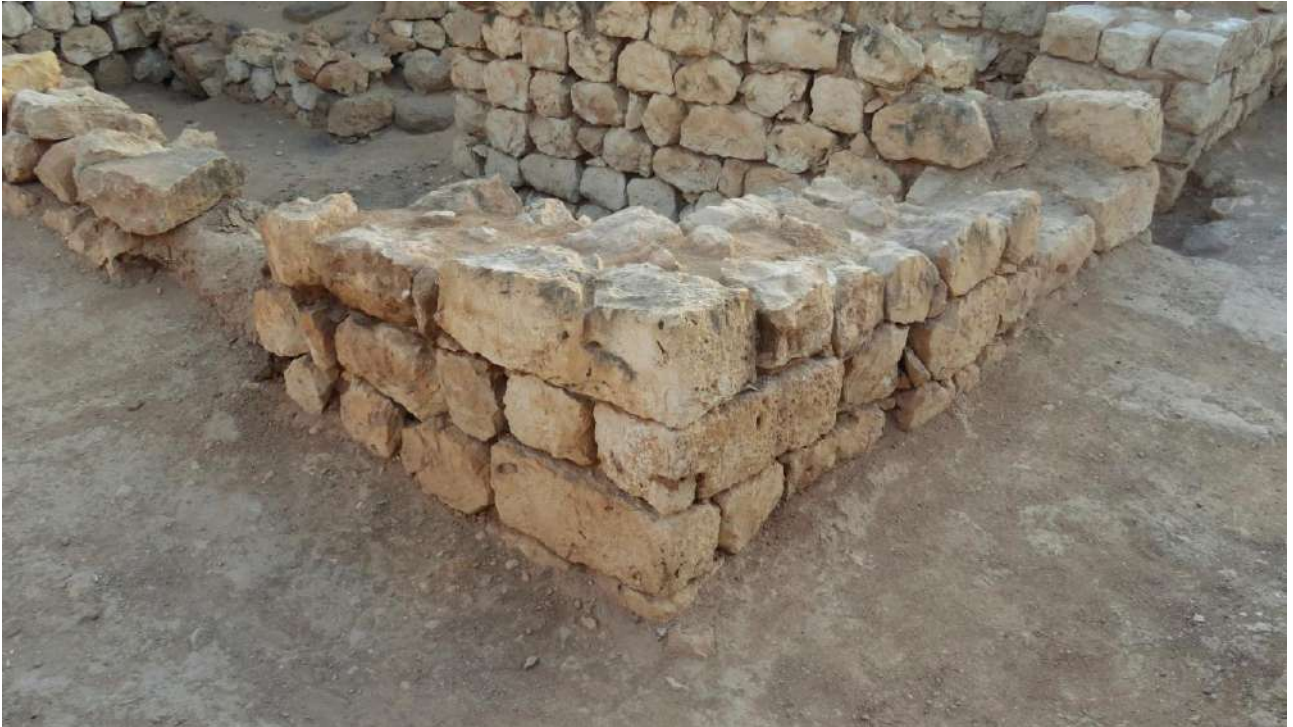
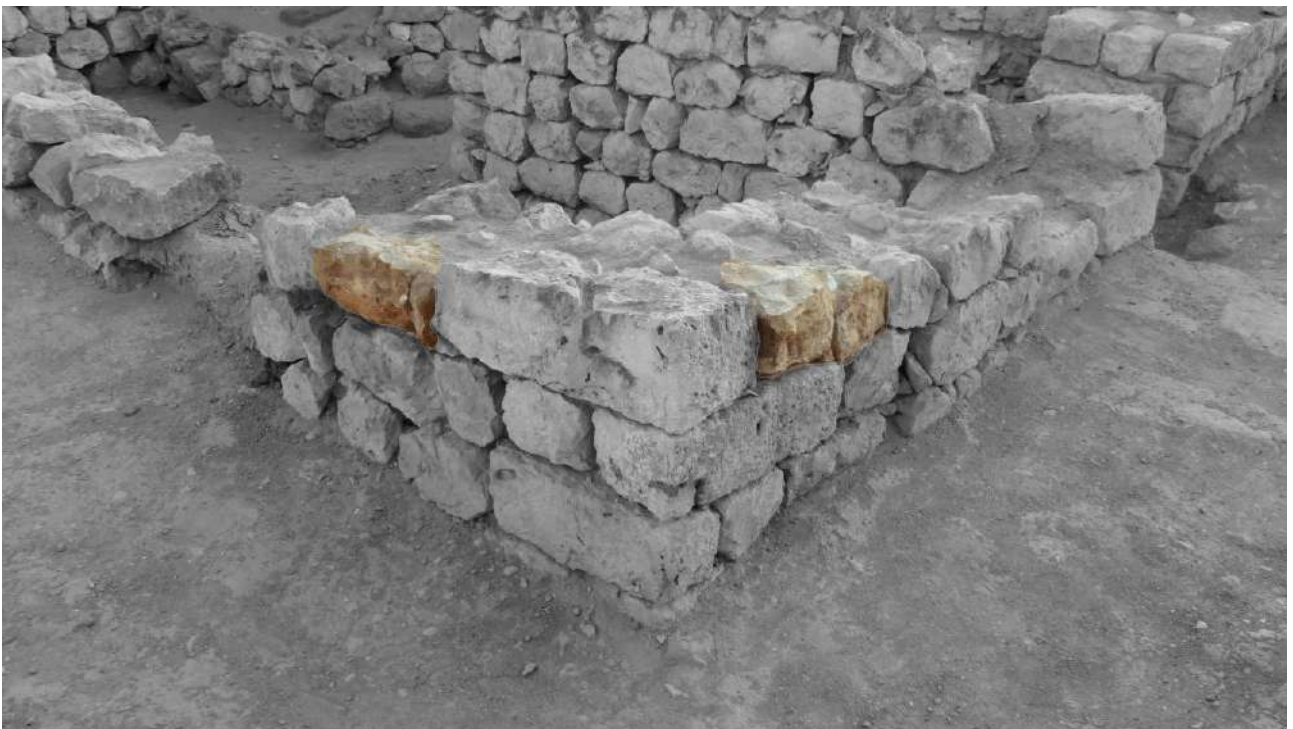
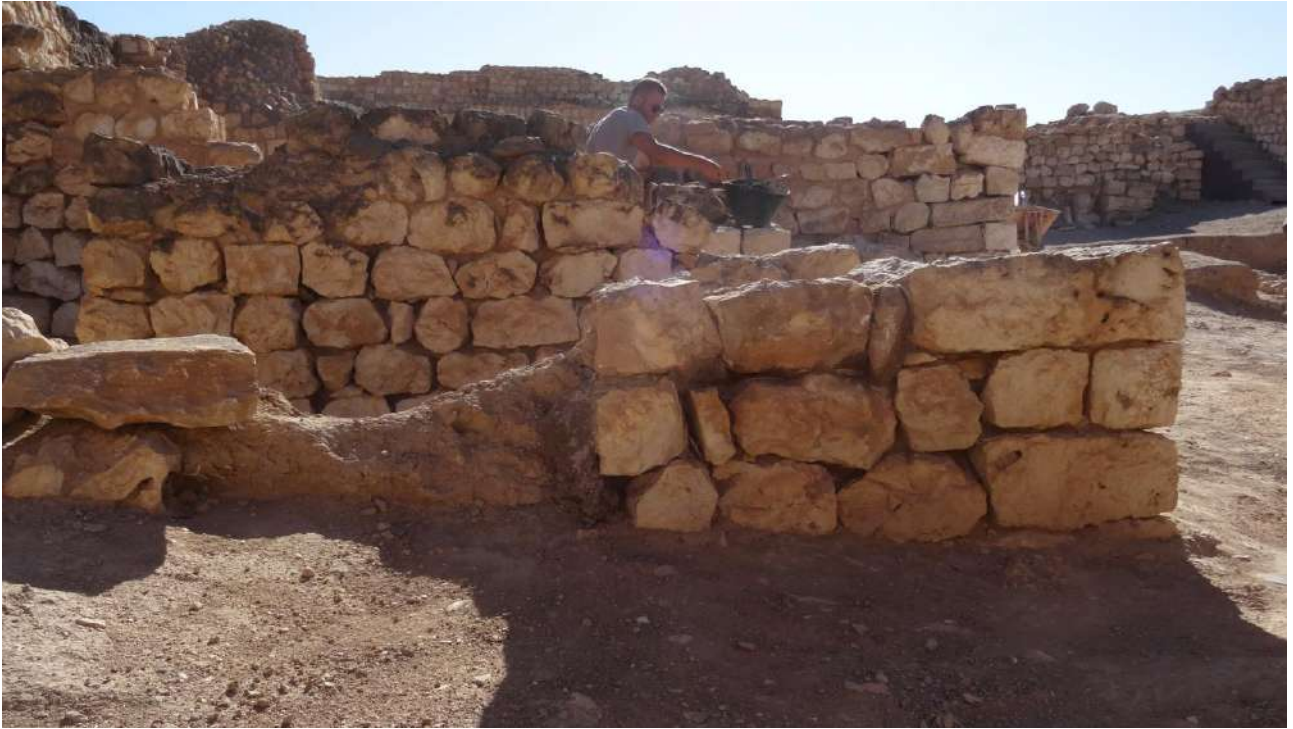
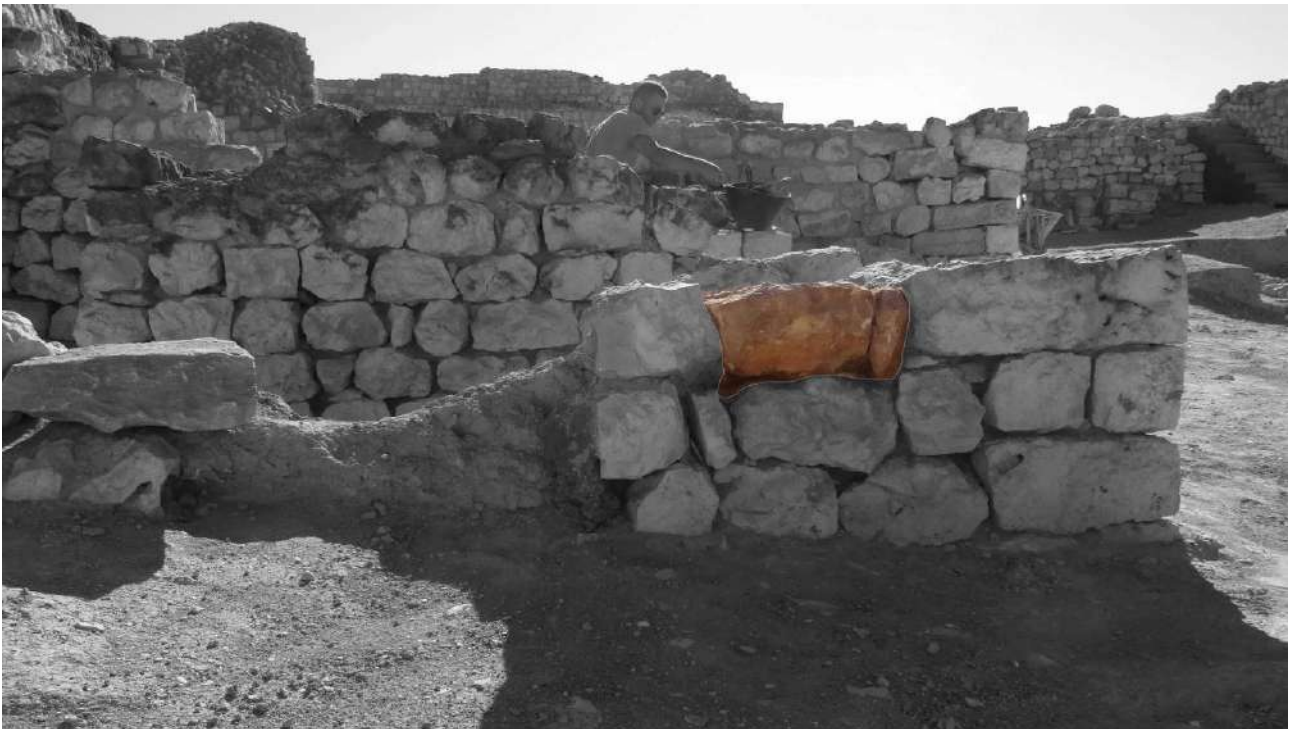
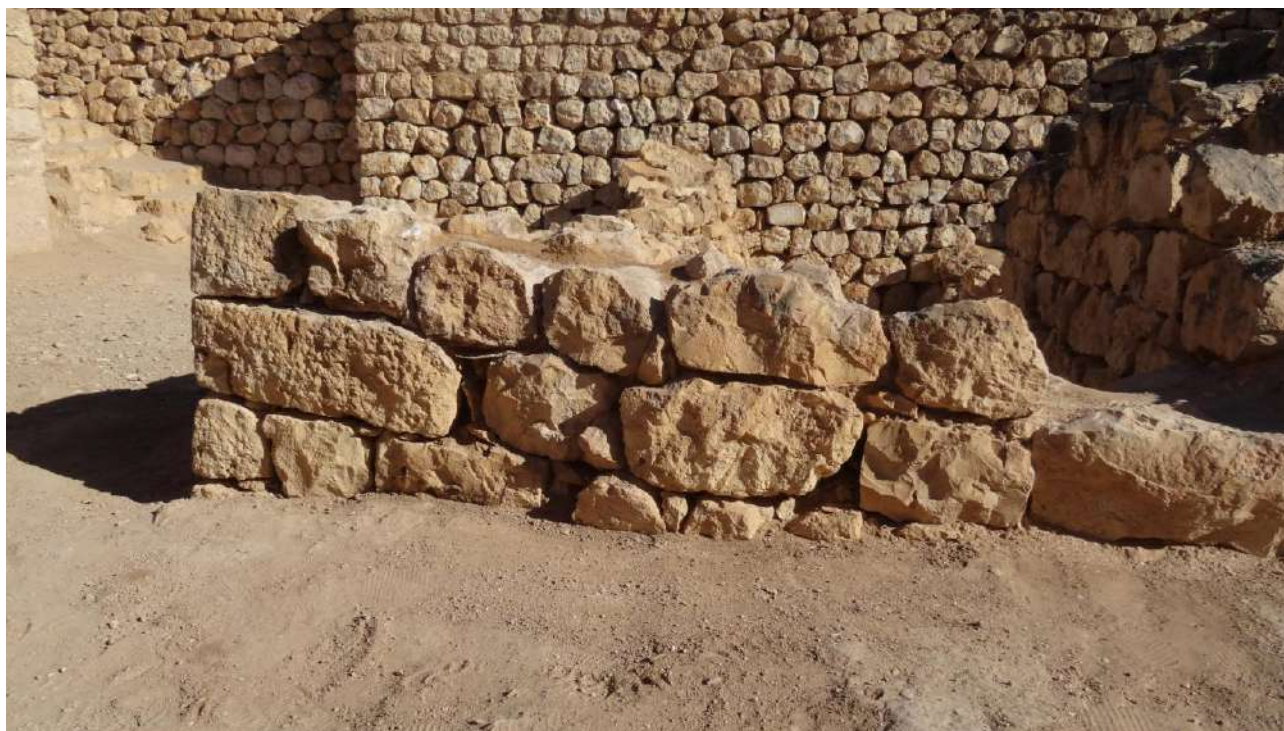
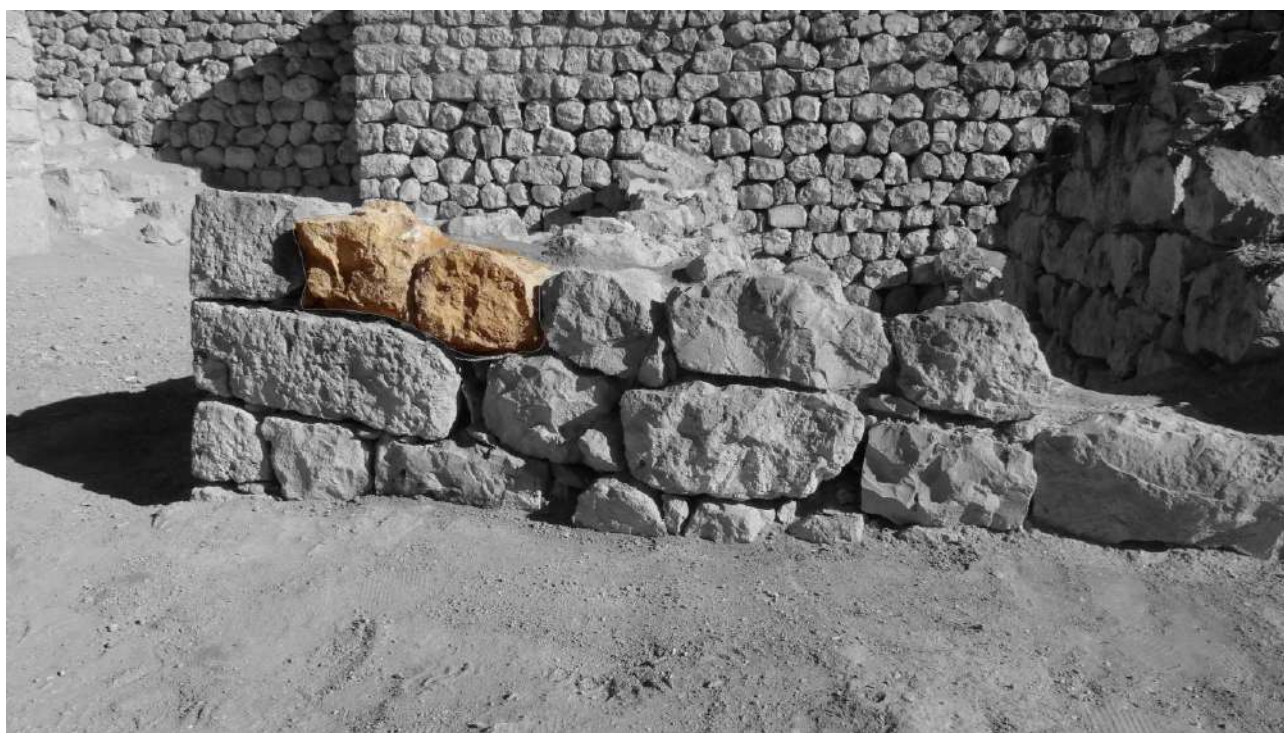
*Fig. 24c – BF2, corner between walls M41 and M42 after the restoration works (view from SW).*

*Fig. 24c e 24d – BF2, details of the restoration works of the corner between walls M41 and M42  
(view from SW).*

*Fig. 24e – BF2, wall M41 after the restoration works (view from W).*

*Fig. 24f – BF2, details of the restoration works of the wall M41 (view from W).*

*Fig. 24g – BF2, wall M42 after the restoration works (view from S).*

*Fig. 24h – BF2, details of the restoration works of the wall M42 (view from S).*

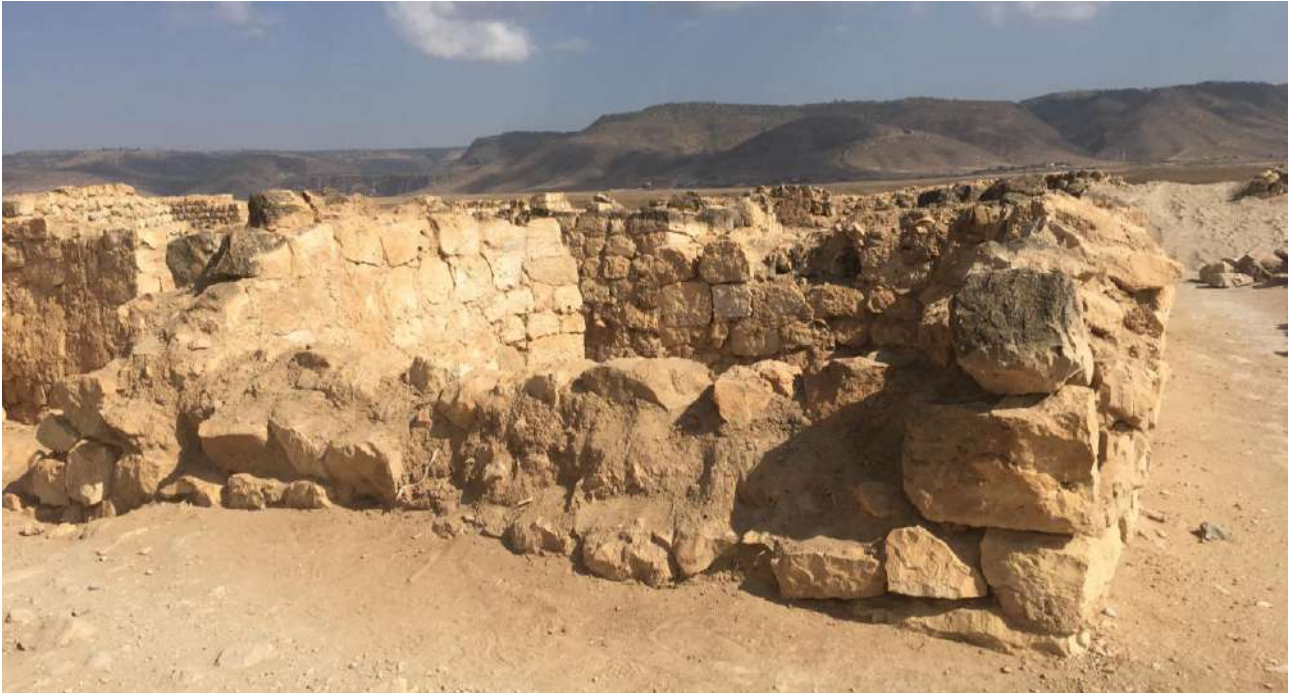
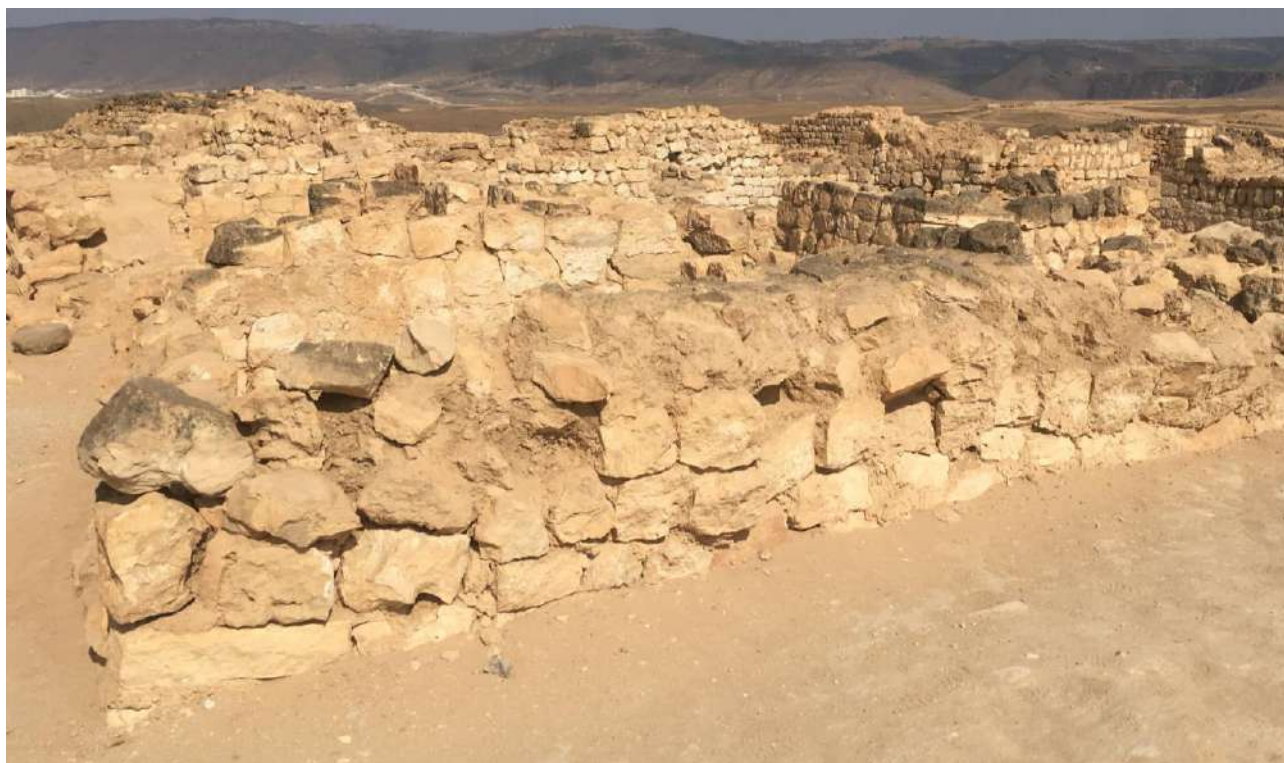
The work is proceeded with the disassembly of some parts of the masonry, the cleaning and the replacement with the same stones as not to alter the original shape. The wall had largely collapsed, part of the wall was rebuilt to allow a better vision and understanding.

*M534, South front wall, before the restoration.*

*M553, East front wall, before the restoration.*

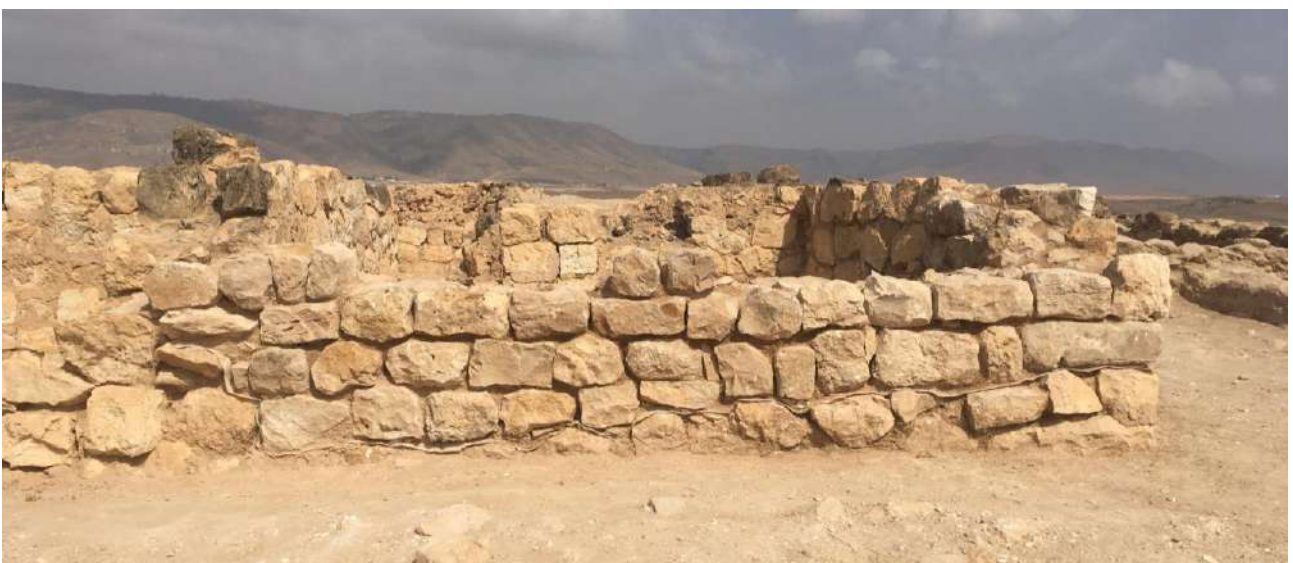
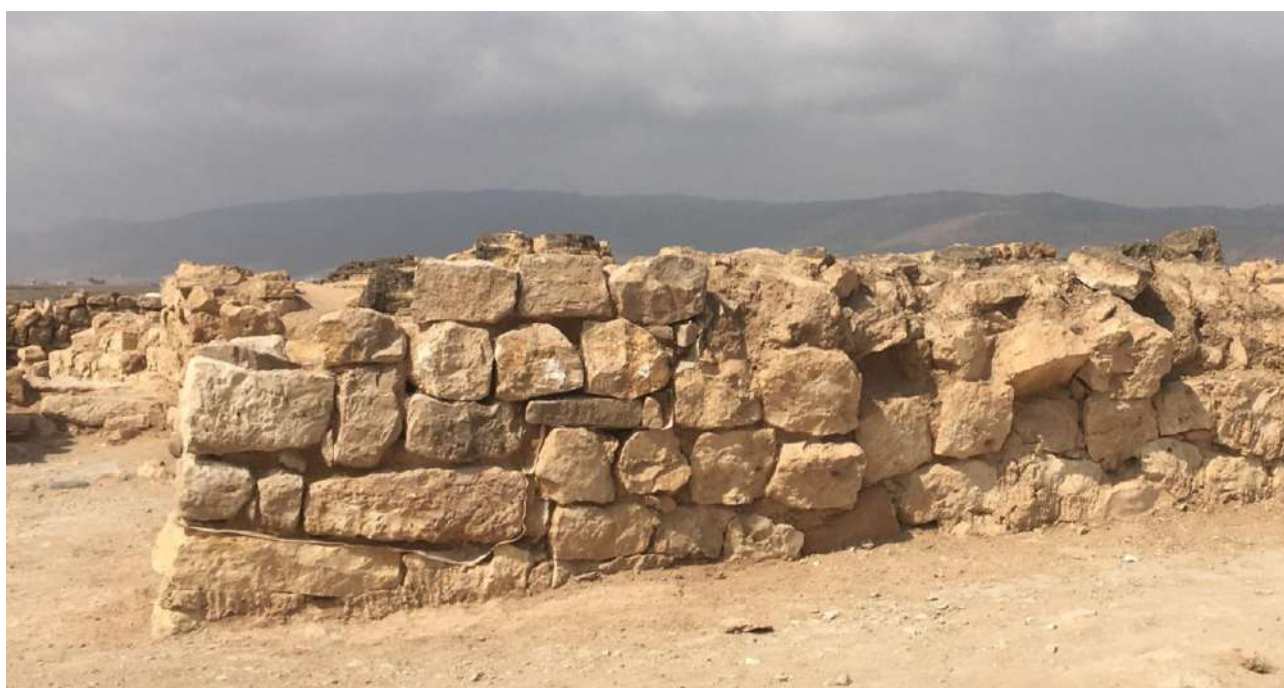
*M534, South front wall, after the restoration.*

*M553, East front wall, after the restoration.*

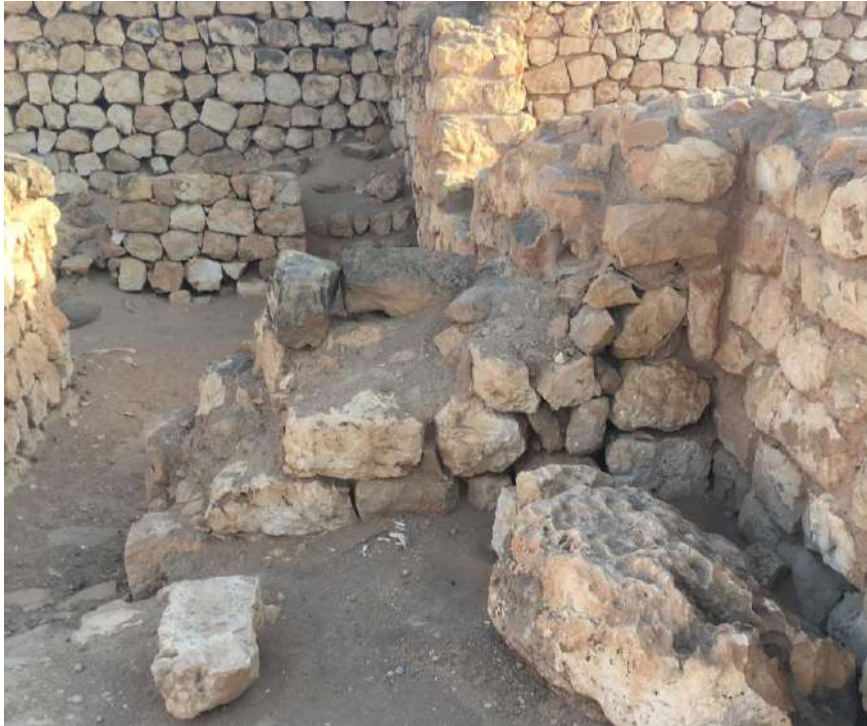
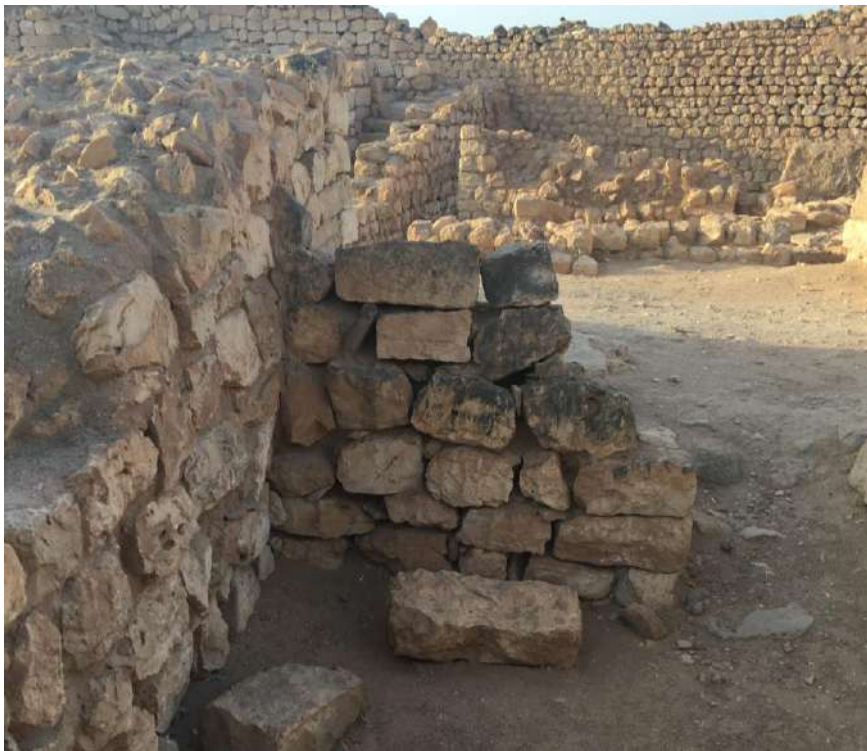
The work is proceeded with the disassembly of some parts of the masonry, the cleaning and the replacement with the same stones as not to alter the original shape. The wall had largely collapsed, part of the wall was rebuilt to allow a better vision and understanding

*M44, South front wall, before the restoration.*

*M44, North front wall, before the restoration.*

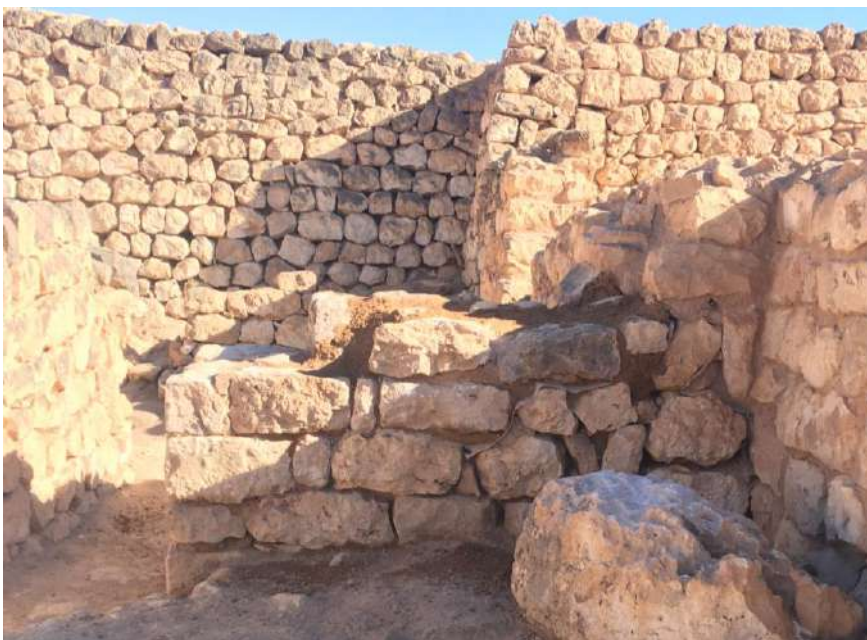
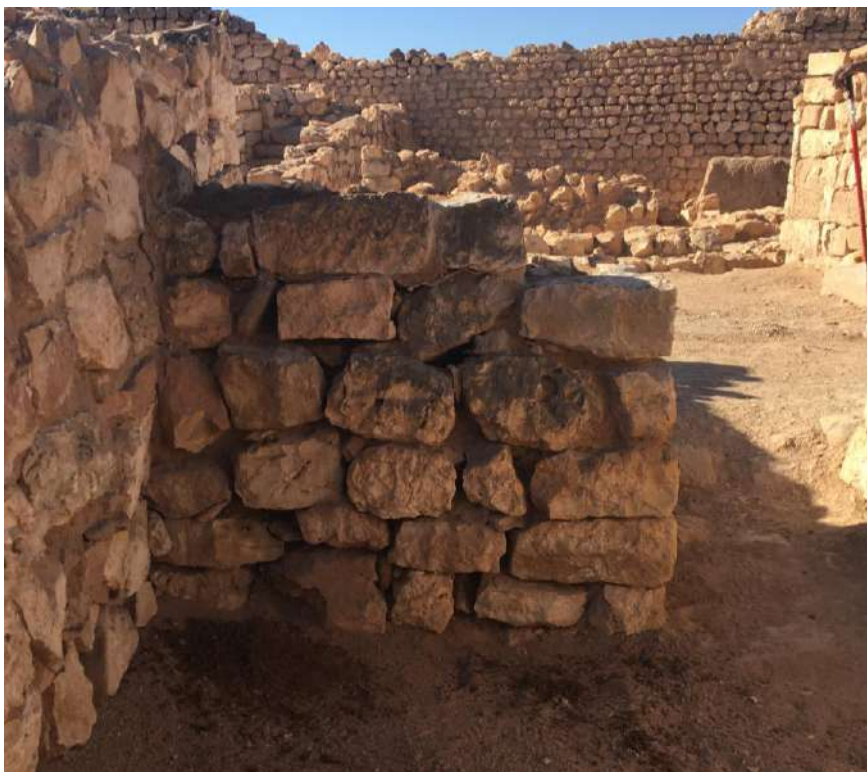
*M44, South front wall, after the restoration.*

*M44, North front wall, after the restoration.*

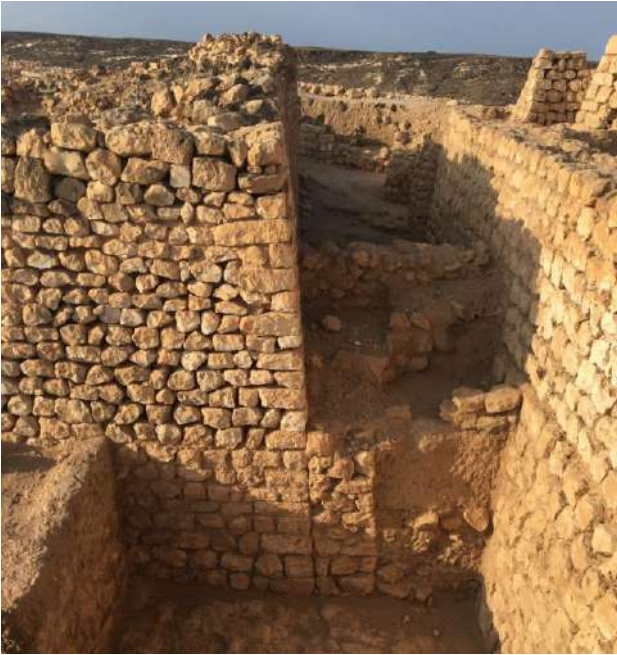
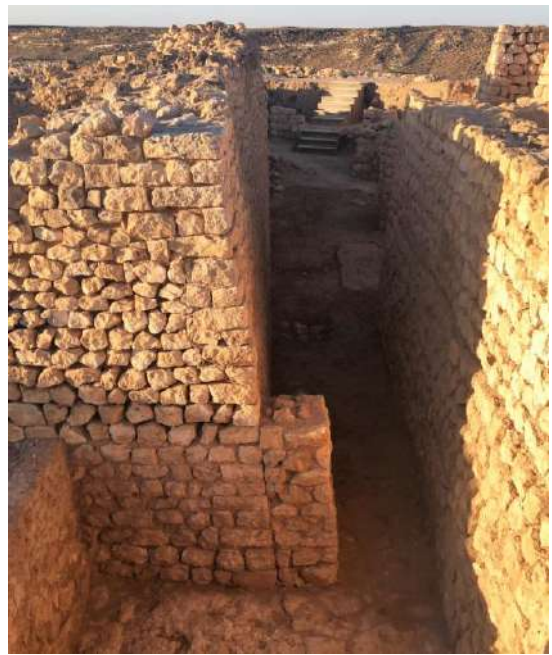
*Monumental building area, before and after the restoration and consolidation of the wall and removal of the section to allow access to visitors. in the distance we see the new wooden stairs to allow access to visitors.*

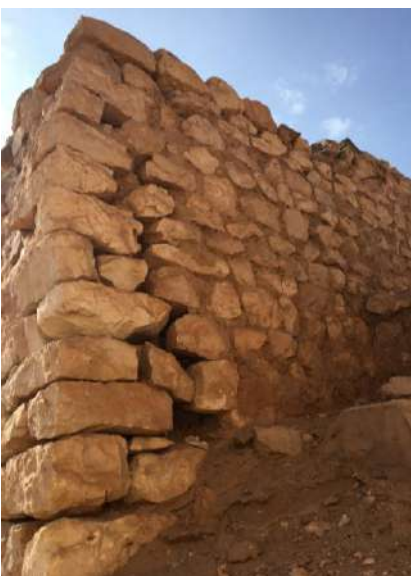
The work is proceeded with the disassembly of some parts of the masonry, the cleaning and the replacement with the same stones as not to alter the original shape. The corner wall had an injury due to the outward thrust and possible collapse of the corner. The blocks at the top of the wall were dangerous because they were no longer fixed to the wall. To do the job it was necessary to mount a scaffolding.

*Corner wall, before the restoration. The fracture along the masonry*

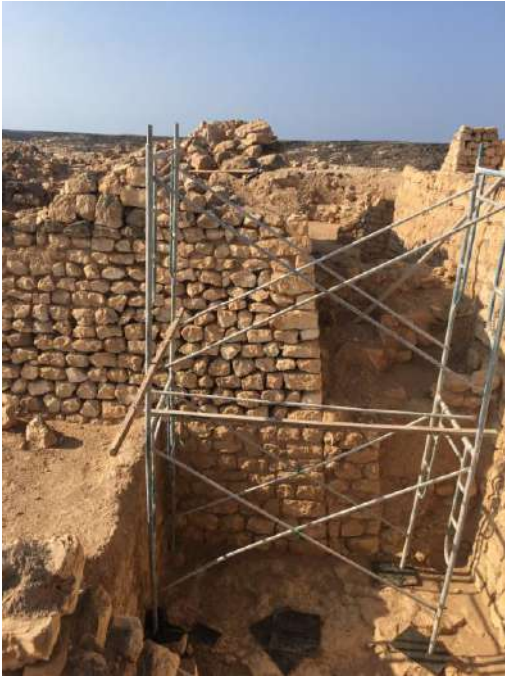
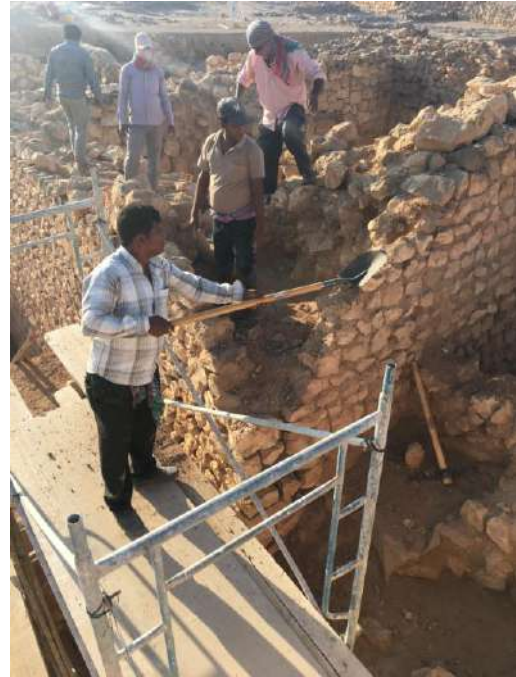
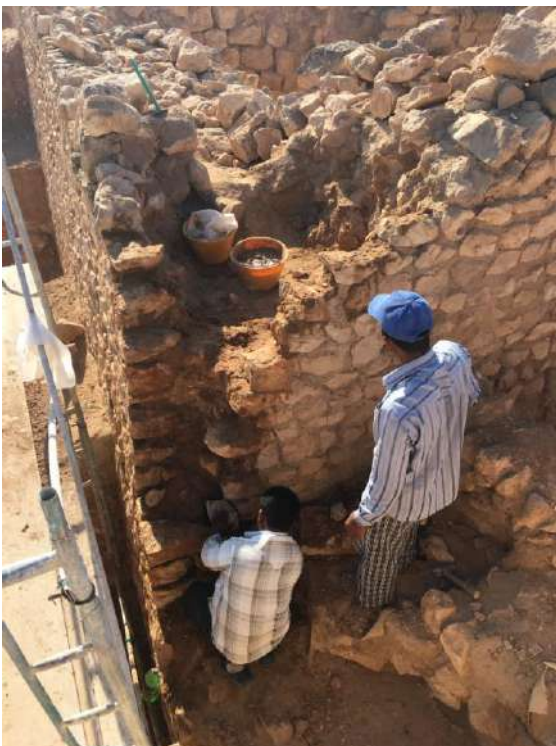
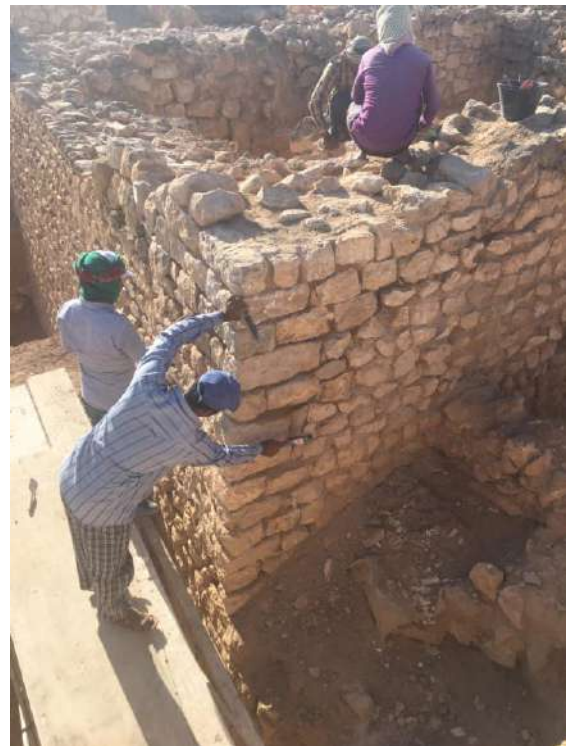
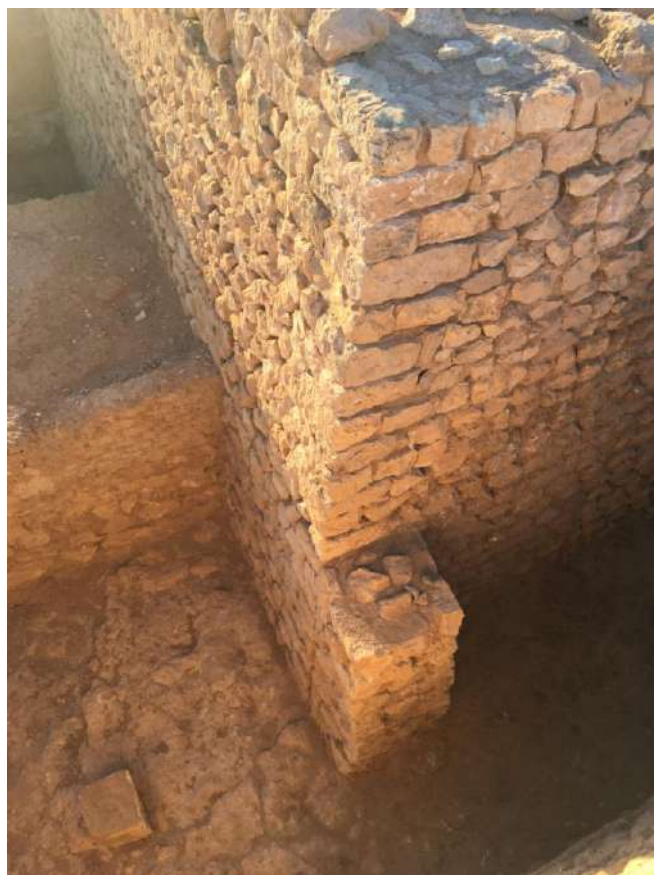
*Scaffolding assembly and cleaning with partial removal of the stones.*

*During the restoration work.*

*M92/M93, North cornerwall, after the restoration.*
