**EXCAVATIONS AND RESTORATION OF THE COMPLEX
OF KHOR RORI
INTERIM REPORT (OCTOBER 2000-APRIL 2001)**

Introduction

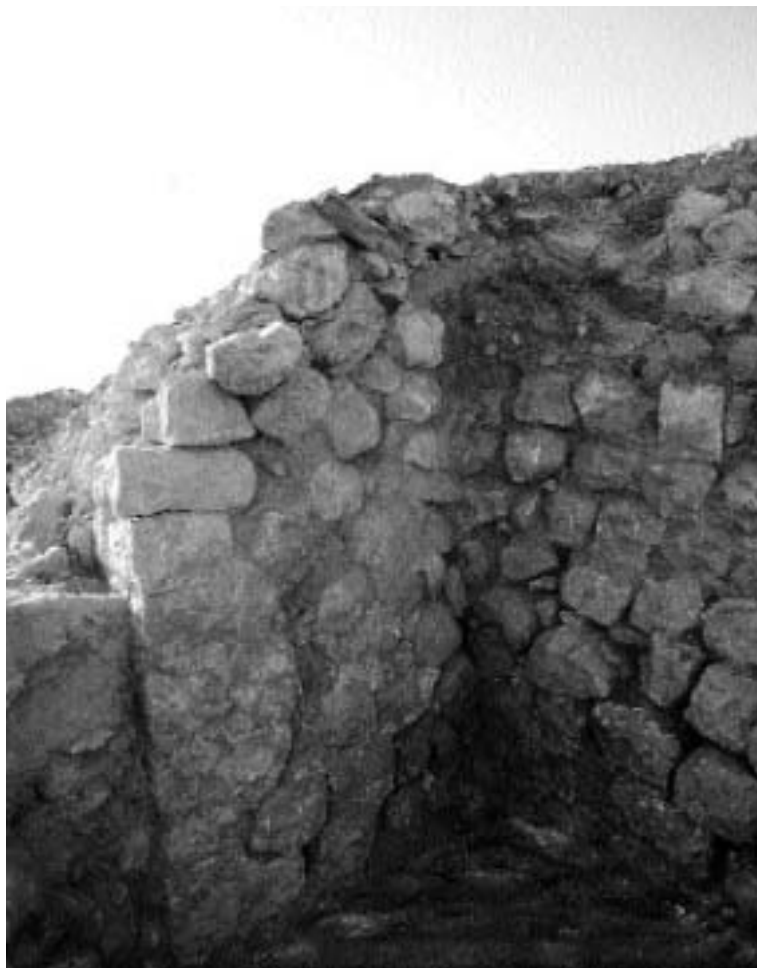
Fig. 4 - Offset of the city wall M15.

(Figs. 2, 3). After removing a huge stratum (US49) consisting of material fallen after the collapsing of the wall and a second filling (US51) partly mixed with the first one and made of richer earth (we also found traces of food, namely animal bones and shells as well as charcoals, ceramic and stone fragments) we unearthed the above mentioned side of the wall. Wall M15, almost in correspondence with the point where it joins the gate wall M8, forms an offset 1,60 m deep⁶ and, in this point, seems to be fairly well preserved: fragments of whitish plaster are still attached to it (Fig. 4).

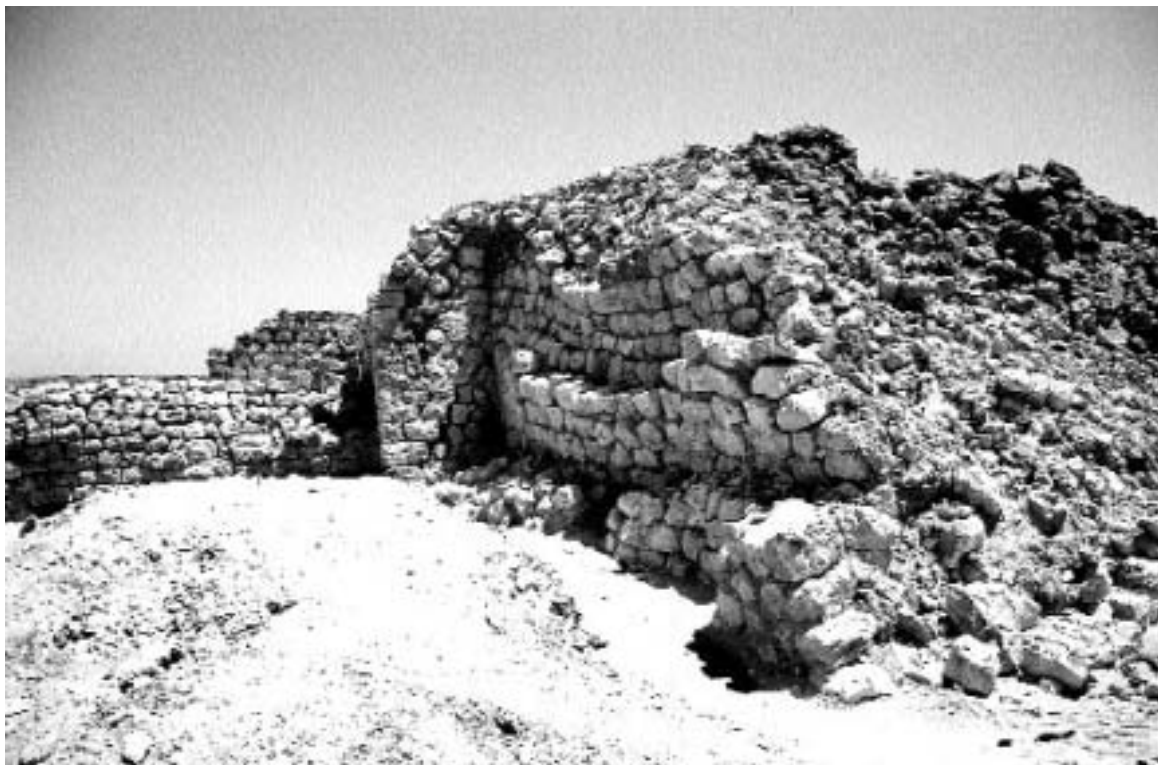
Fig. 5 - View of M15 with the ancient restoration.

Moving in a western direction, with respect to the above mentioned offset, the city wall's side seems to be made of two overlapping structures: the top part, which recedes about 30 or 40 cm from the border of the lower one, seems to be vertical enough, whereas the lower one appears to be inclined forward. At the base of these two overlapping structures we found another wall structure consisting of two rows of roughly worked stones interspersed with a filling made of smaller stones (Fig. 5).

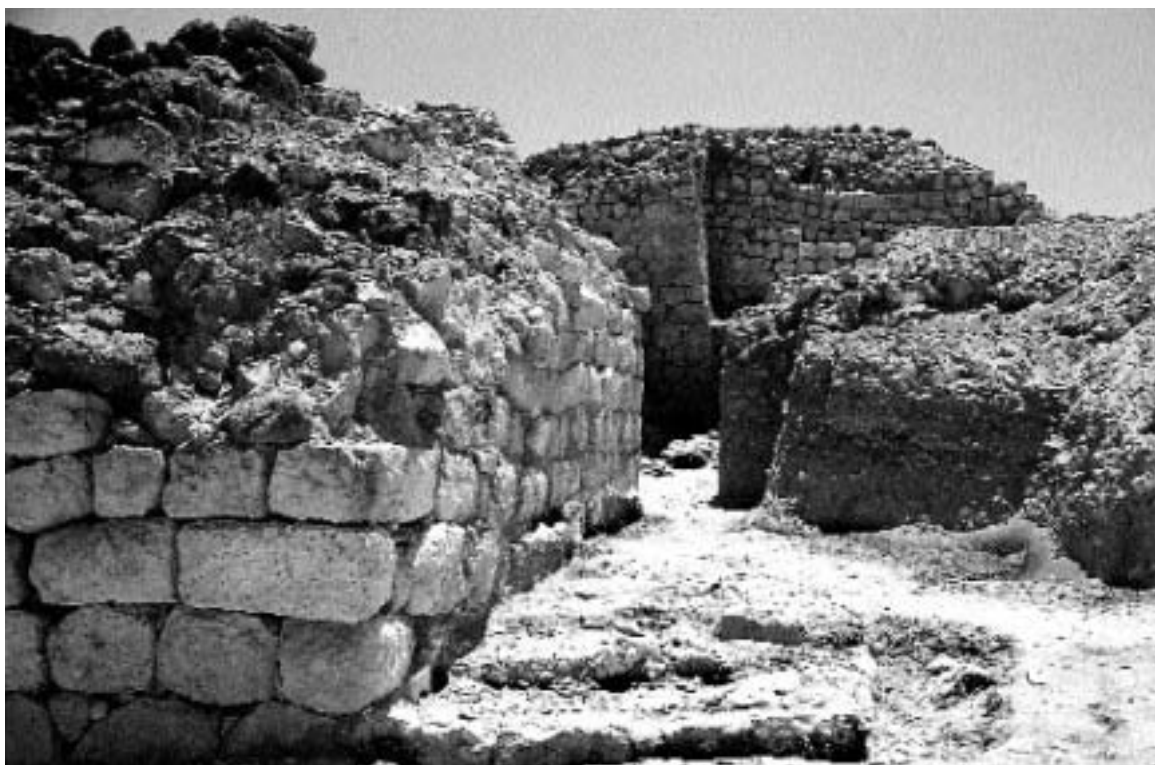
Fig. 6 - The stone platform connected with the turret M9.

packed earth (US59), compacted with pebbles and gravel; this paving has been only partly preserved (Fig. 6).

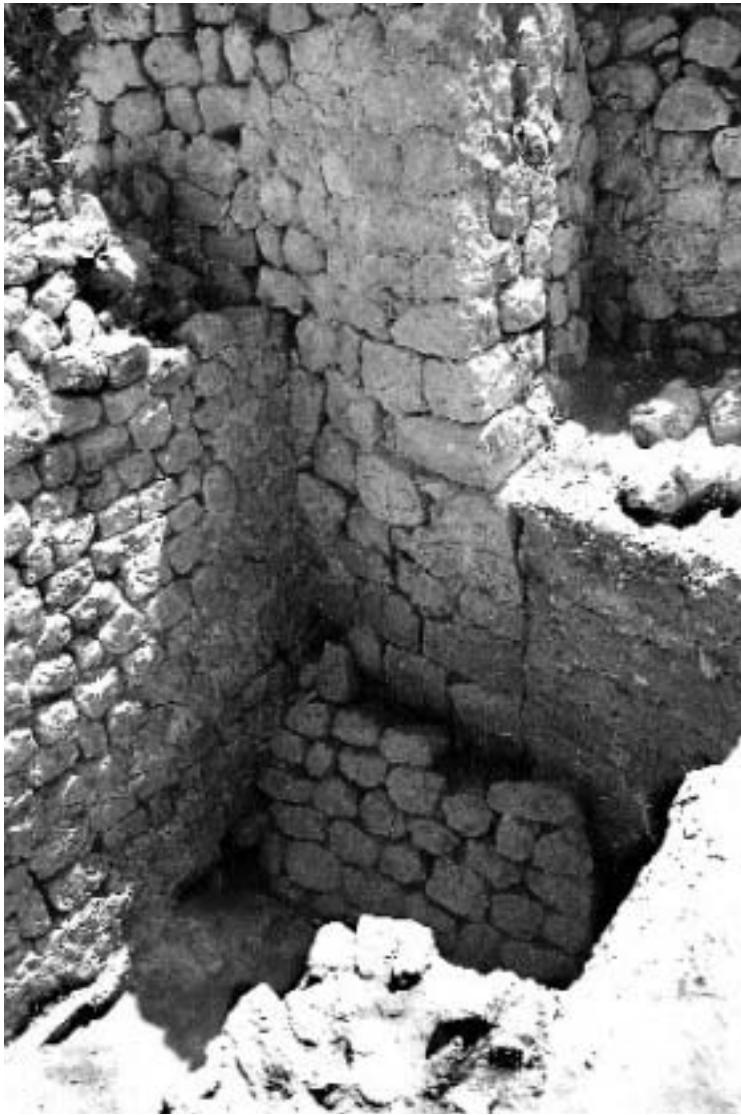
Fig. 12 - Stone buttness at the base of the offset on M15.

In the southern part, just at the base of the offset between M8 and M15, a small opening was made, about 1 m in depth, to the underlying natural rock and this brought to light a stone buttress, clearly leaning on the outer wall M15 and for now to be found only in correspondence with the offset of this same M15 (Fig. 12).

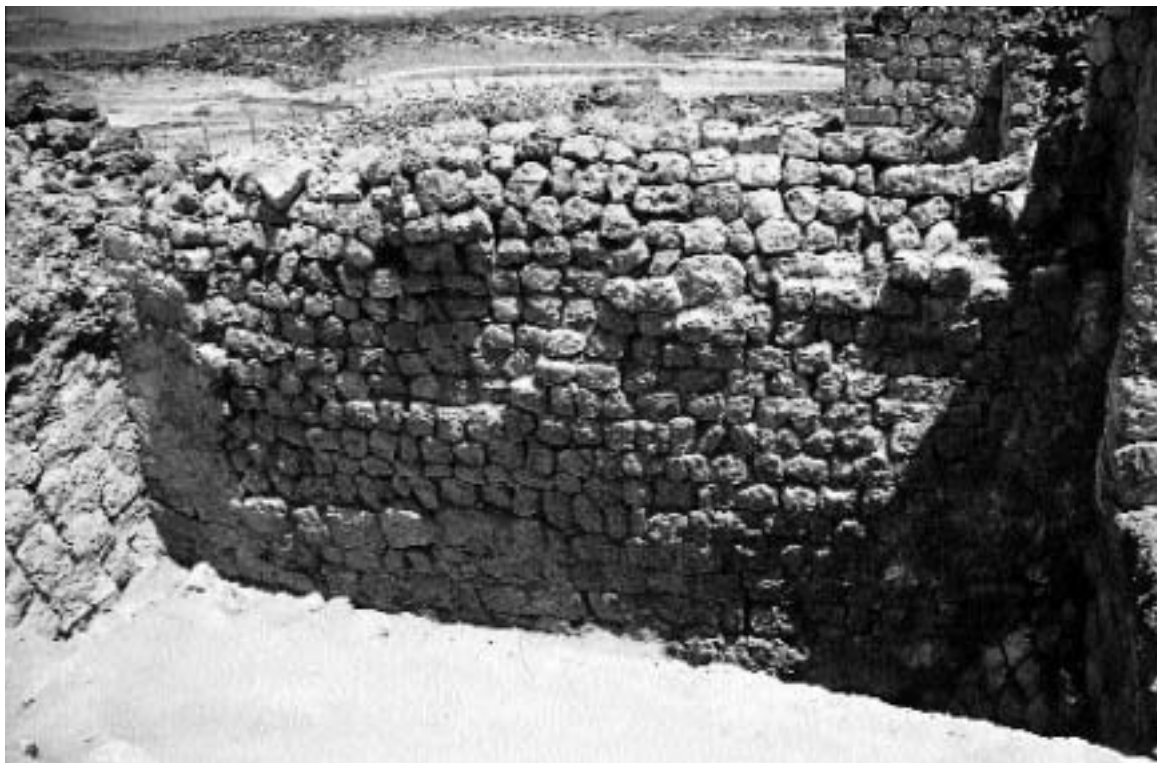
Fig. 13 - View of western side of M8.

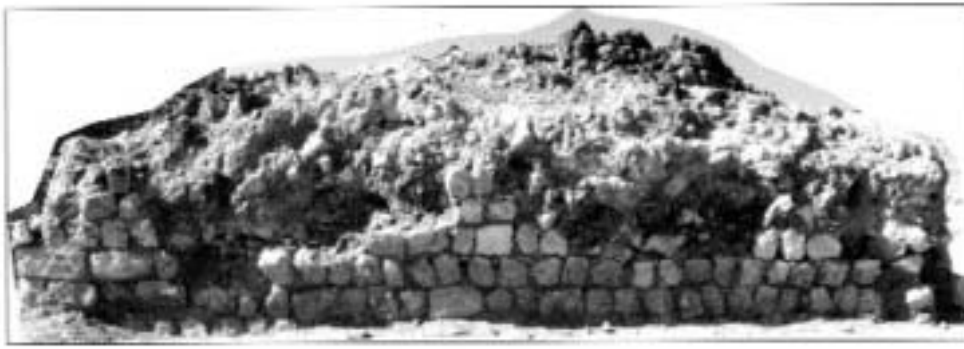
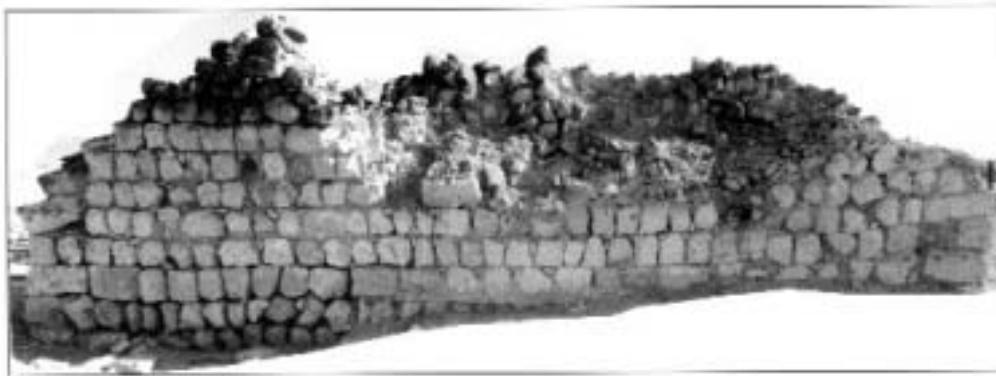
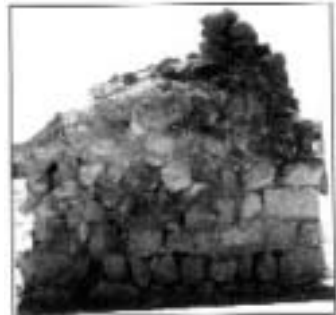
Fig. 15 - City gate: elevation of the external wall (M1).

An example of this procedure has been used to represent a part of the city wall located between the city gate and the palace-temple (Fig 14) and to represent the first structures to be restored as the external wall and the western wall of the city gate (Fgs. 15-16).

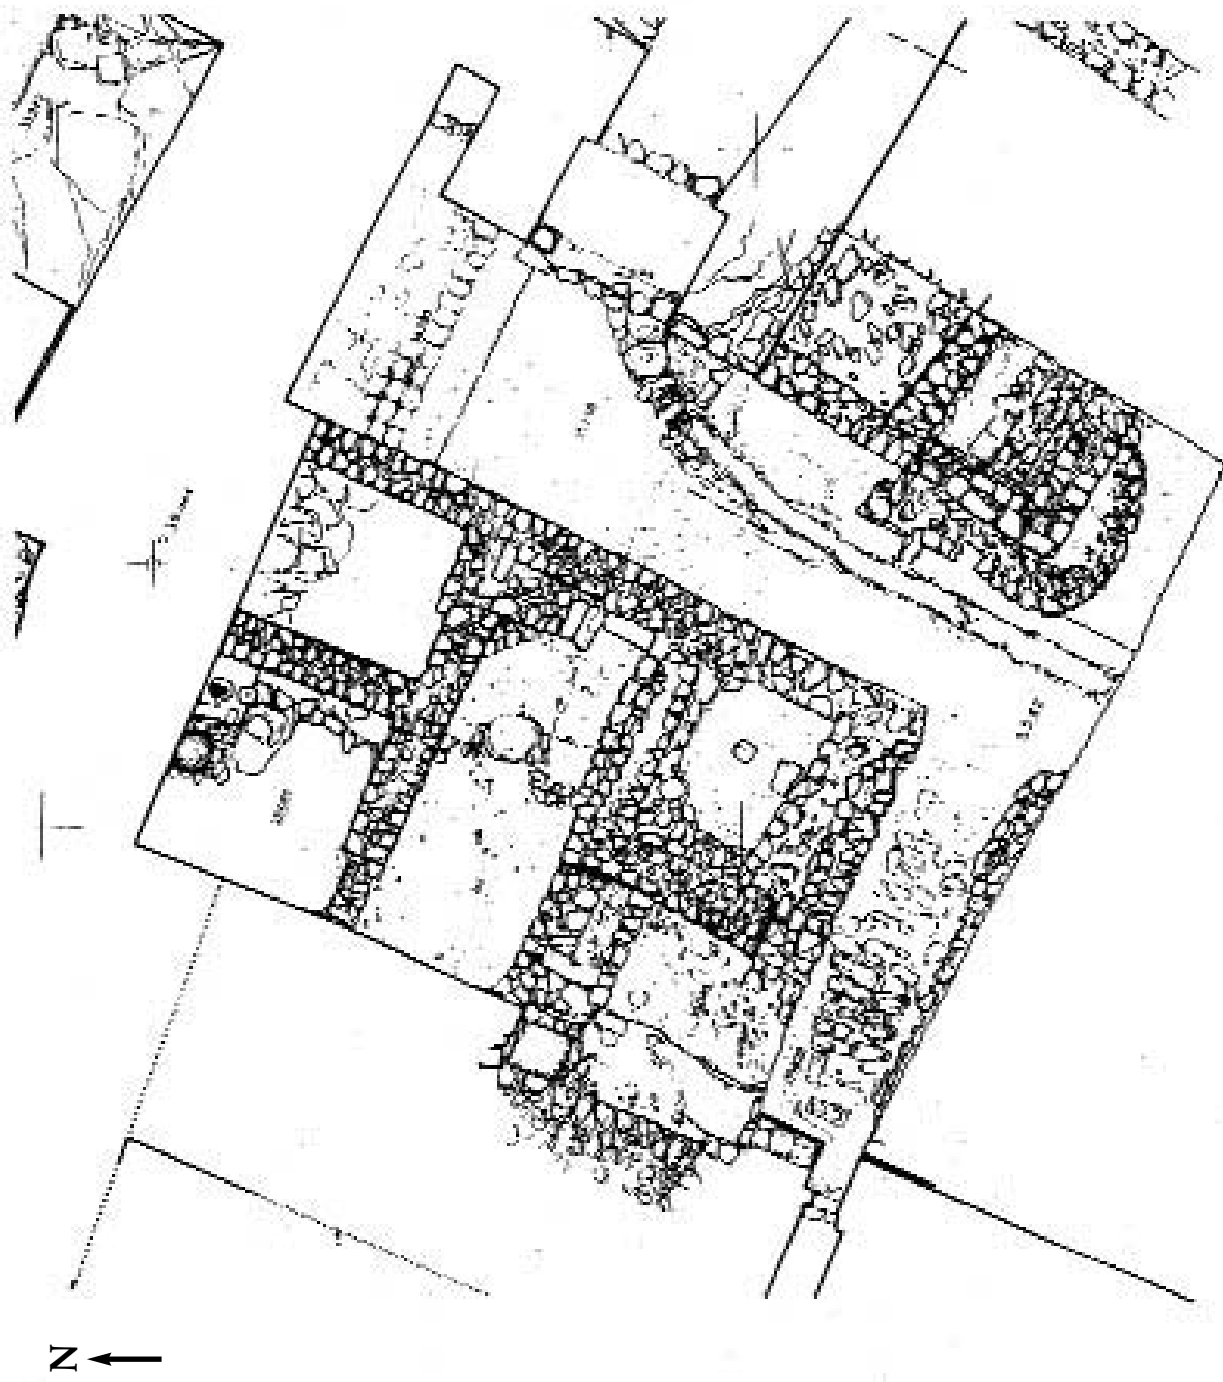
Fig. 17 - Area A8: detailed plan.

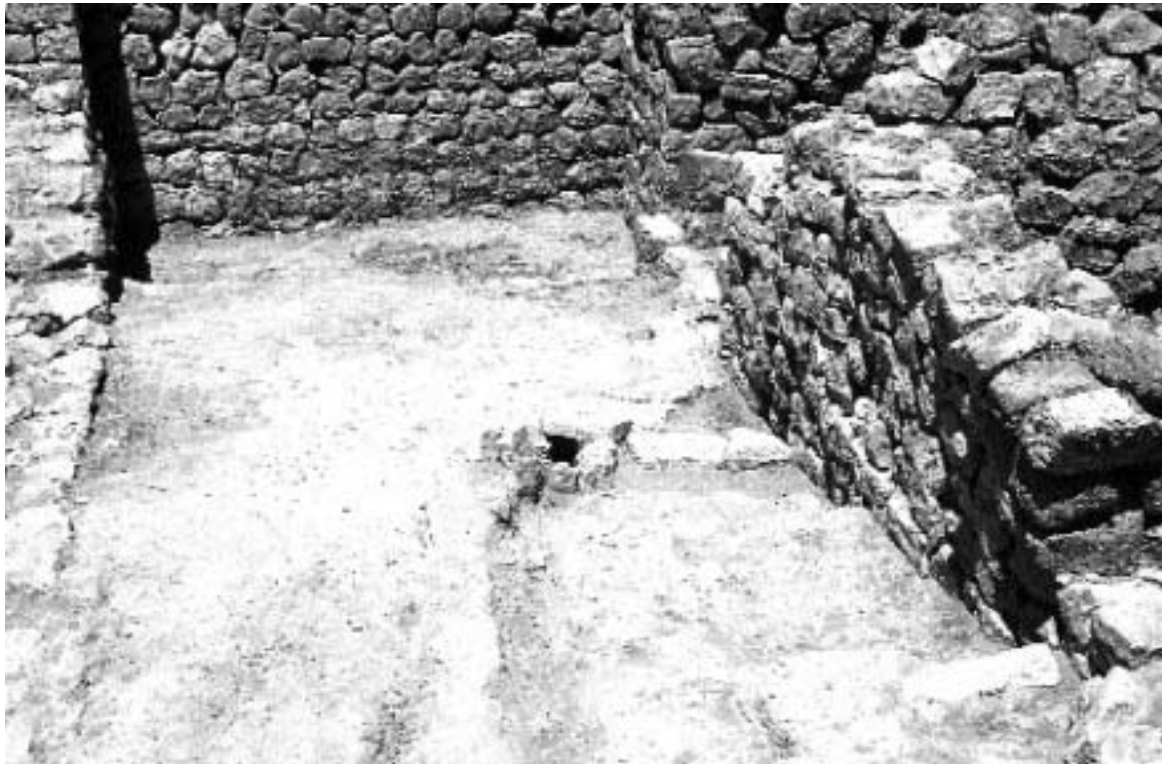
Fig. 20 - Area A8: channel in the square.

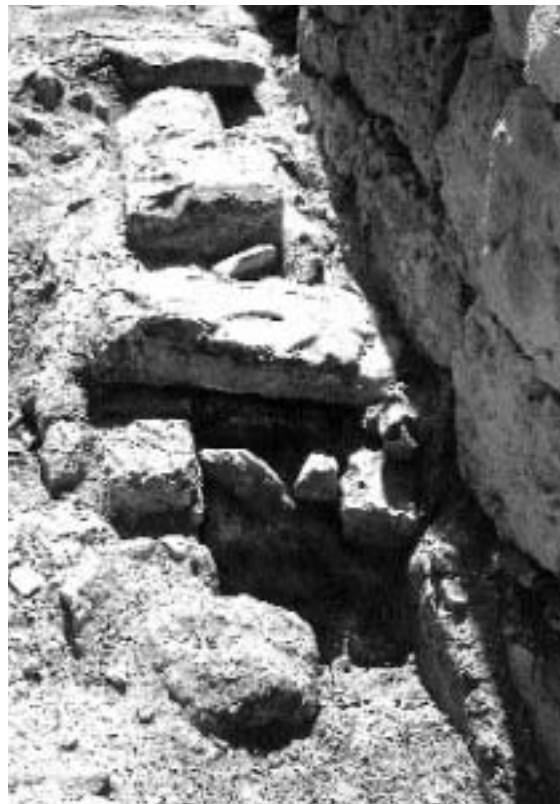
Fig. 21 - Channel in the corridor A4.

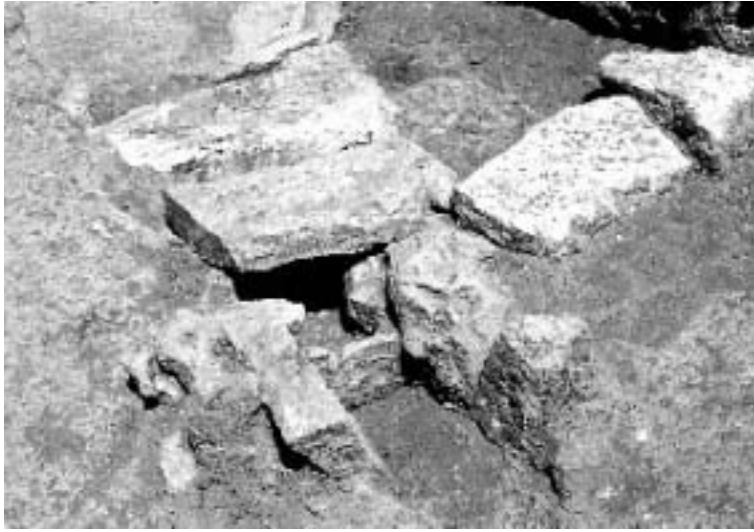
Fig. 22 - Flat stones blocking the channel.

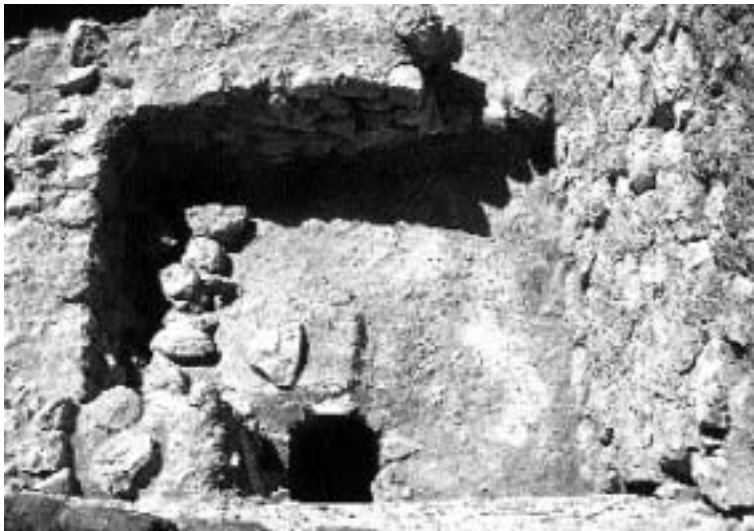
Fig. 23 - Well in A14.

The “wells” discovered under the floors of the rooms A14 against wall M15 (Fig. 23) and A19 were 0.55x0.6 m and 0.45x0.5 m in size accordingly. The “well” in the room A14 was traced down to 1.6 m depth. The “well” in the room A19, with a visible depth of about 0.5 m, was covered with a triangular flat stone block. The purpose of construction of these “wells” remained unknown, but probably it was connected with the drainage or sewage systems of the ancient town.

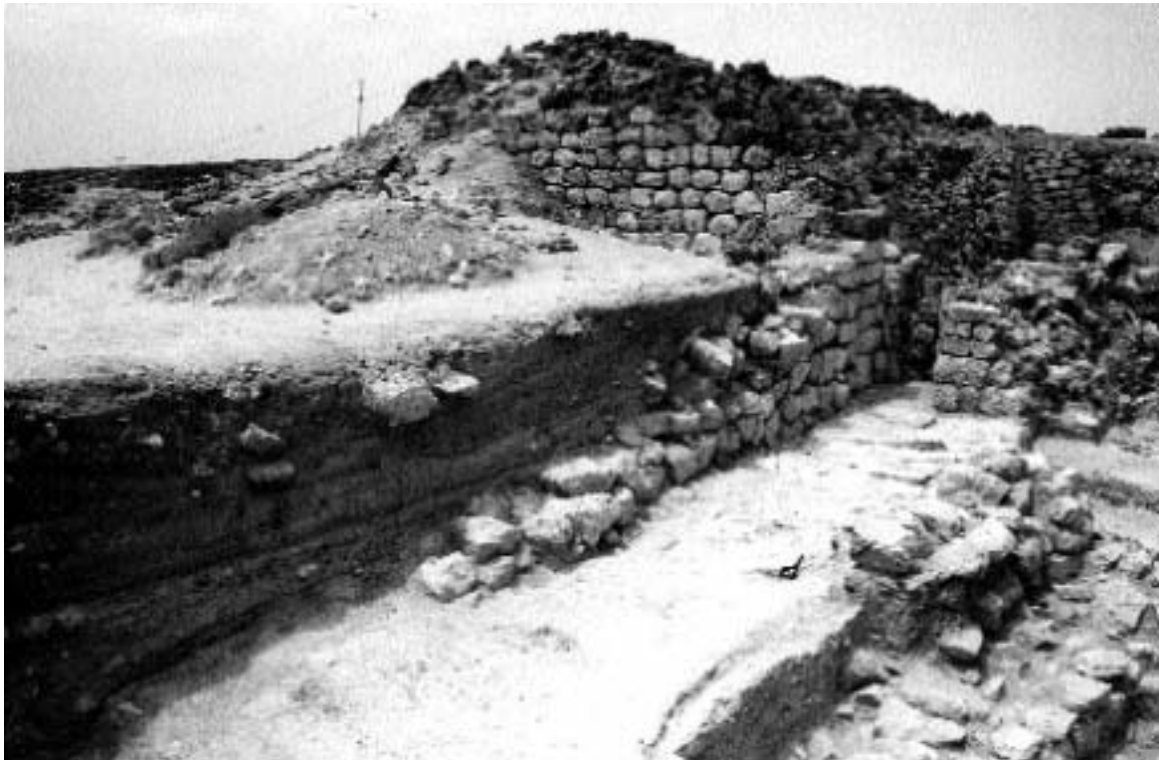
Fig. 25 - Stone paving at the small zigzag entrance to palace-temple.

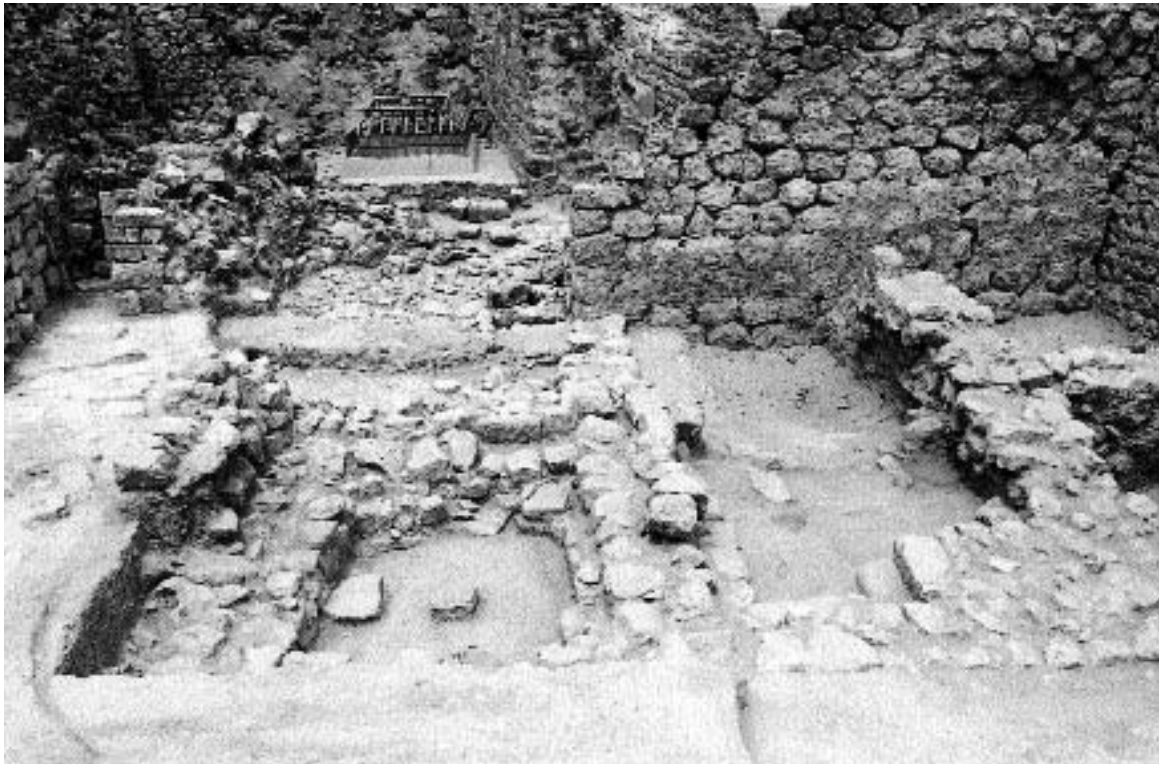
Fig. 26 - Building BA1.

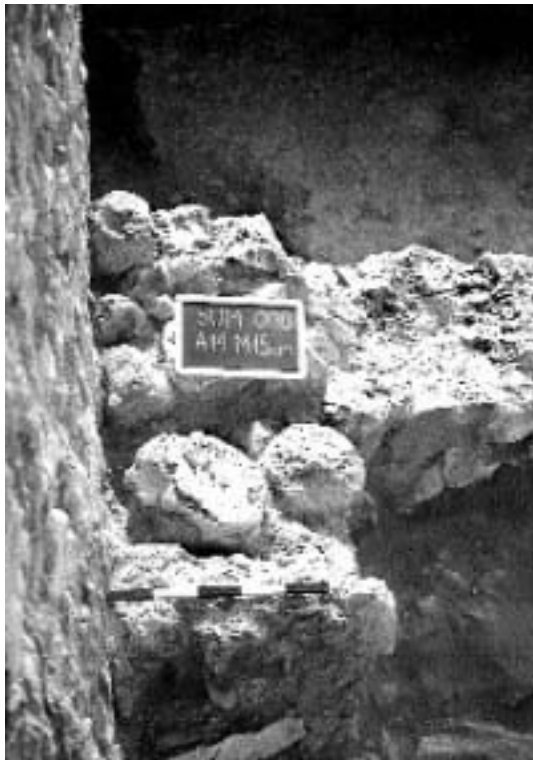
Fig. 27 - Cubic-shaped structure with the whale vertebra in A14.

carelessly built along the eastern wall (M27) of the room. Its N-E corner was occupied by a cubic-shaped construction, the outer surfaces of which were plastered. The vertebra of a whale and the low stone of a hand mill were mounted in the top rows of this construction (Fig. 27). A fireplace and part of the carefully plastered floor (US29B) were unearthed, during the 2000A expedition, in the centre of the room. A nicely paved oval pit, 0.55x0.6 m in size and 1.2 m deep, was found immediately next to the fire-place, against wall M15. It was filled with very soft brown loam containing a lot of organic remains and animal bones (US61). A cubic-shaped grinding stone (S17) was found in the filling of the pit. One of the entrances to the room, c. 1.0 m wide, was in its SW corner. It had a stone doorstep 0.3 m high.

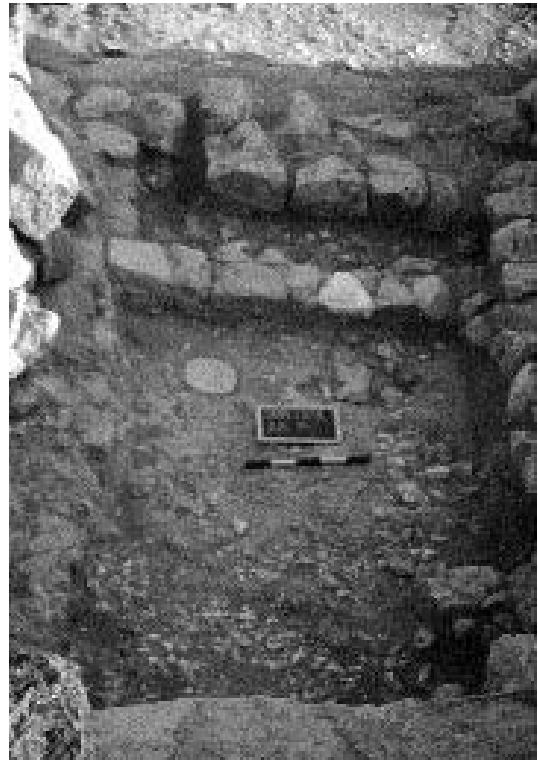
Fig. 29 - The room A19 with the lower part of a column.

Room A19, revealed to the south of the corridor A18, was constructed against the wall M16 (Fig. 29). It was adjacent to the corridor and was separated from it by a very badly preserved wall M31. Its Western wall was, probably, the wall of a collapsed niche, and

the eastern (M32) and southern (M33; partly destroyed) walls were carelessly built from fieldstones. The room was rectangular in shape, and 2.4x2.8 m in size. There were two entrances: in the N-W corner, 0.8-0.9 m wide with a low stone doorstep, connecting the room and the corridor A18, and in the N-E corner, c. 0.6 m wide, connecting it with the room A26. The broken lower part of a column mounted into the bedrock was found in the centre of the room. Probably, it once supported the roof of the structure. The floor of the room (US48) was reinforced by a thin stone wall, whose blocks covered the “well” unearthed under the floor (see above). Two bronze “early Hadramawt imitations” (Co53 and Co54) were found under the floor US48 near the broken column in the stratum US64 accumulated above the bedrock.

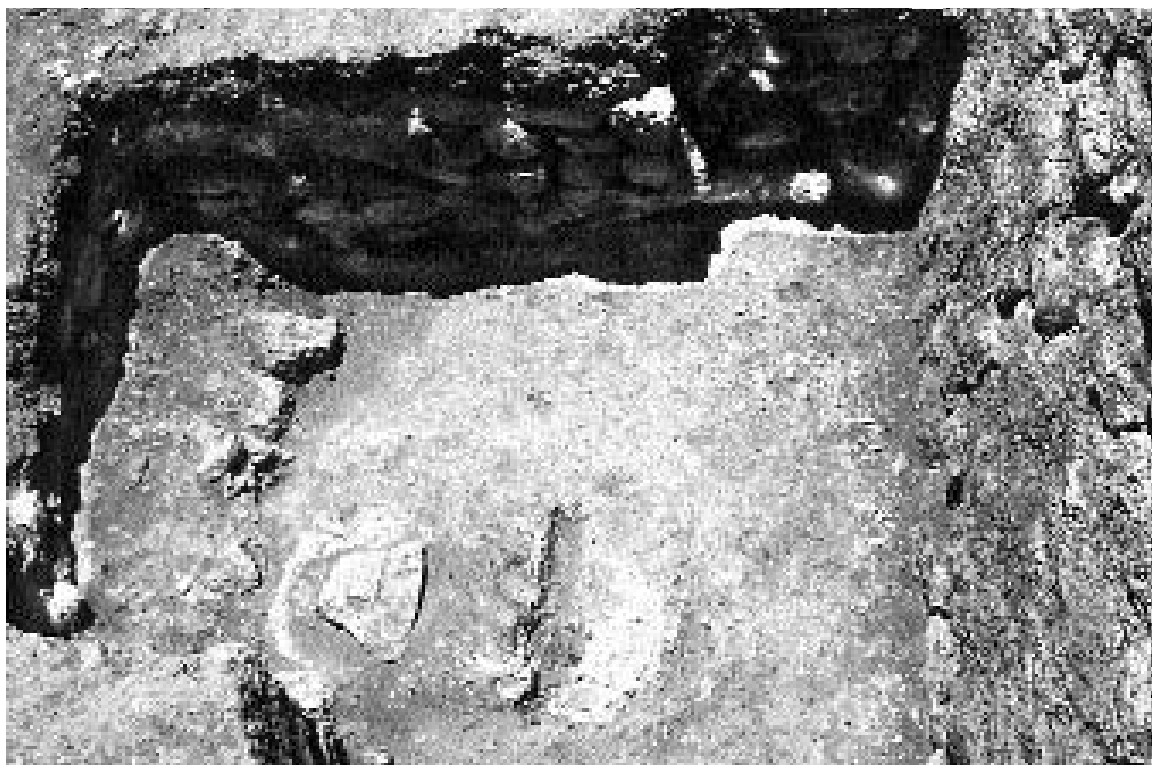
Fig. 30 - Room A14 during the 3rd phase.

The only room still in function during the third phase was the kitchen A14 (Fig. 30). It was slightly renovated: (1) new layers of plaster covered the floor US29bis including the fire-place, adjacent wall M15, cubic structure in the N-E corner and the part adjacent to the bench; (2) the second step was added in the entrance; (3) the southern wall (M28) of the room was reinforced and slightly widened. All these renovations might be connected with the construction of the floor US22, when the kitchen was transformed into the subterranean room (the difference between layer US38 and room's floor US29bis was about 0.4 m; the difference between floor US22 and room's floor US29bis was about 0.65 m.). Thus, the filling of the room A14 was mostly accumulated during the second period of its

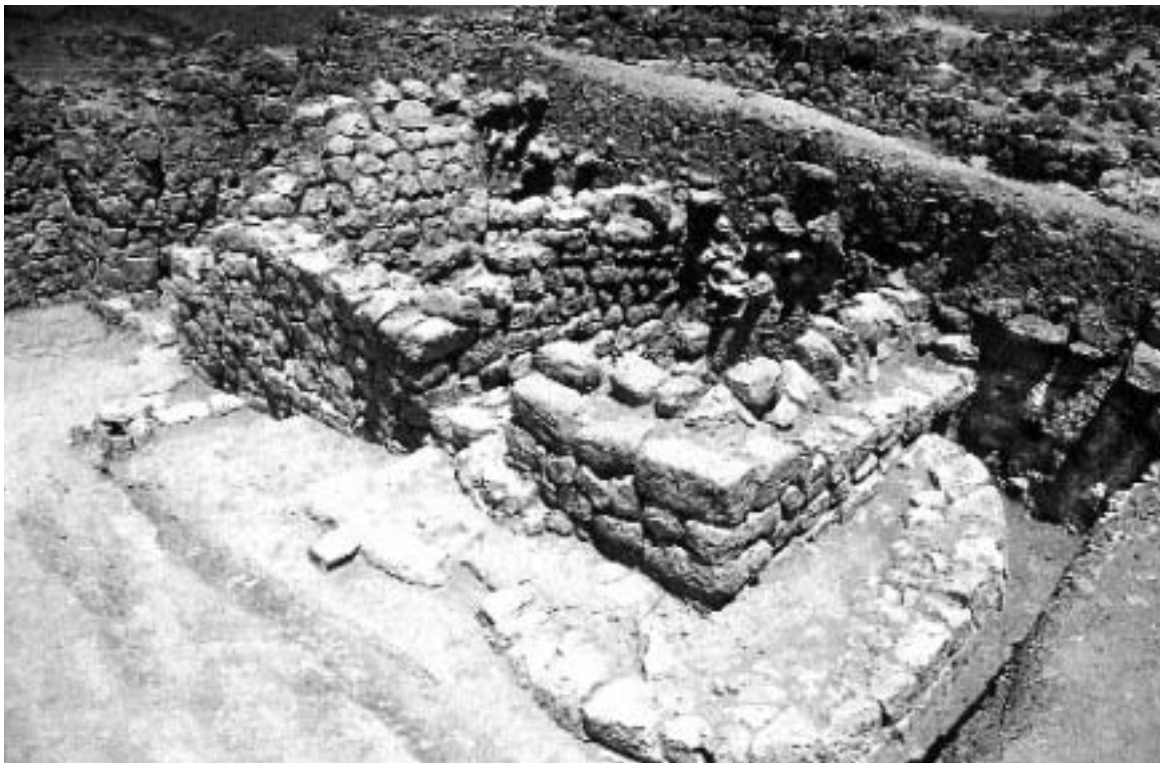
Fig. 31 - Building BA3 with semicircular construction.

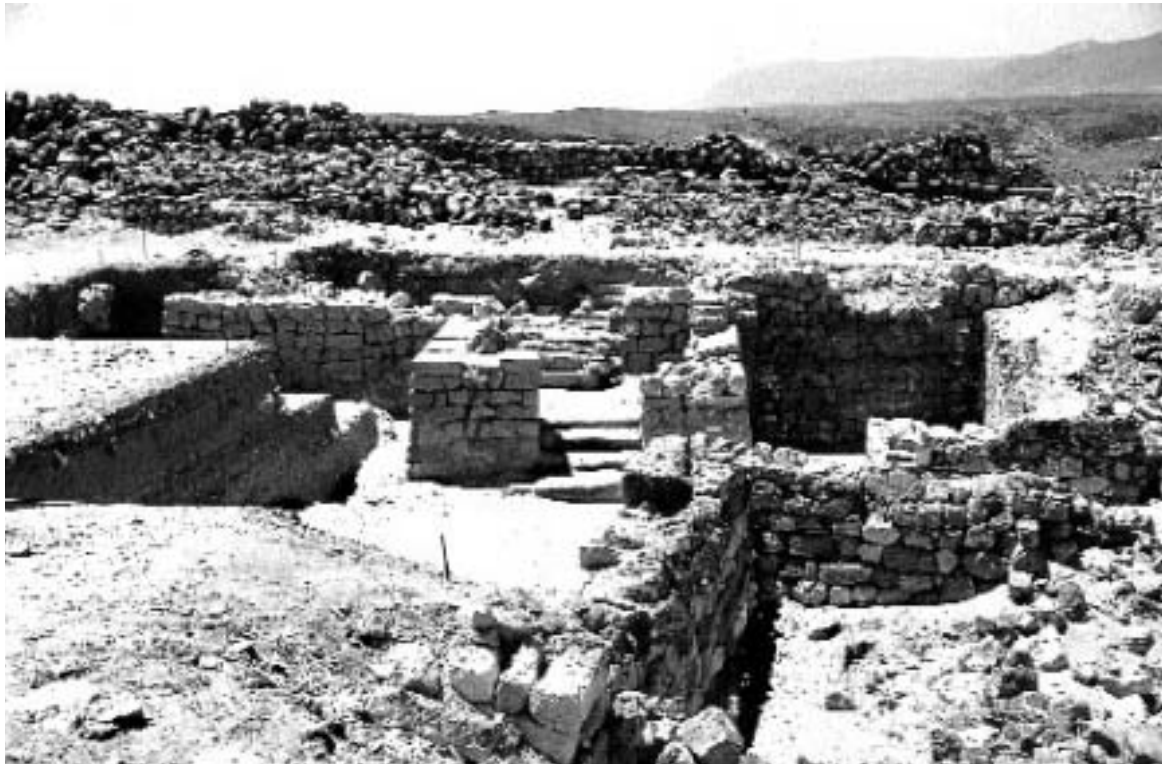
Fig. 37 - Building BF3.

The external walls of the structure were 0.75-0.8 m wide, and were preserved to a height of more than 1.5 m. They were constructed from roughly dressed limestone blocks, and their lower rows were mounted into a kind of cement mortar. Probably the exterior of the building was faced with polished limestone slabs, fragments of which were found in the filling outside the building.

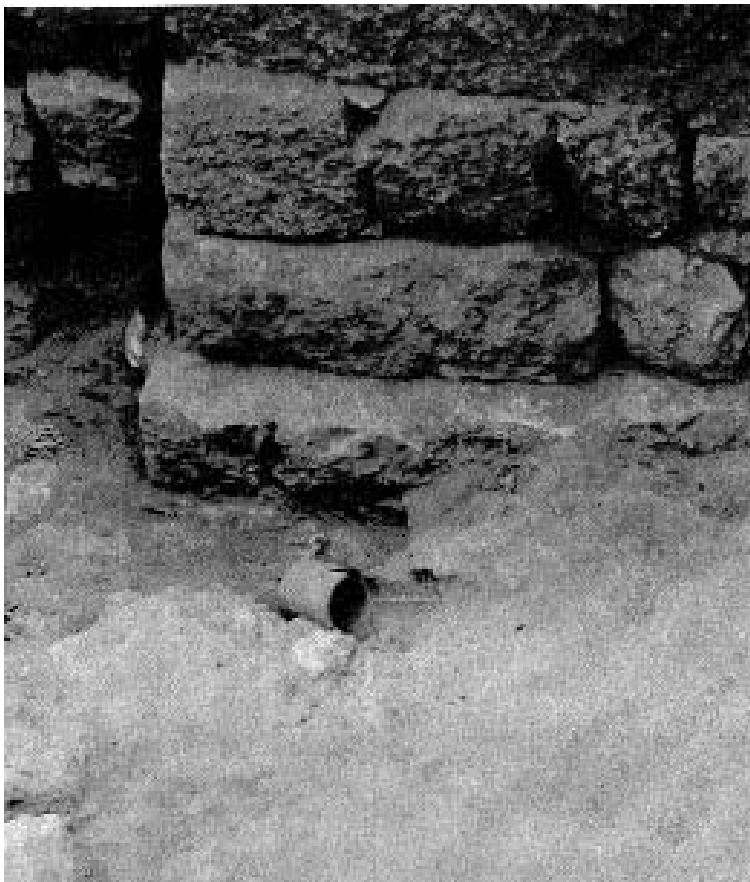
Fig. 38 - Dressel 2-4 amphora used as a drainage pipe.

unclear character: remains of a small (1.5x1.6 m in size) platform carefully plastered with mortar and an oven next to it were found. An upper part of a Dressel 2-4 amphora was mounted into the corner of the platform serving as a kind of drainage pipe (Fig. 38). Quite a number of grinding stones, pestles and mortars, pottery shards and a bronze coin (Co.91) were found in the layer US98 above the platform and around the oven.

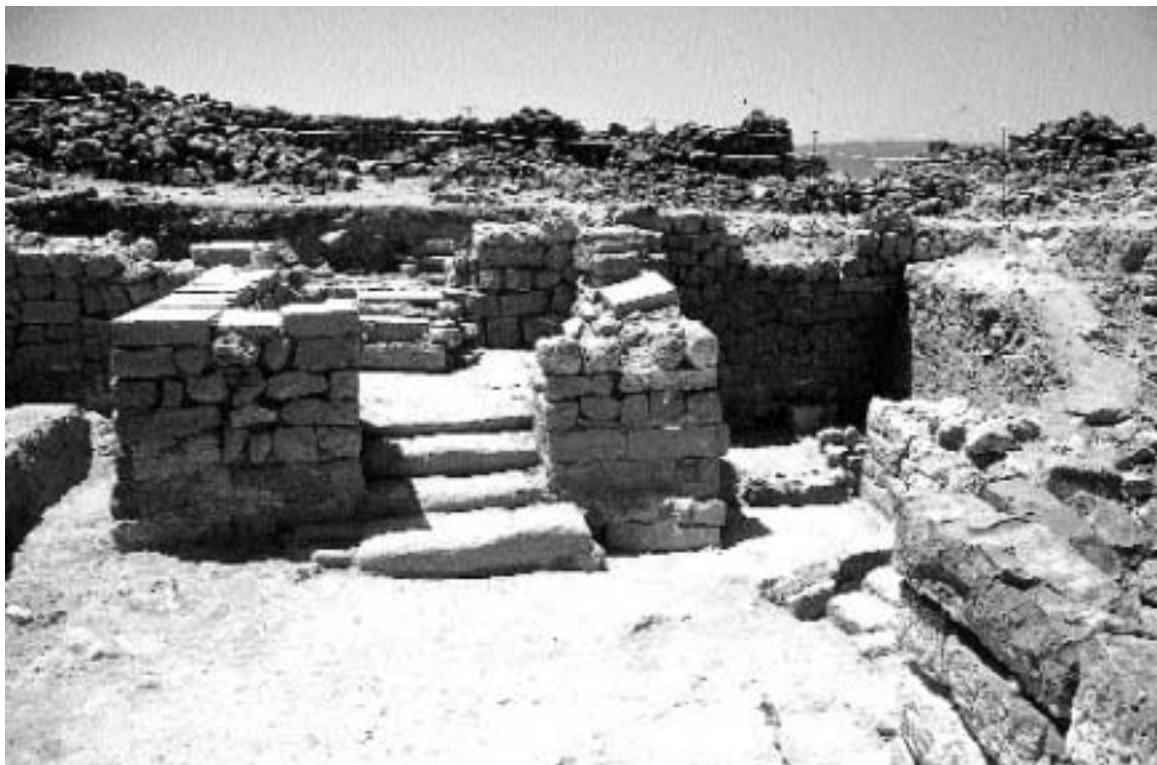
Fig. 39 - Square in front of the stepped entrance of building BF3.

It seems that the contemporary floor of the street A32 was high than the floor US55 of the street A29: it roughly corresponds with floor US54 unearthed in the square A20 in front of the building BF3 (Fig. 39). Probably, such a difference was connected with general inclination of the rock, on which the city was founded, in the north-south direction.

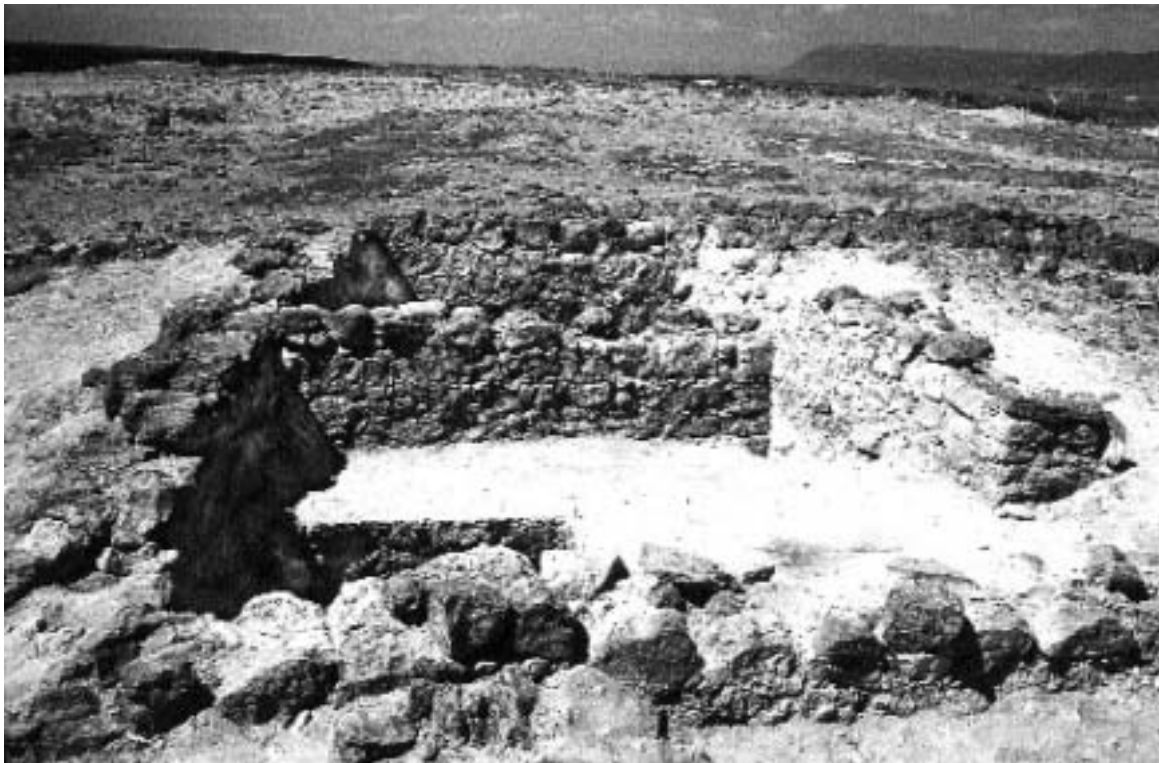
Fig. 48 - Al-Hamr al-Sharqiya: excavation at “house with a patio”.

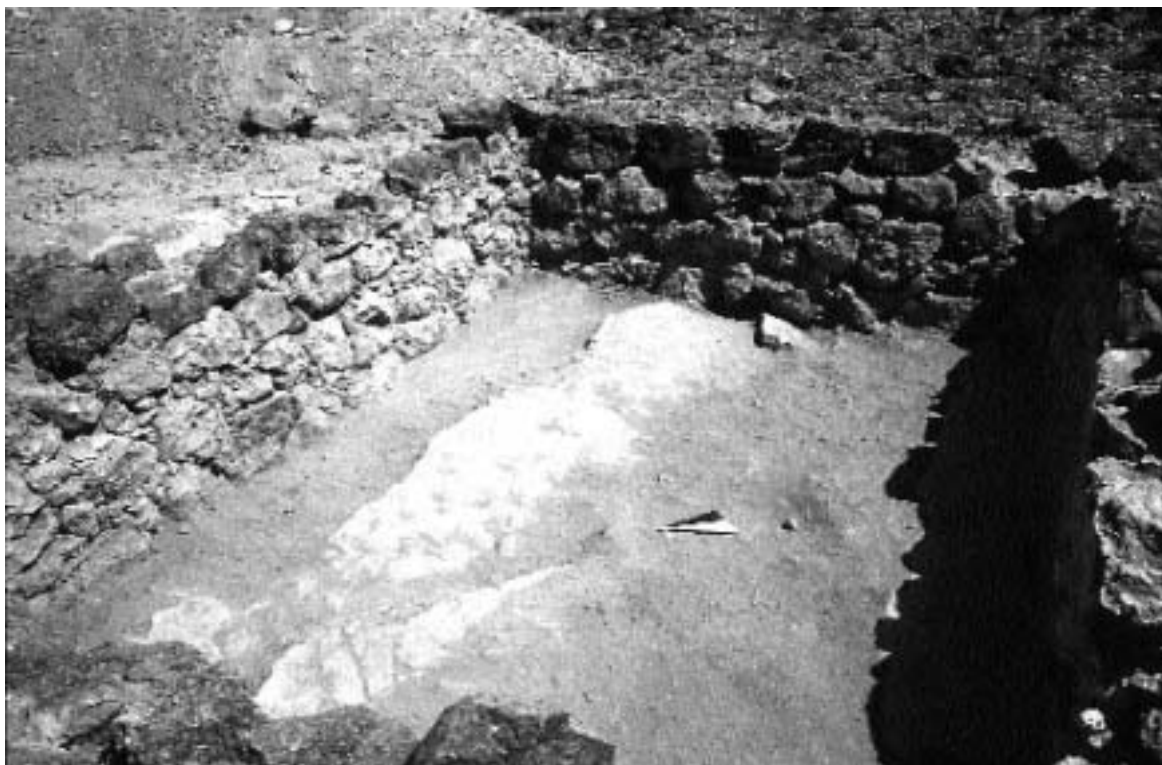
Fig. 50 - Al-Hamr al-Sharqiya: excavation at the "palace".

In all the rooms we explored, with the exception of A1 (where we found a second packed earth paving US20, 10-12 cm under the first US5), we discovered two occupation levels: the first one is more recent and is constituted by packed earth pavements (US5, US11, US12 and US24) and the second one which is the original one is constituted by the bedrock itself, levelled and smoothed with compact clay strata, the thickness of which varied depending of the need. So for example in A3 a large portion of emerging rock that crosses the whole room lengthwise, is naturally inclined towards the west and it seems that it was levelled with a mixture of clay that unfortunately is only partially preserved (Fig. 50).

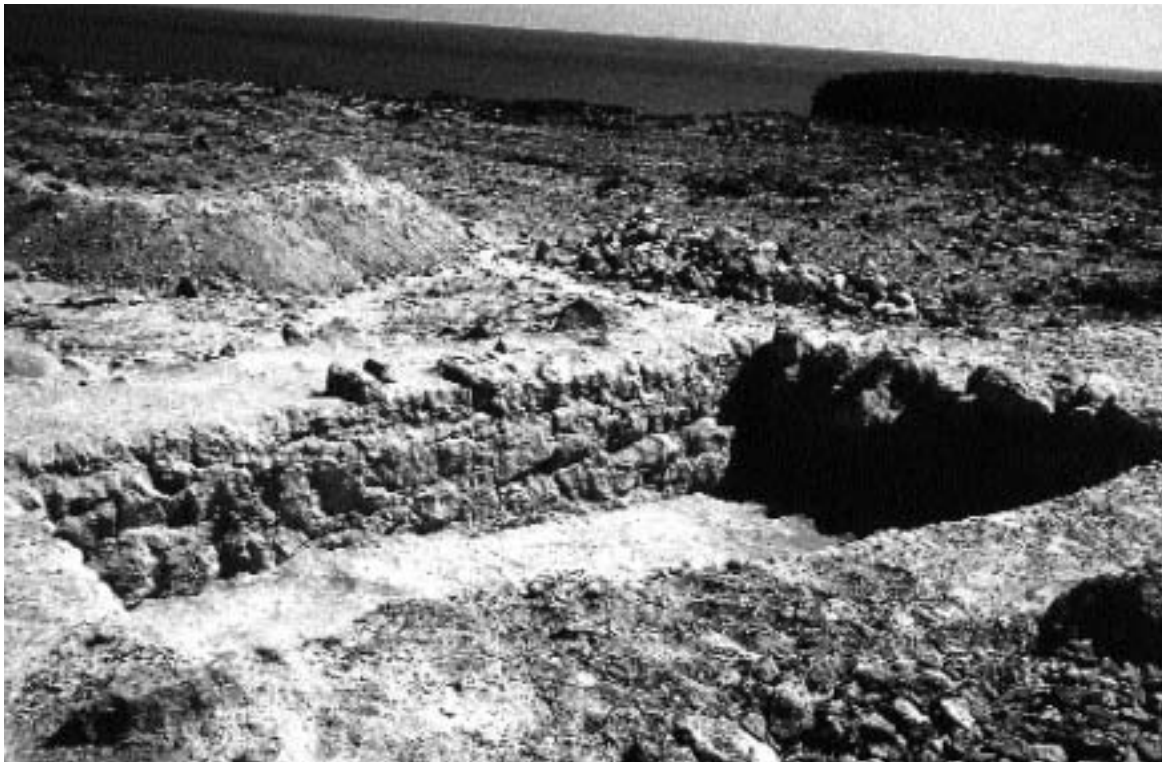
Fig. 52 - Al-Hamr al-Sharqiya: excavation at the "stores". (A4)

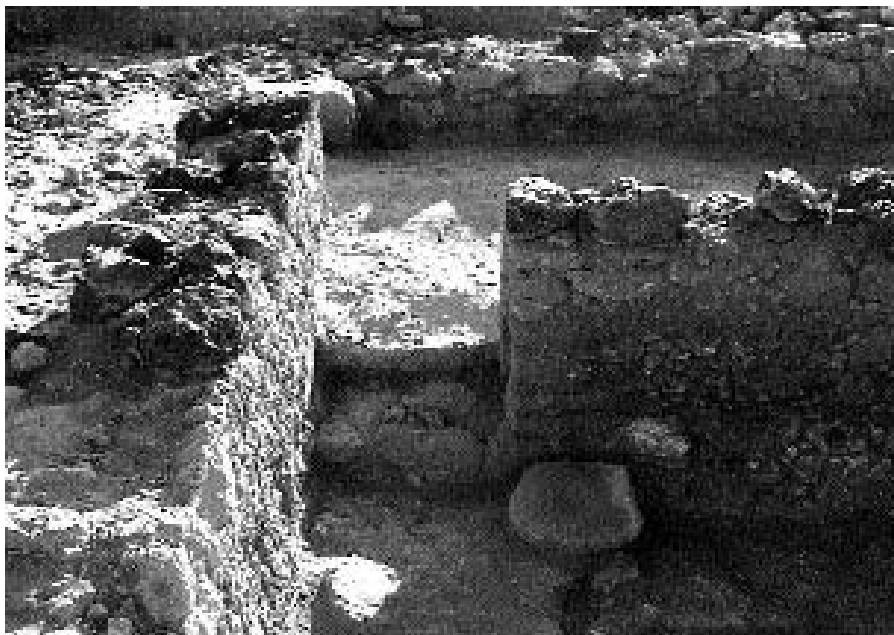
Fig. 53 - Al-Hamr al-Sharqiya: communication door, with steps, between A1 and A2.

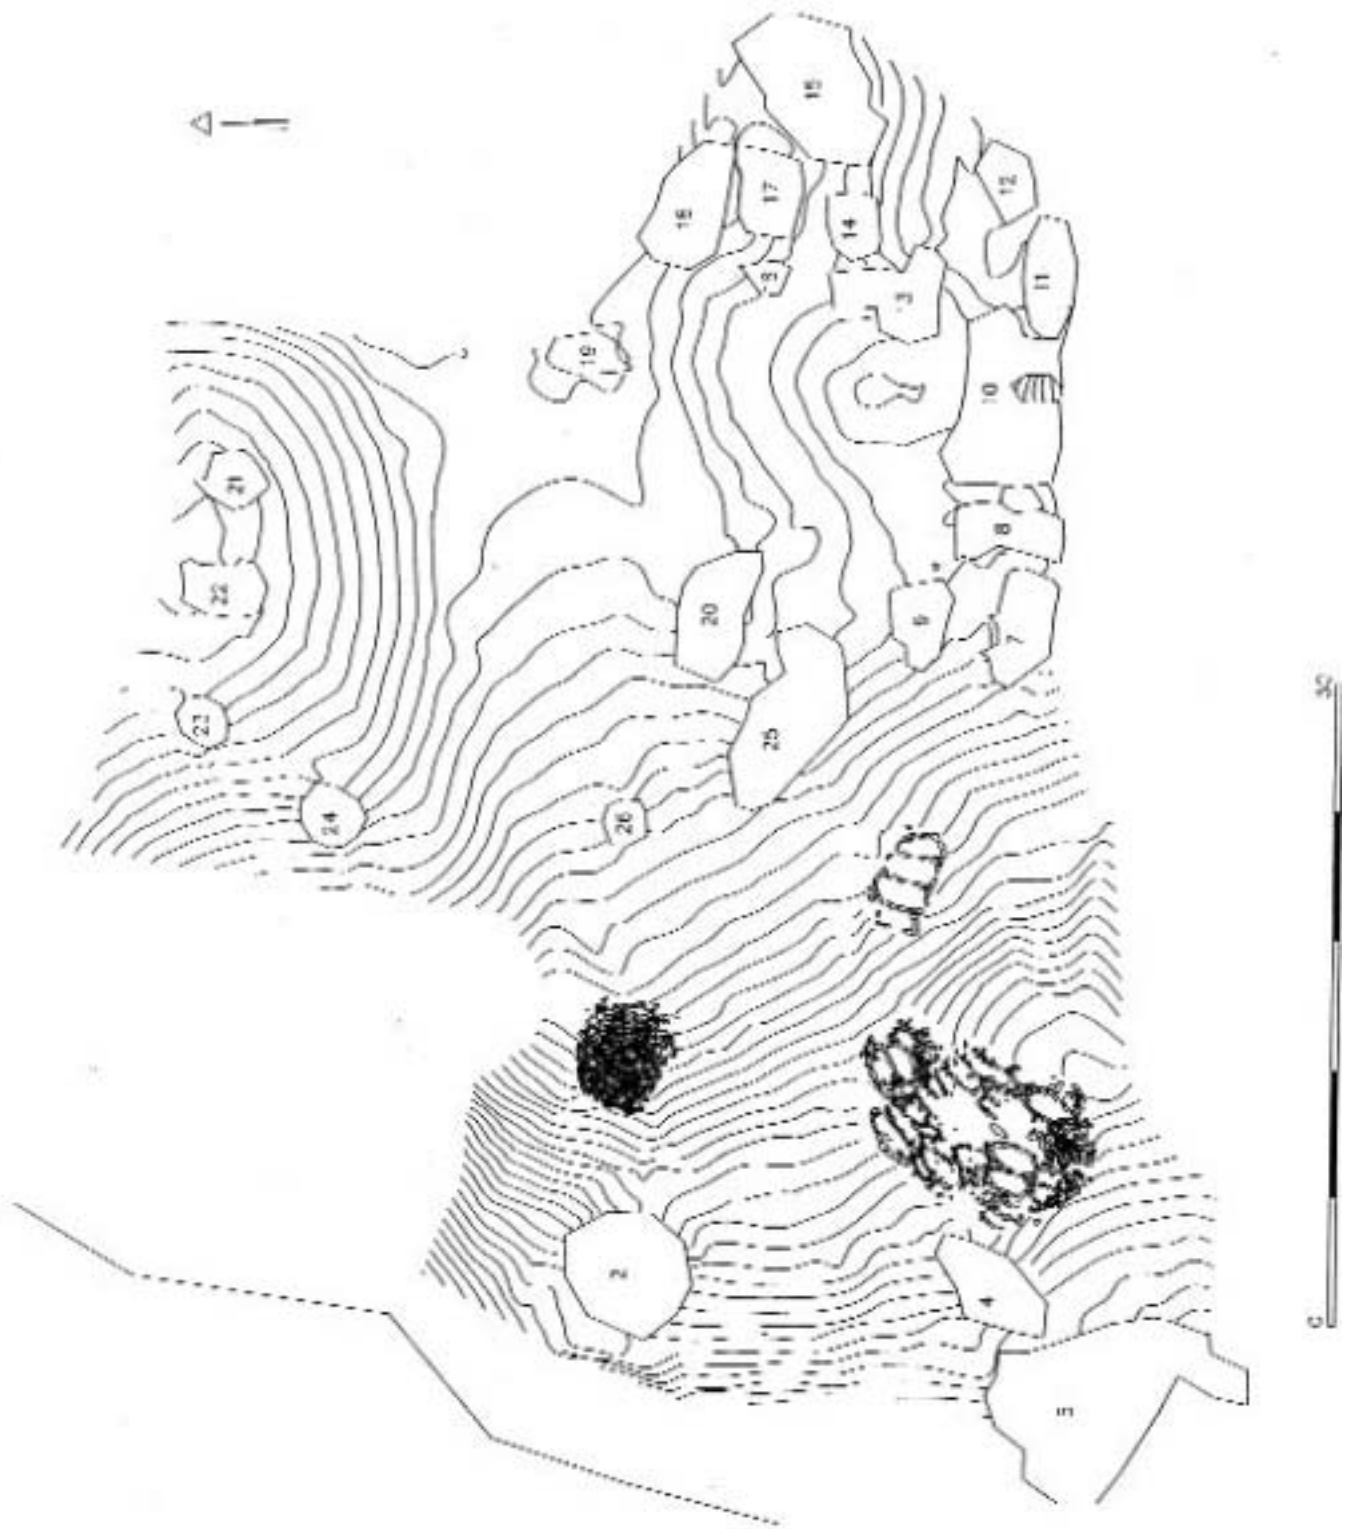
Fig. 58 - Necropolis N-W of Khor Rori: surveyed area.
