SUMHURAM

Preliminary Report

March - June 2014 (SUM14B)

Technical Report

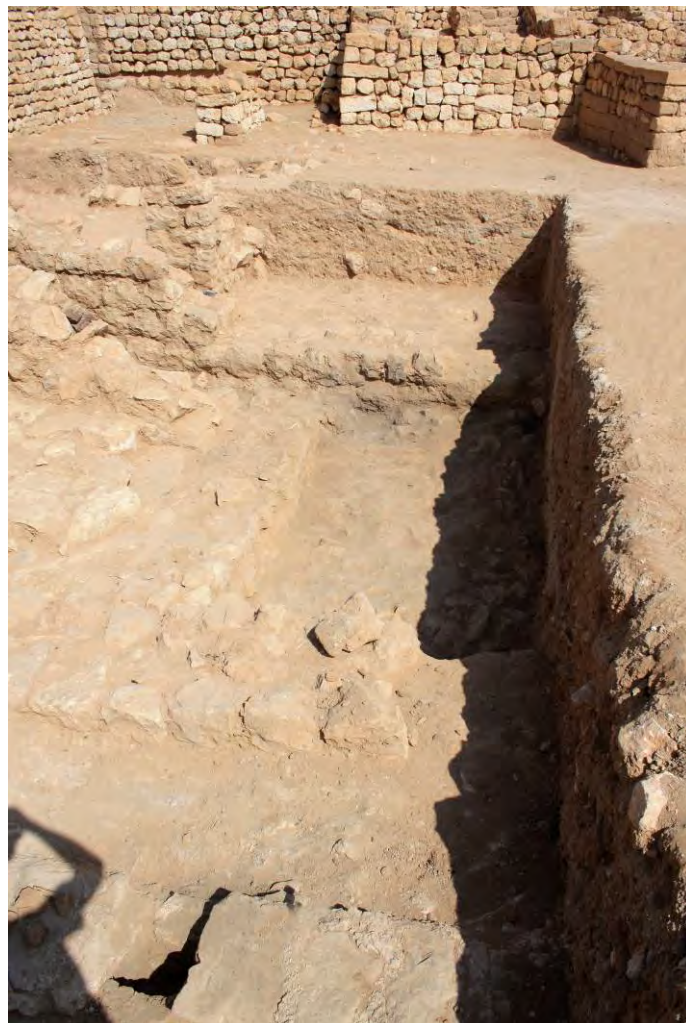
When we removed the **US660 floor** (compact and grey surface with few pottery fragments, bones, shells, three objects: Sh583, G209, MB839 and coin Co861), excavated during the campaign SUM14A contemporary to the channel in A217, we found **US696**. This layer is characterized of medium and big stones that appear to come from intentional demolition of the walls M627, M647, M603. These walls are kept at the same height and they seem to continue under the square A20. In the south-west corner, between M679 and M603, have been found traces of a fireplace of medium size.

Below this layer, composed mainly of stones mixed with earth, we found the **US704**. This stratum is characterized by an extensive layer of ash and charcoal and a considerable quantity of iron slags (sample 2) has been found.

Under US704, which seems to confirm the use of the area for fireplaces, perhaps for the production of metals, has been found **US698**. This layer consists of compact clay and earth cooked by the overlying fireplaces covered by limestone chips mixed with earth used to level the bedrock (elevation 25,63 – 25,07). This was necessary to create the foundation of the surrounding walls.

A224 (east view): before excavation

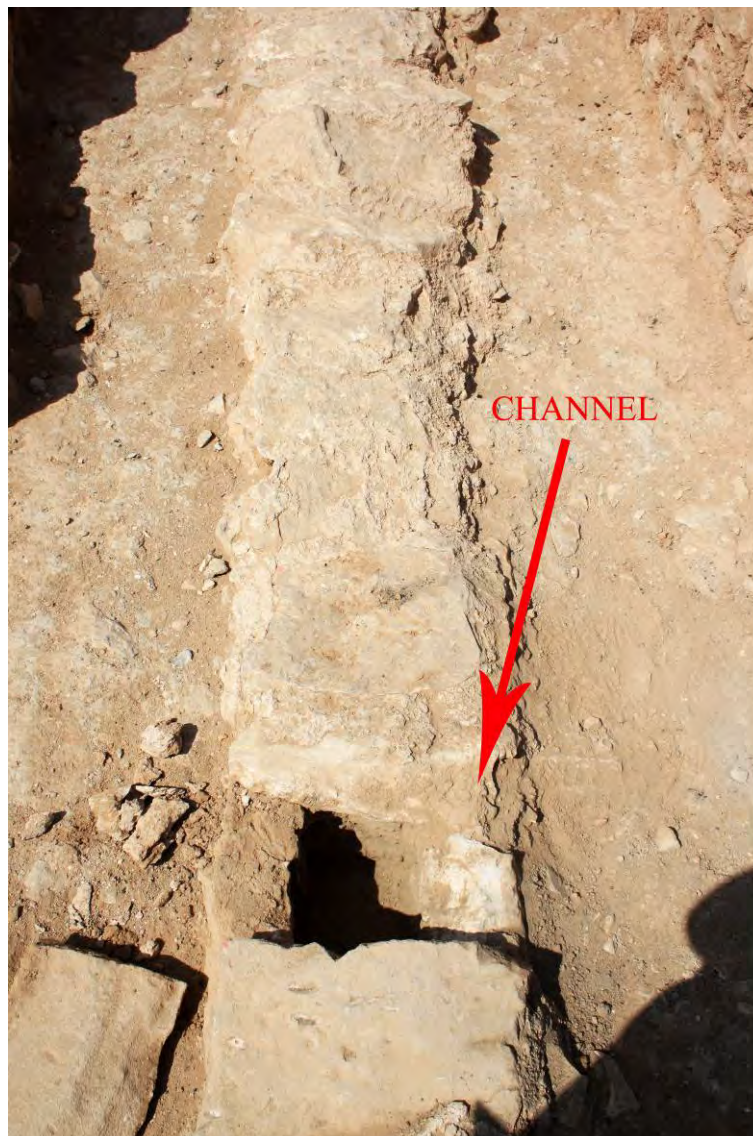
During the excavation, it was decided to investigate the function of structure in stone slabs and plaster found in A217, during the campaign SUM14A (q. 26,35 – 26,50). The excavation of a small part, has allowed us to identify it as a **channel** in plaster, covered with stone slabs and plaster. It remains to explain the presence of the two stone basins, one with a lower hole and the other without. Maybe it will be possible to define better the use of this structure when the excavated area will be enlarged. It would be interesting to continue in the north direction to find the path to the channel, the hypothesis is that the channel goes in direction to the A129 for continue in direction to the exit channel in the wall near the west side of MB1.

A217 (north view): channel in plaster covered with stone slabs.

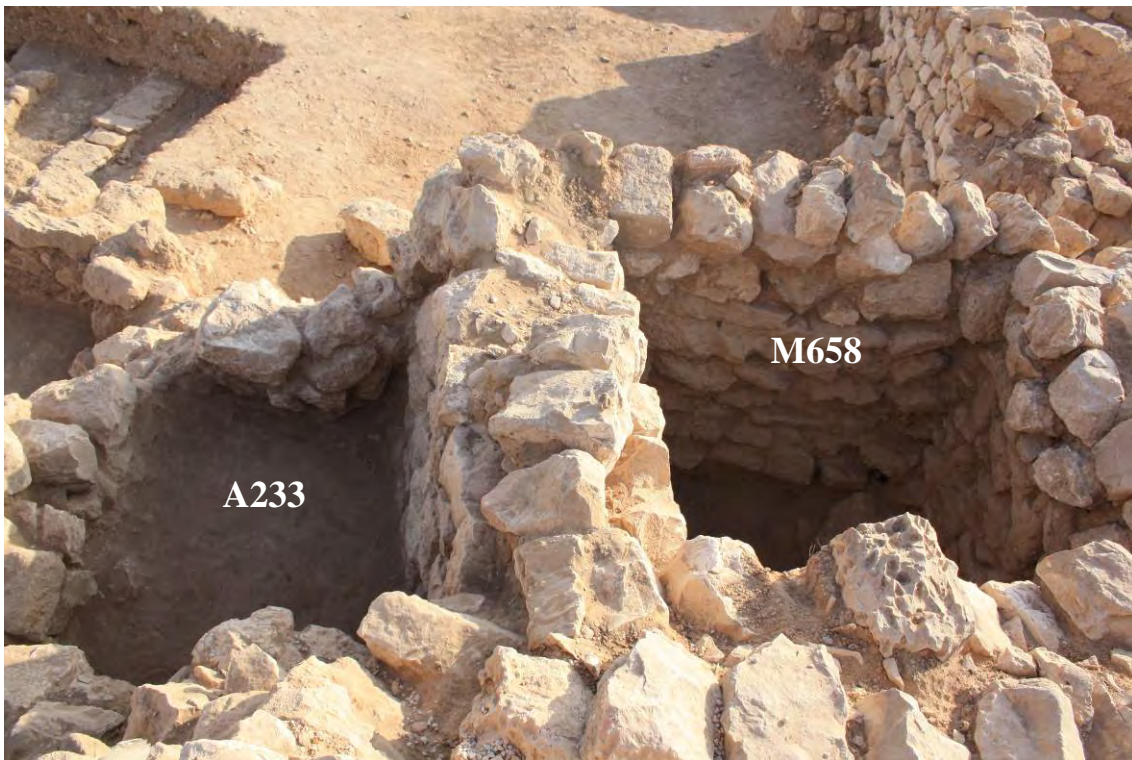
The cleaning revealed a small room (A233), located between A232 (excavated during the last campaign) and A142 – A143 to the west. This room is defined by the walls M658 to the north, M661 to the east, M660 to the south and M384 to the west.

In addition to the cleaning a small excavation was carried on, to reach the foundation of the wall M658. The excavated layer was called **US699**. This layer consists of loose dark brown earth finishing at the end of the foundation of wall M658. Here a difference in compactness of the soil was evident, probably related to the presence of a floor, called **US699floor**, where the investigations stopped. In US699 we found few materials (pottery, shells and bones), one oil lamp (Sh586) and few iron slags (sample 3).

A233 (south view): after excavation the room and before restoration the wall M658.

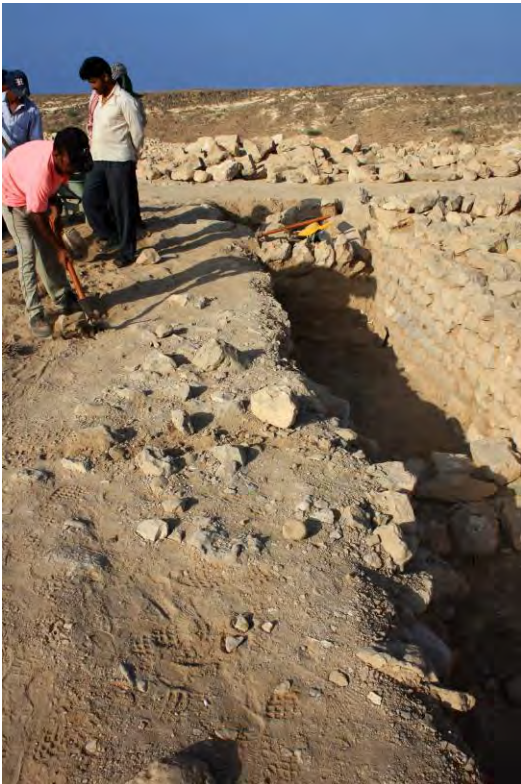
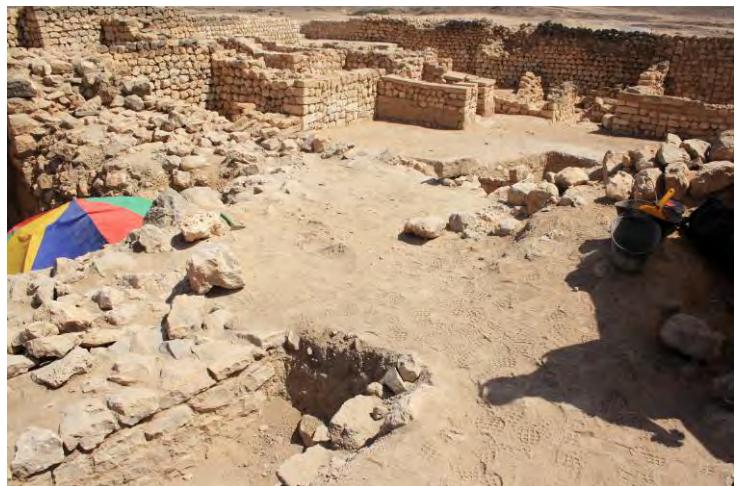
East of MB2 (north-east view and south east view): before excavation.

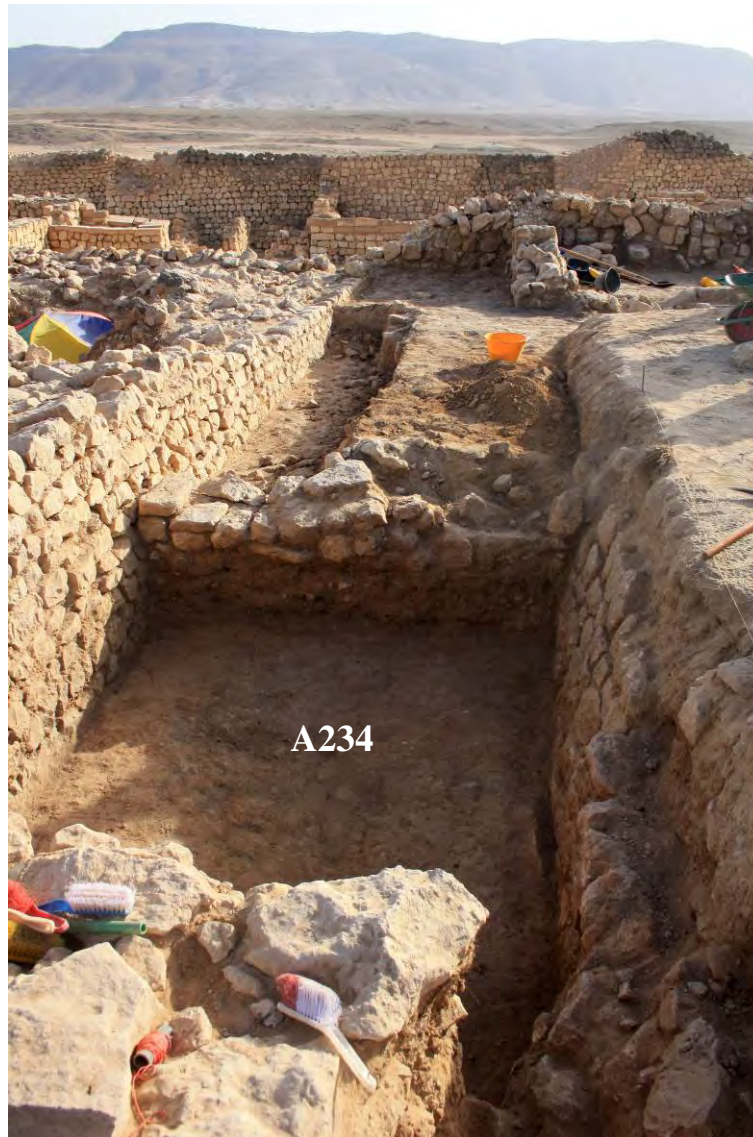
This room was defined by the walls **M673** to the south, **M670** and **M671** to the east, **M666** and **M669** to the north. M669 was built before M666.

Under **US700 floor** we found **US701** characterized by a large amount of ashes and charcoals, probably attributable to several fireplaces. The layer is very compact and dark in colour. Inside were found pottery fragments, bones, shells and some iron slags (sample 5 and sample 9). Few objects have been recovered in this layer (Co862, S2504, Co863, MB844).

A234 (south view): during excavation.

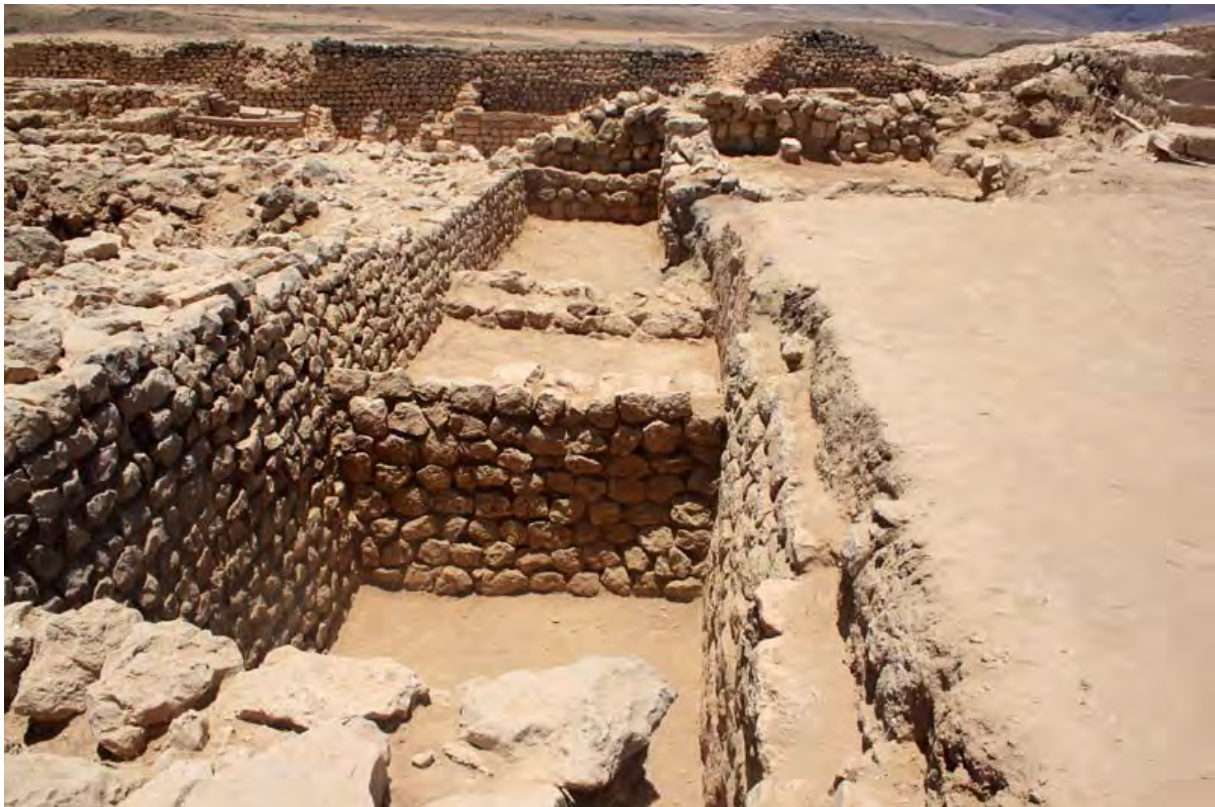
A234, A235, A236 (south view): after excavation.

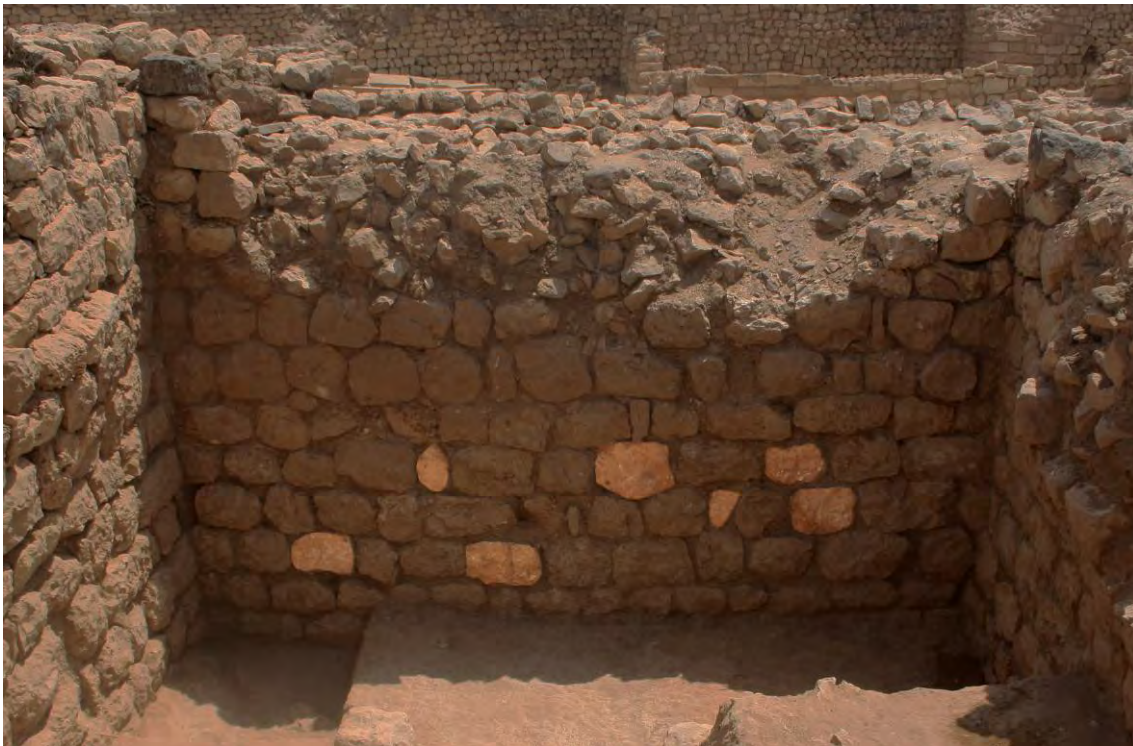
On the north wall of MB2 were found other three carved stones representing ibex.

North wall of MB2 (M93) with highlight the carved stone found during SUM14A and SUM14B.

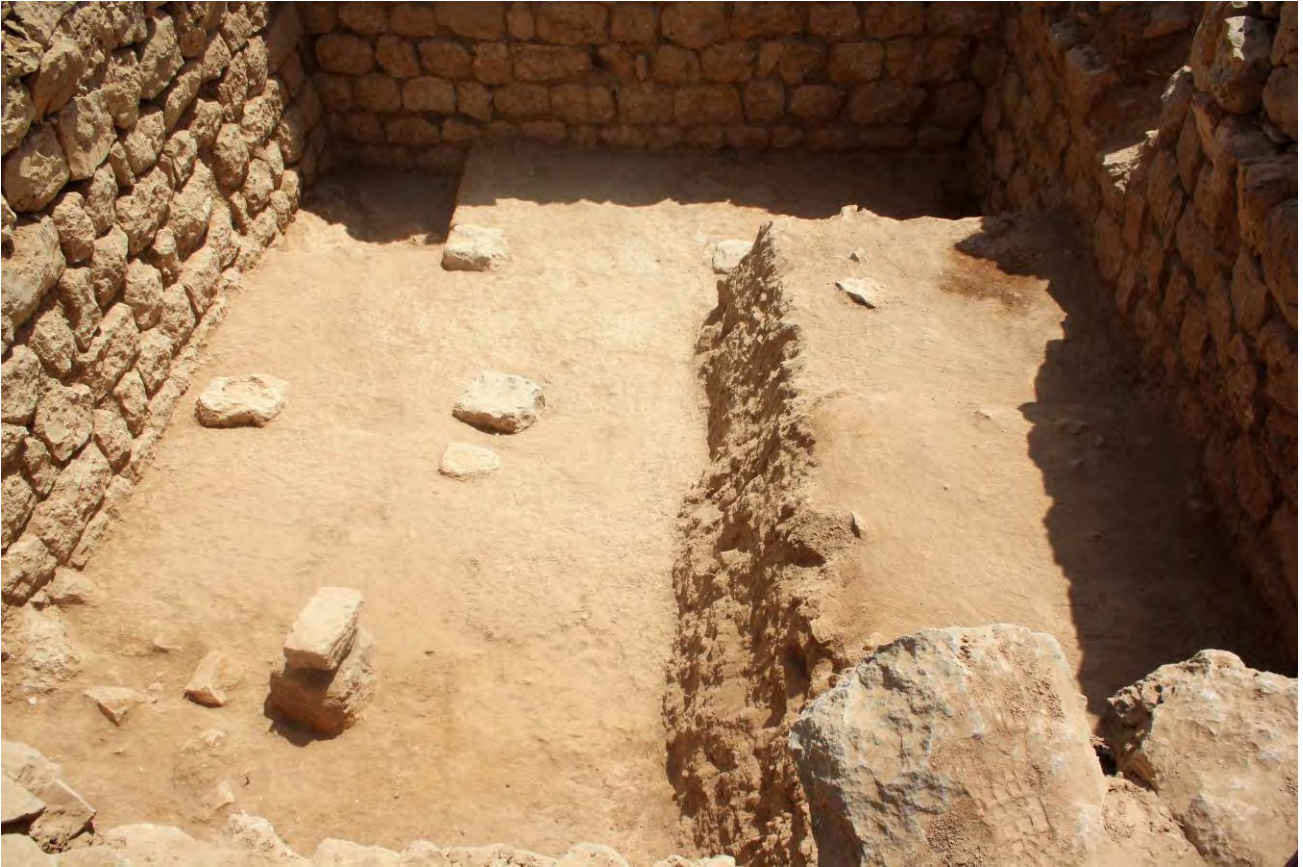
Goal of the next campaign is the removal of US705 in whole ambient to reach **US678floor**, at the base of the columns. Near the southern wall of MB2 there are some stones, probably leaning on US678floor. These stones may be the traces of some structures.

MB2 (south view): after excavation.

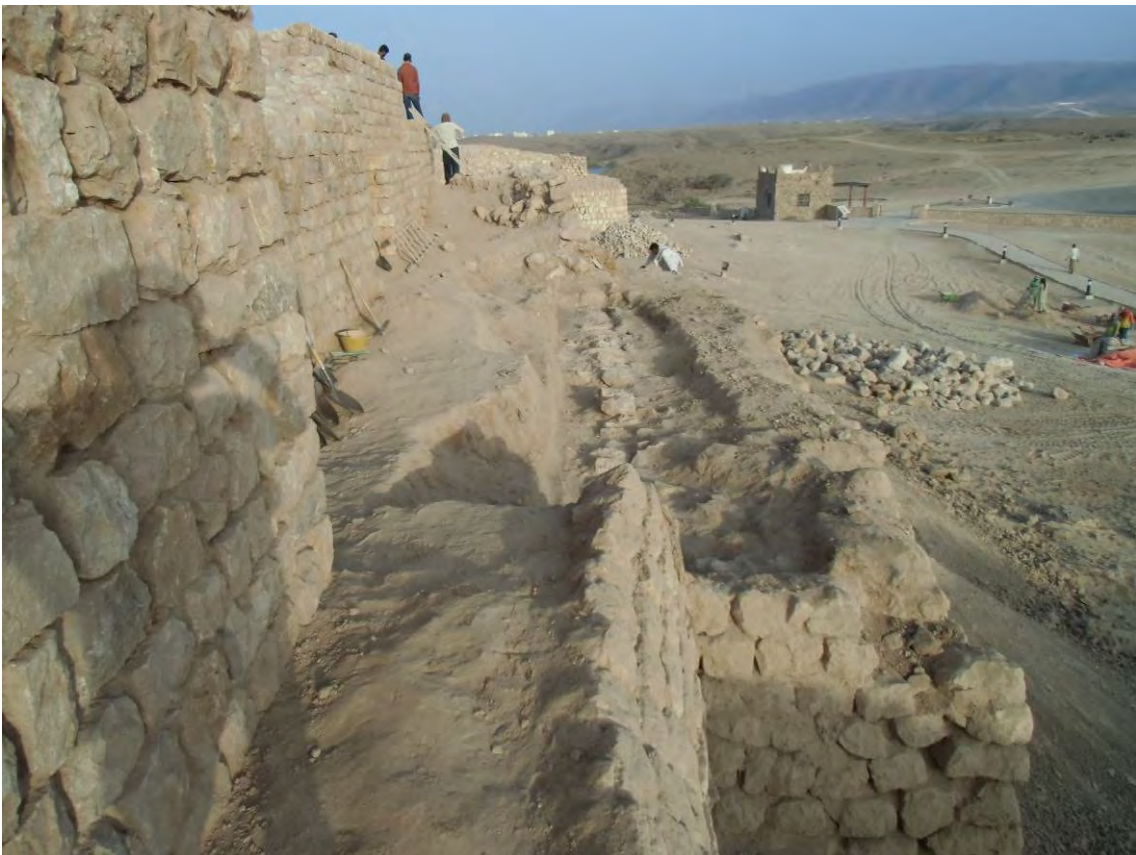
On 21st March 2014 we started the excavation at the area A15 searching the stones of the wall M179. We were sure that there should be an alignment between the starting point of the wall M179 on the east side of the monumental building and the west corner close to the basins. The picture below shows the found alignment.

As you can see on the picture, the previous restoration of the M179 has been considered the wall as a prop and therefore they made the external leave of the stones in slope. We decided to remove the three top level of the stones to rebuild them straight in the continuation of the discovered alignment. This wall therefore, can be considered the third and last phase of the construction of the monumental building 1.

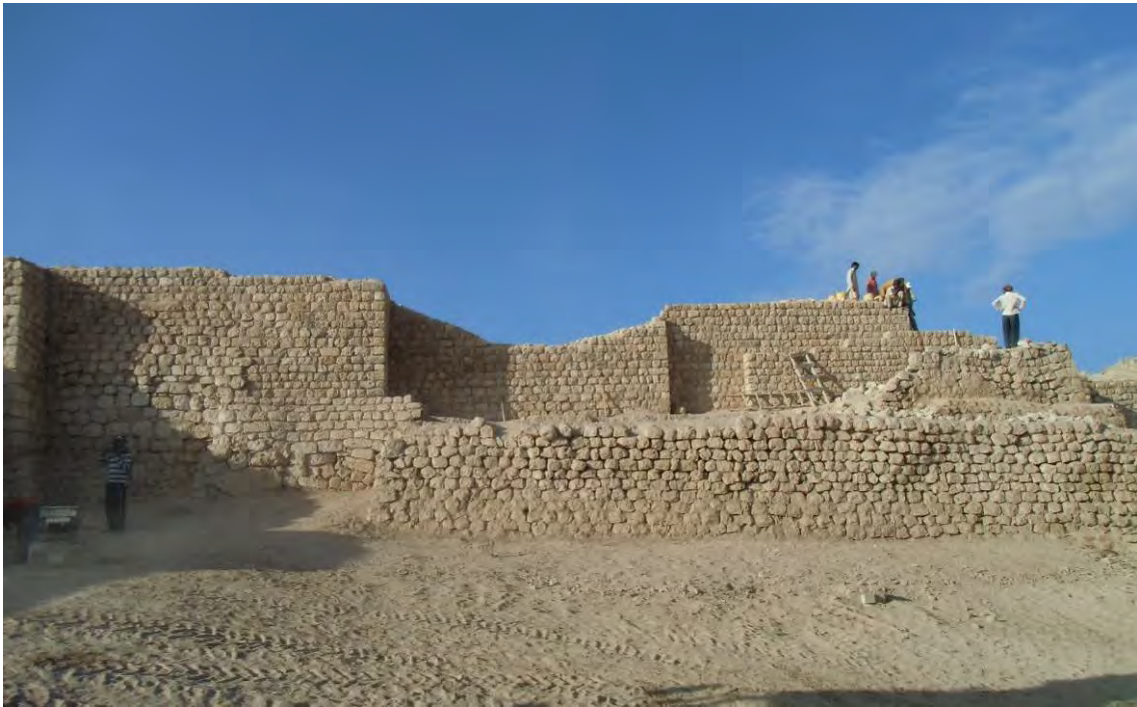
The following picture shows the front north elevation of the wall on 21st March 2014.

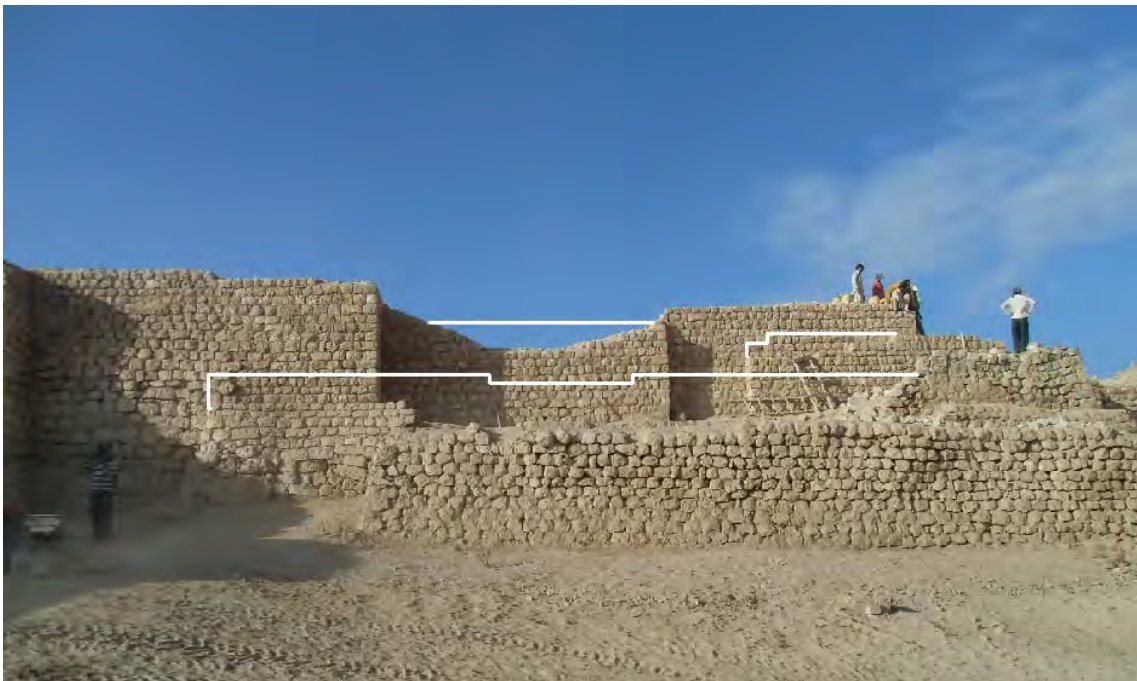
On 22nd March 2014, we started the reconstruction of the wall keeping in mind the indication of the following sketch.

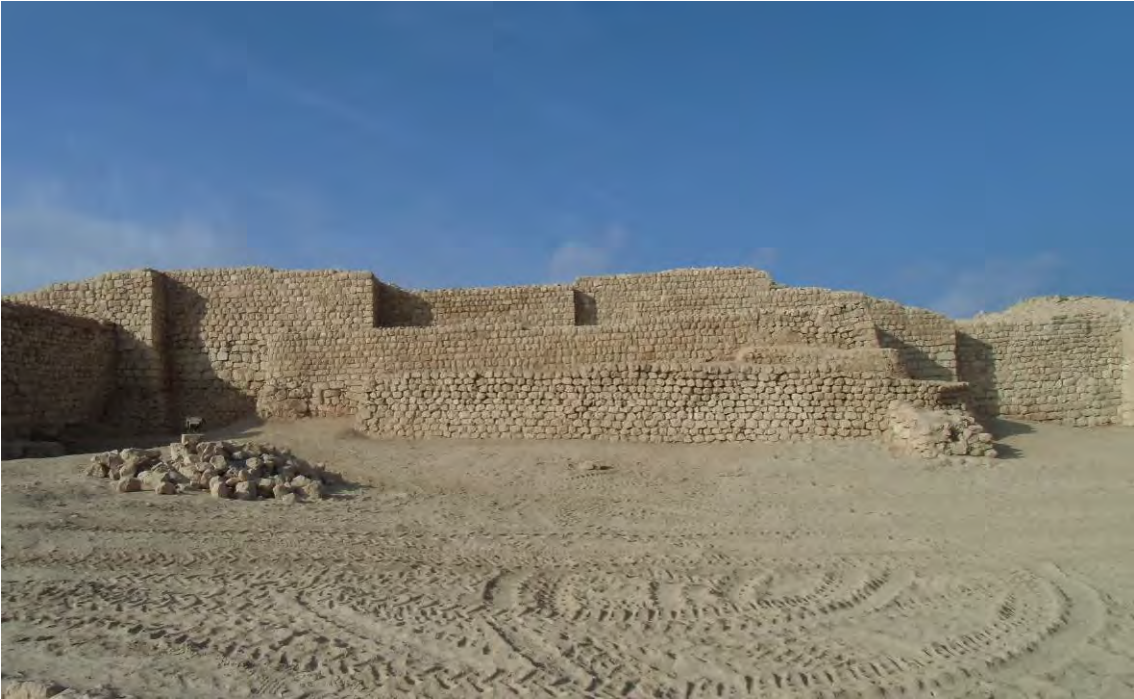
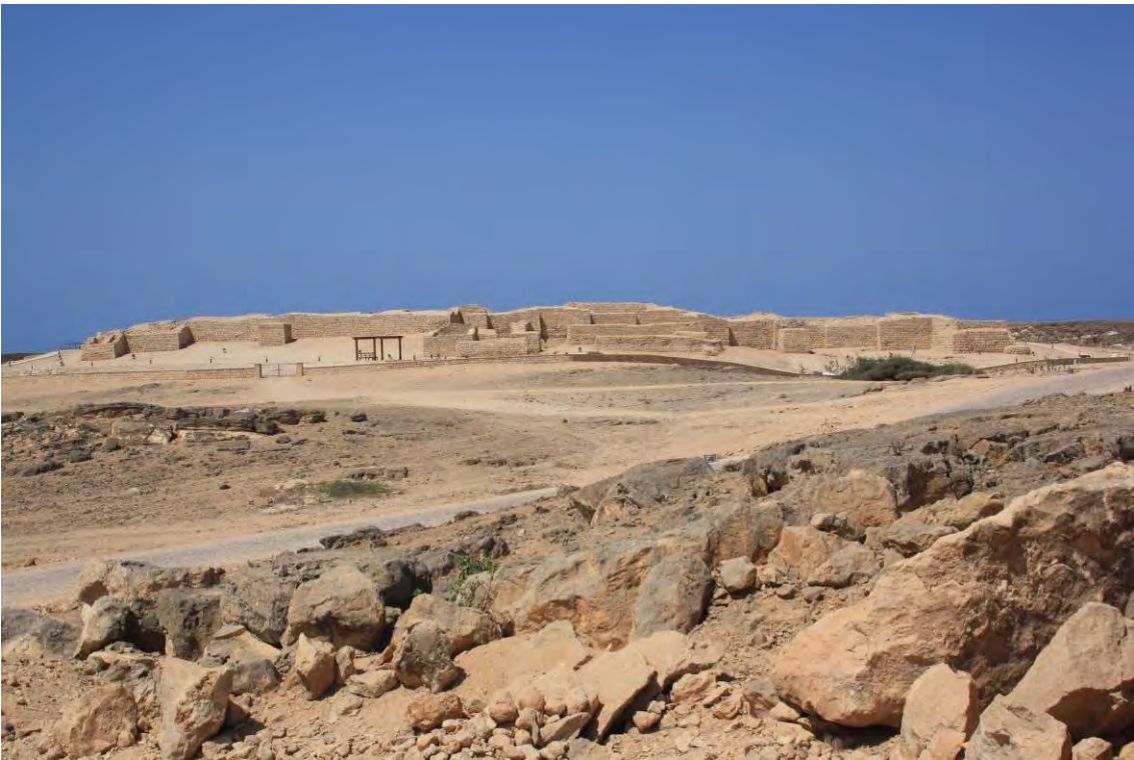
On 30th April 2014, the reconstruction of the walls at the north side of the monumental building were finished as shown on the pictures below.

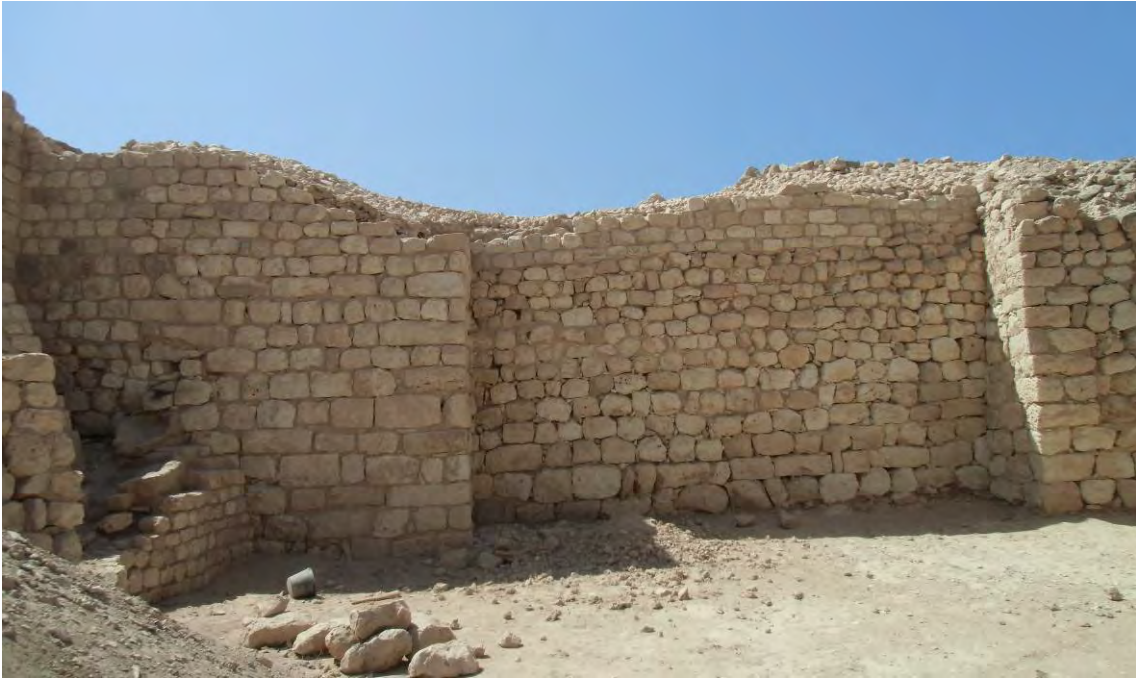
The situation of the wall M22 on 20th March 2014 was as shown on the picture below.

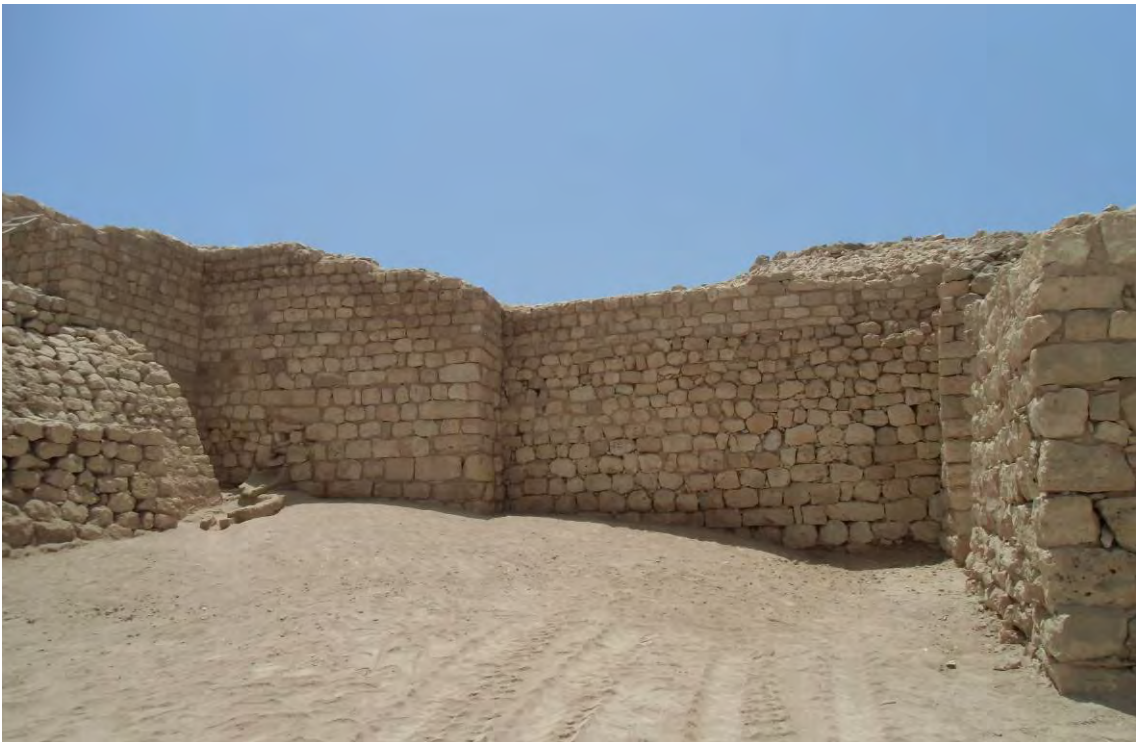
On 10th April 2014 the restoration was finished as shown below.

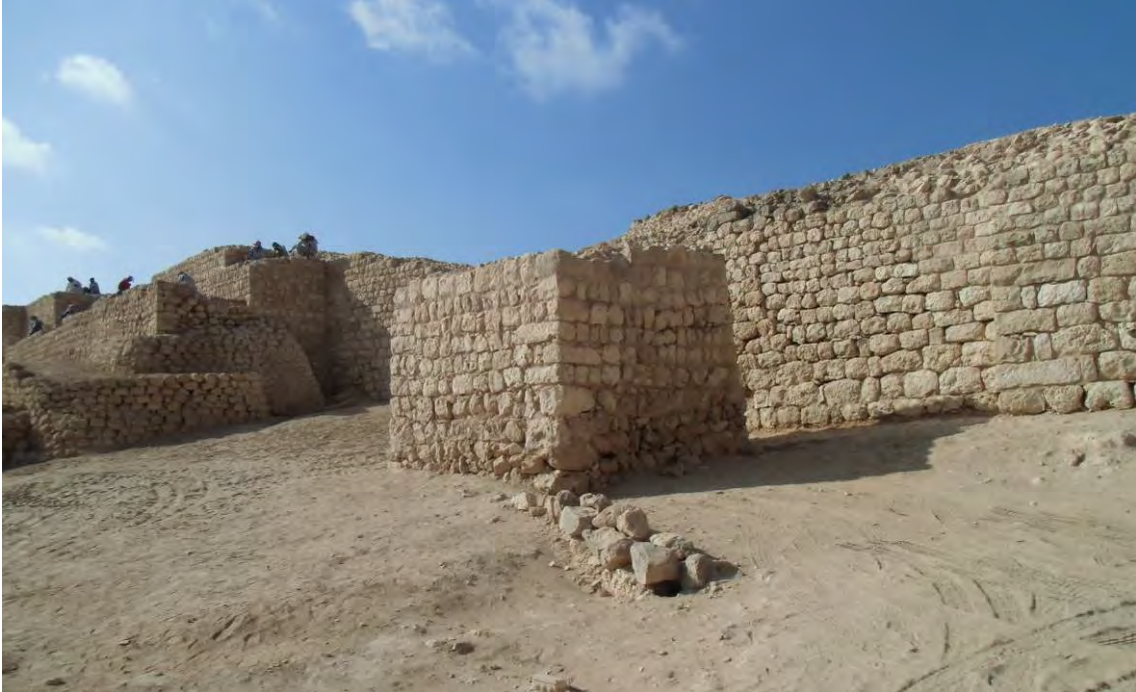
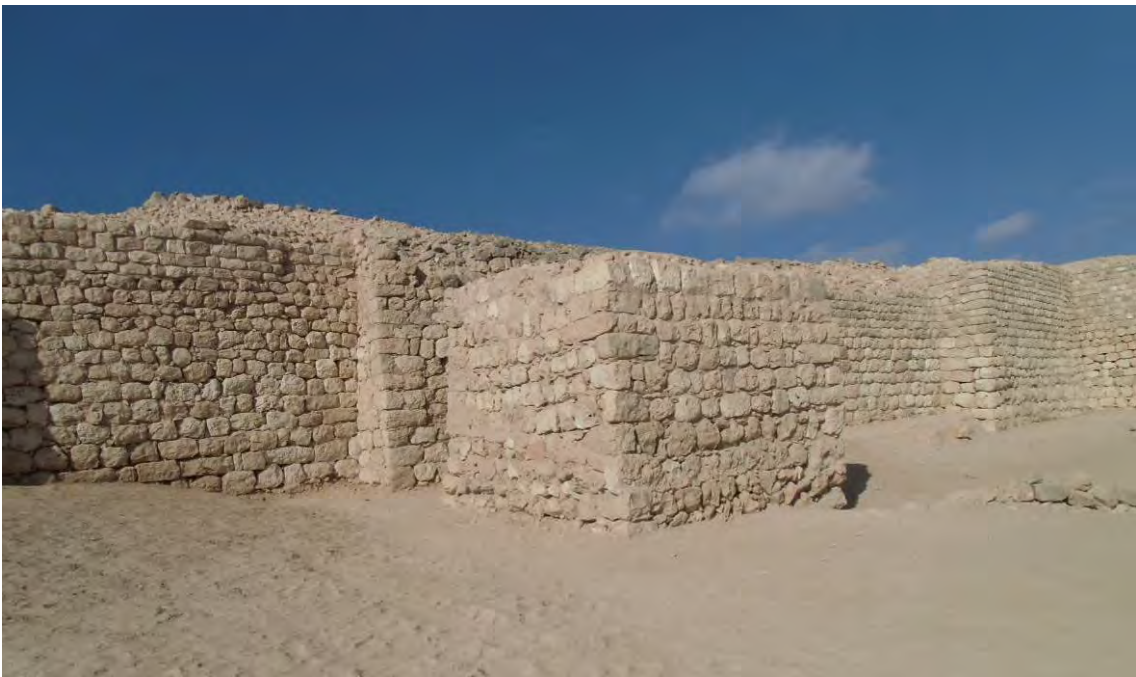
The situation of the tower A61 on 30th April 2014 was as shown on the picture below.

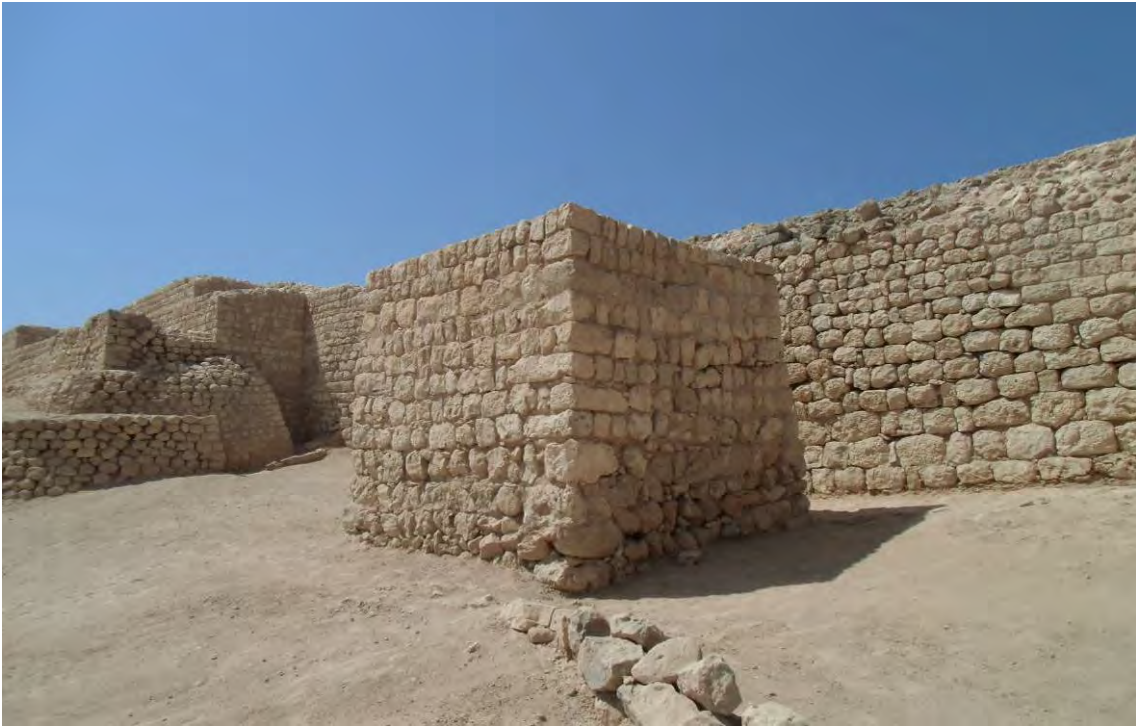
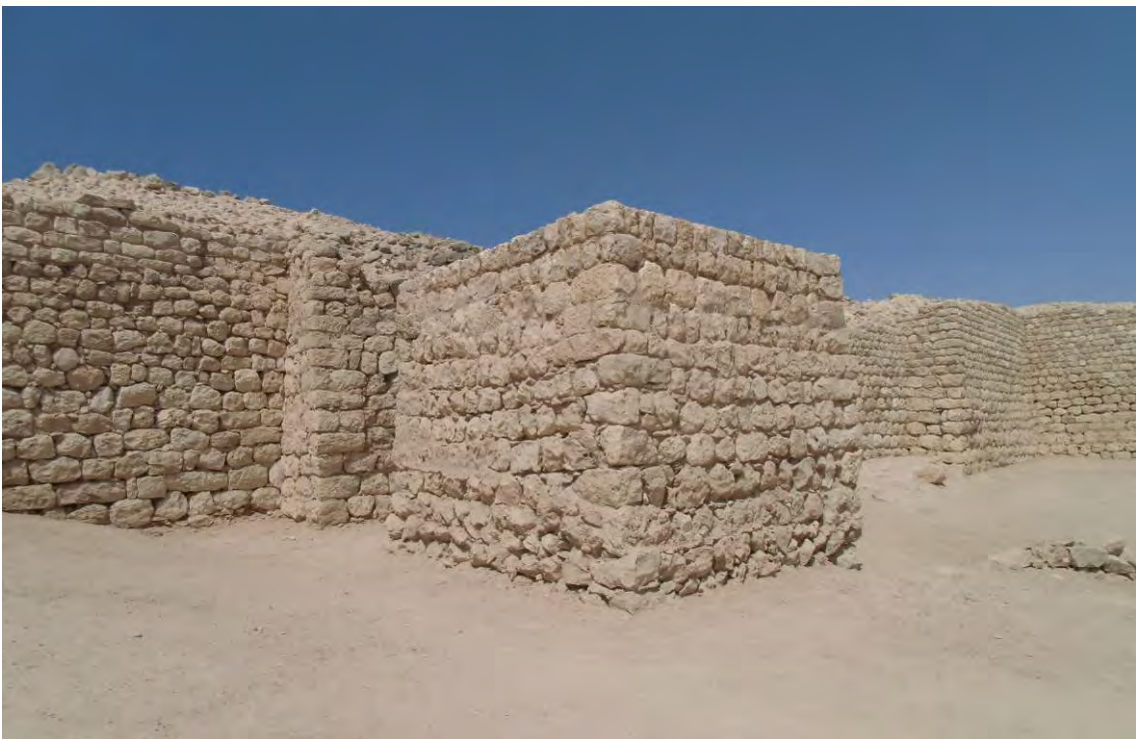
After the restoration the tower A61 is as shown on the pictures below.

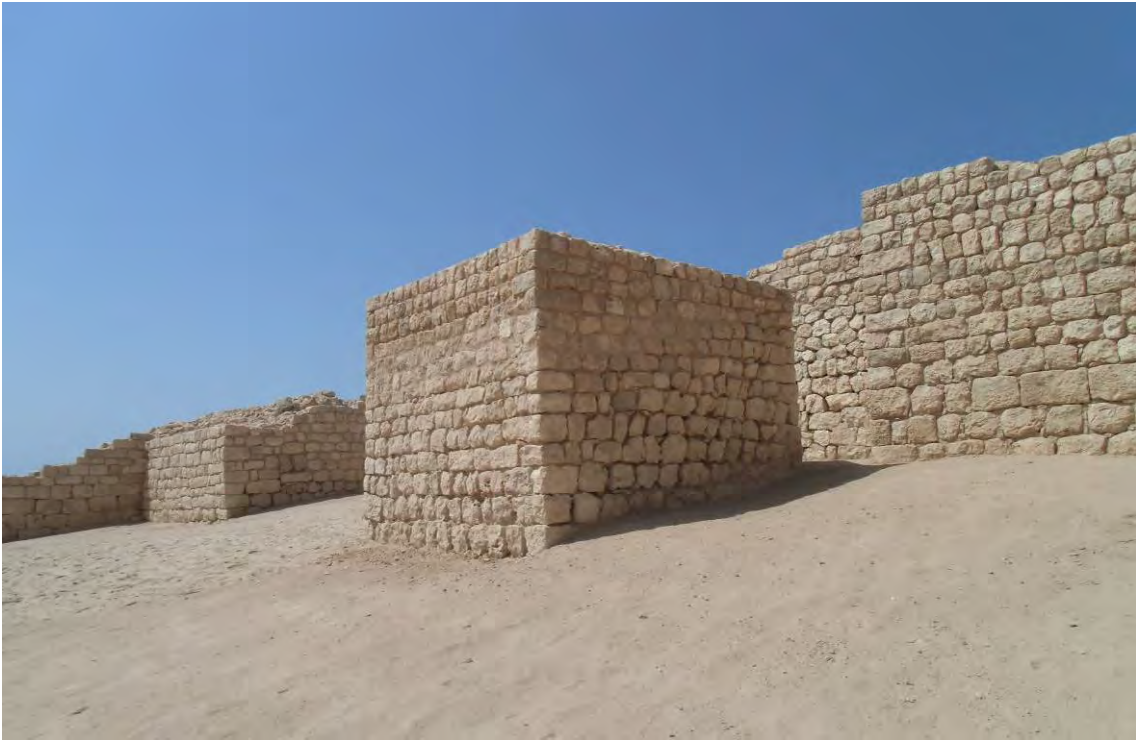
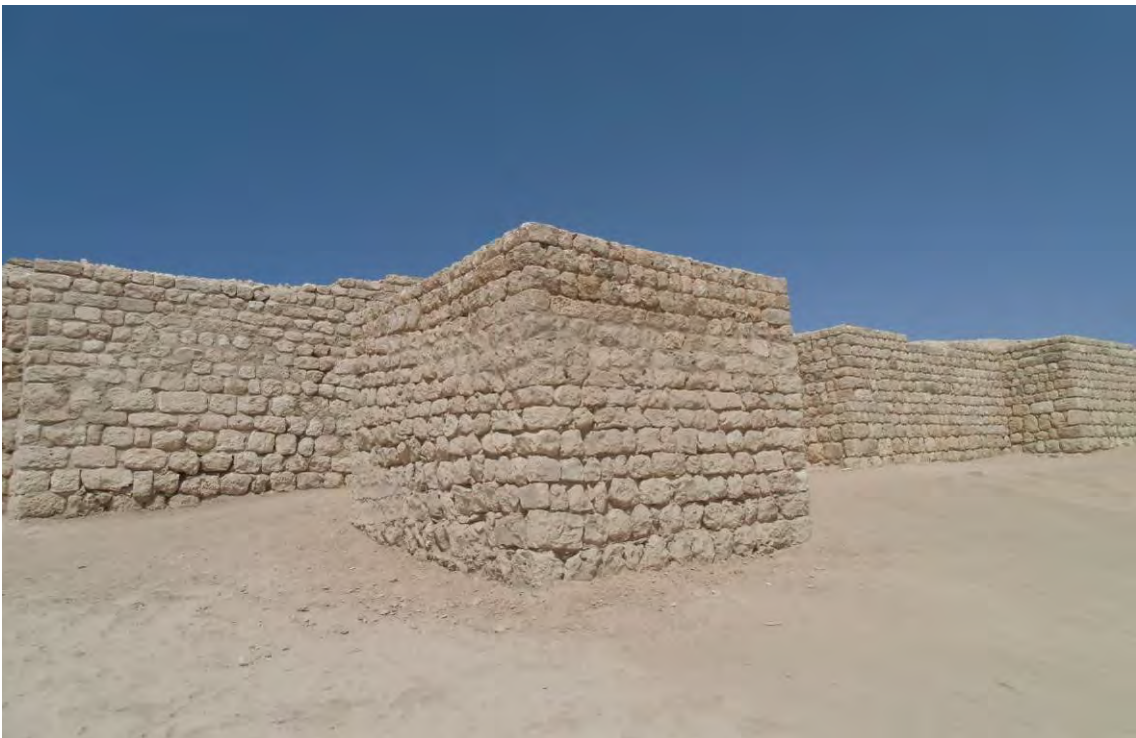
After the restoration the tower A61 is as shown on the pictures below.

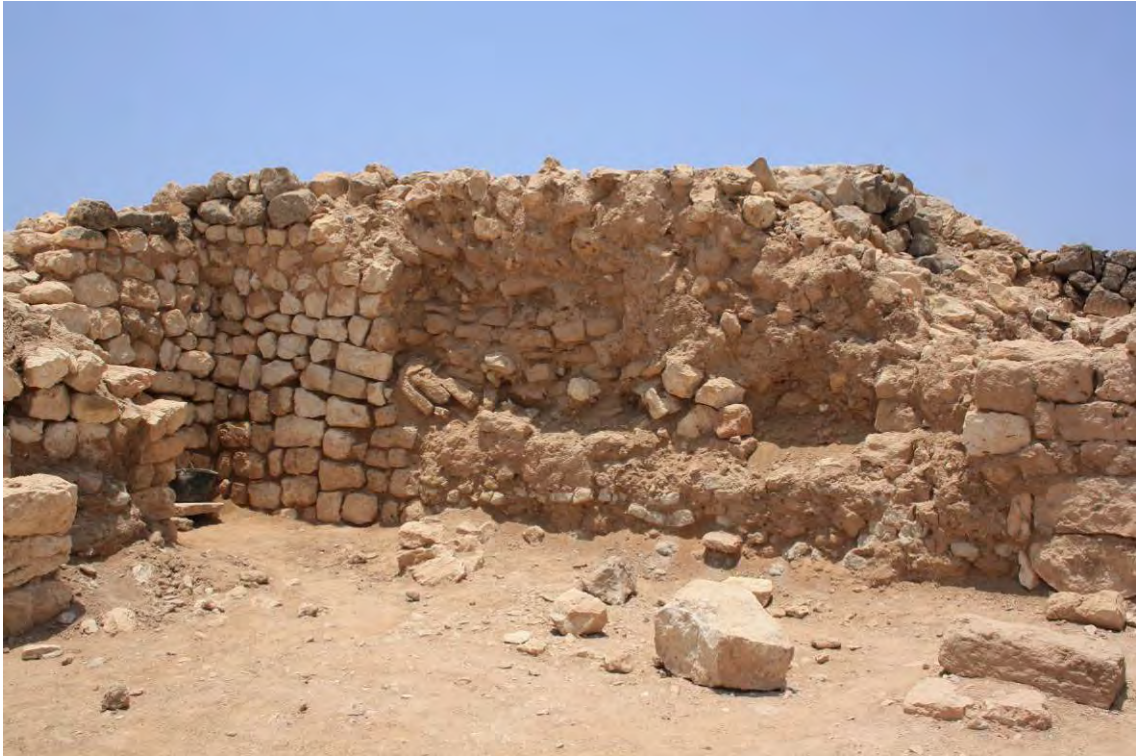
On 13th May 2014 the situation was as shown on the picture below.
