IMTO – Italian Mission to Oman
University of Pisa

Salut

ARCHITECTURAL REPORT (September - December 2016)

Stefano Bizzarri Architect

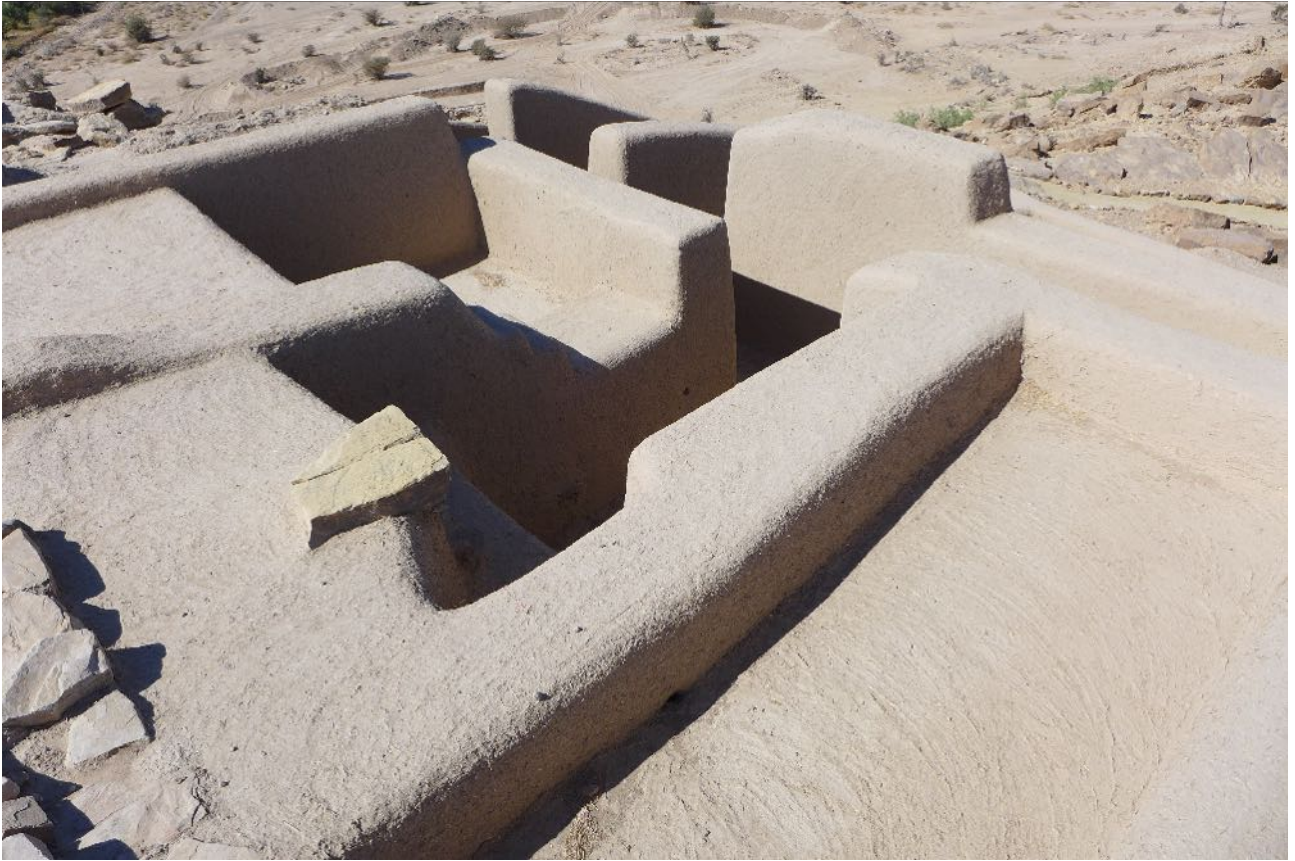
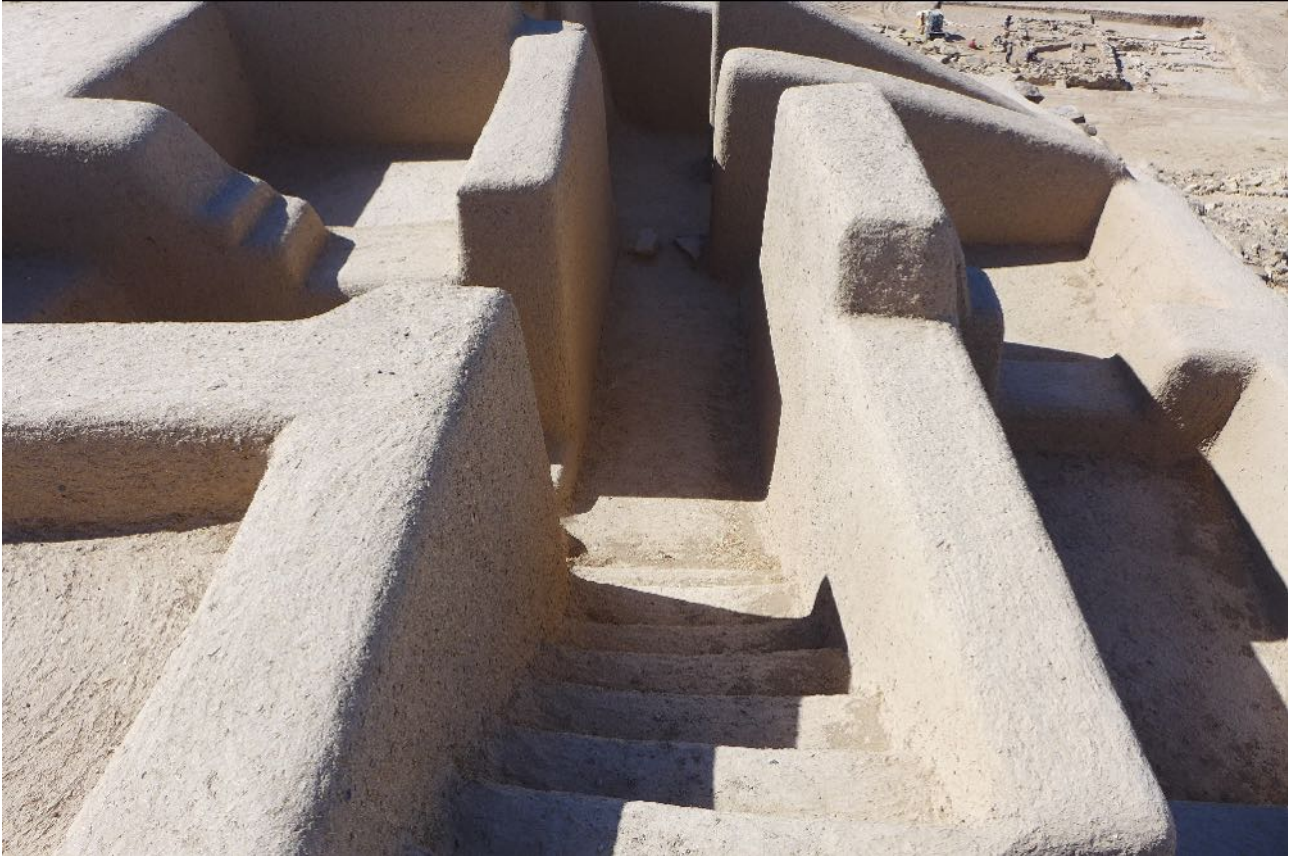
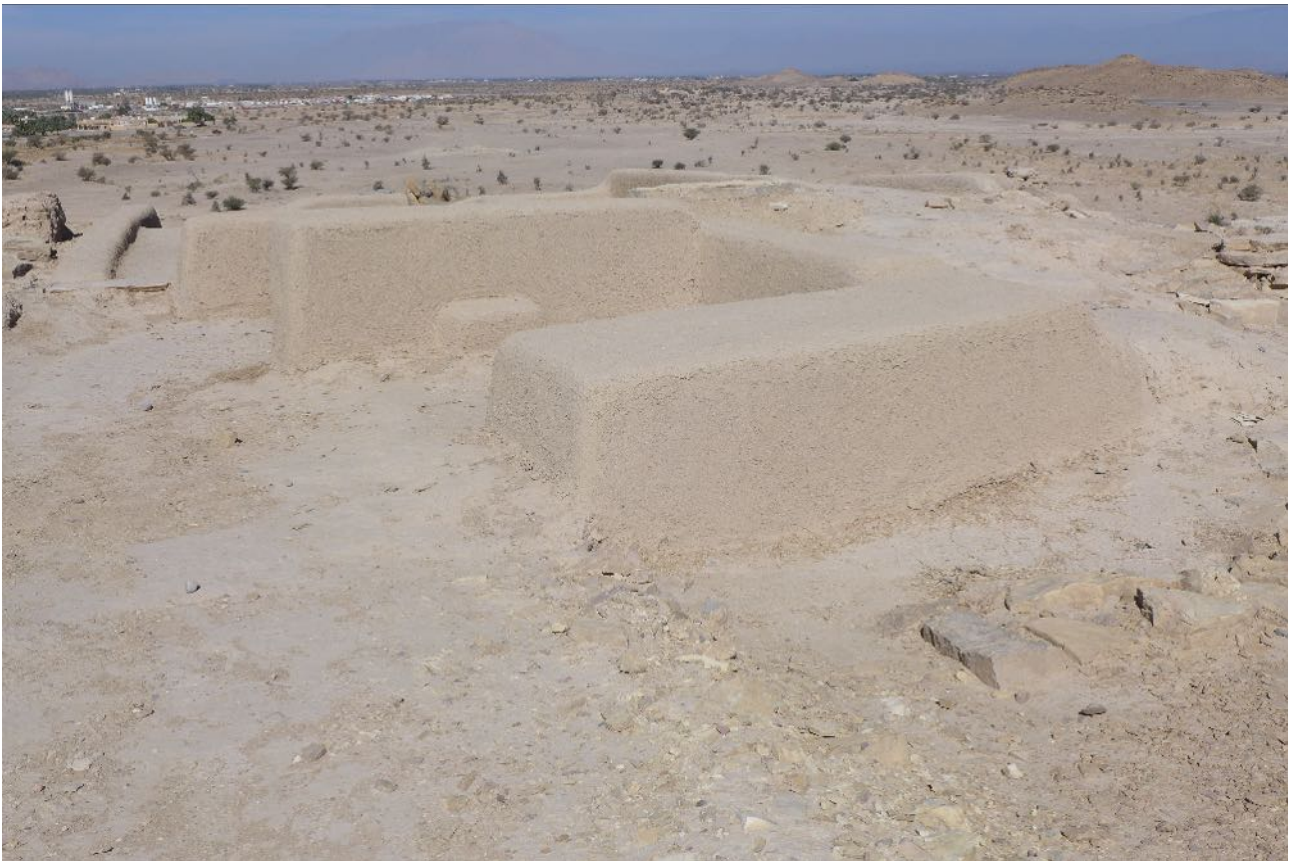
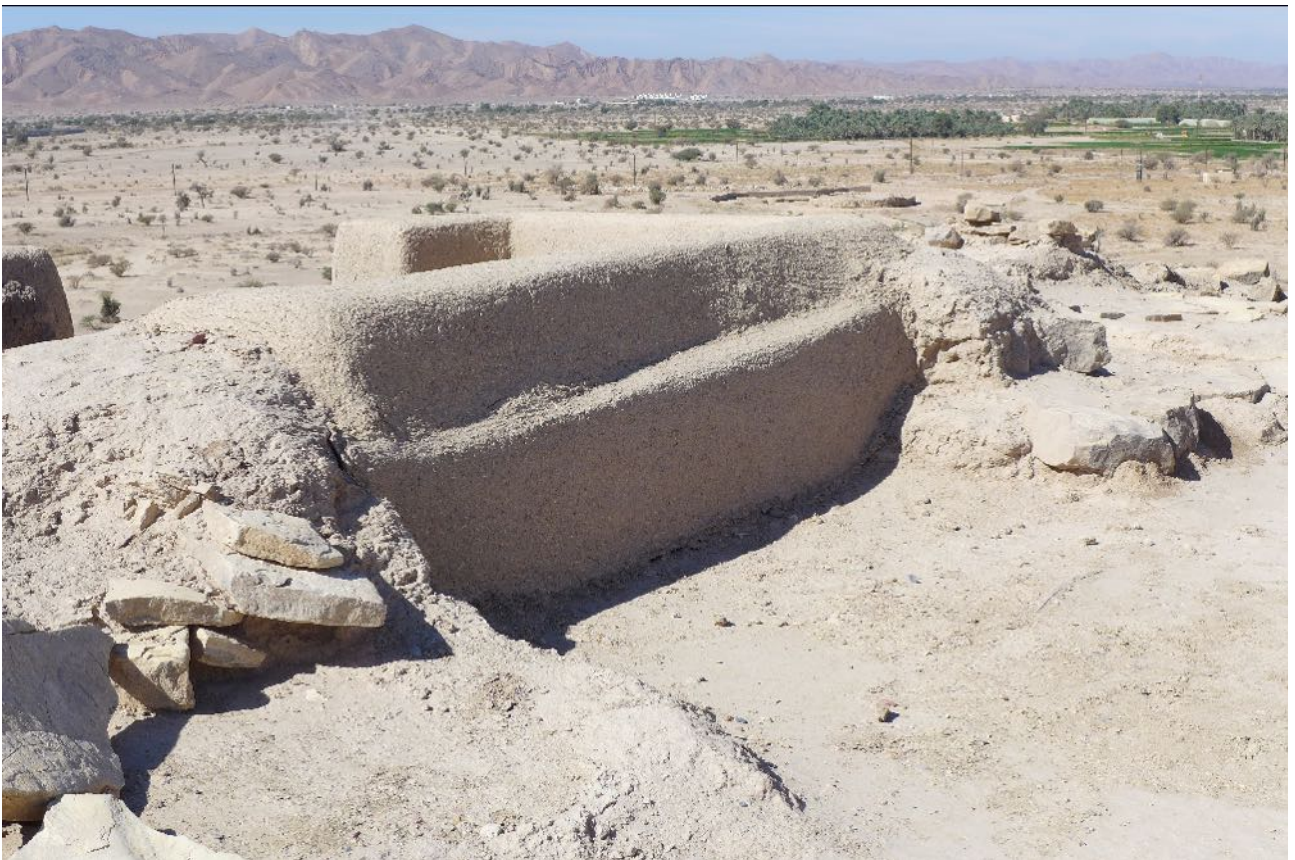
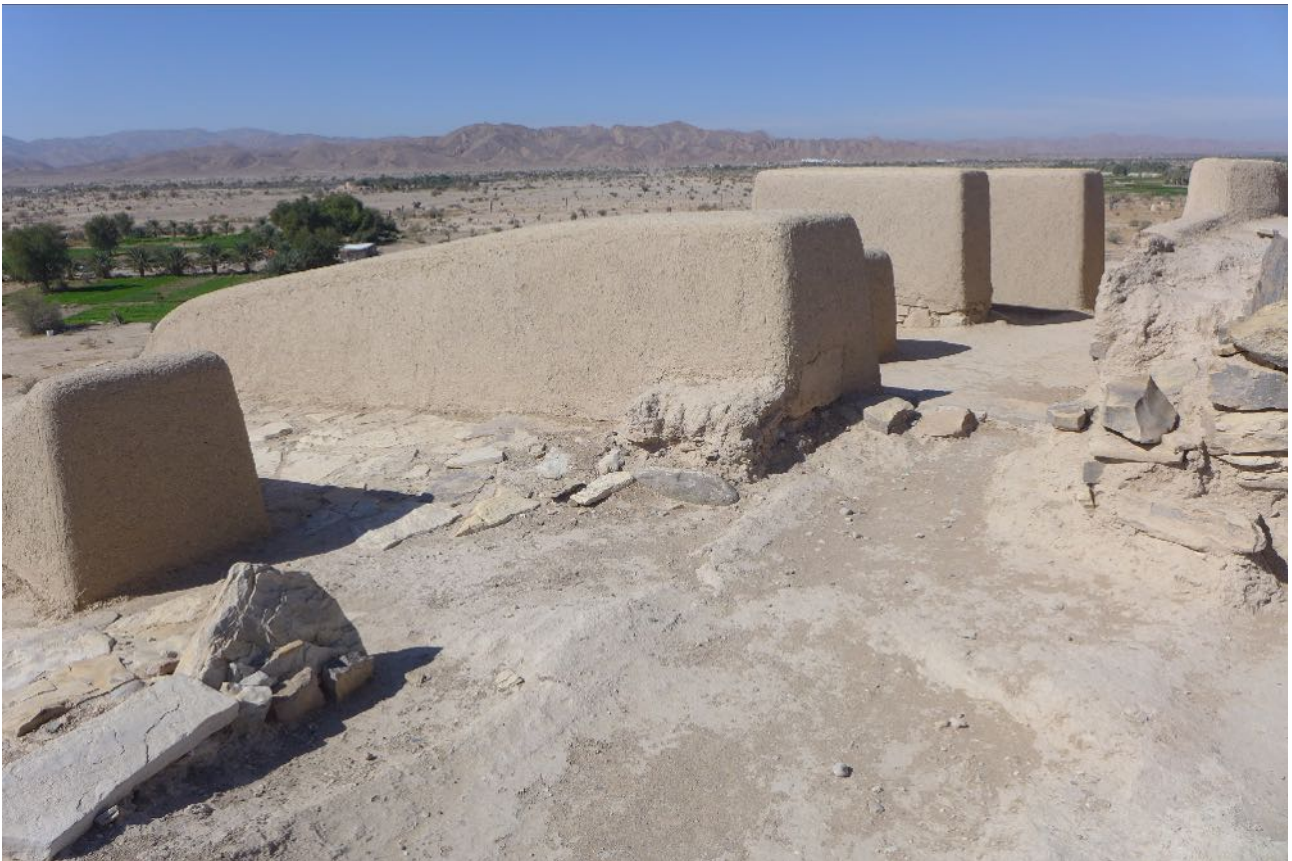
Maintenance

One of the tasks required to the Italian Mission To Oman is the maintenance of the mudbrick walls. Following the work carried out during the previous campaigns, we went on with the fixing of the coverage of some existing mud-brick walls and floors previously restored with a layer of mud and straw mortar.

After the plaster was prepared we carried it up on the site. There the mud was mixed again with water to get the correct consistency. Afterwards small amounts of this mixture were further prepared by the man before to be spreading it, coat after coat, on the mudbrick walls fixing the cracks. Once the procedure was finished, part the walls were covered by mud plaster, giving a wet, deep brown colour. The sun then dried the plaster in two/three days giving it a solid structure and a final light brown colour, well-integrated among the others walls.

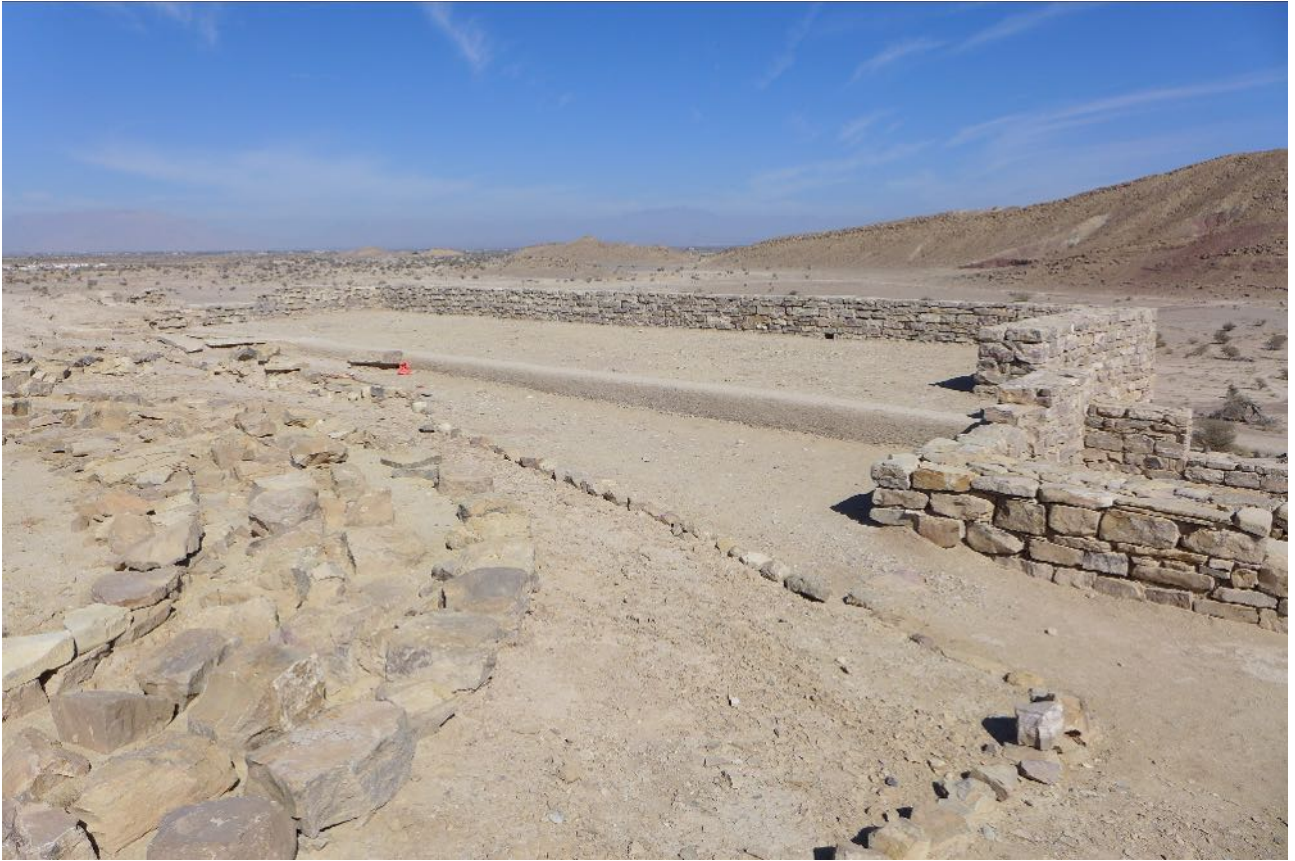
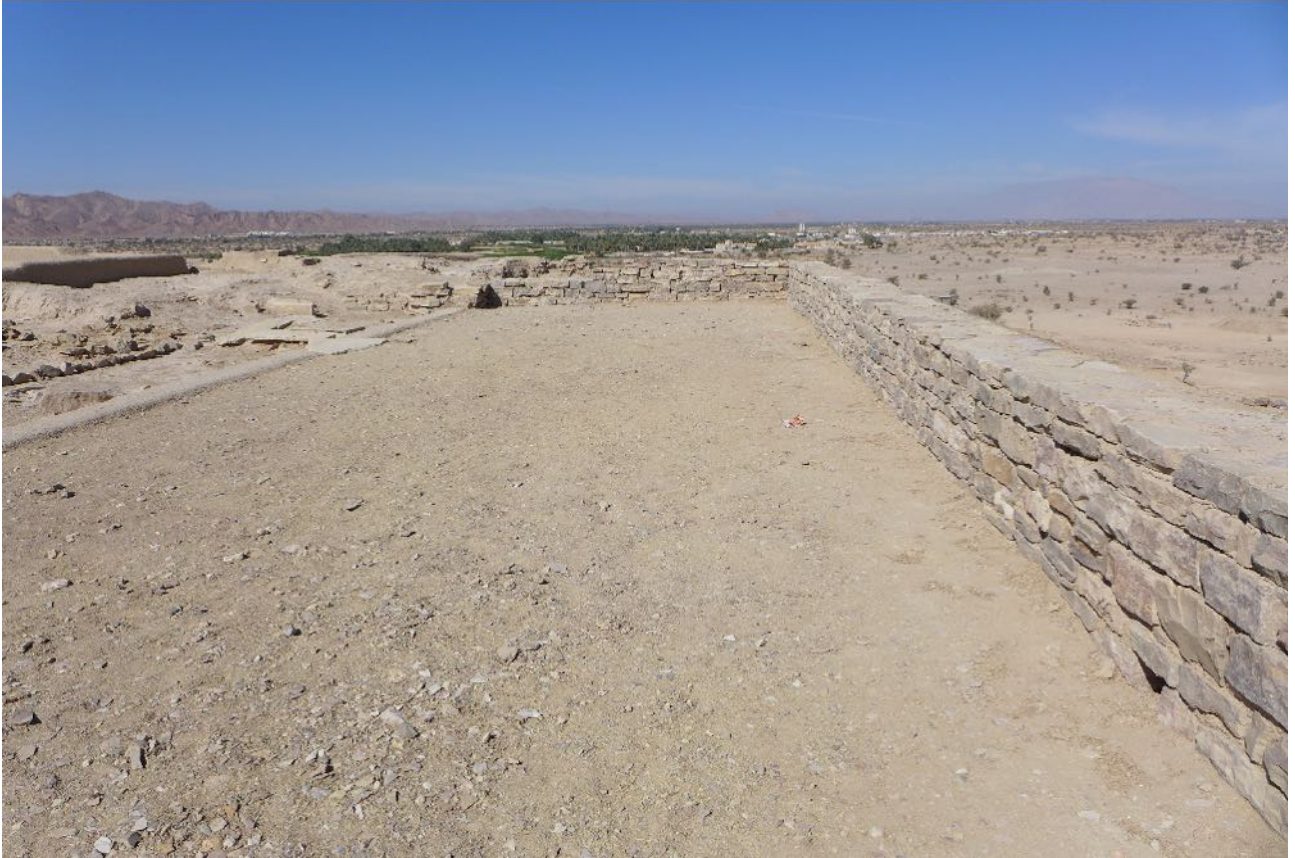
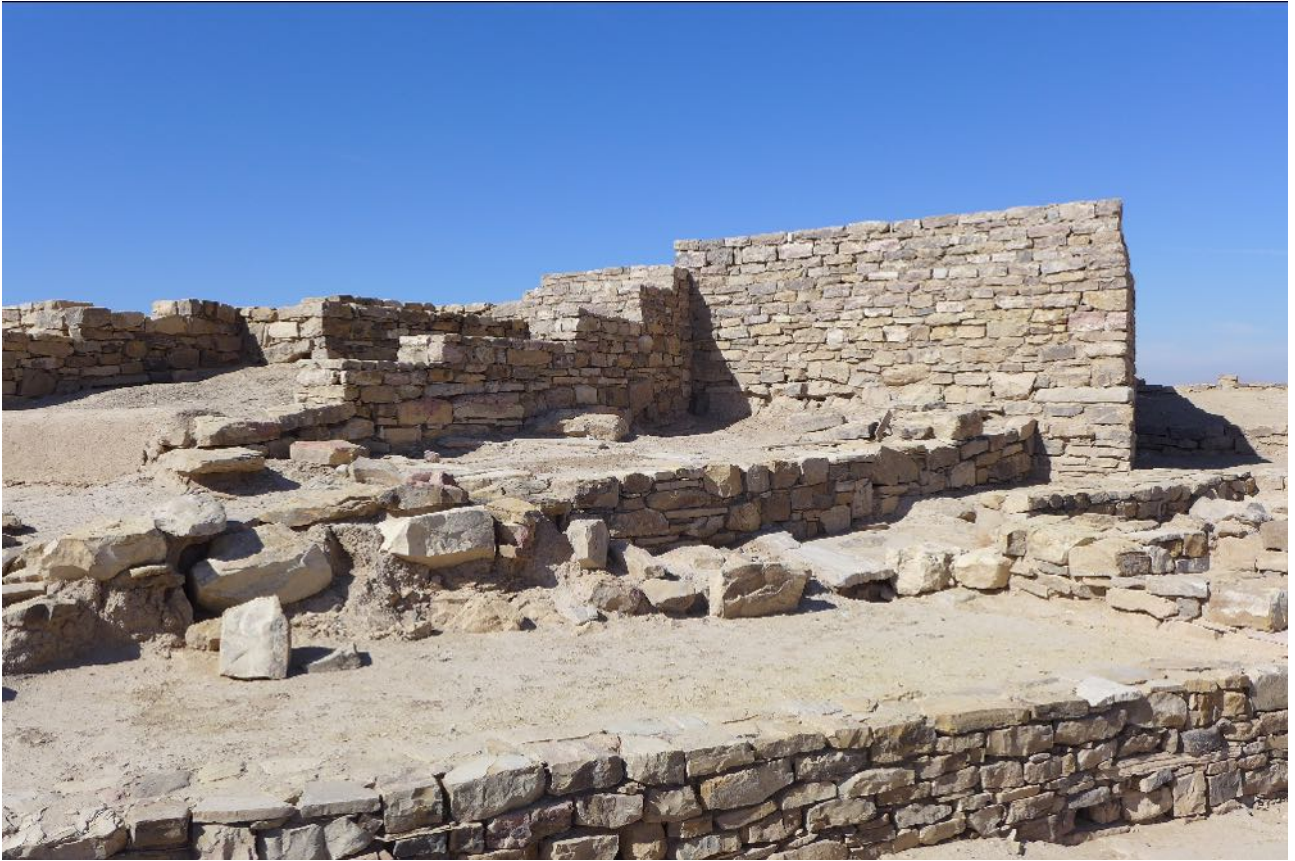
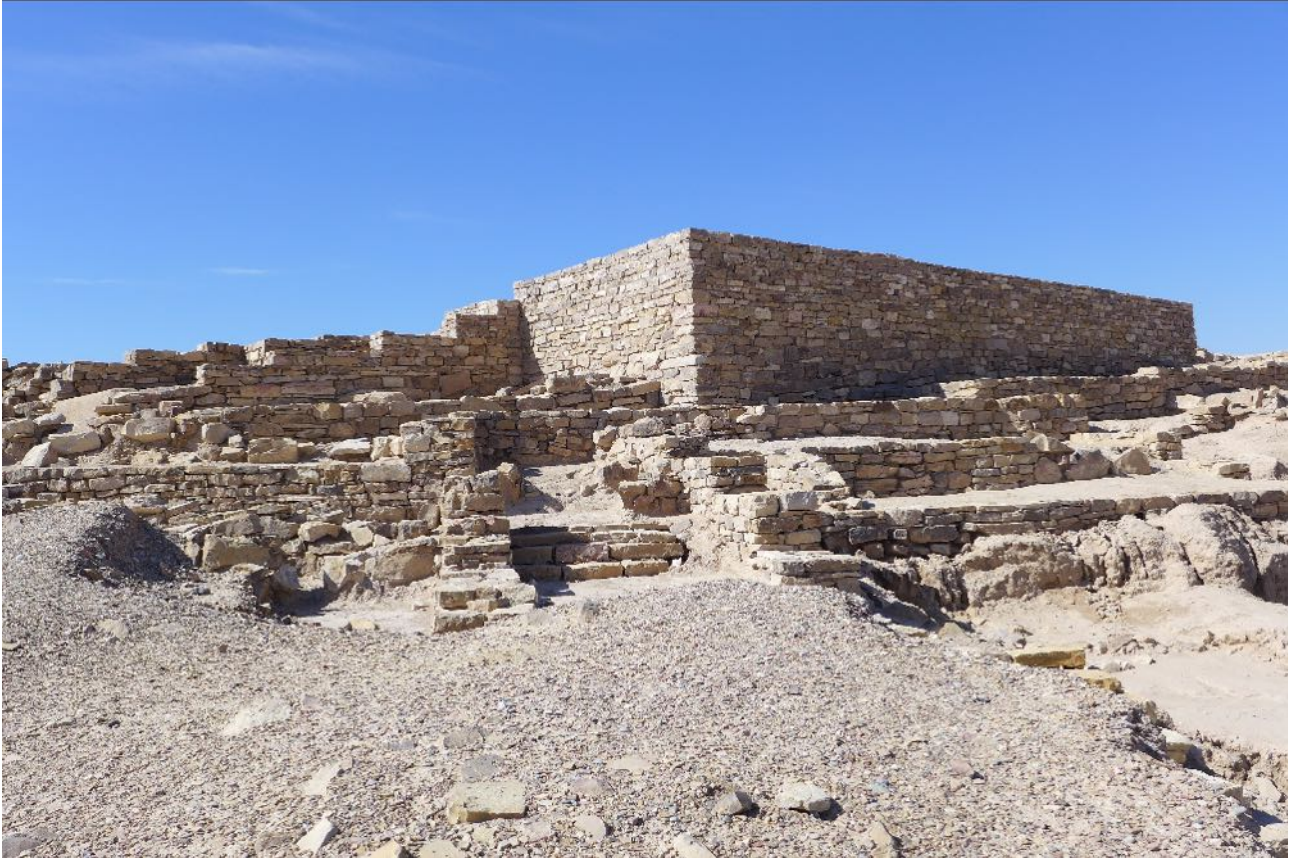
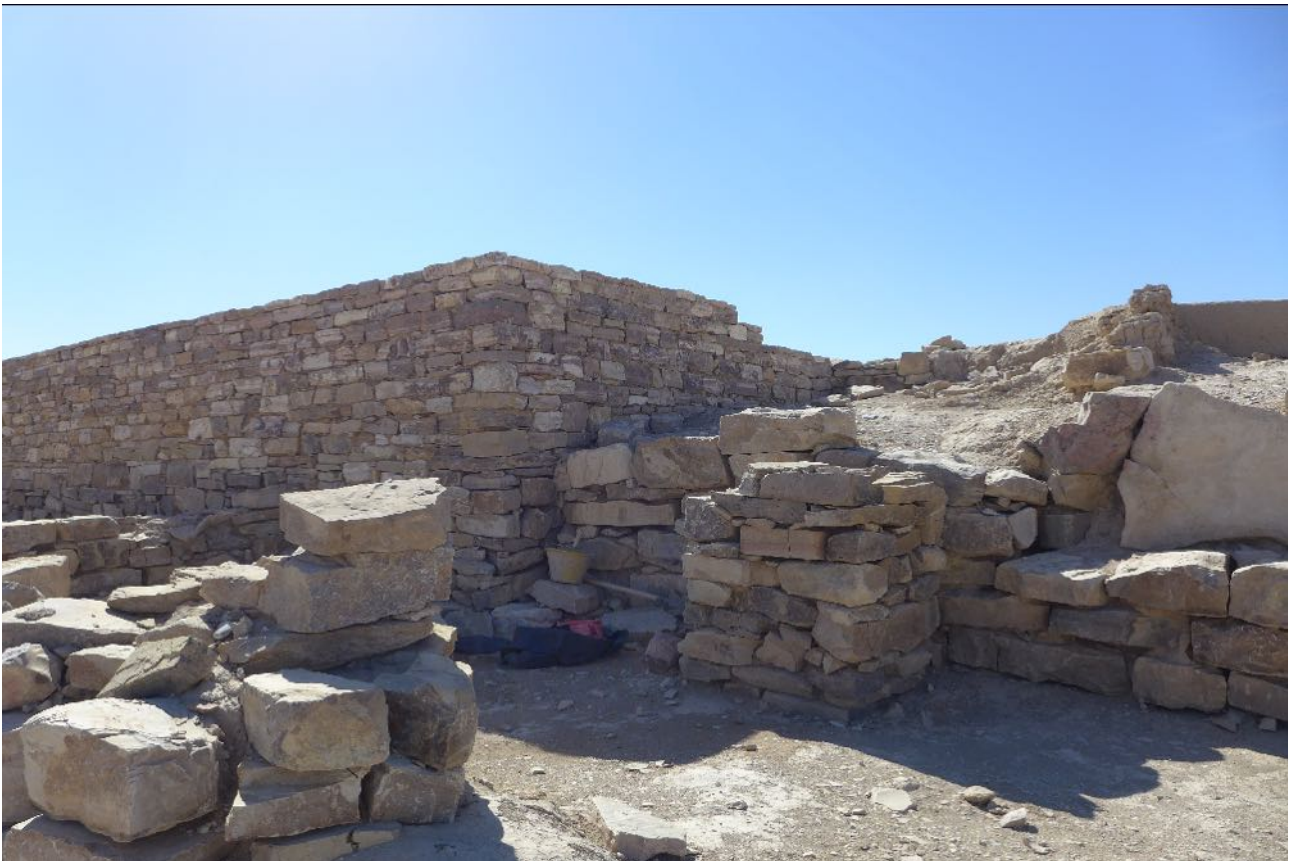
Raising of the walls located close to the platform

After the work made by the office team during the period between the end of 2016A and the start of 2016B IMTO mission, we had to modify the height of some walls around the platform in order to better connect them with the platform. As described above, first of all we analyzed the strength of the wall in order to maintain the original structure as much as possible. the technique of a double faced stone wall with orthogonal stretchers to afford it more strength, we finished to restore and raise the walls on the left and the right side of the platform. The work is carefully carried out to keep the final appearance of the reconstructed part as similar as possible to the original site walls. A dry stone wall was built with no need of mortar. type and methodology of intervention are chosen in respect of the Unesco-Icomos general principles.

Some further work has to be done in the next missions.

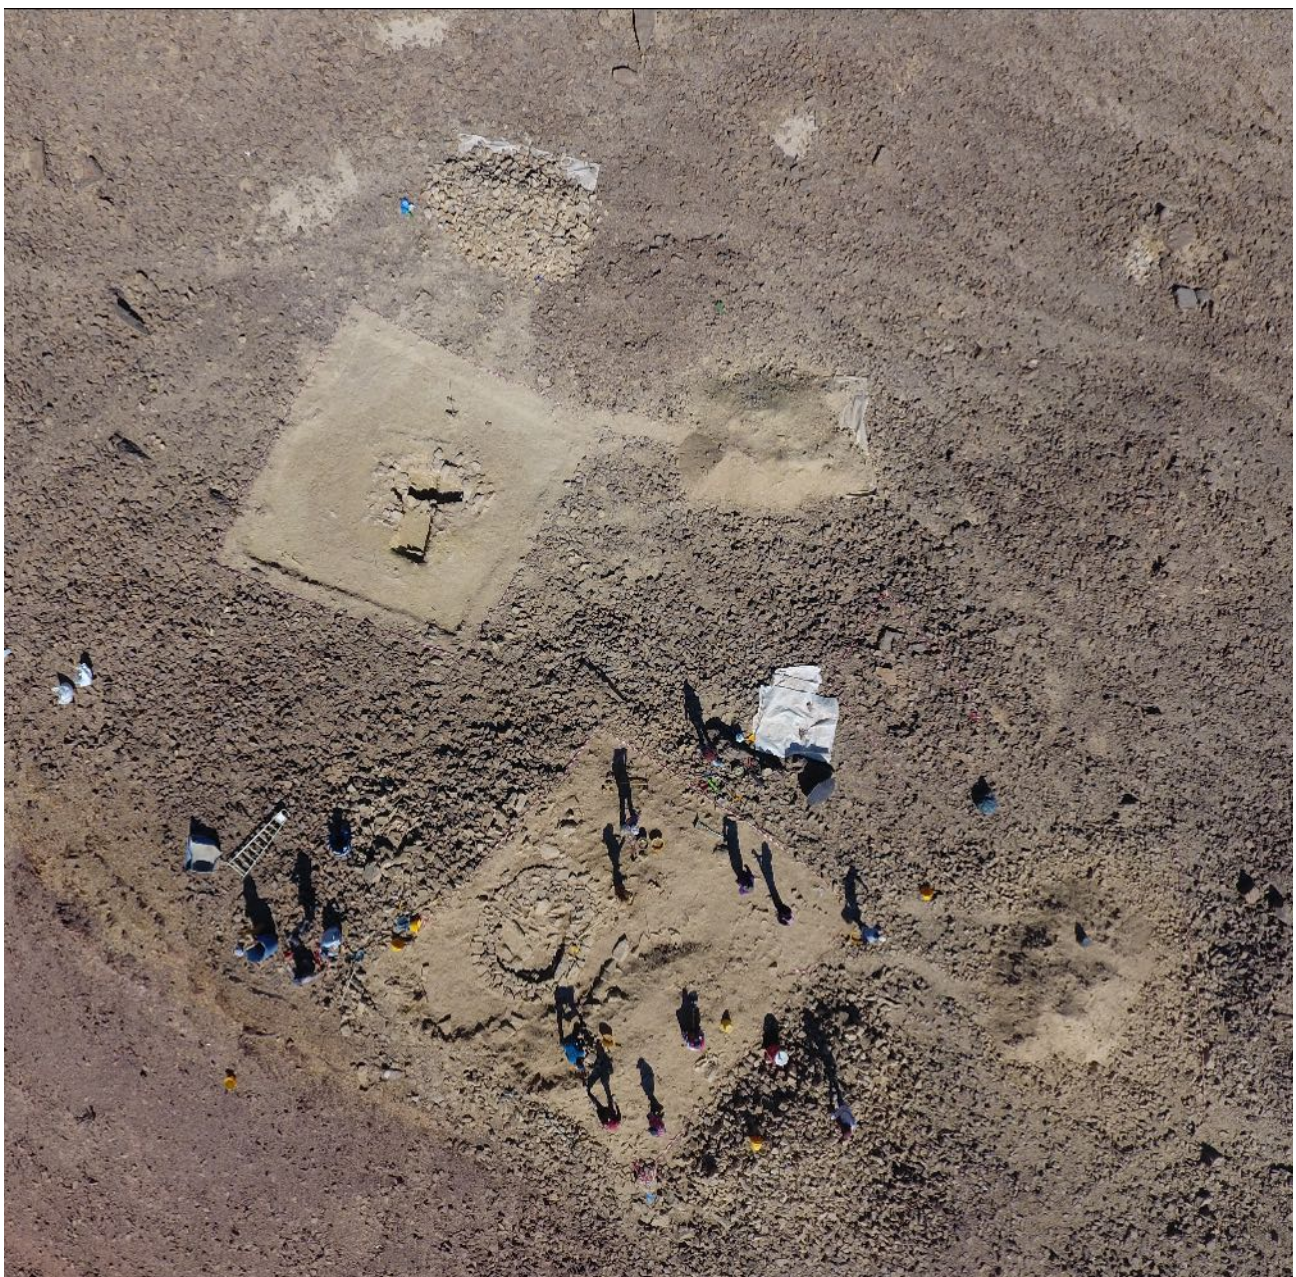
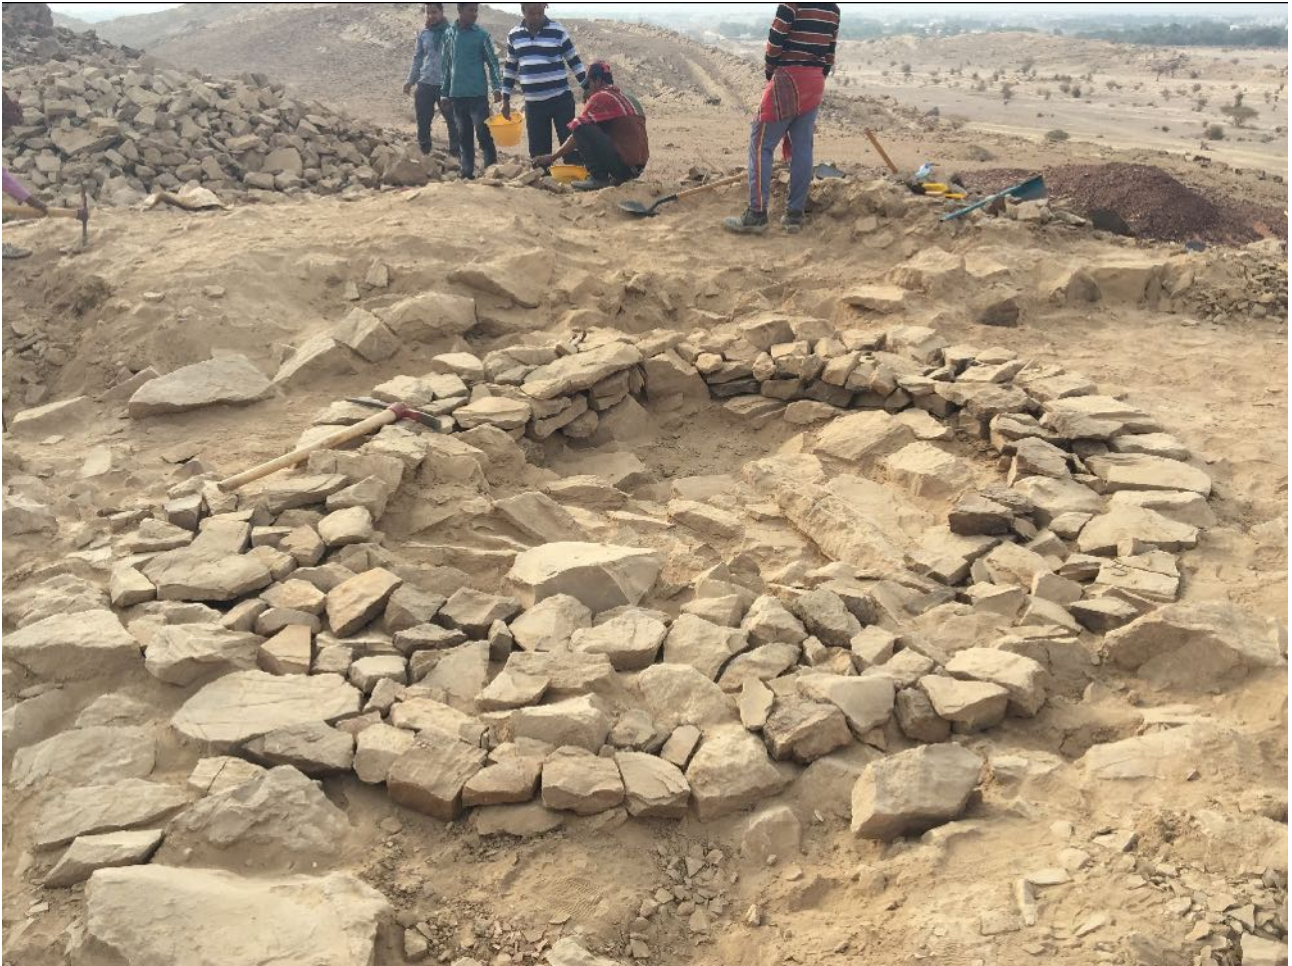
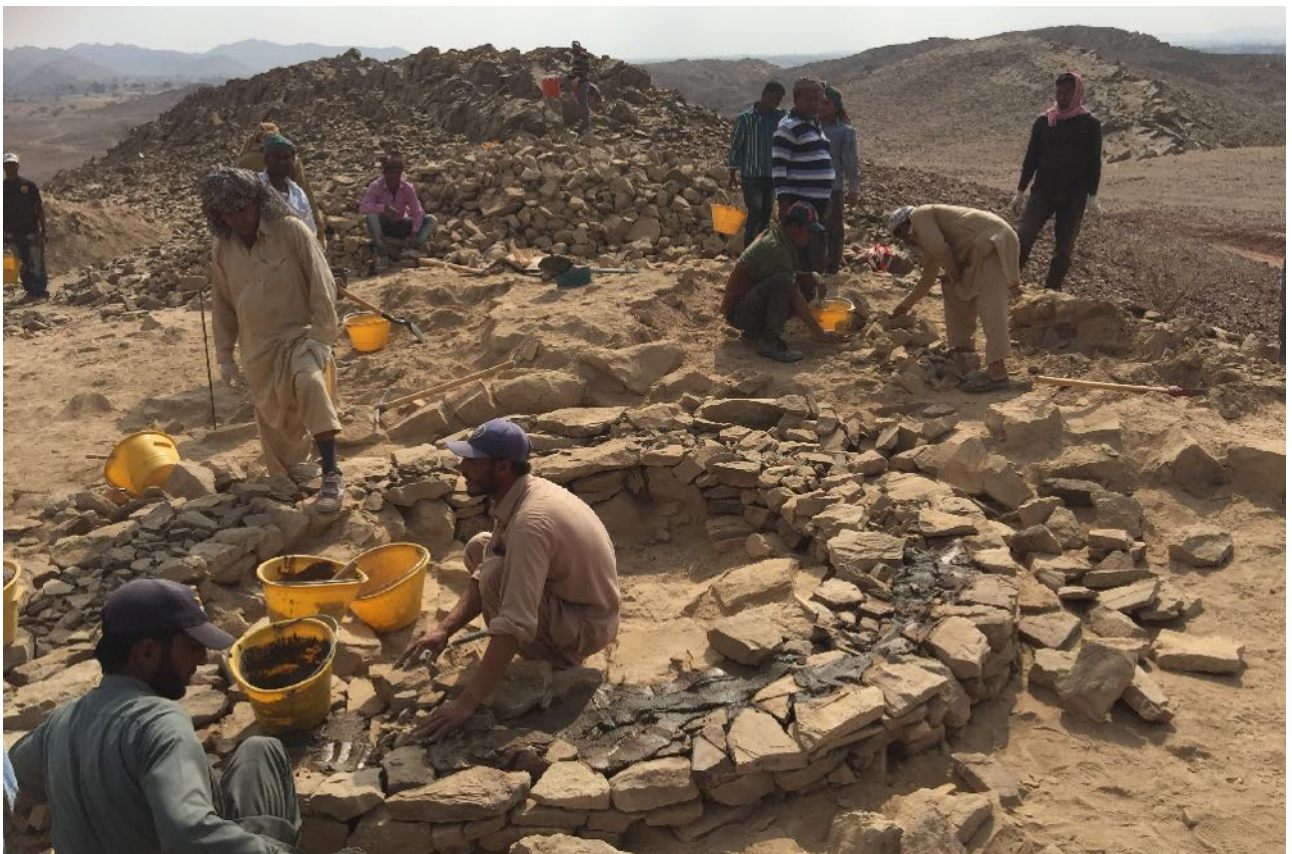
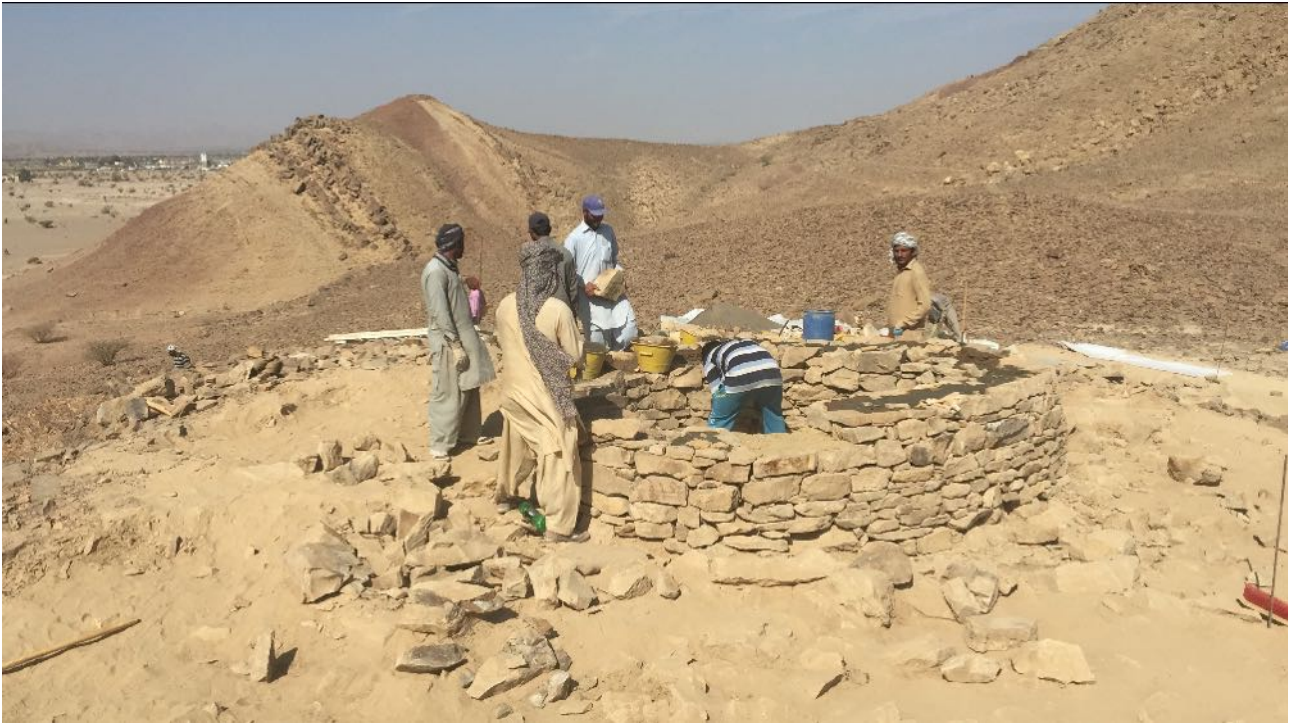
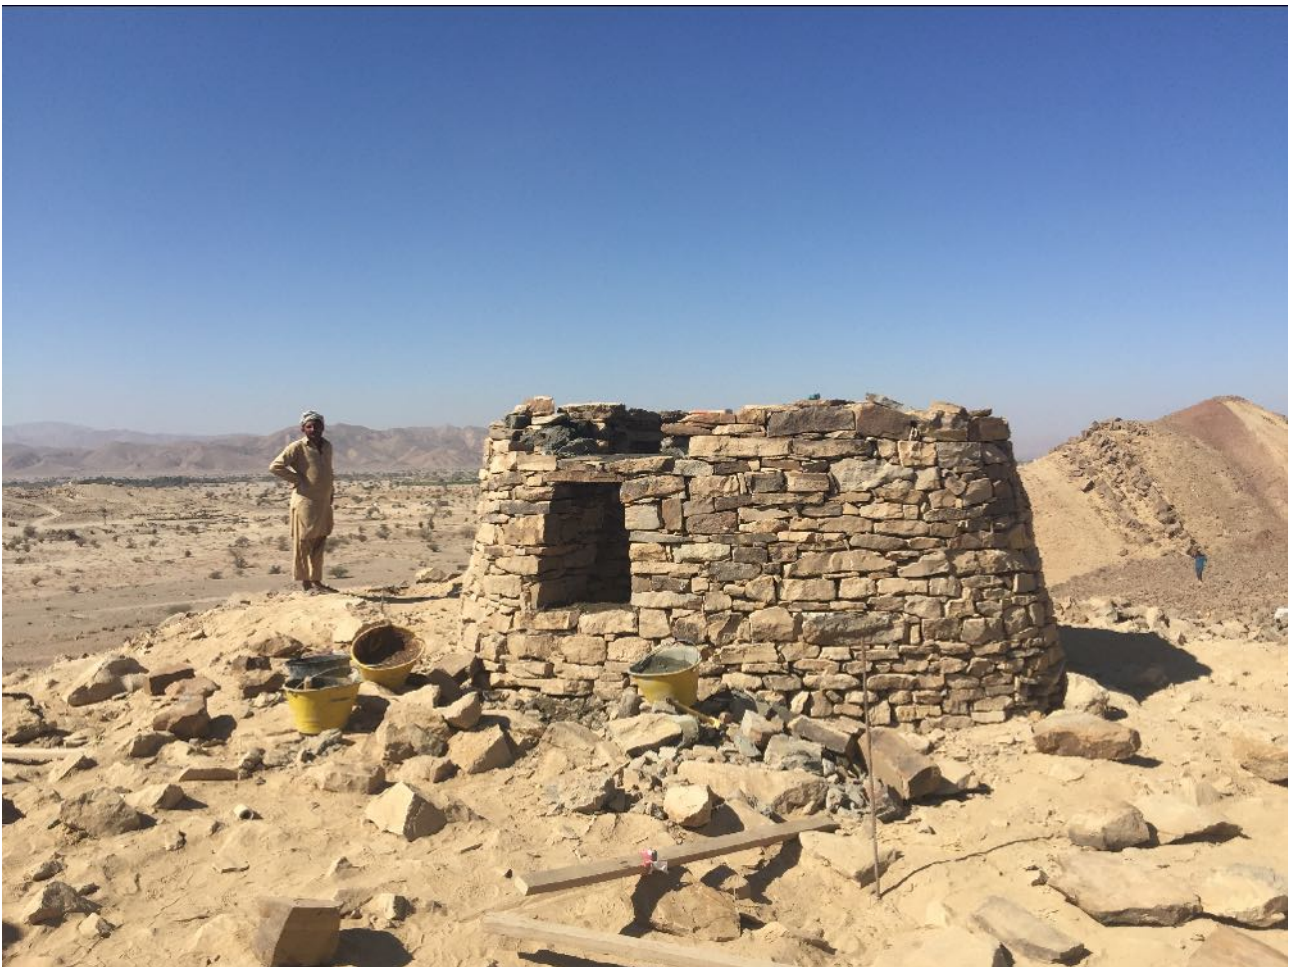
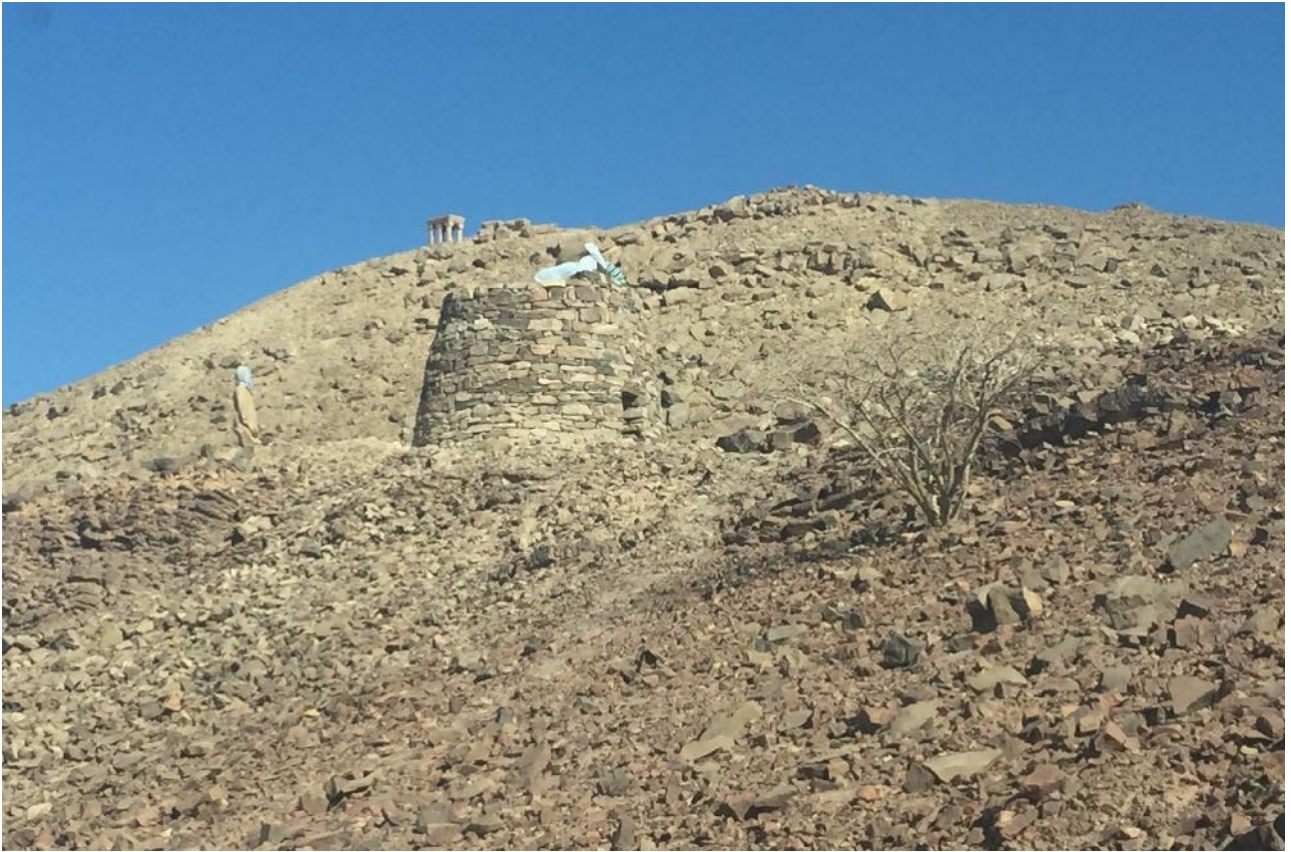
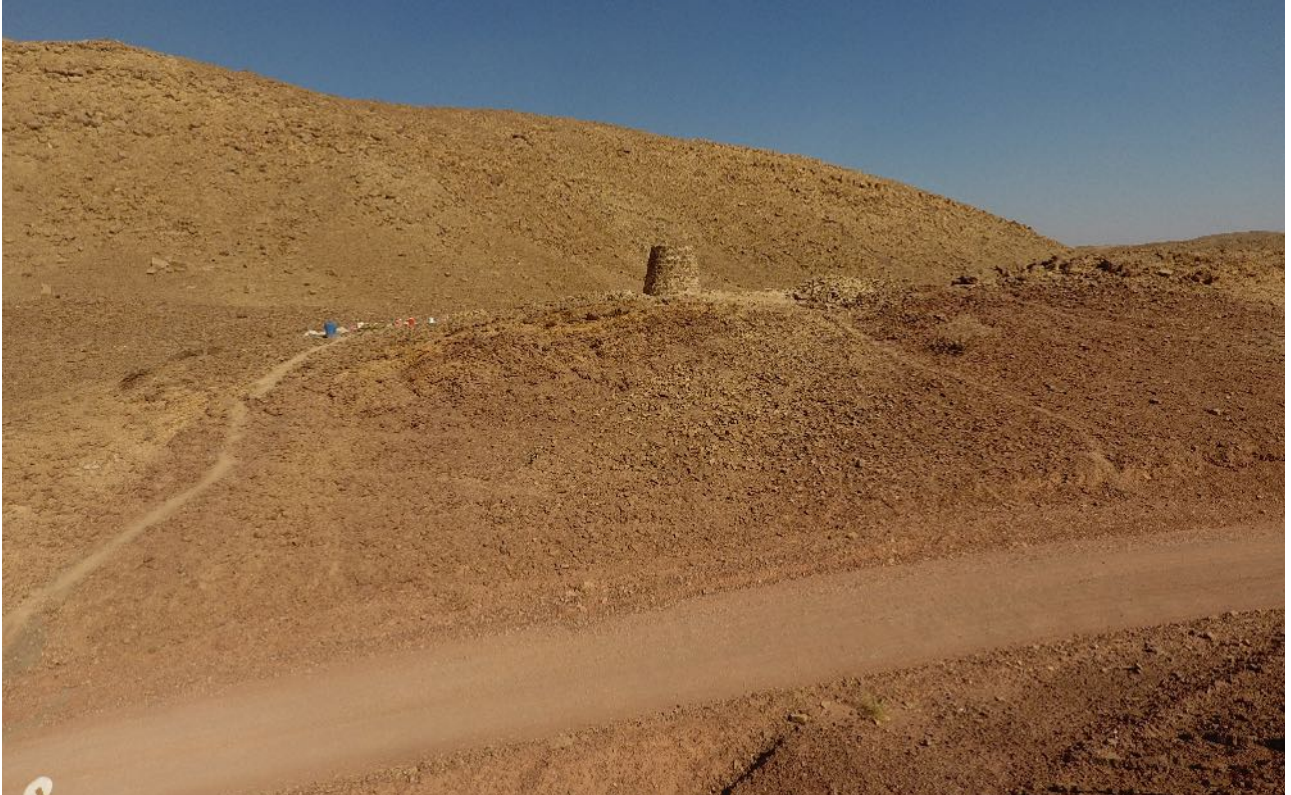
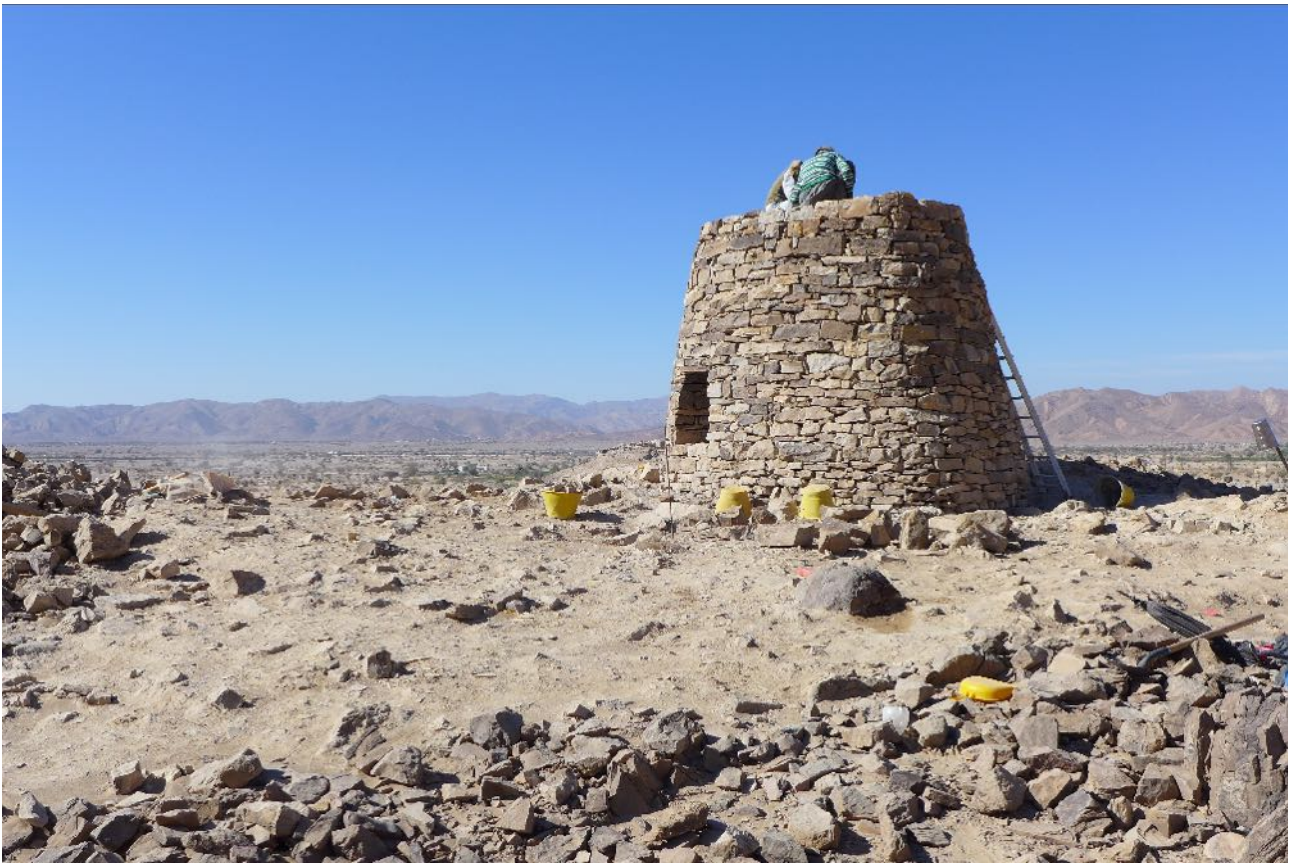
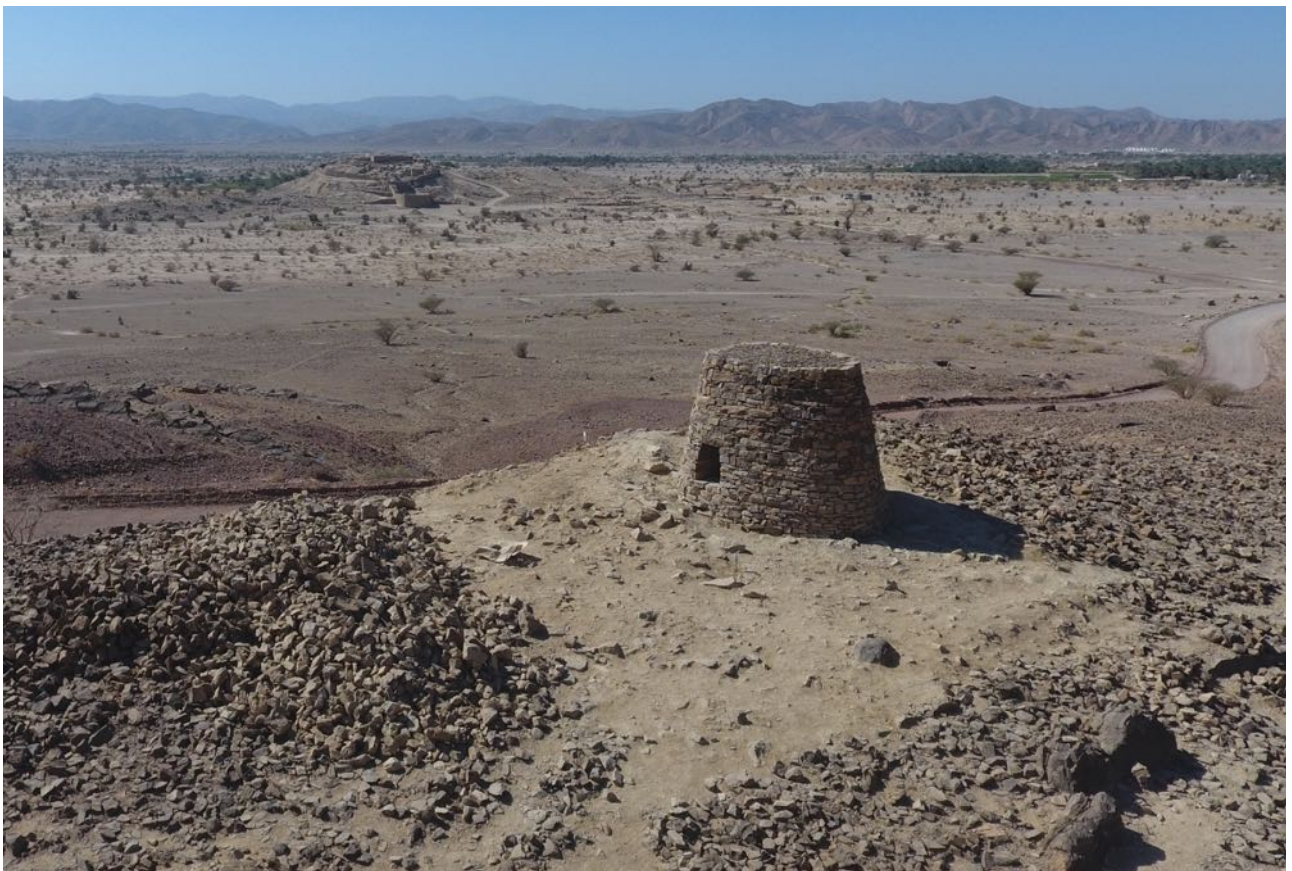
JEBEL SALUT 4, GRAVE 2

During the 2016B mission we also worked on the Jebel Salut, restoring the Jebel Salut 4, grave 2 situated where many collapsed tombs are located. The tomb was investigated by archaeologists before our work.

This tomb, situated close to the access road facing directly the site of Salut, was almost completely destroyed, but traces of the external wall and the inner chamber were still visible.

The methodological approach was the same of the old interventions: checking of the existing structures, estimating the amount of damage and verifying which parts could be preserved and, at the end, starting with the restoration.

The remains of the grave 2 were composed of an irregular circular plan of stones. The structure was made up in part of two and mostly of one rows of stones. Inside the perimeter another shape showed the burial chamber. First of all we checked the solidity of the structure, taking away the unstable stones and trying to consolidate the old parts. Only when these actions proved in effective, were

parts removed. Then, in order to separate the new stones from the old ones, we put a geotex layer before starting the rebuilding.

Stones from the collapse tomb and others from the closest area were used.

Before the rebuilding phase we didn't discover indication where the small door was located, then we placed it following the same direction of Jebel Salut grave 1 and 2.

The rebuilding was started by putting rows of stones one after another, one concentric row after the other.

After the rebuilding we cleaned the area around the tomb.
