IMTO – Italian Mission to Oman
University of Pisa

Salut

ARCHITECTURAL REPORT (September - December 2016)

Stefano Bizzarri Architect

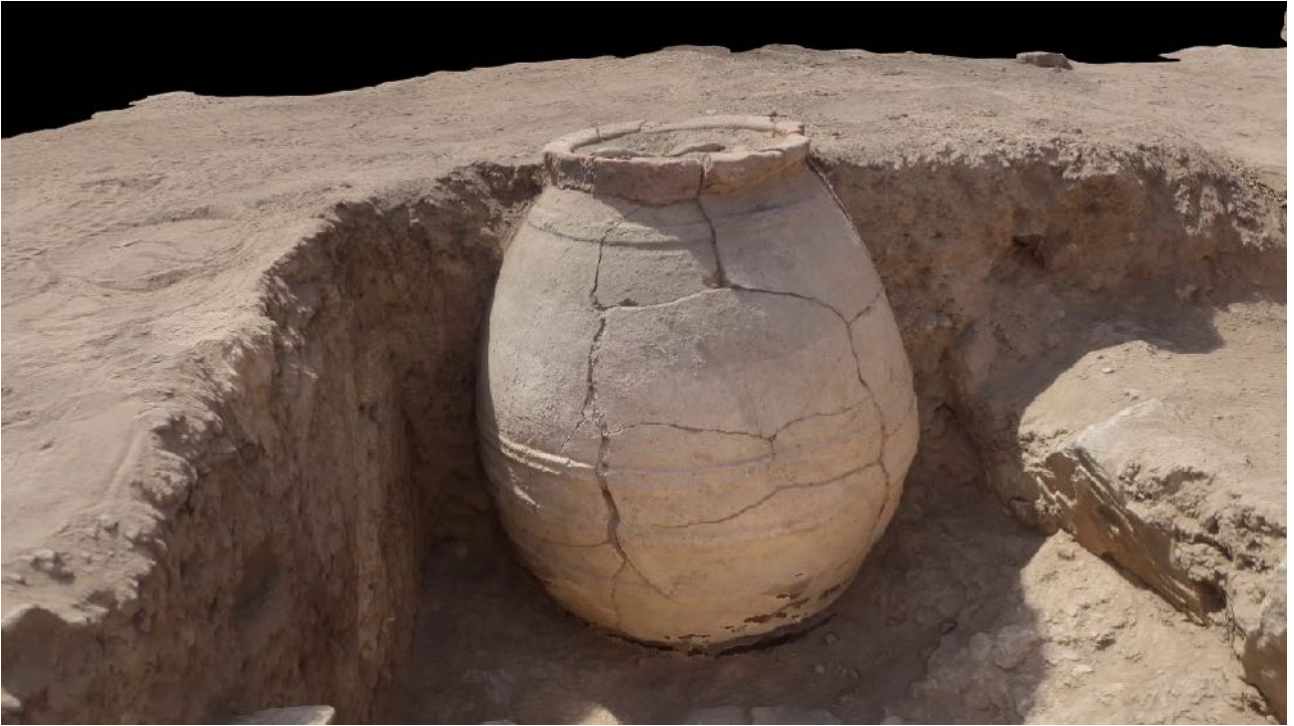
3D reconstruction of late Iron Age jar (F147) - snapshot from the video clip
