**RESTORATION WORKS AT SUMHURAM
(ARCHAEOLOGICAL PARK OF KHOR RORI)
(Sultanate of Oman)
CAMPAIGN February-March 2016**

**Technical Report
06th February – 24th March 2016**

RESTORATION WORKS AT HAMR AL-SHARQIYA

Technical Report
06th February – 24th March 2016

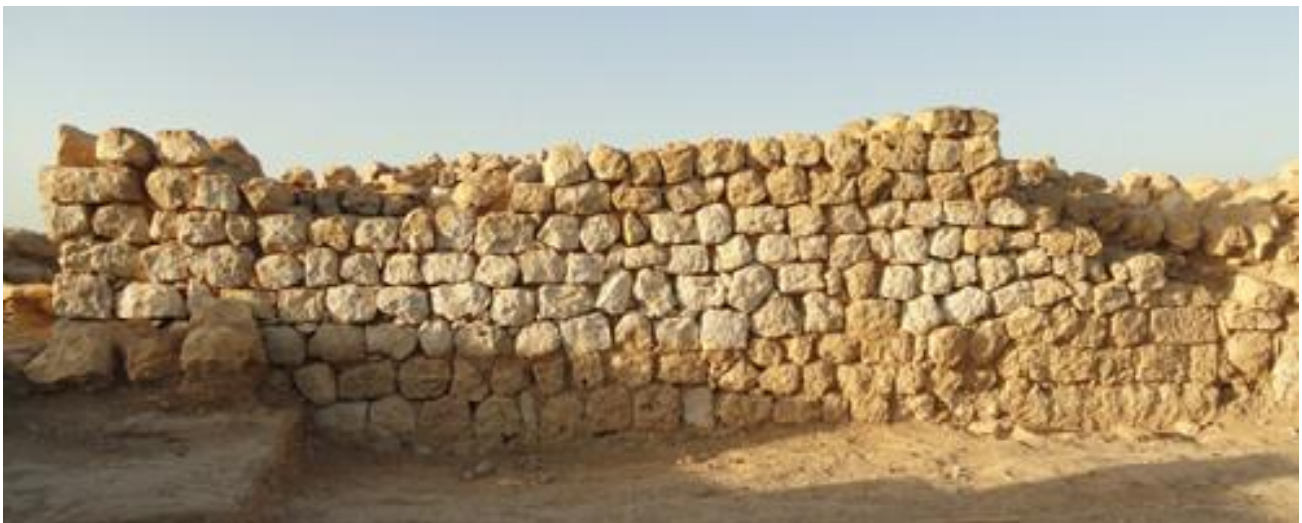
M485, south front wall, before the restoration.

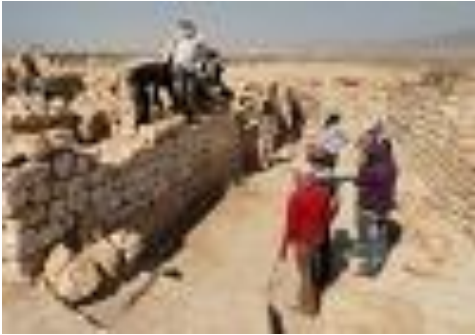
M485, south front wall, during removing stones.

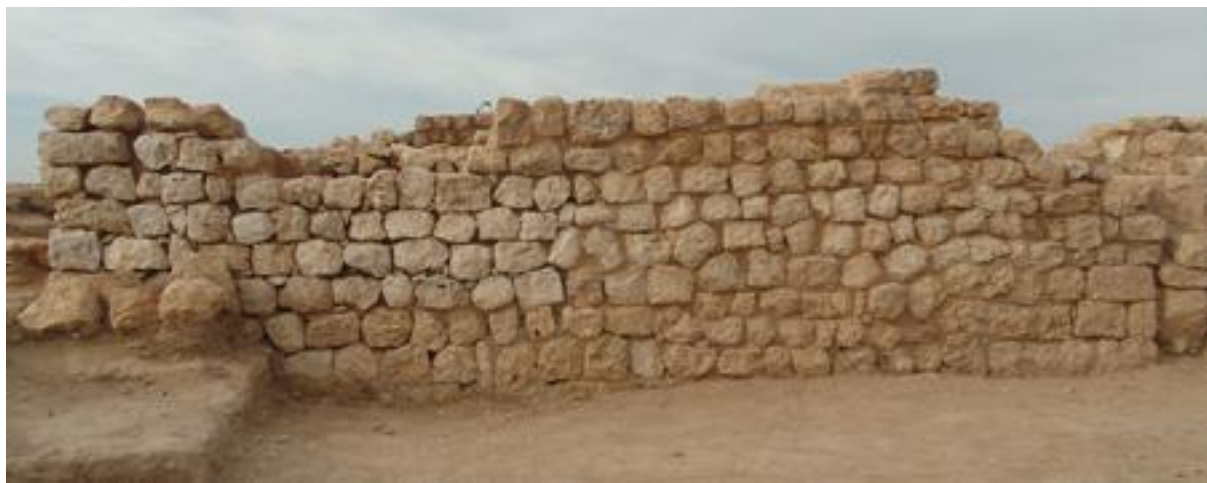
M485, south front wall, after the restoration.

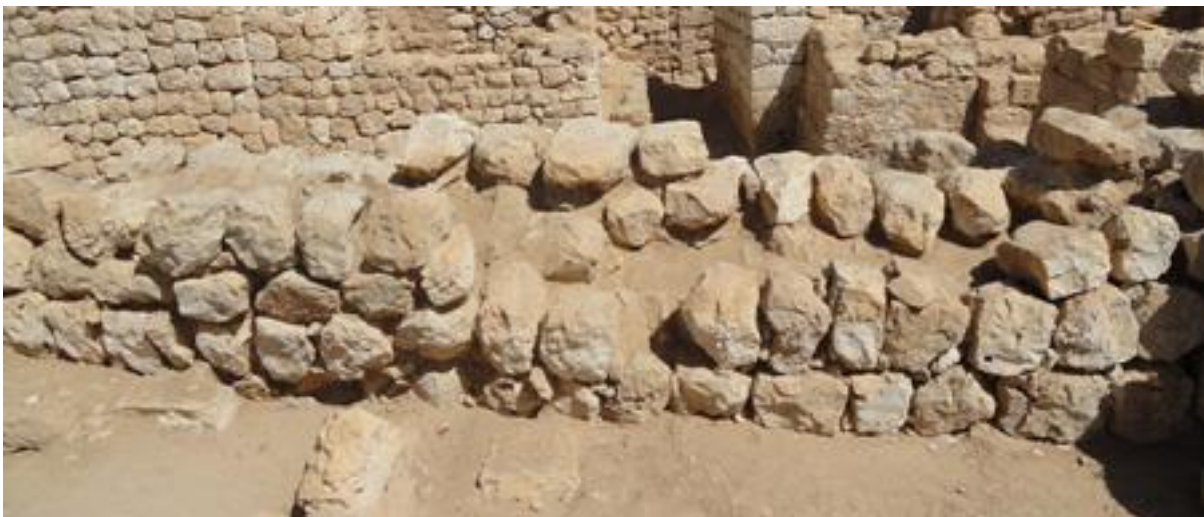
M485, north front wall, before the restoration.

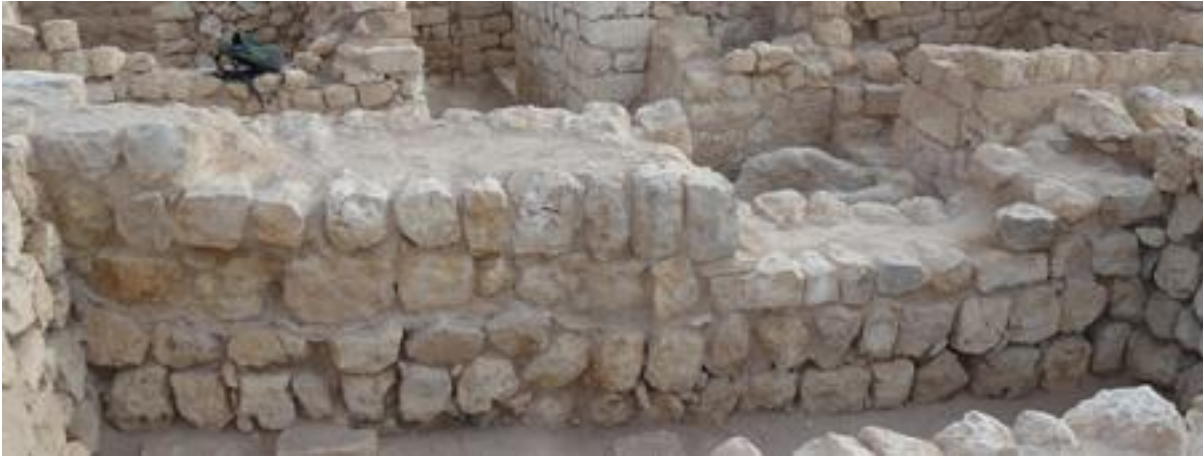
M485, north front wall, after the restoration.

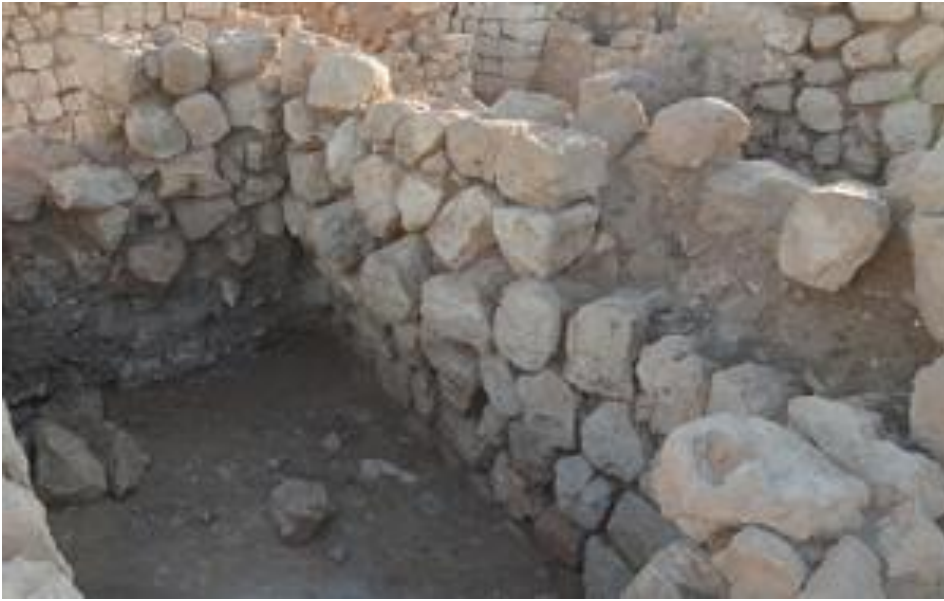
M494, west front wall, before the restoration.

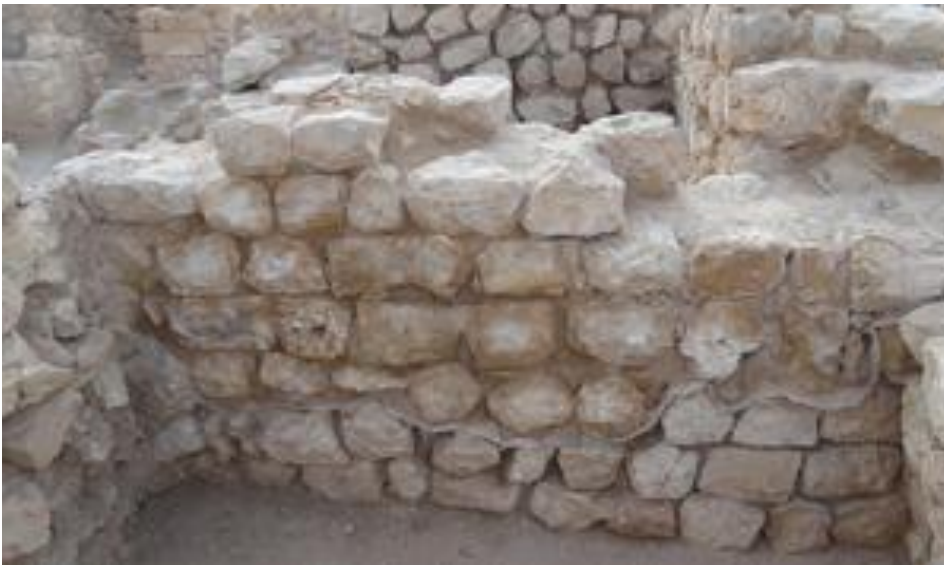
M494, west front wall, after the restoration.

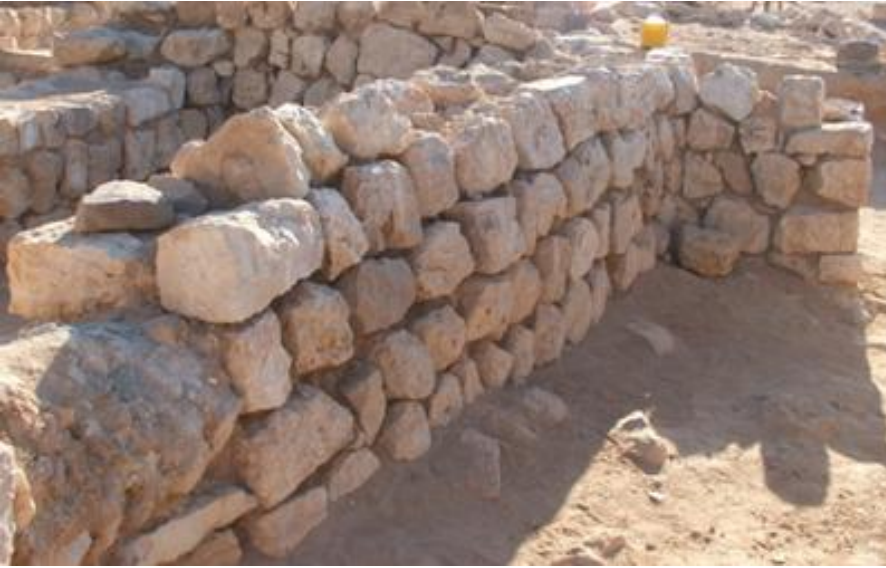
M569, north front wall, before the restoration.

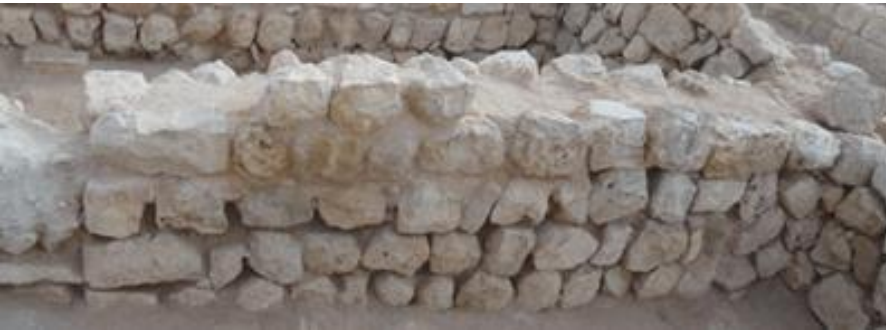
M569, north front wall, after the restoration.

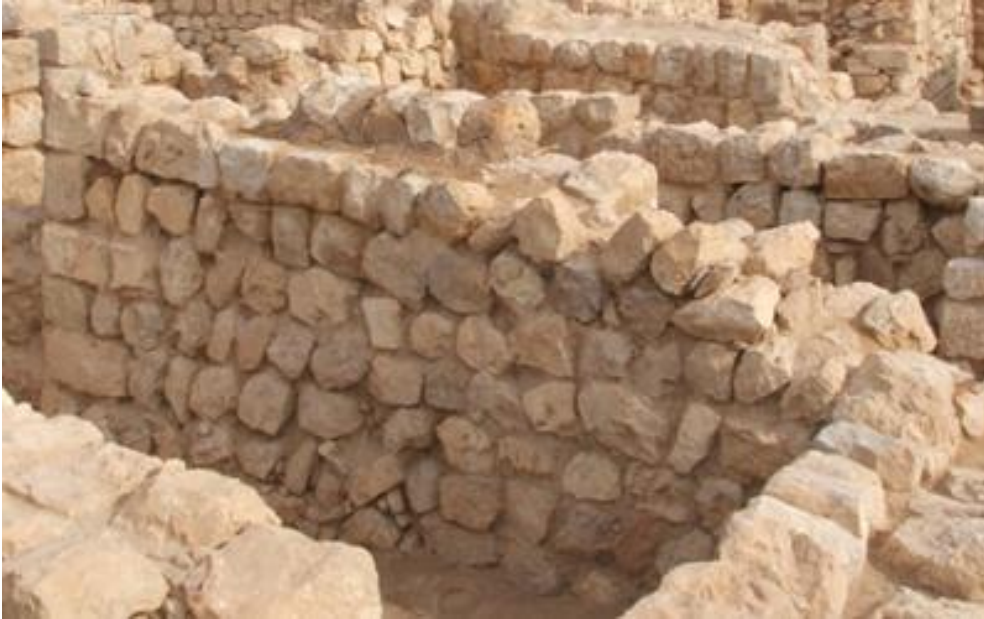
M562, north front wall, after the restoration.

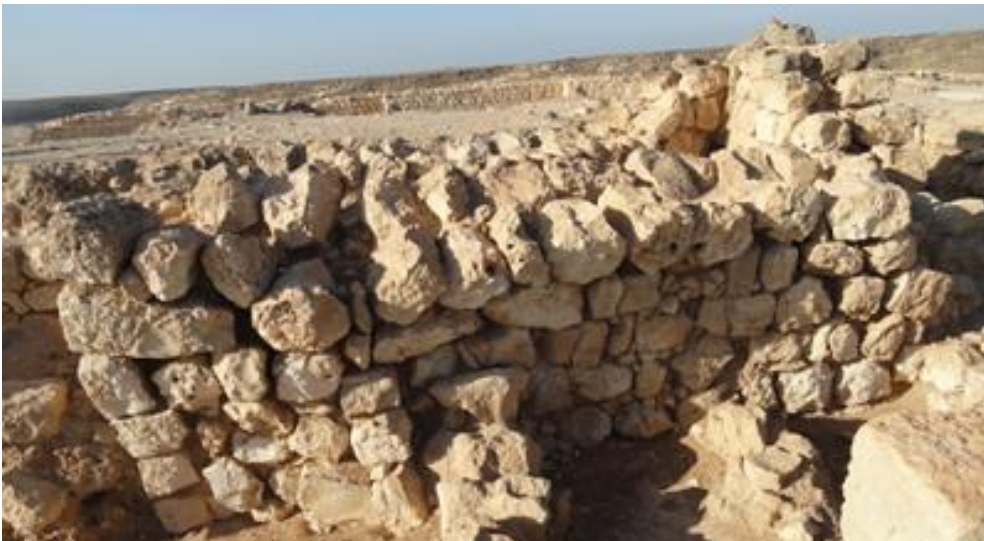
M567, south front wall, before the restoration.

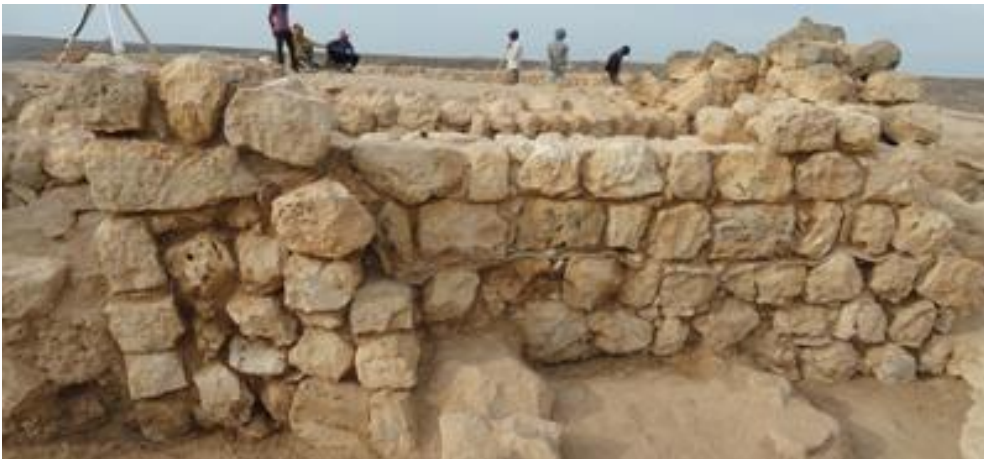
M567, south front wall, after the restoration.

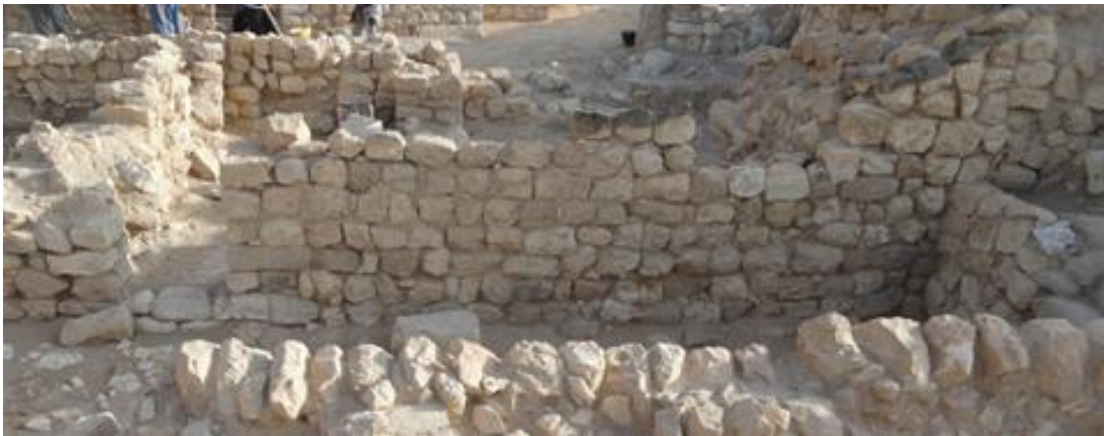
M581, south front wall, before the restoration.

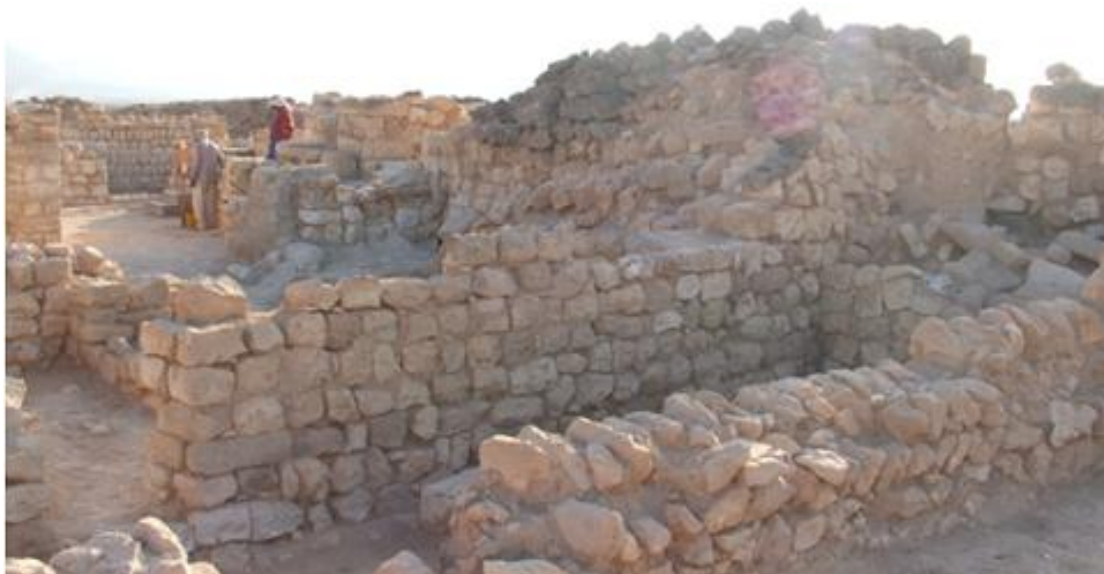
M581, south front wall, after the restoration.

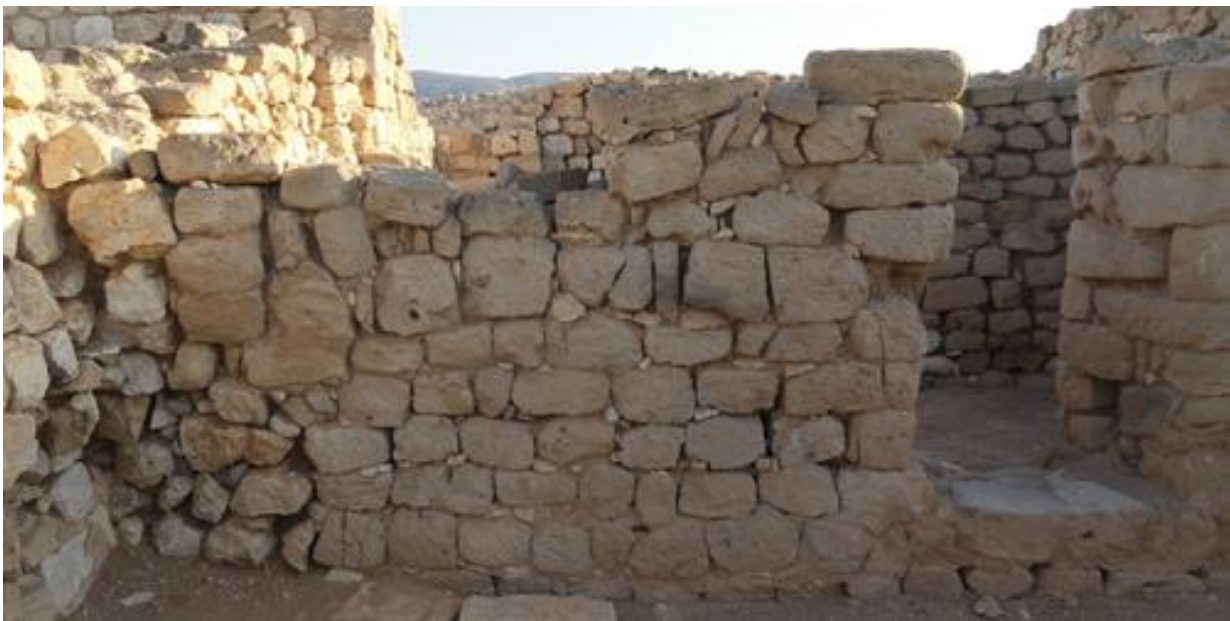
M70, south front wall, before the restoration.

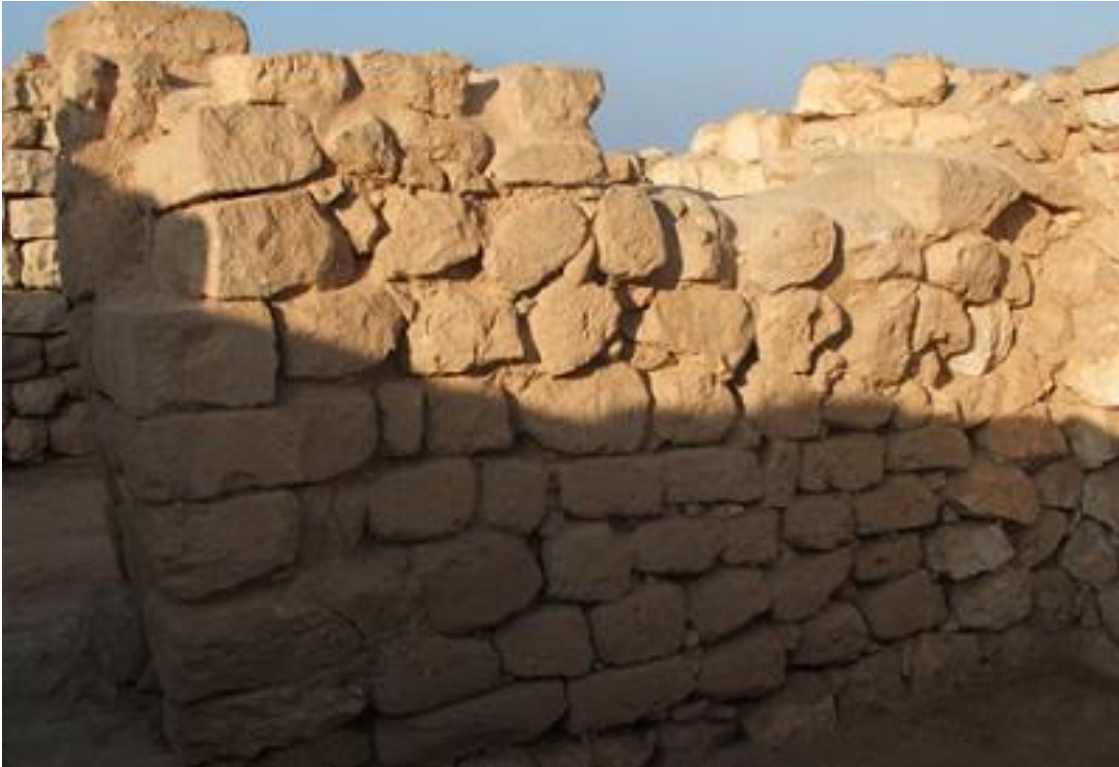
70, south front wall, after the restoration

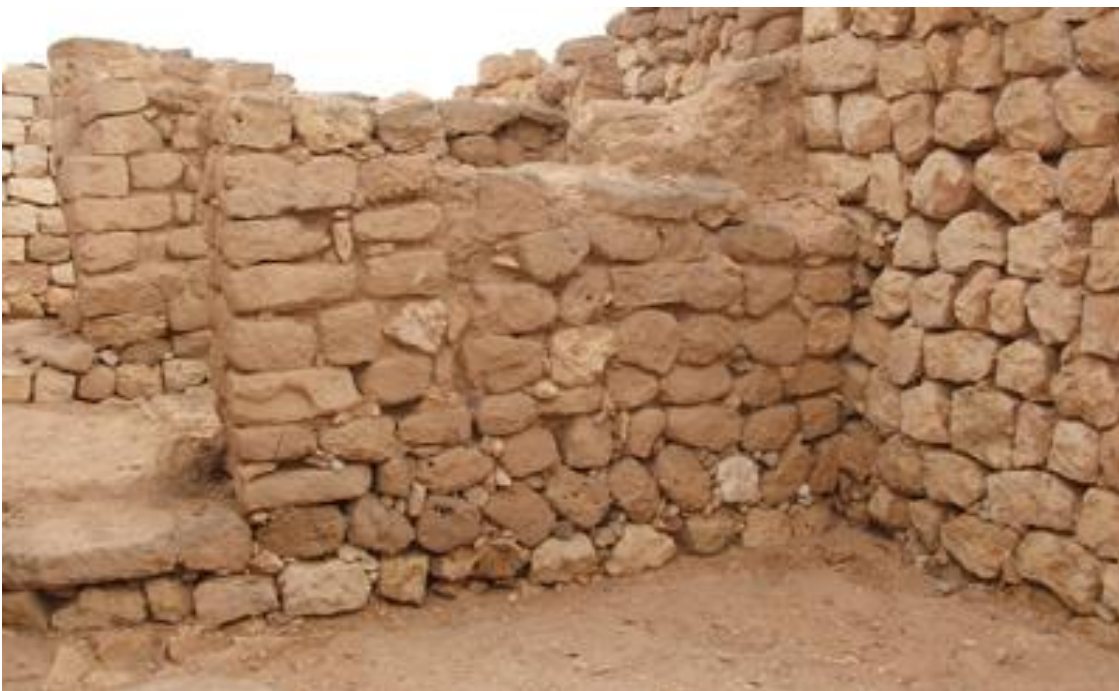
M77, north front wall, before the restoration.

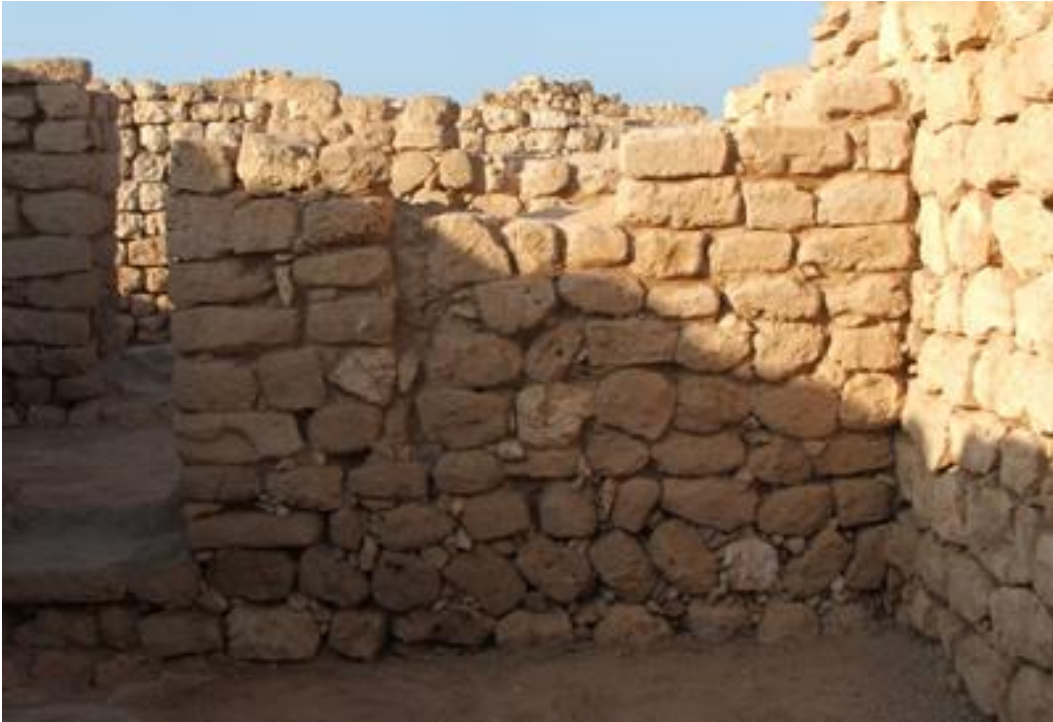
M77, north front wall, after the restoration.

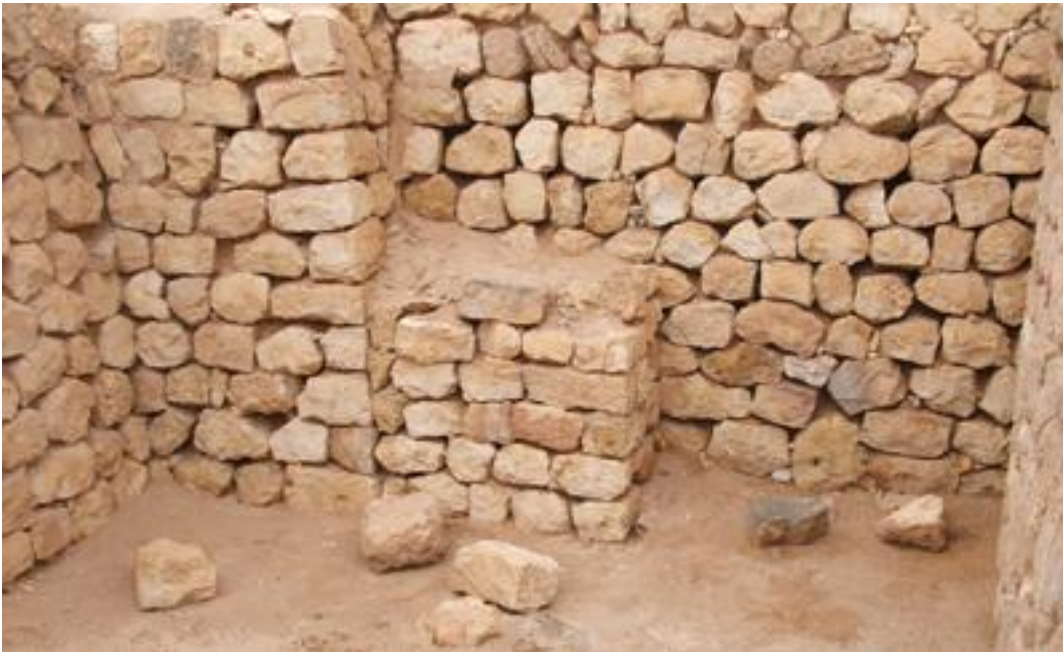
M69, south front wall, before the restoration.

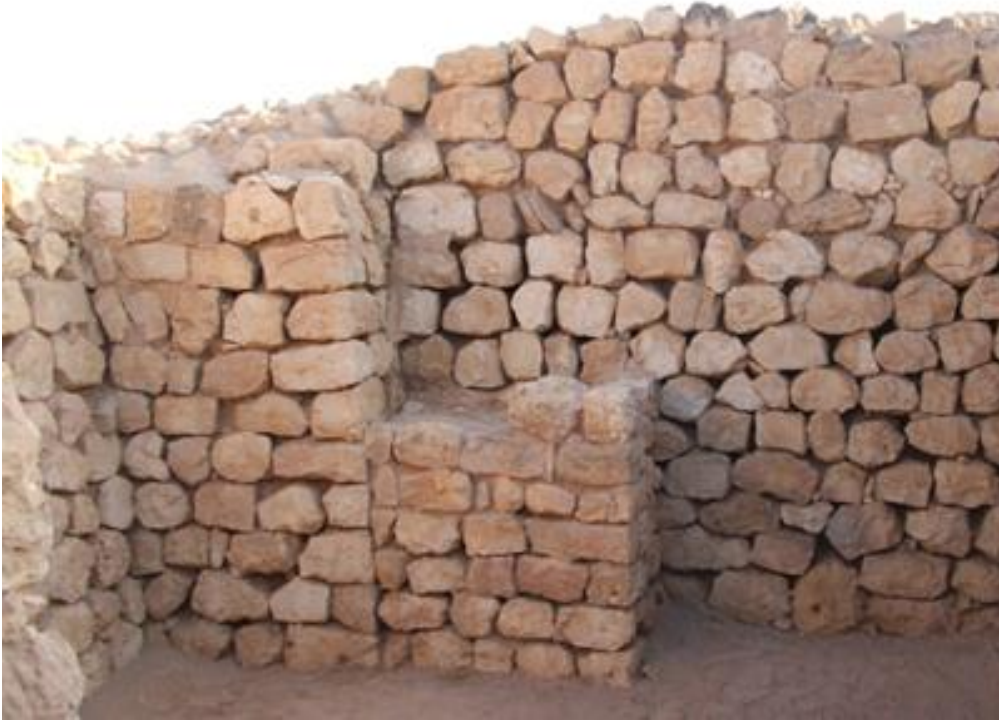
M69, south front wall, after the restoration.

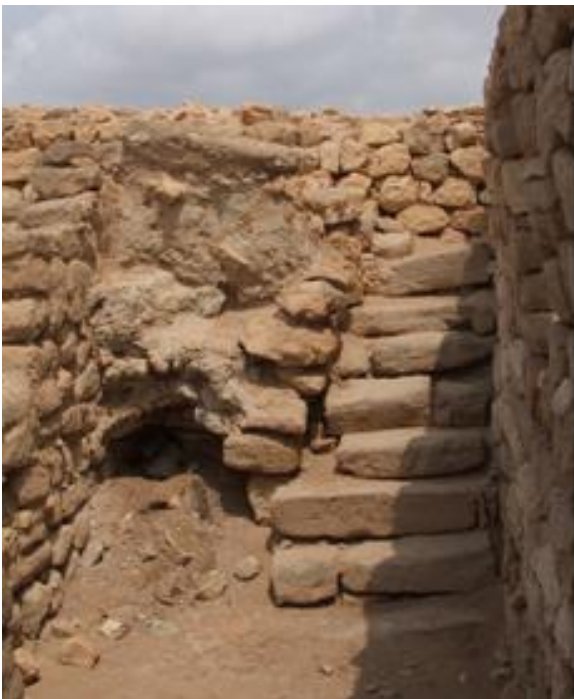
M63, south front wall, before the restoration.

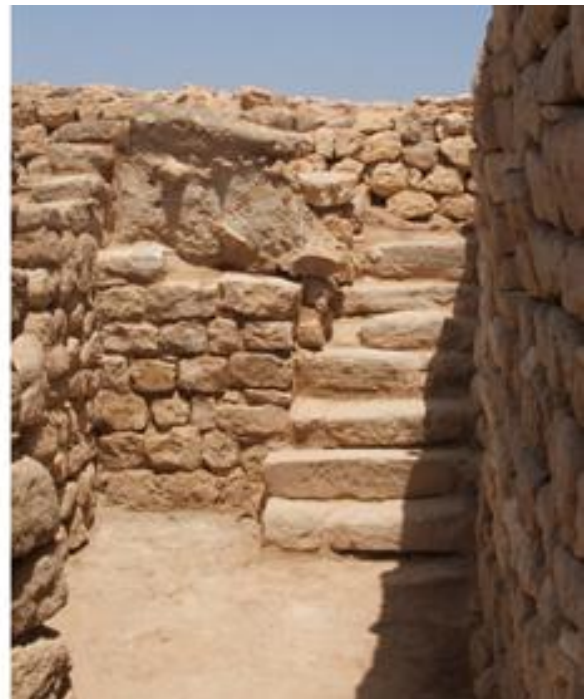
M63, south front wall, after the restoration

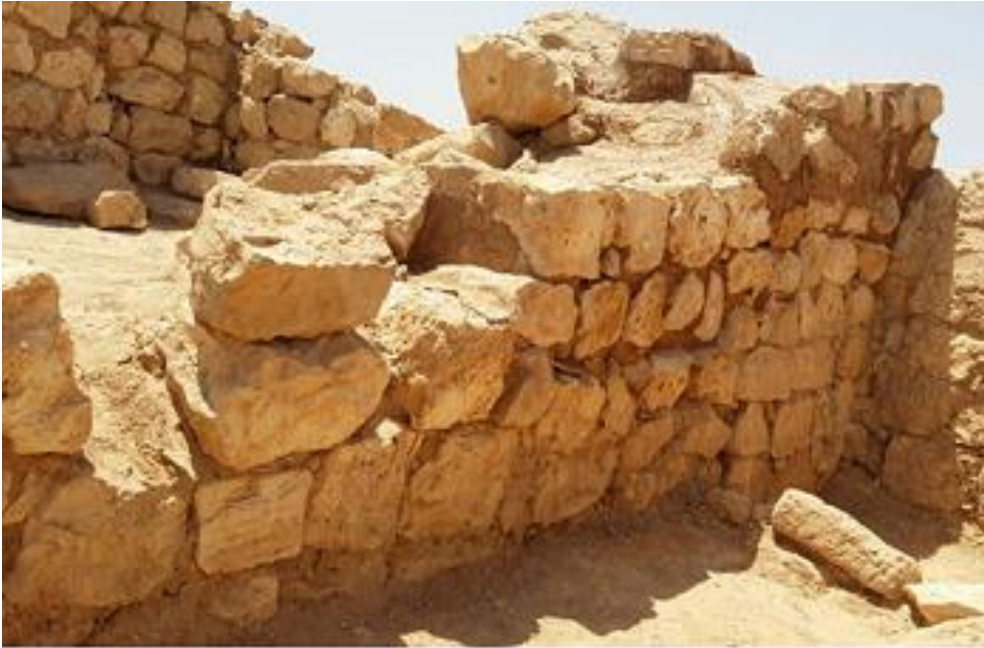
M529, north front wall after the restoration

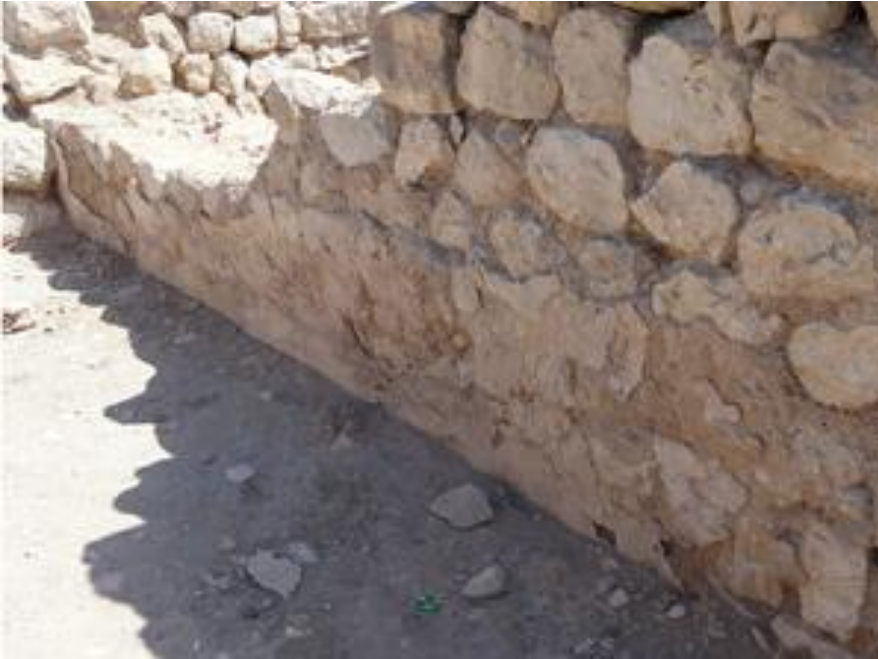
M494 (BA13), west wall, façade. before the restoration

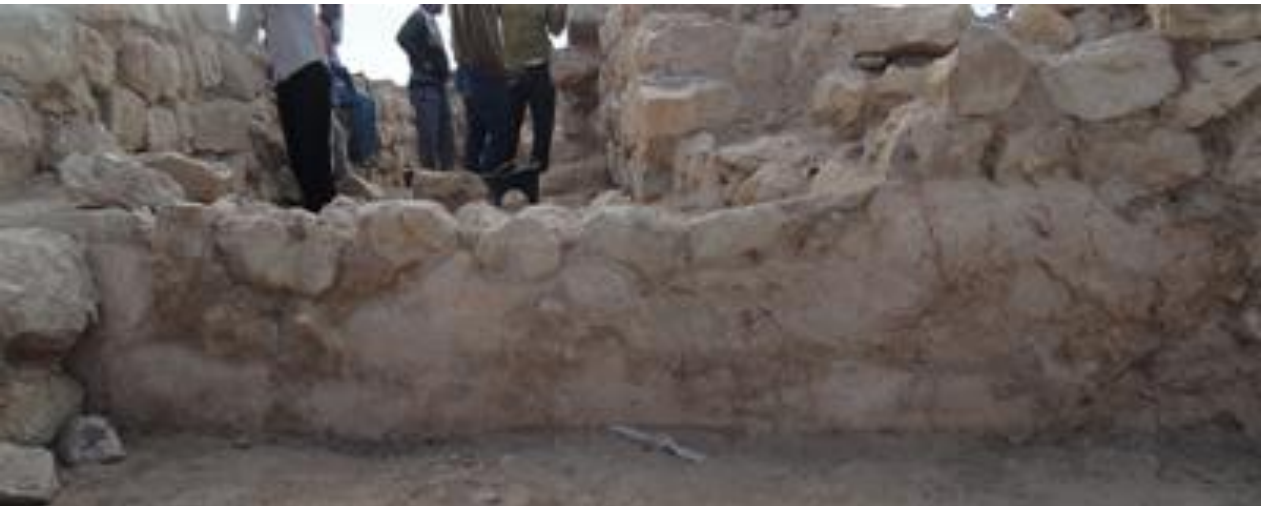
M494 (BA13), west wall, façade. before the restoration

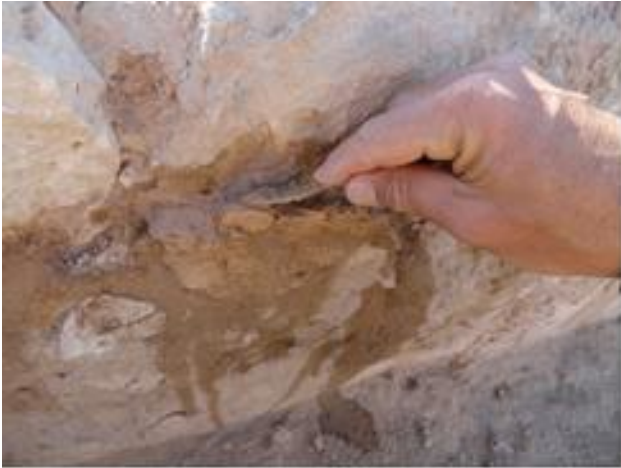
Laying of new plaster

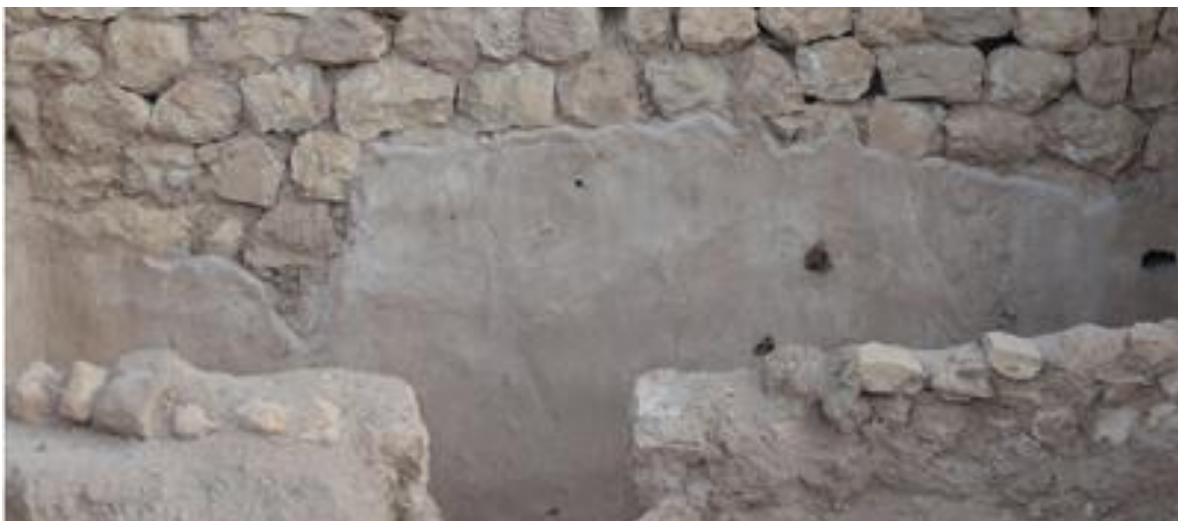
M17 (A121), south wall, façade. after the restoration

Restoration of the plaster wall M17

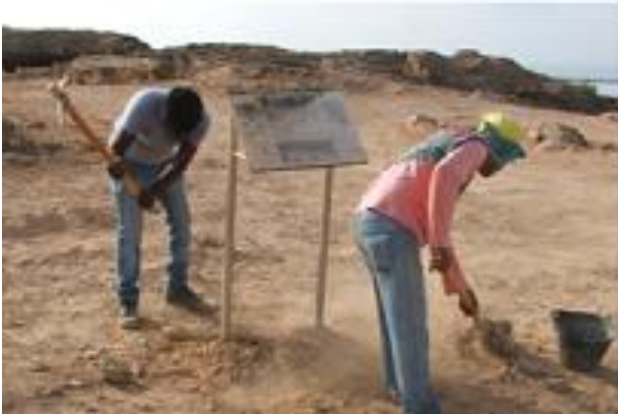
Removing the existing panel

It has been decided to change three panels and their support in the archaeological park, out of the city wall, and exactly in the site of necropolis, the houses near the gallery, and for the wall of Inqitat.

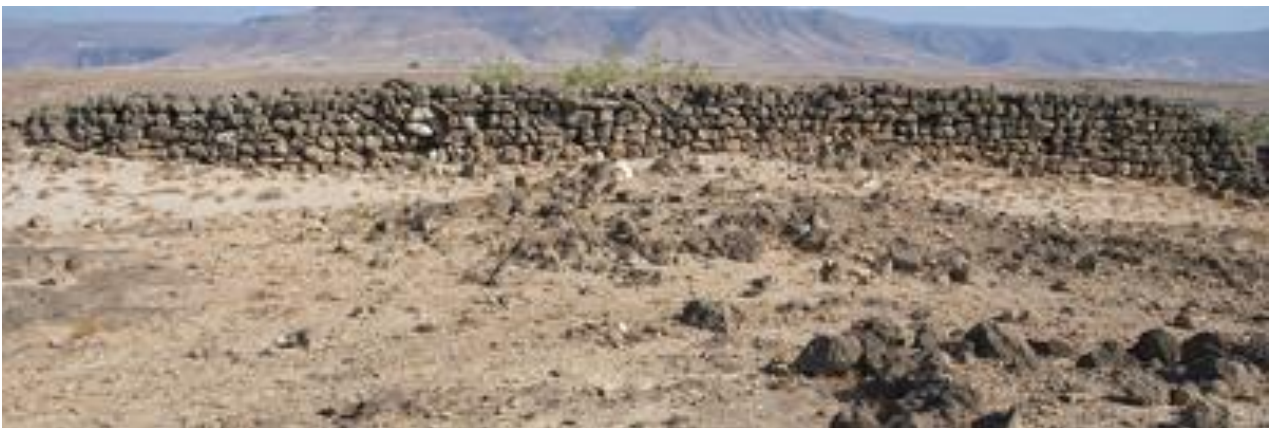
East wall in good condition

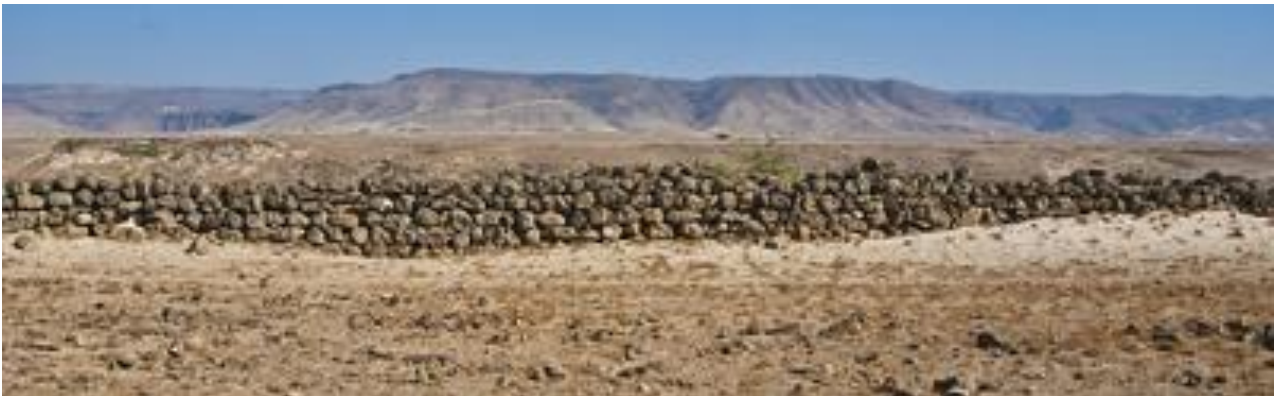
West wall in good condition

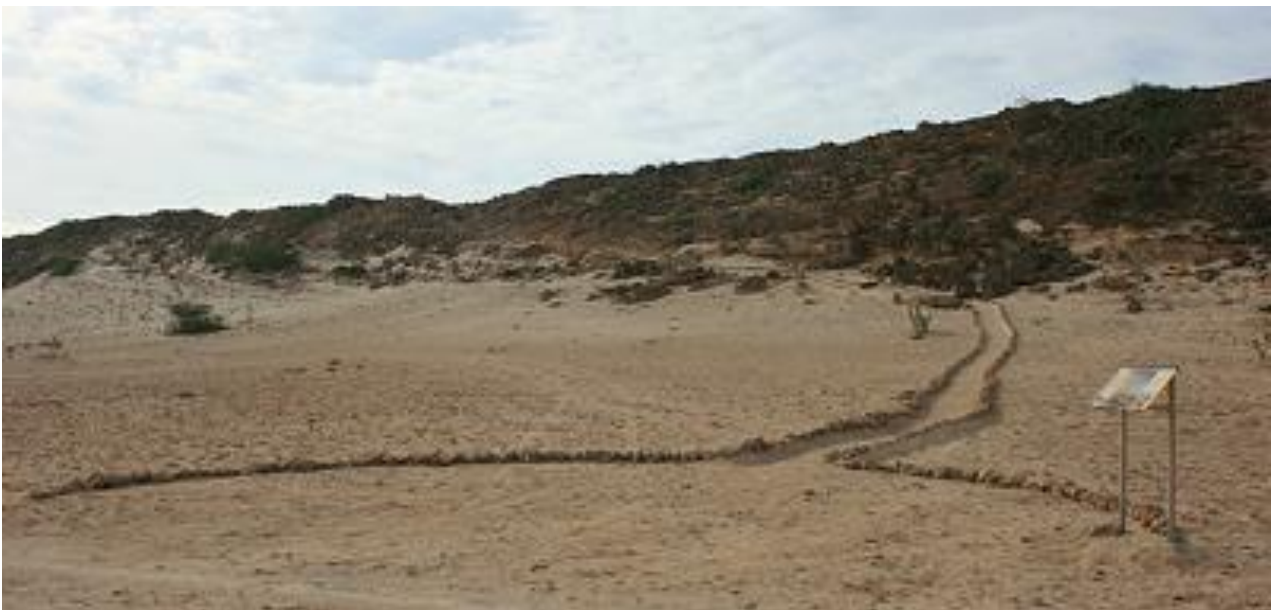
Street after zone 1

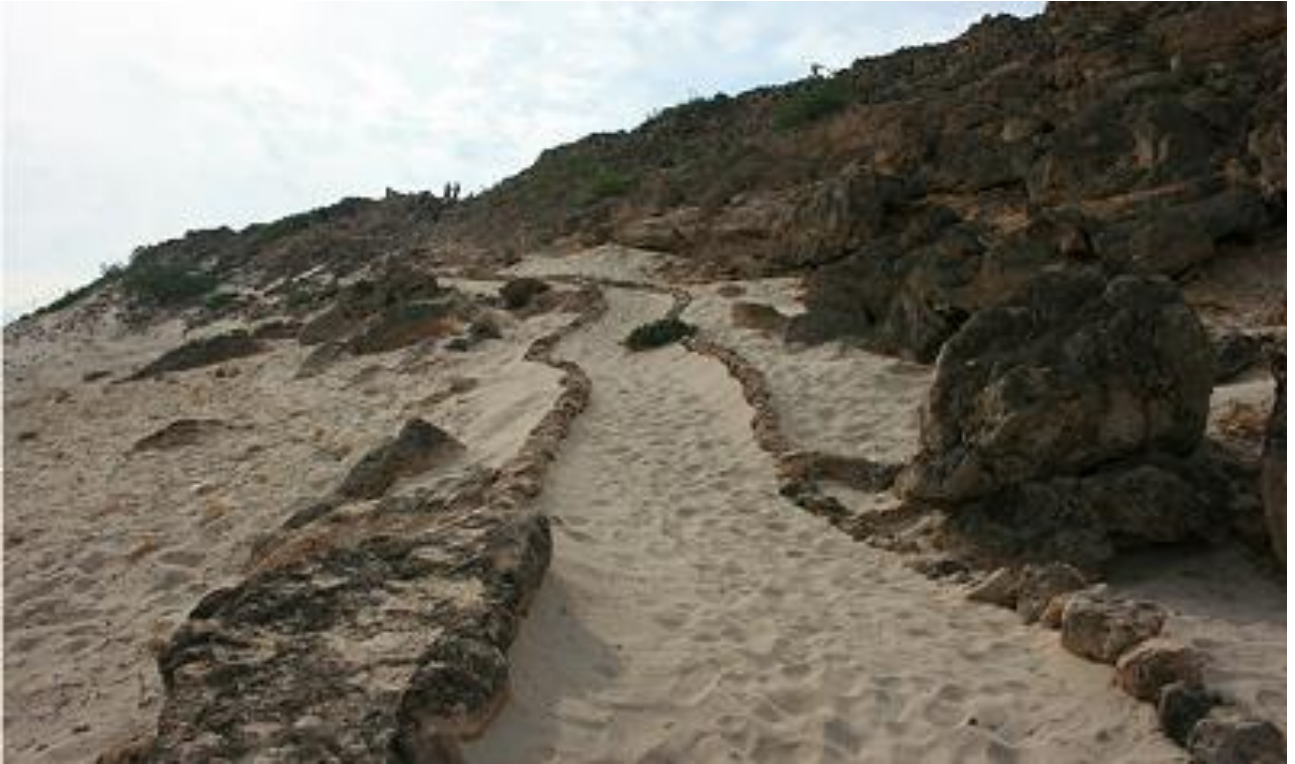
Street after zone 2

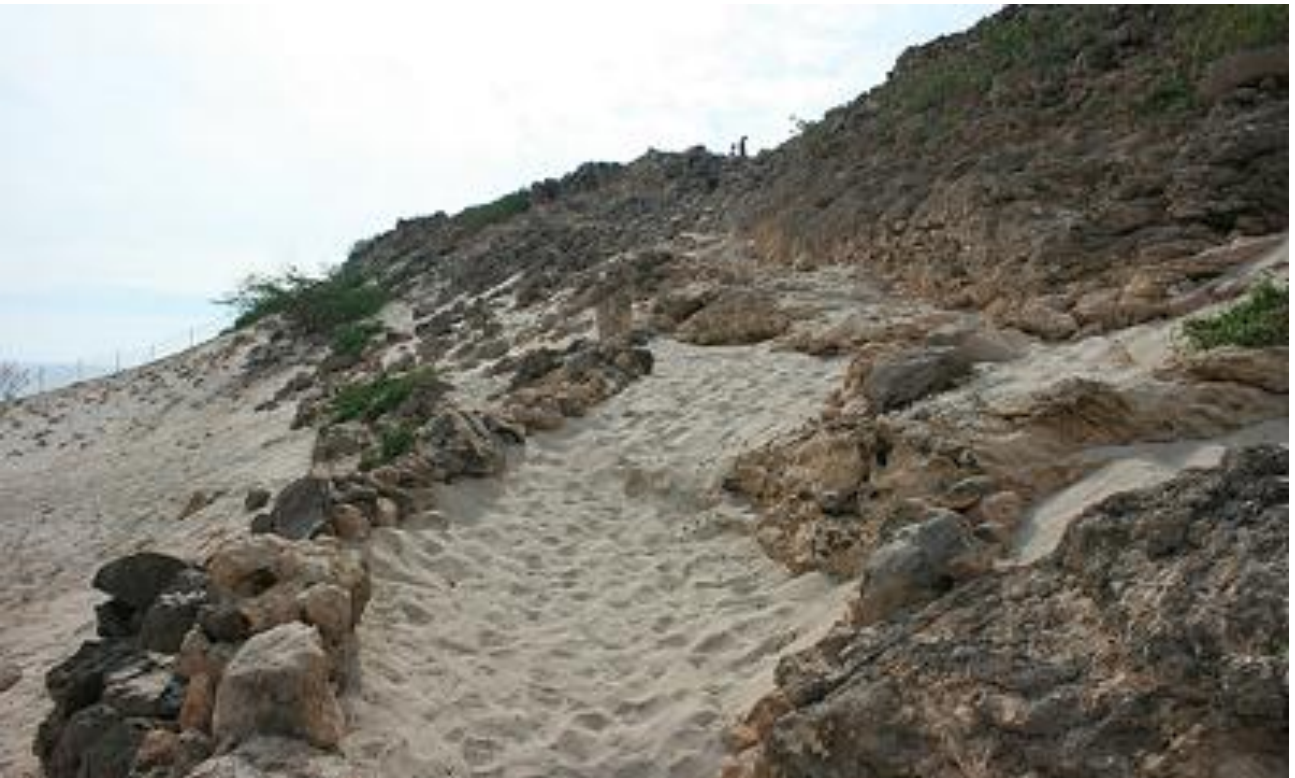
Street after zone 3

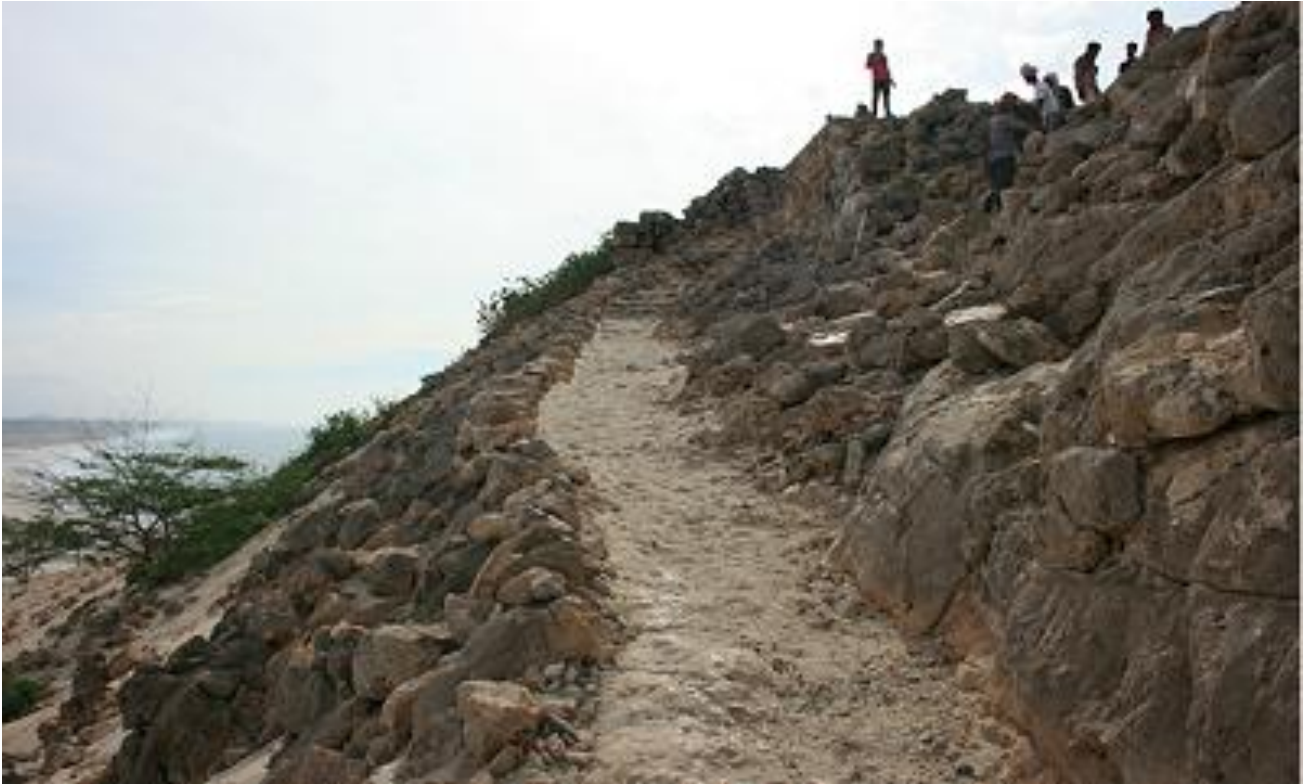
Street after zone 4

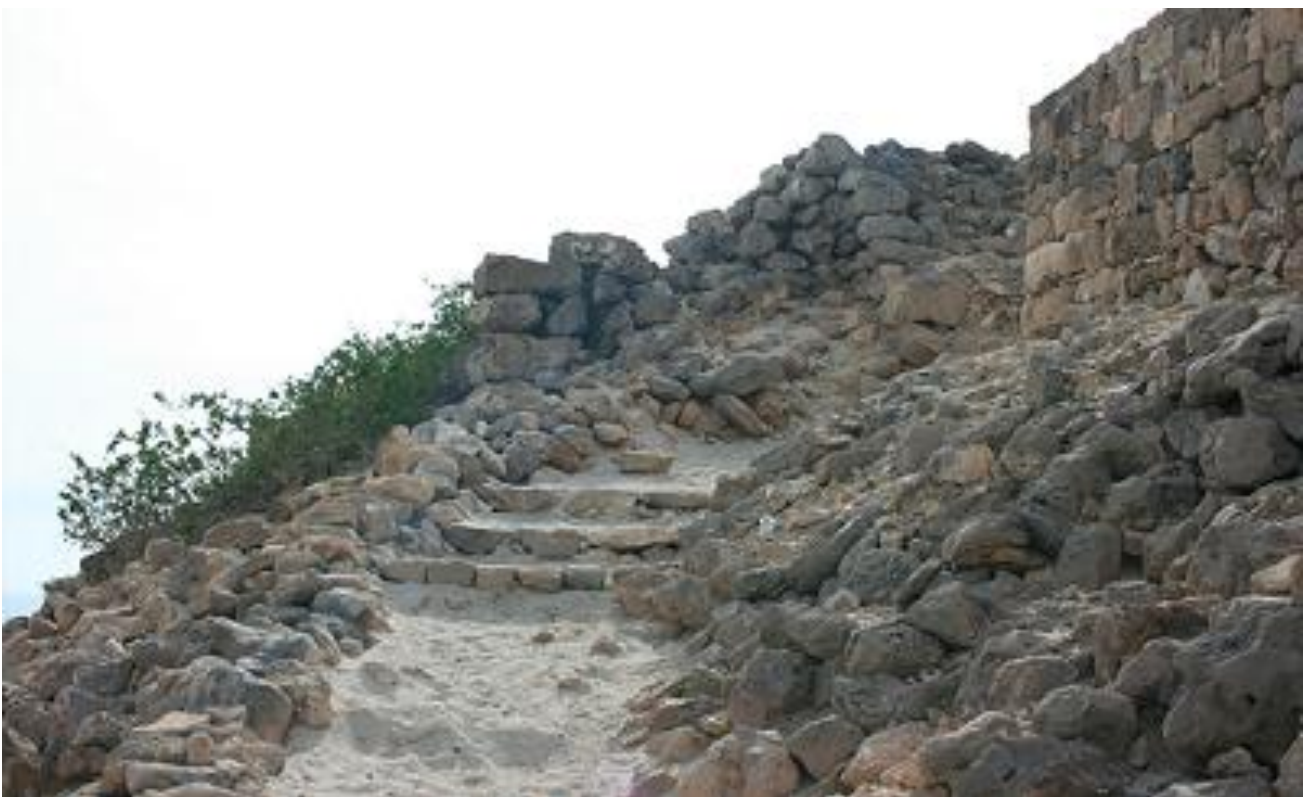
Street after zone 5

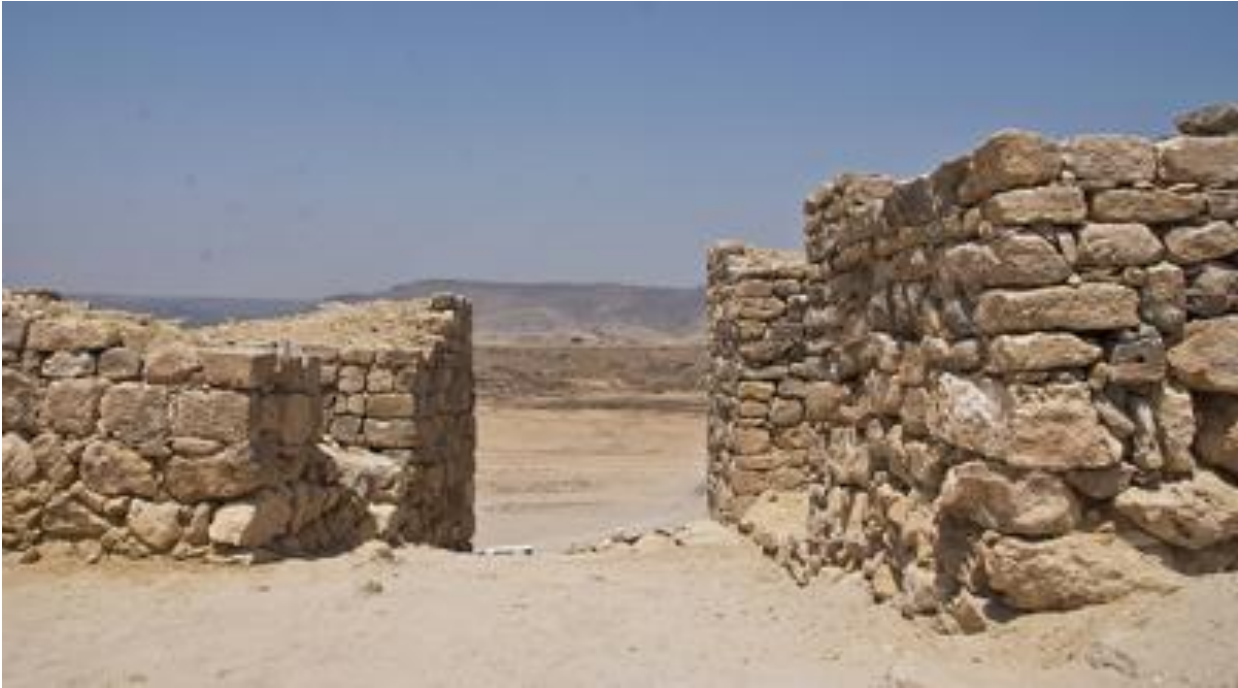
Principal door south side after restoration
