**RESTORATION WORKS AT SUMHURAM
(ARCHAEOLOGICAL PARK OF KHOR RORI)
(Sultanate of Oman)
CAMPAIGN February-March 2016**

**Technical Report
06th February – 24th March 2016**

RESTORATION WORKS AT HAMR AL-SHARQIYA

Technical Report
06th February – 24th March 2016

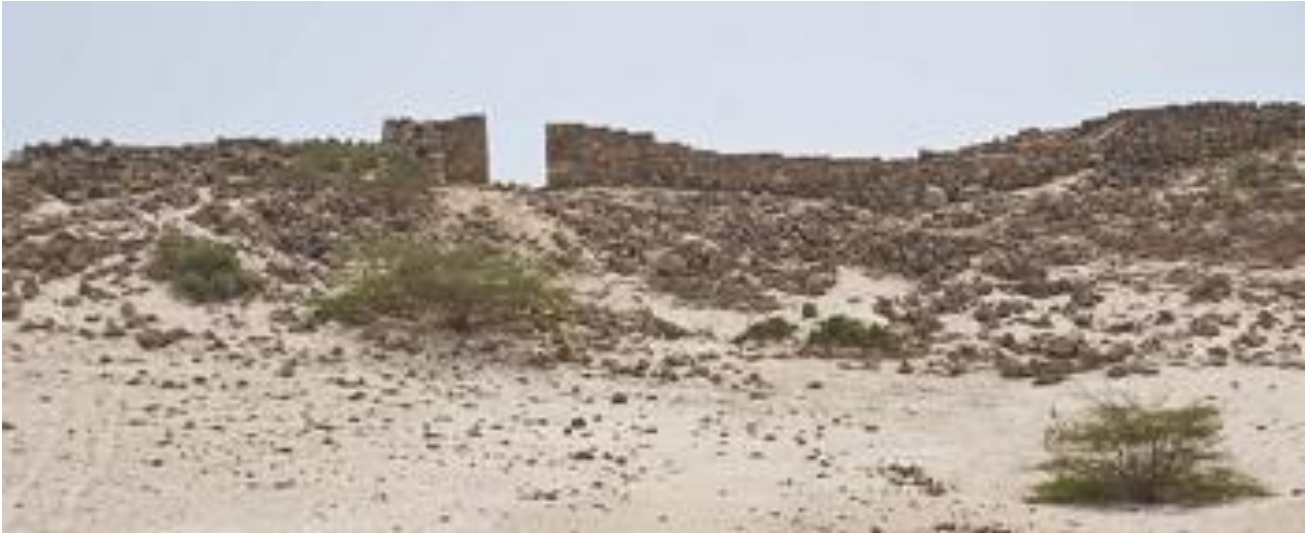
View on the down street after restoration

The restoration of the tower was carried out using the technique of dry wall , with a filling of different grain of stones and ground.

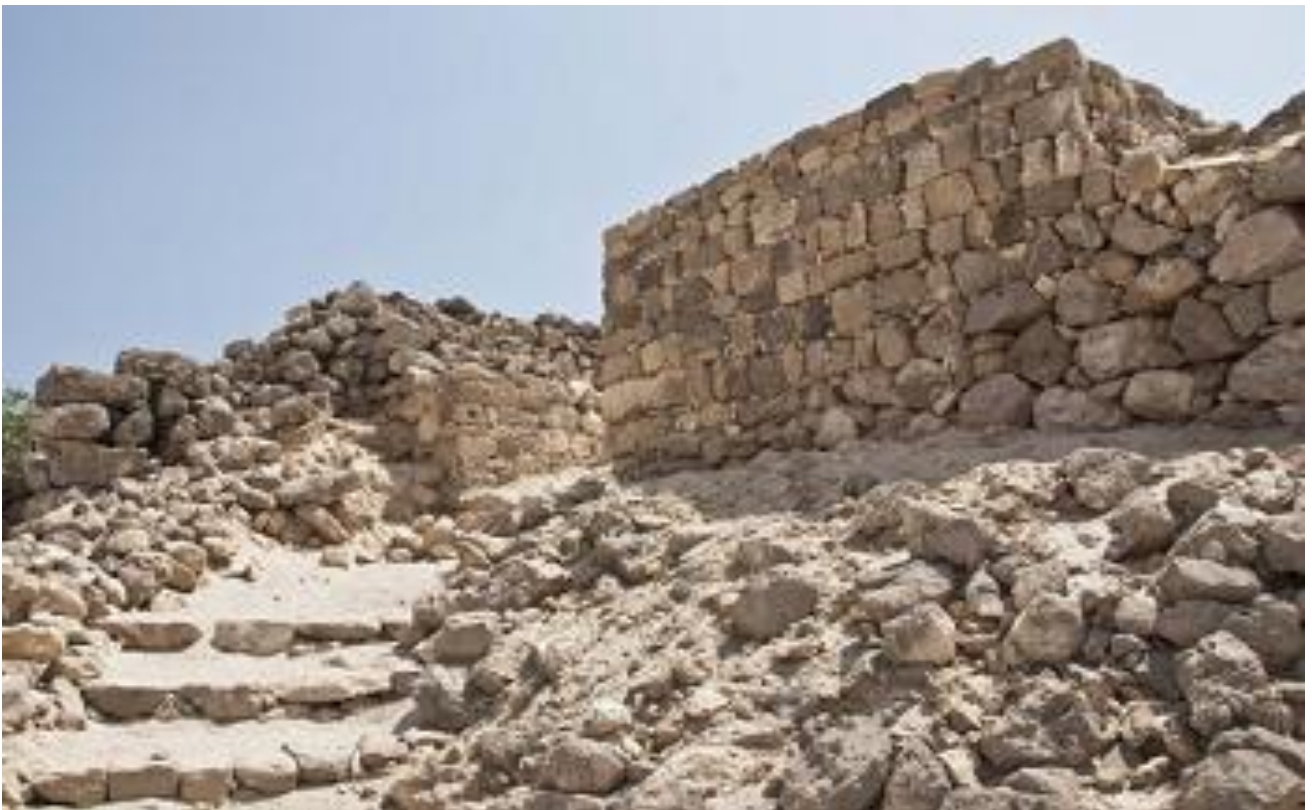
View on the up street before restoration

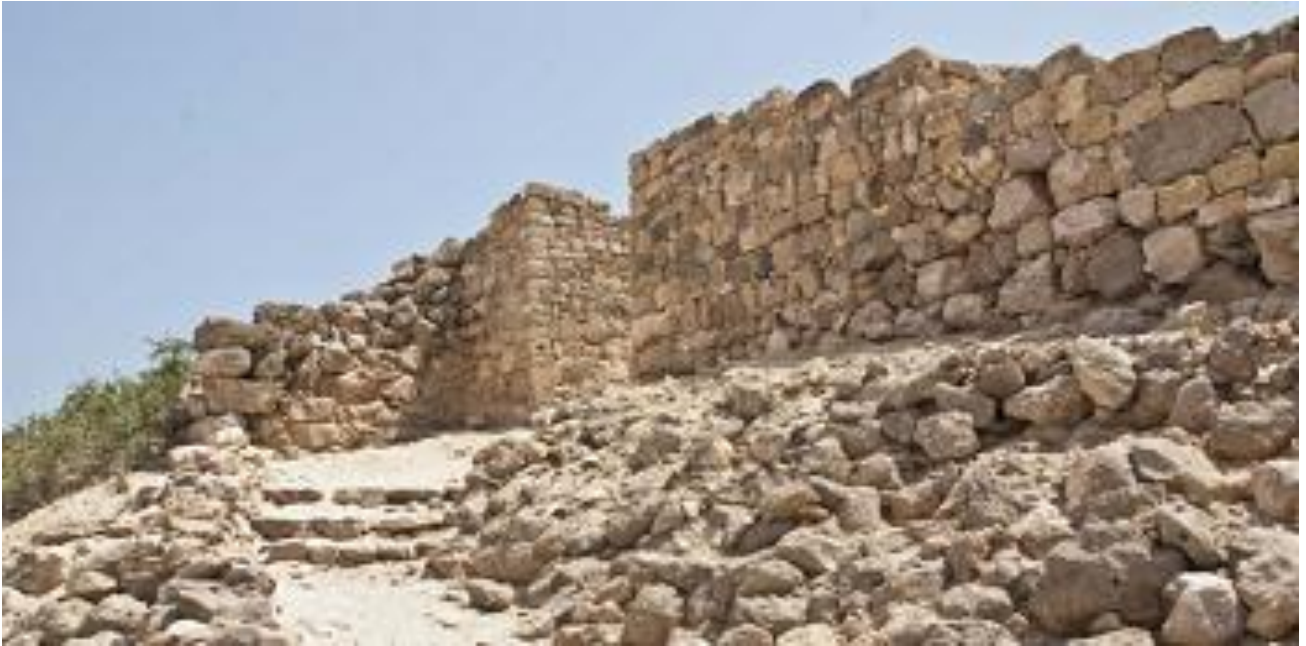
View on the up street after restoration

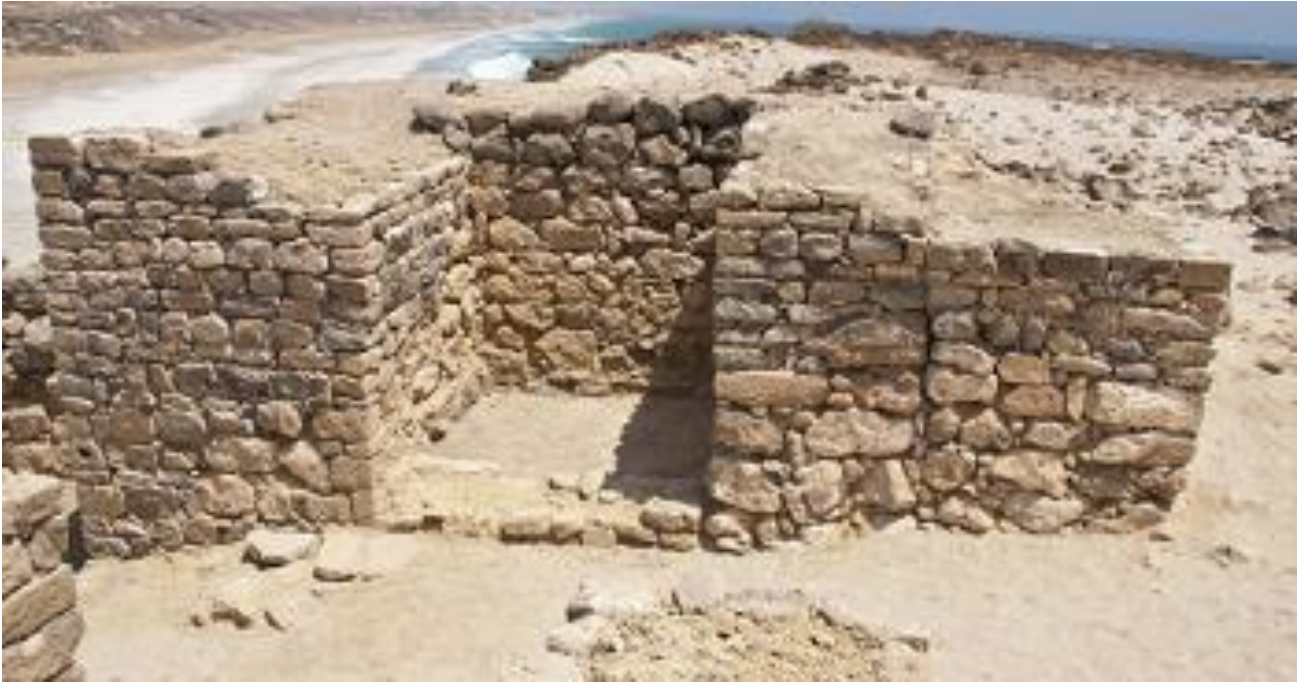
View east side after restoration

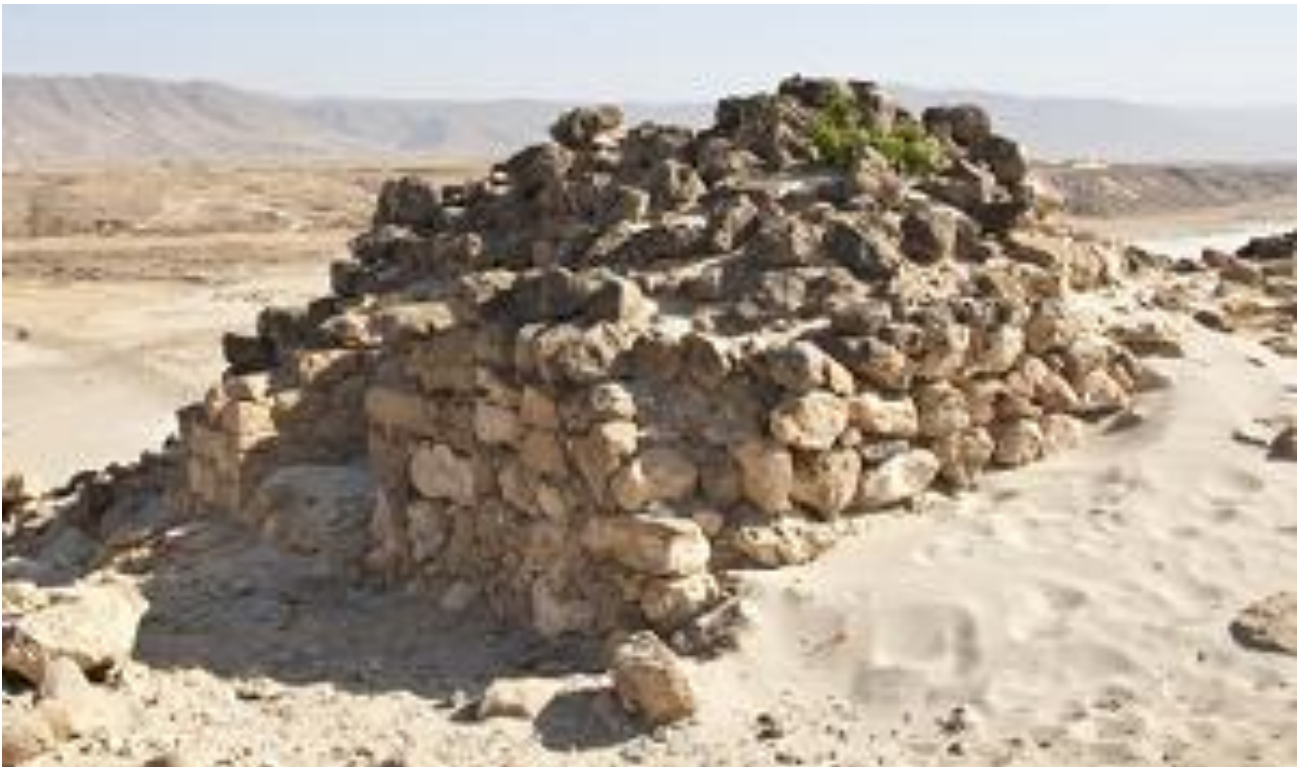
View east-south side before restoration

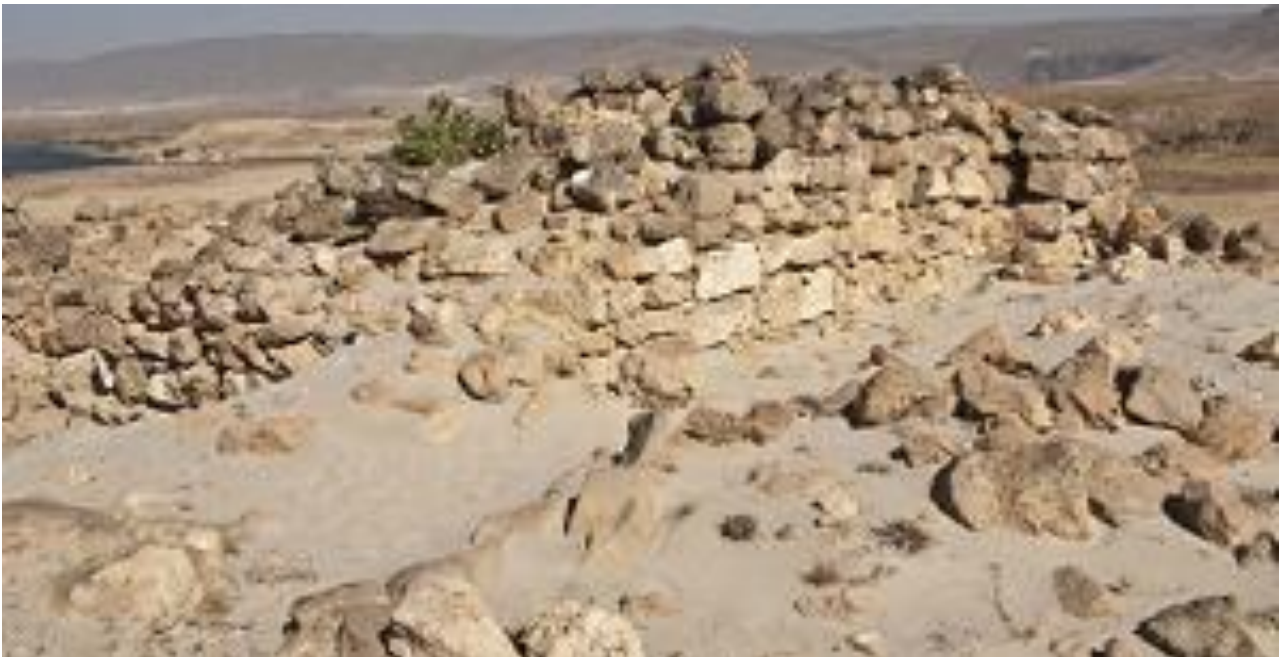
View south-west side before restoration

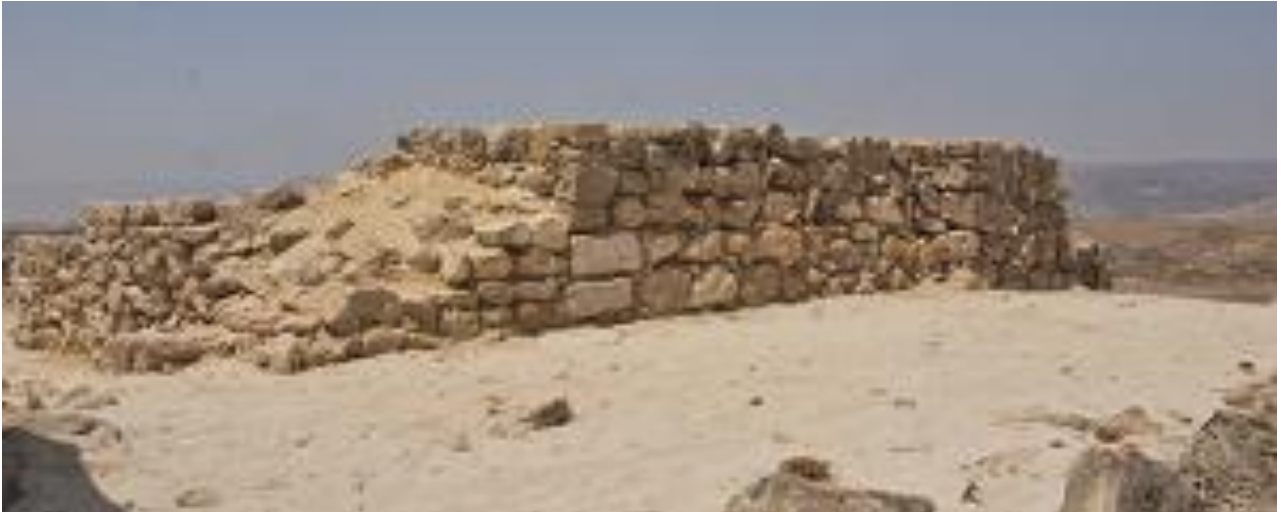
View south-west side after restoration

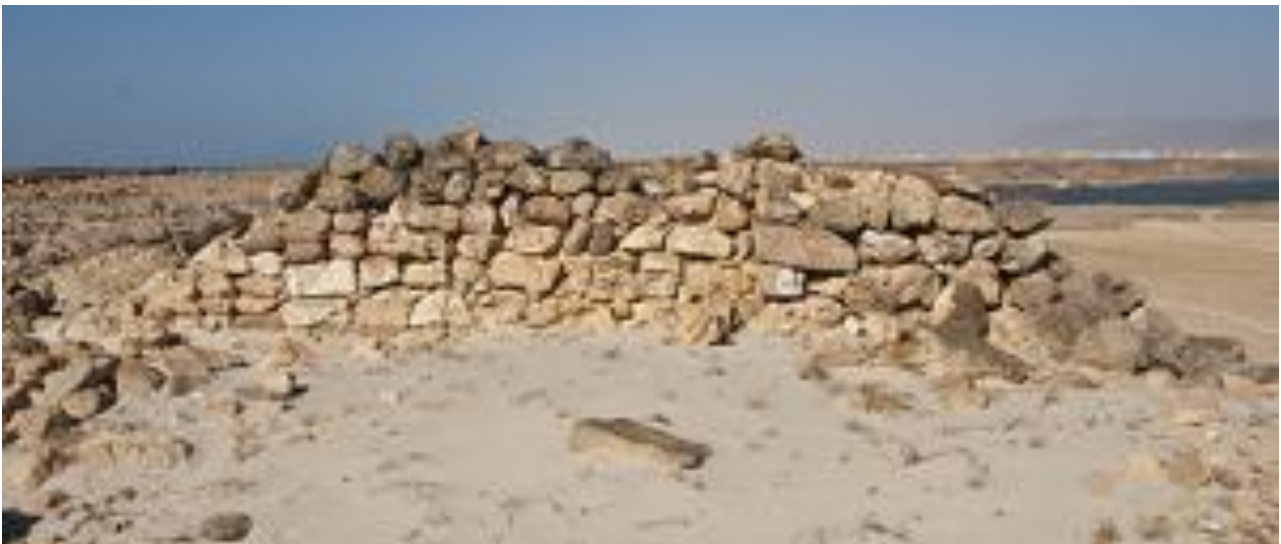
View west side before restoration

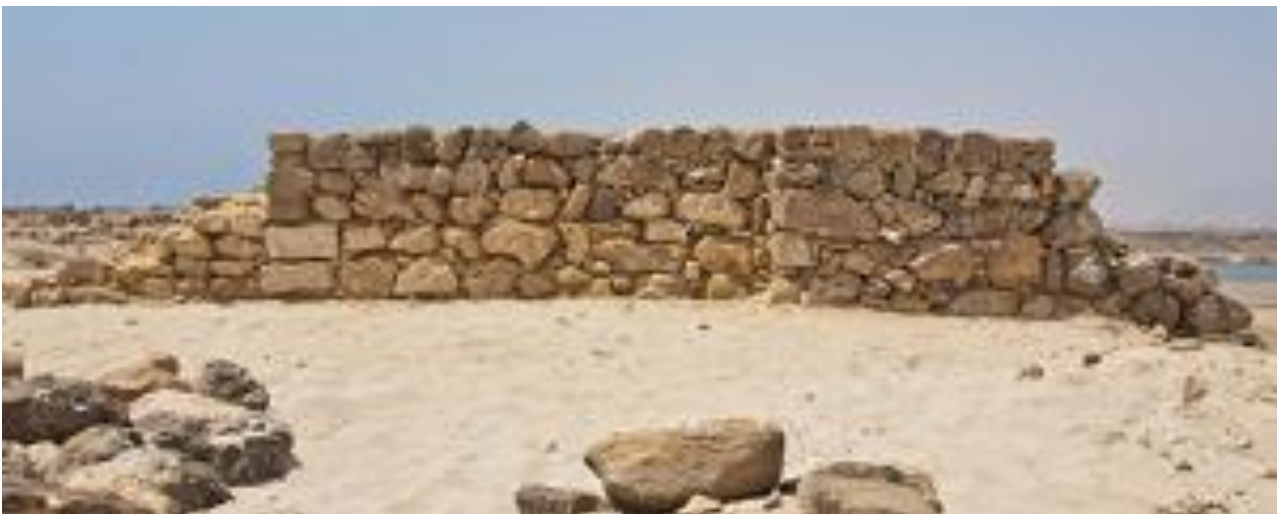
View west side after restoration

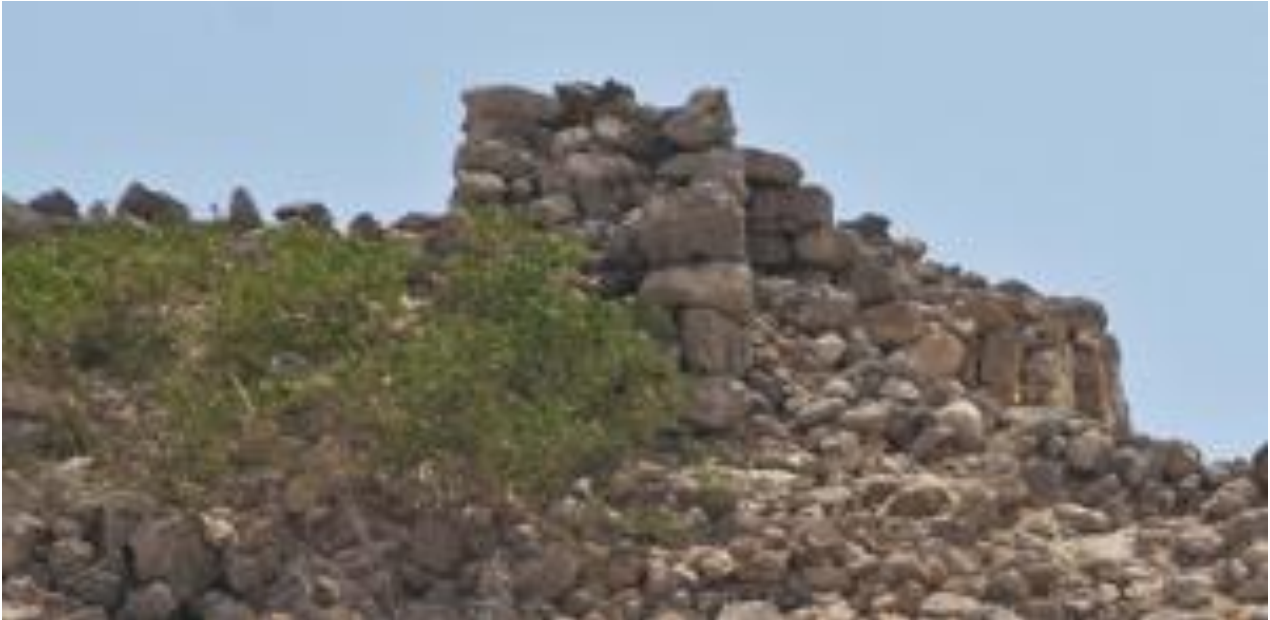
View north side before restoration

In the last job I worked to consolidate the beginning of the east wall.
This consolidation will serve for the continuation the restoration of walls in future missions .

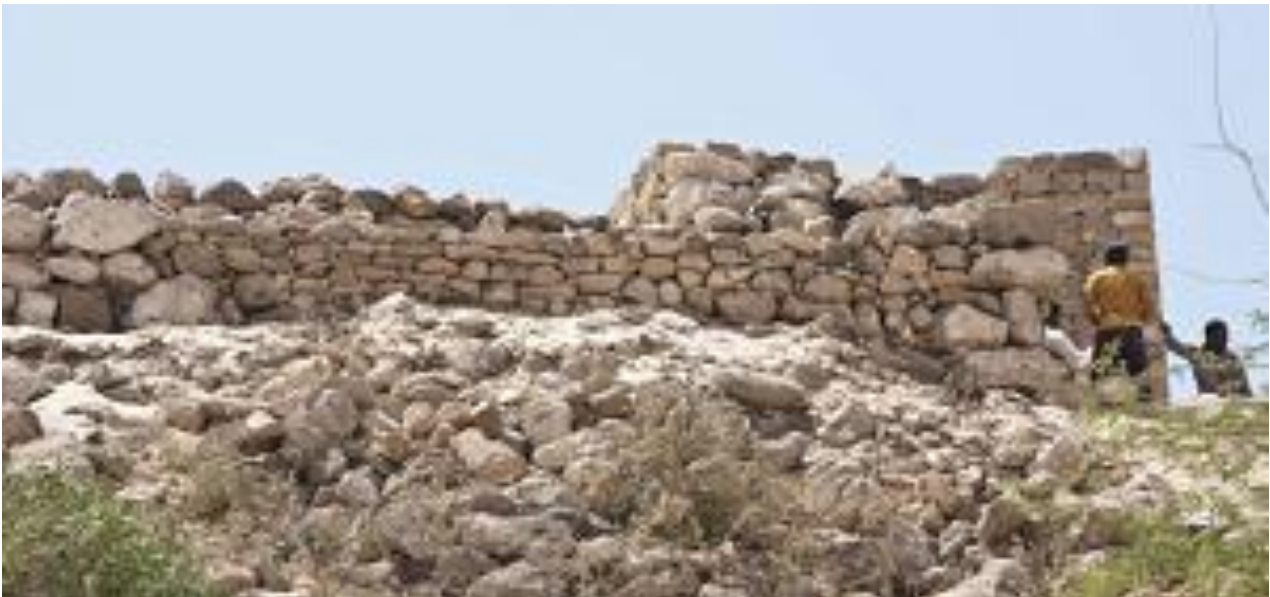
View north side after restoration

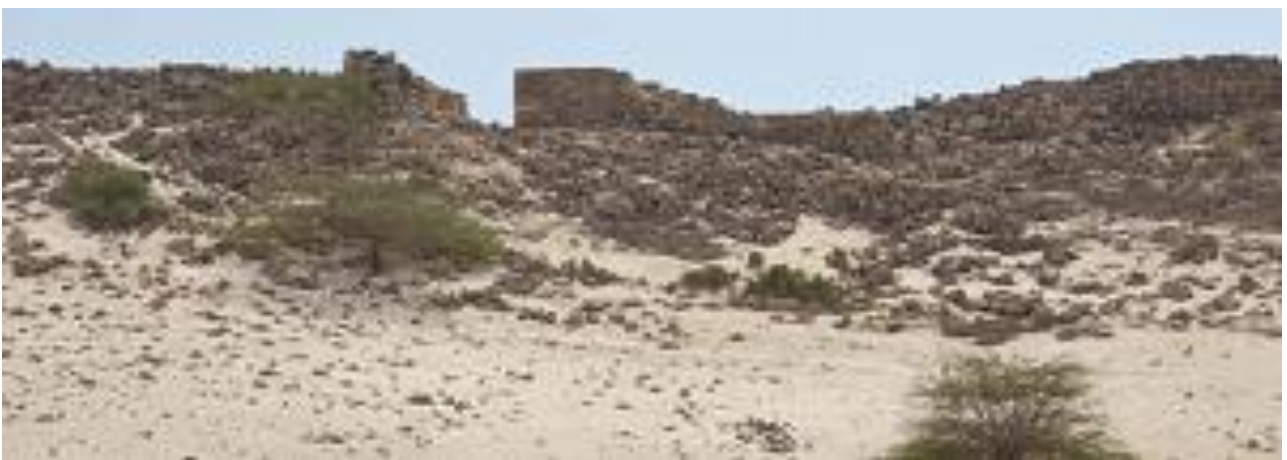
View on the down street after restoration

The restoration of the tower was carried out using the technique of dry wall , with a filling of different grain of stones and ground.

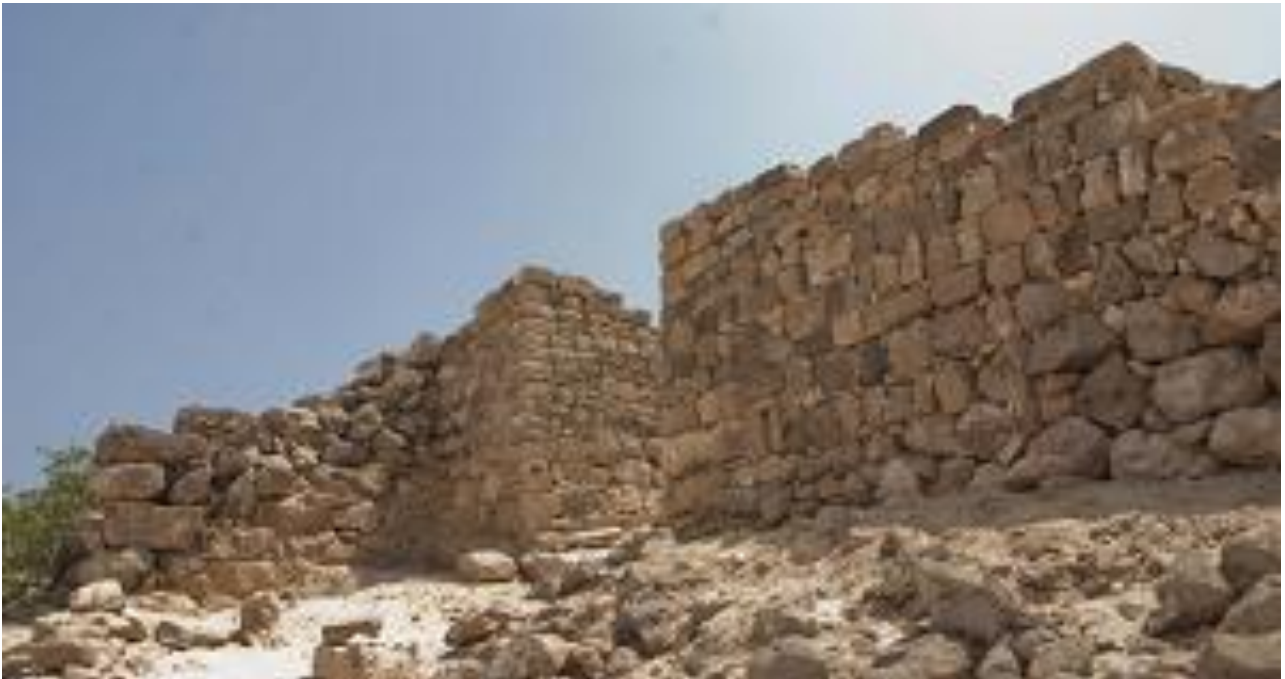
View on the up street after restoration

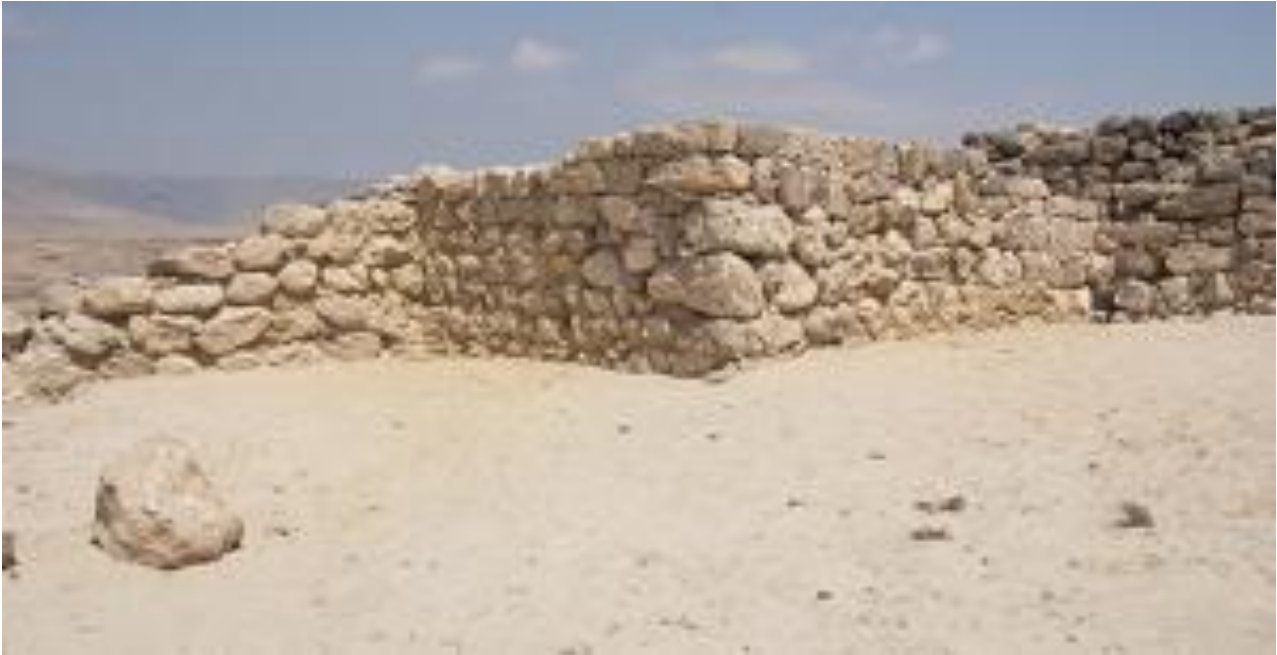
South - East side after restoration

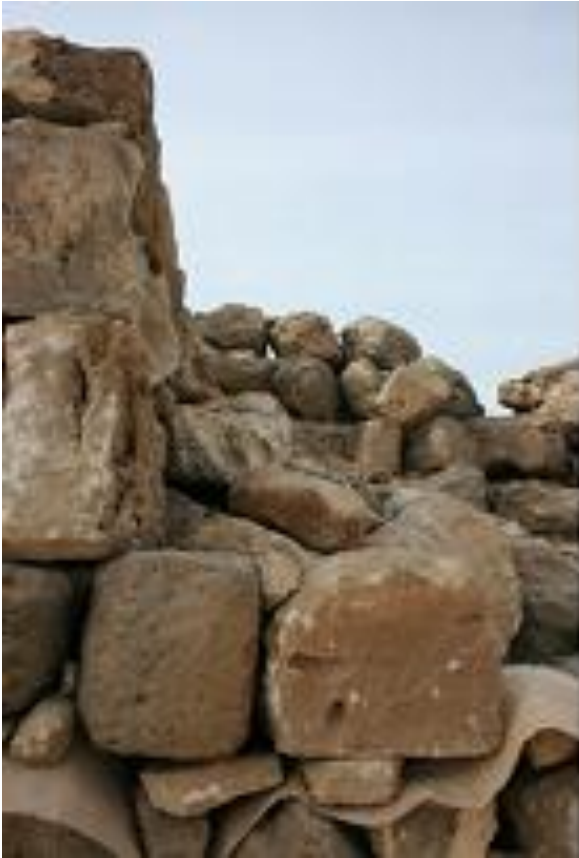
North face, connection with west tower

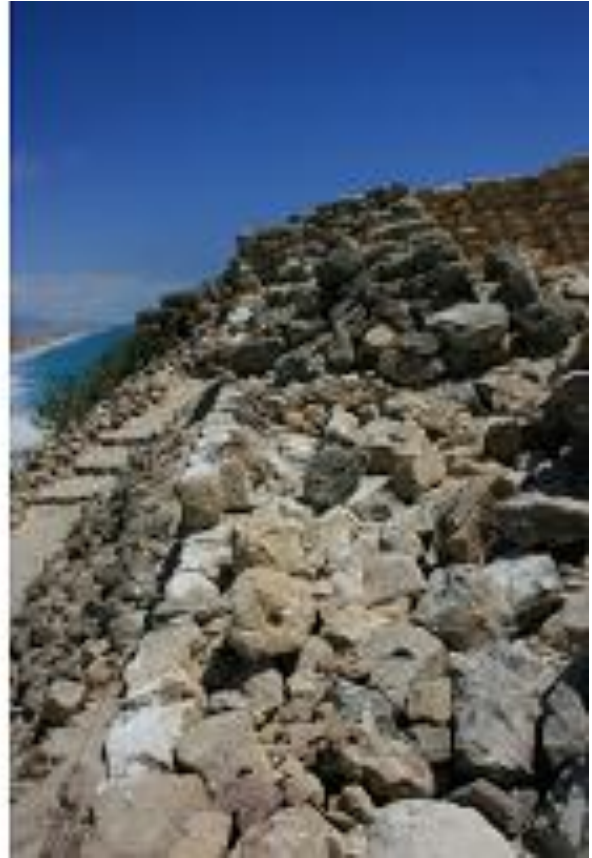
Construction of regular rows

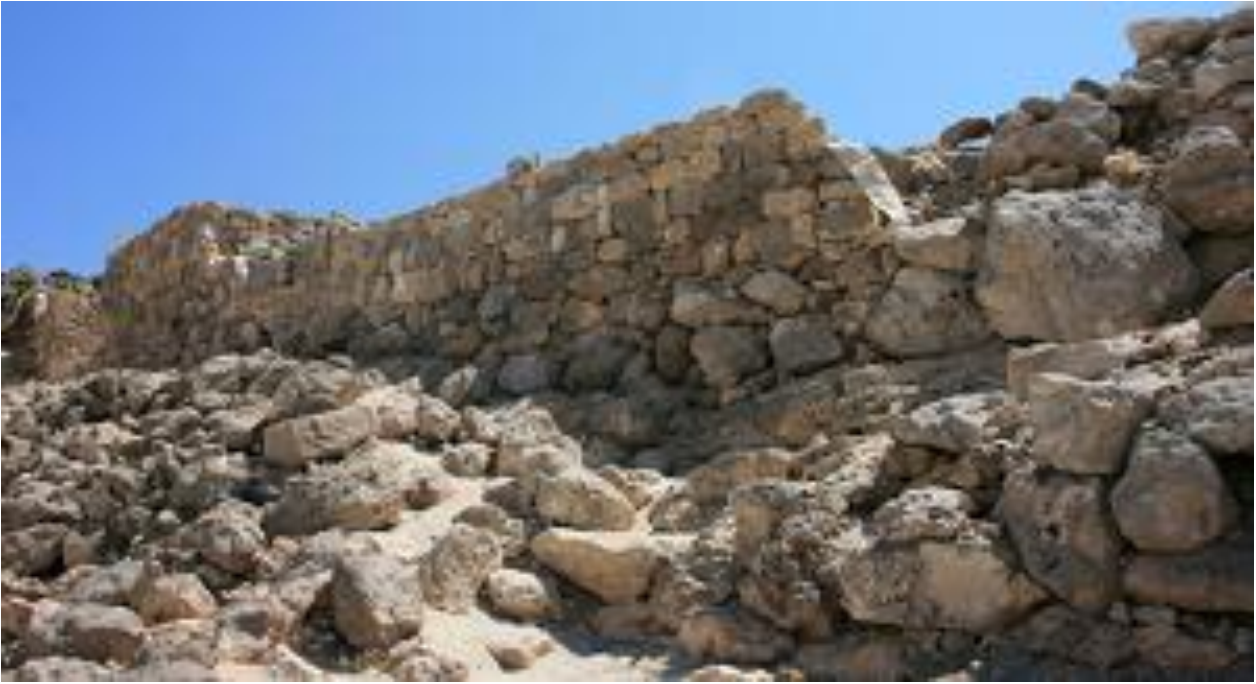
Northern face during restoration

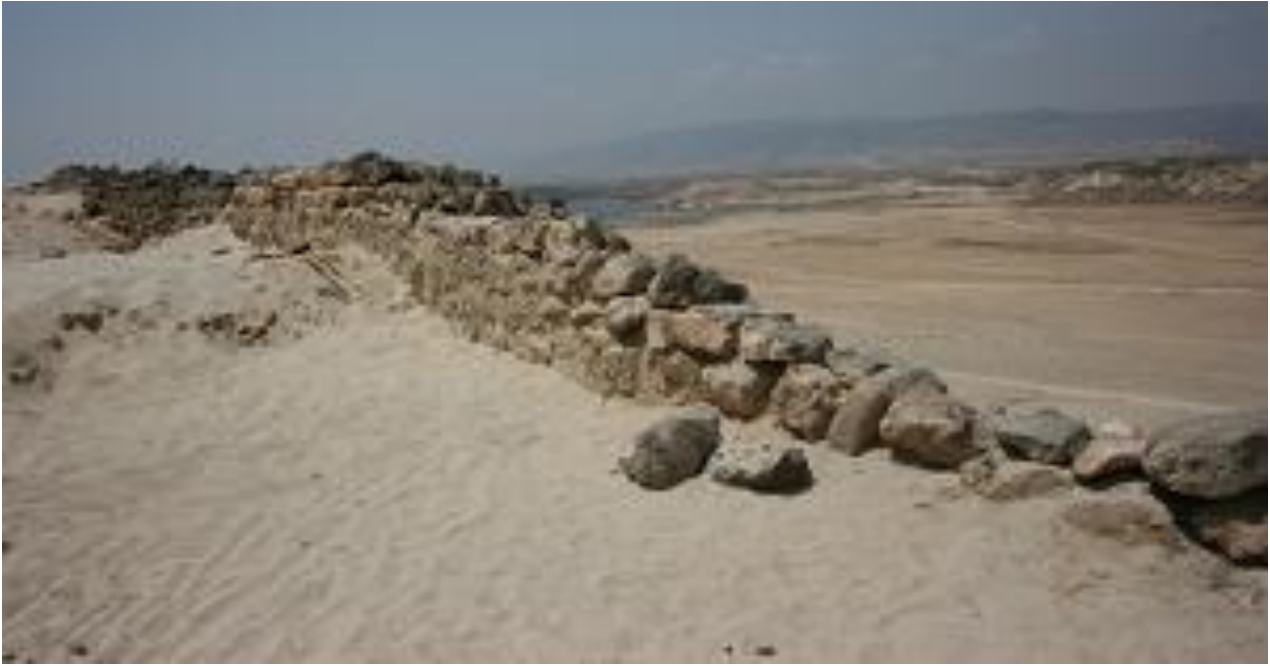
Cleaning of the southern face

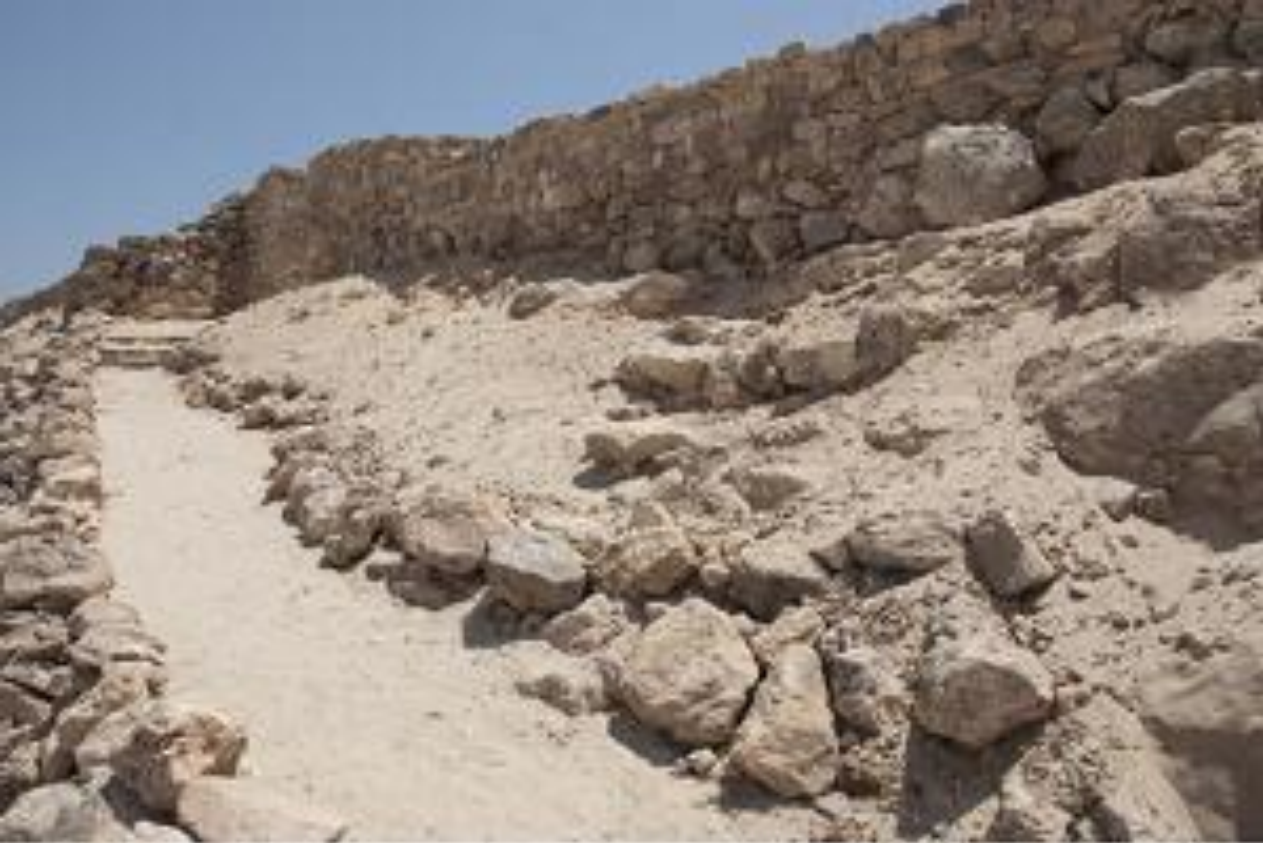
Project area after cleaning north side

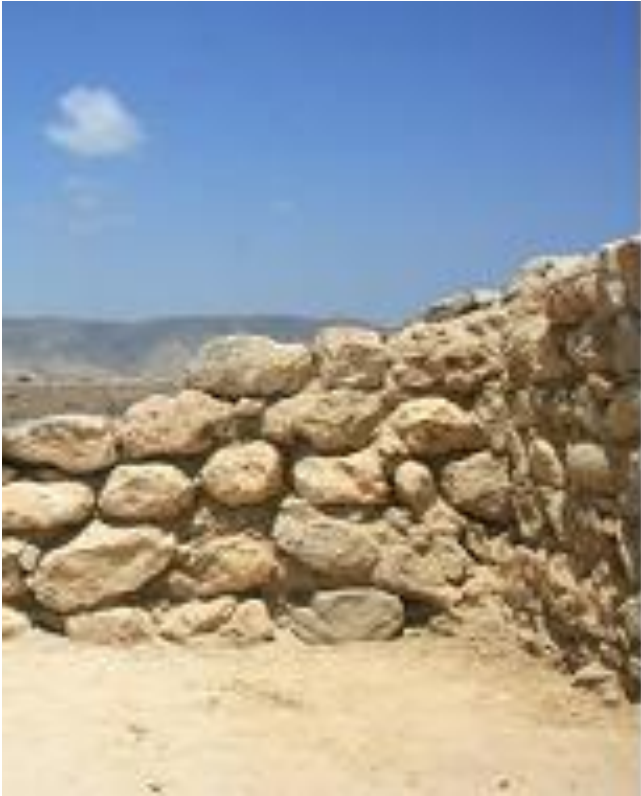
West wall and towers from South-West

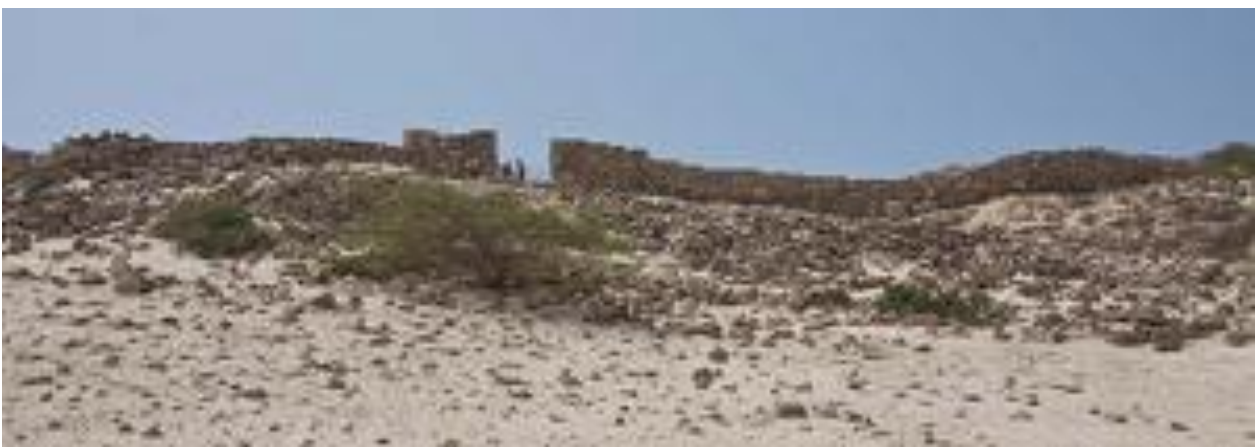
South Side
