**RESTORATION WORKS AT SUMHURAM  
(ARCHAEOLOGICAL PARK OF KHOR RORI)  
(Sultanate of Oman)  
CAMPAIGN October-December 2017**

**Technical Report**  
**16<sup>th</sup> October – 14<sup>th</sup> December 2017**

**Michele Chimienti – Emiliano Mura**  
**ARCHITECTS**

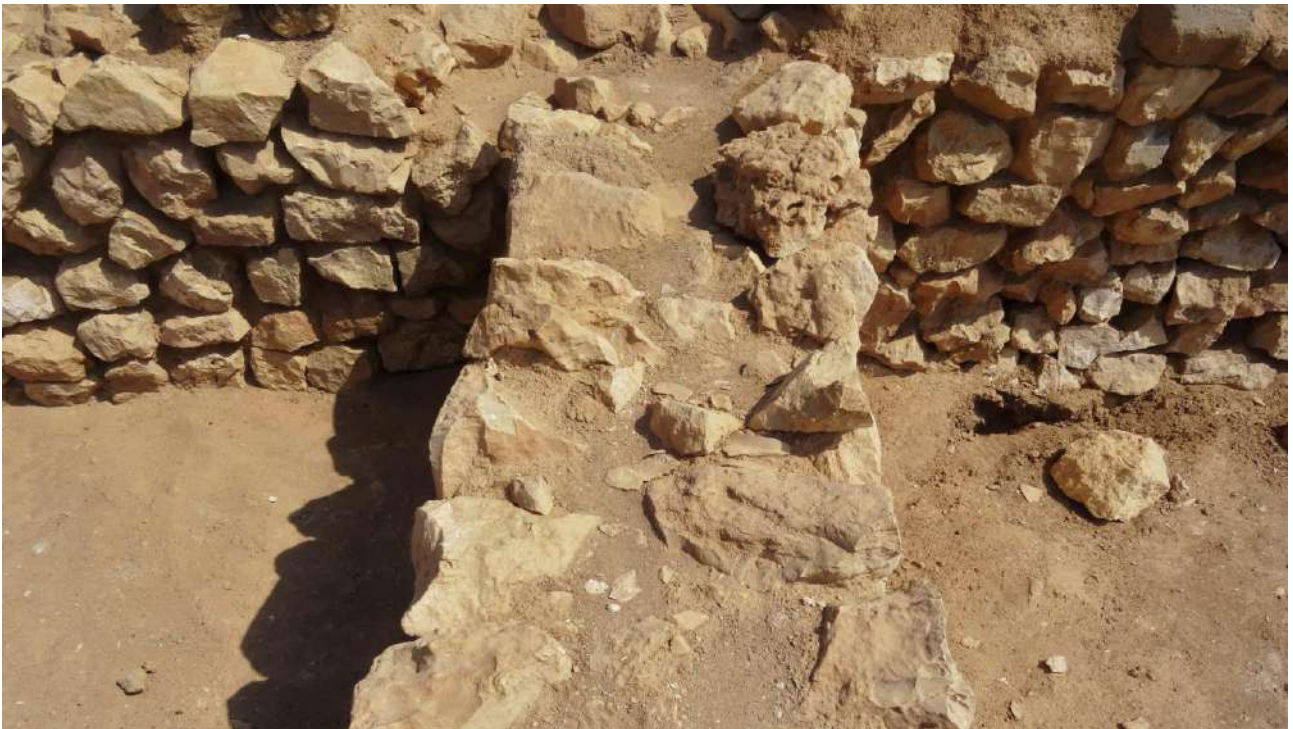
The work in this mission was carried out after careful analysis of the surrounding original wall structures, especially those not yet restored in previous missions. Throughout the archaeological site of Sumhuram, the walls are double faced, with outer faces in rough stone blocks and mortar and filling in small stones, sand and mortar. Orthogonal binding stones are very rarely present (Fig. 2).

*Fig. 2 – Typical masonry section in Sumhuram archeological site.*

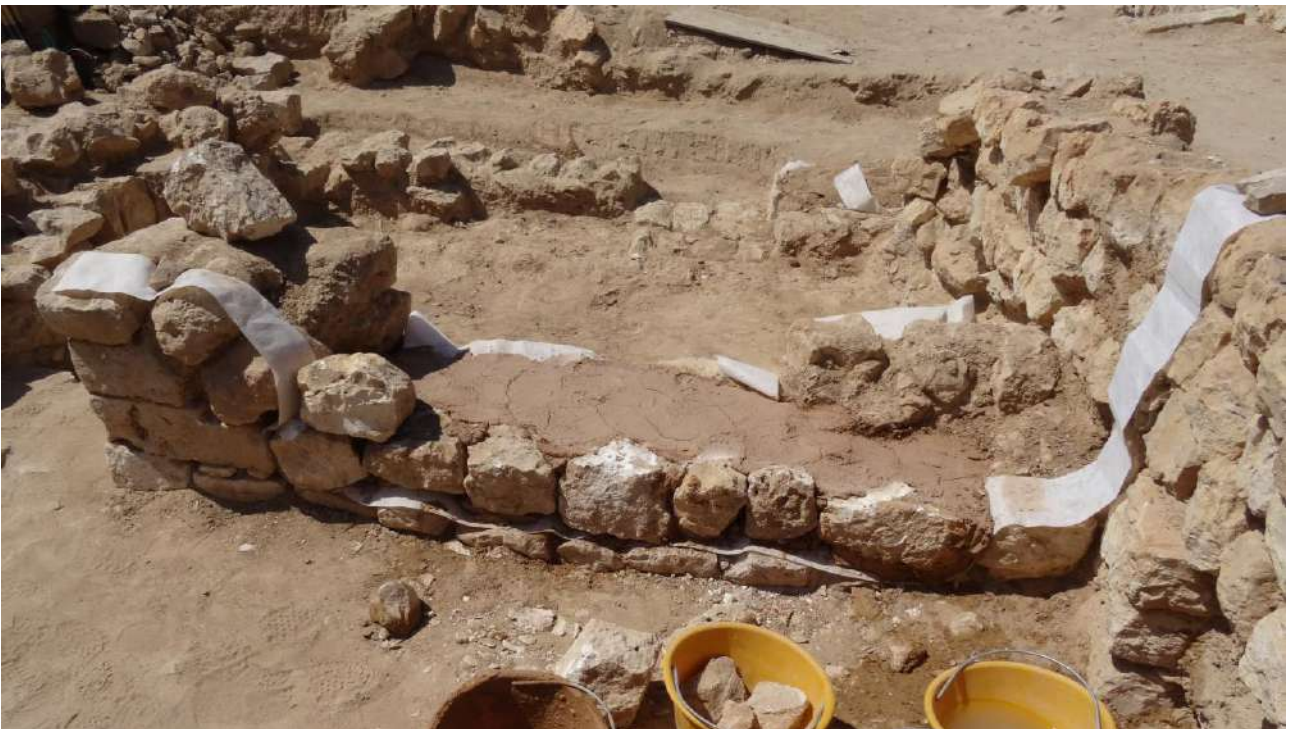
*Fig. 4 – Geotextile layer placed between the original masonry and the reconstructed wall. Building BB4, wall M645.*

Whenever a new wall section was built or a detached portion was removed and reassembled, a layer of geotextile was interposed between the untouched and the new or reconstructed masonry part. The geotextile layer was placed only under the two faces (Fig. 4).

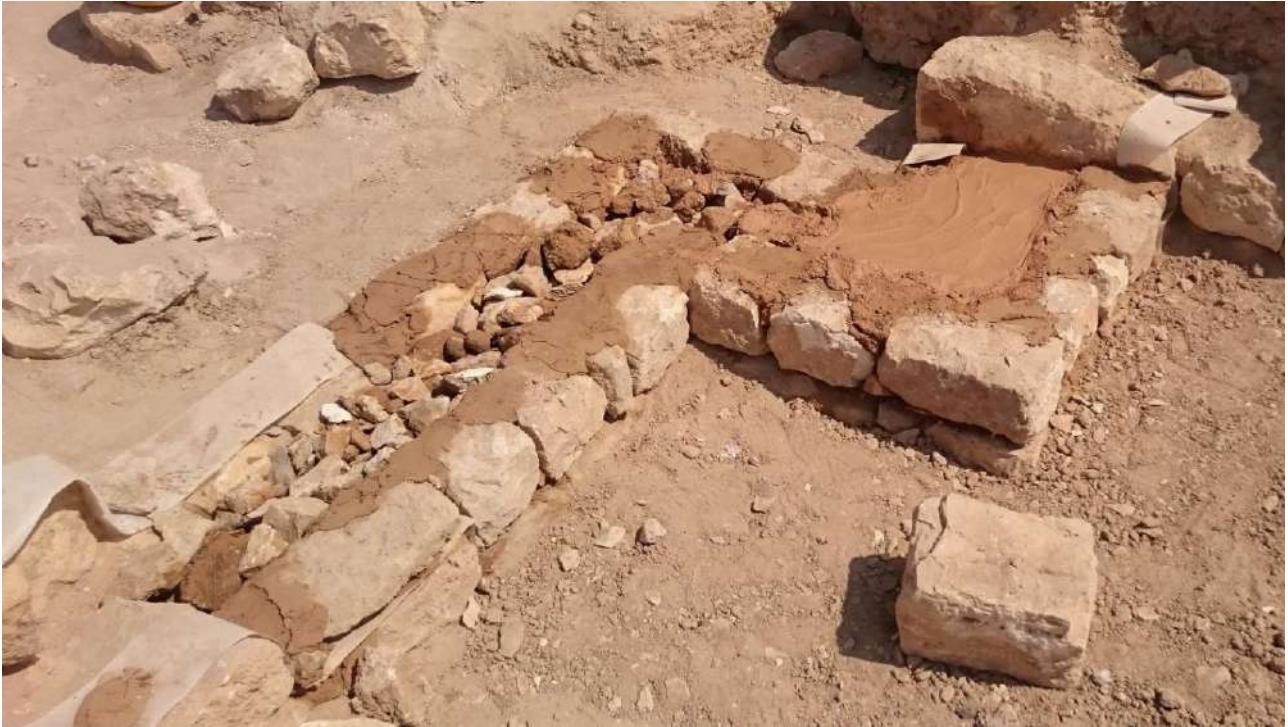
*Fig. 5 – Realization of a new masonry wall, with the two outer faces in rough stone blocks and with the core filled with small stones and mortar. Building BB4, wall M646.*

New masonry sections were realized a row at a time, at first realizing the two outer faces, with rough stone blocks and mortar, then filling the gap with small stones and finally saturating the core with very smooth mortar to level everything and prepare a good laying plan for the next row (Fig. 5). When it was the upper row, the core was not completely filled but rather the upper surface was shaped to give the appearance of ruins (Fig. 6). Prior to each new row, the bottom surface was wet until saturation to prevent absorption of the mix water.

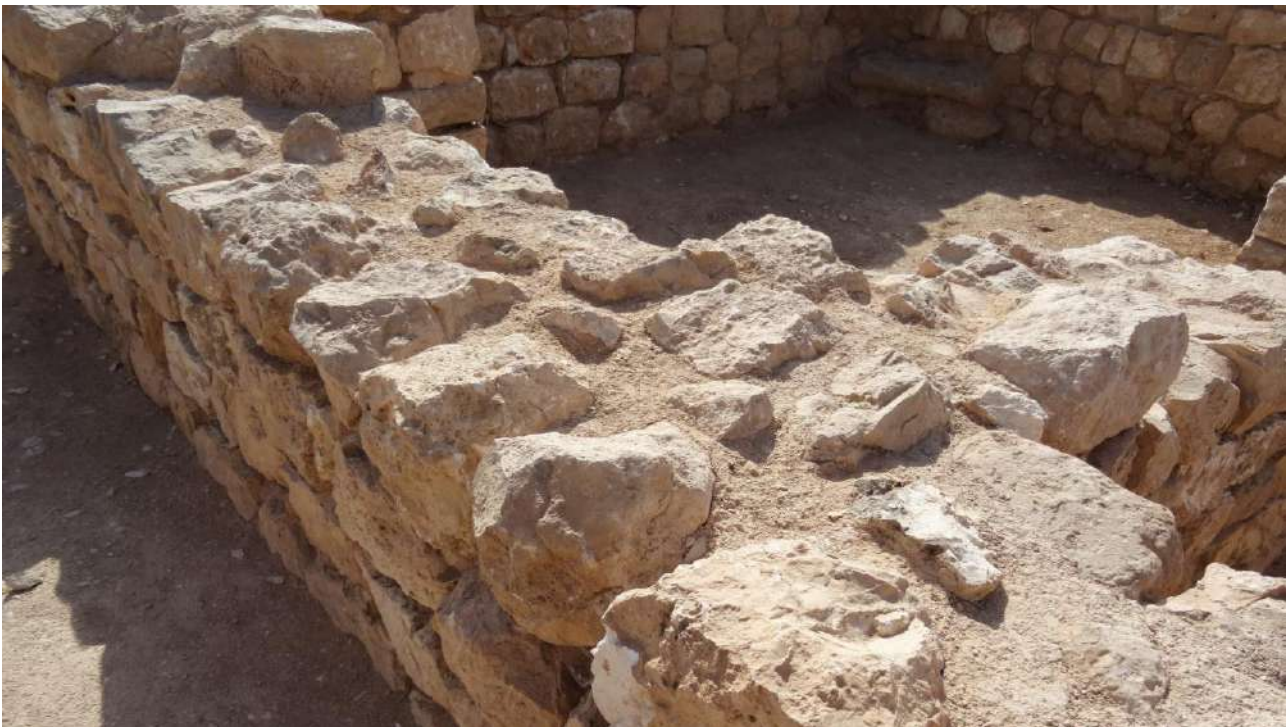
*Fig. 6 – Top row of restored walls. Building BB4, wall M646.*

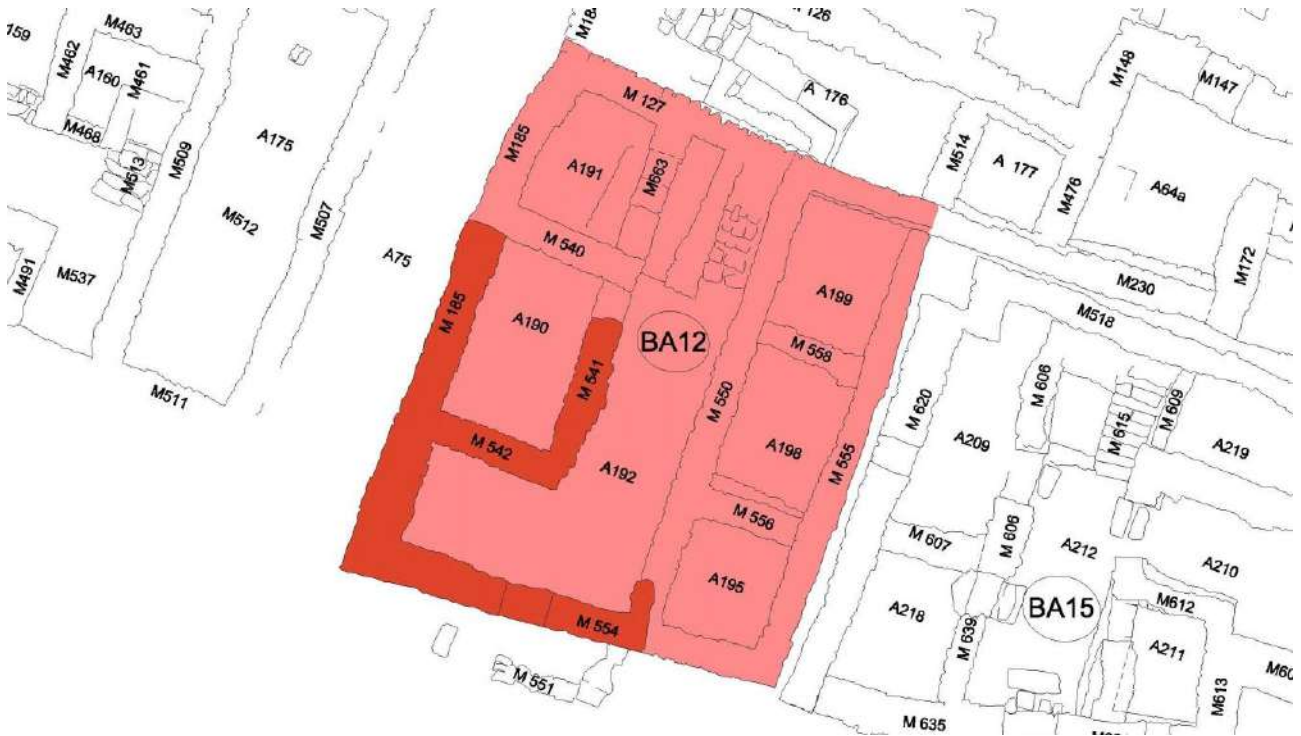
*Fig. 7a – BA12 plan with highlighted the restored walls.*

The first part of the Mission concerned the restoration of part of BA12. In particular, it was rebuilt the corner between the walls M541 and M542, the upper part of the the walls M541 and M542, the western part of the wall M554 and the southern part of the wall M185, and it was disassembled and reconstructed the upper part of the southern area of the wall M550 (Figs. 7).

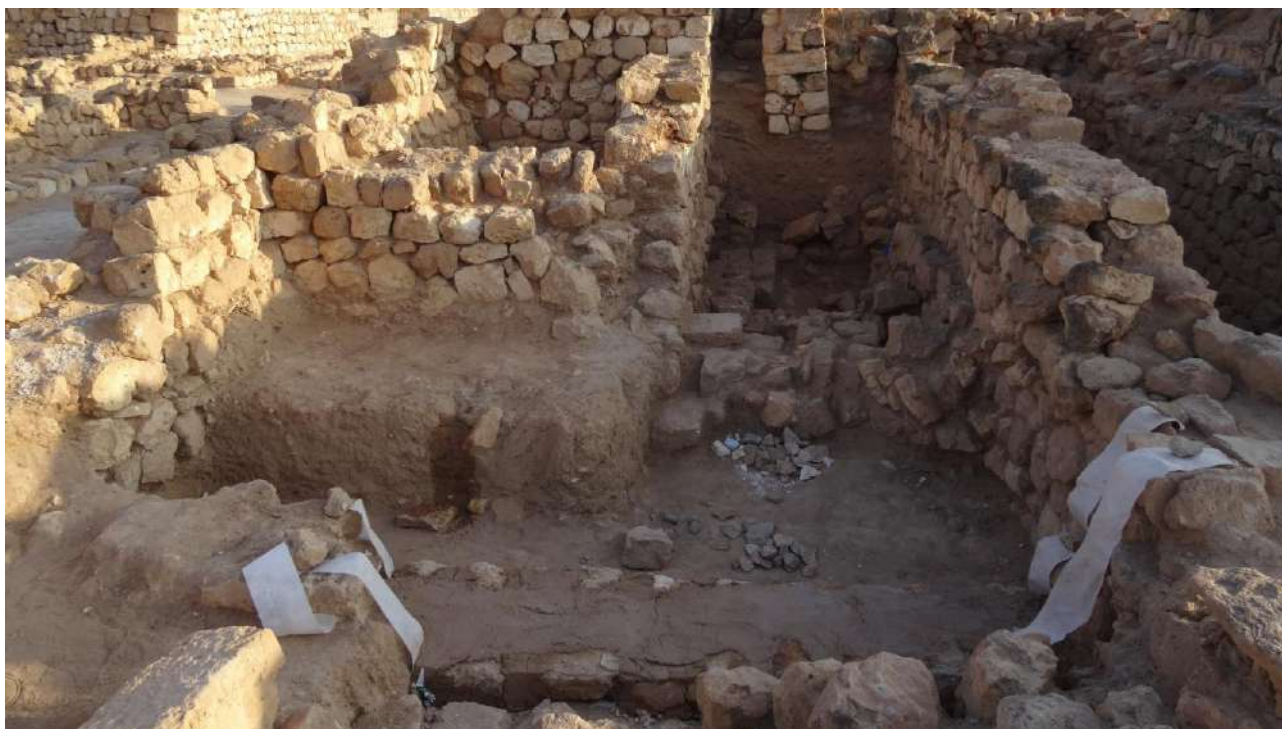
*Fig. 7c – BA12 before the restoration work (view from S).*

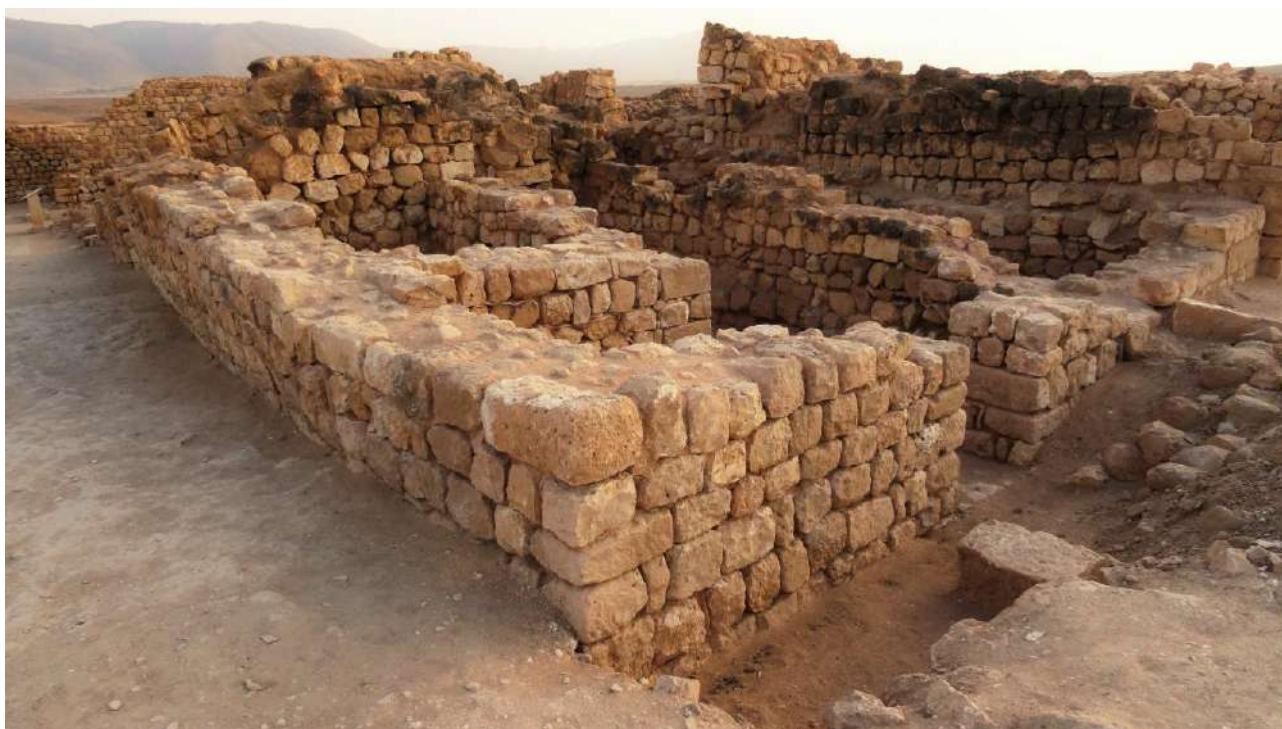
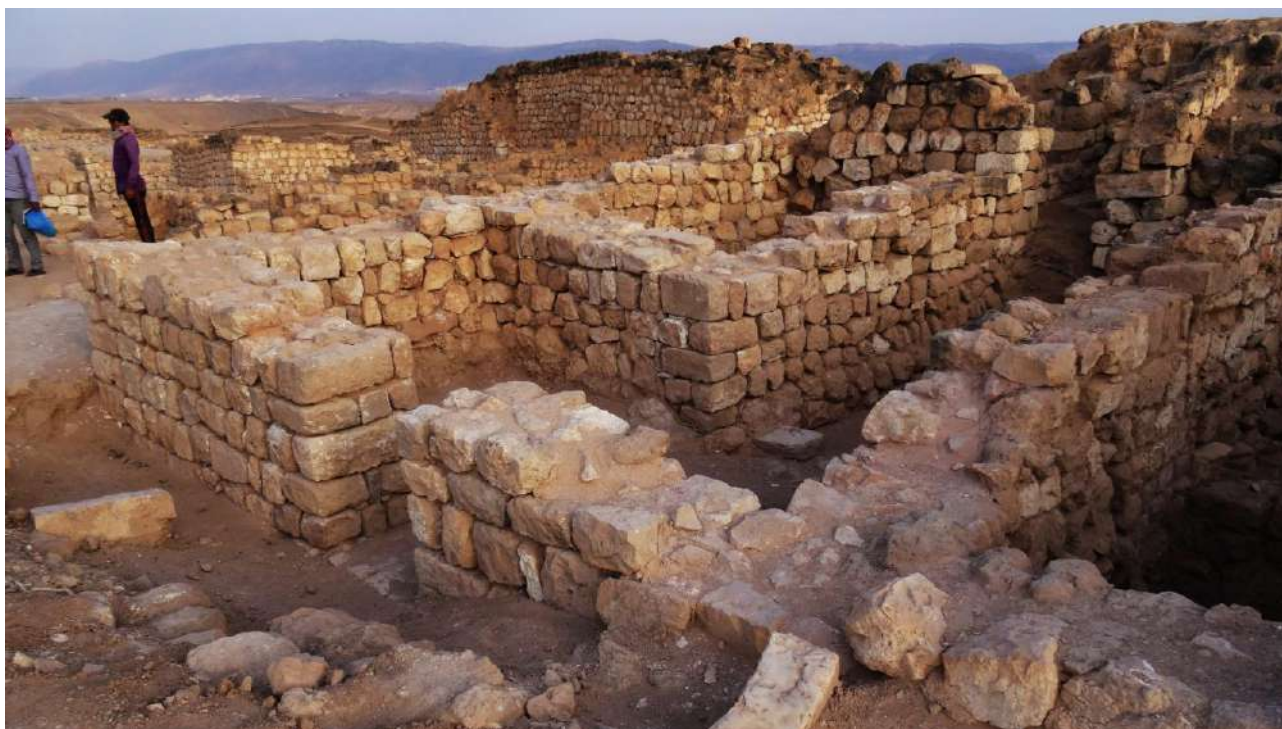
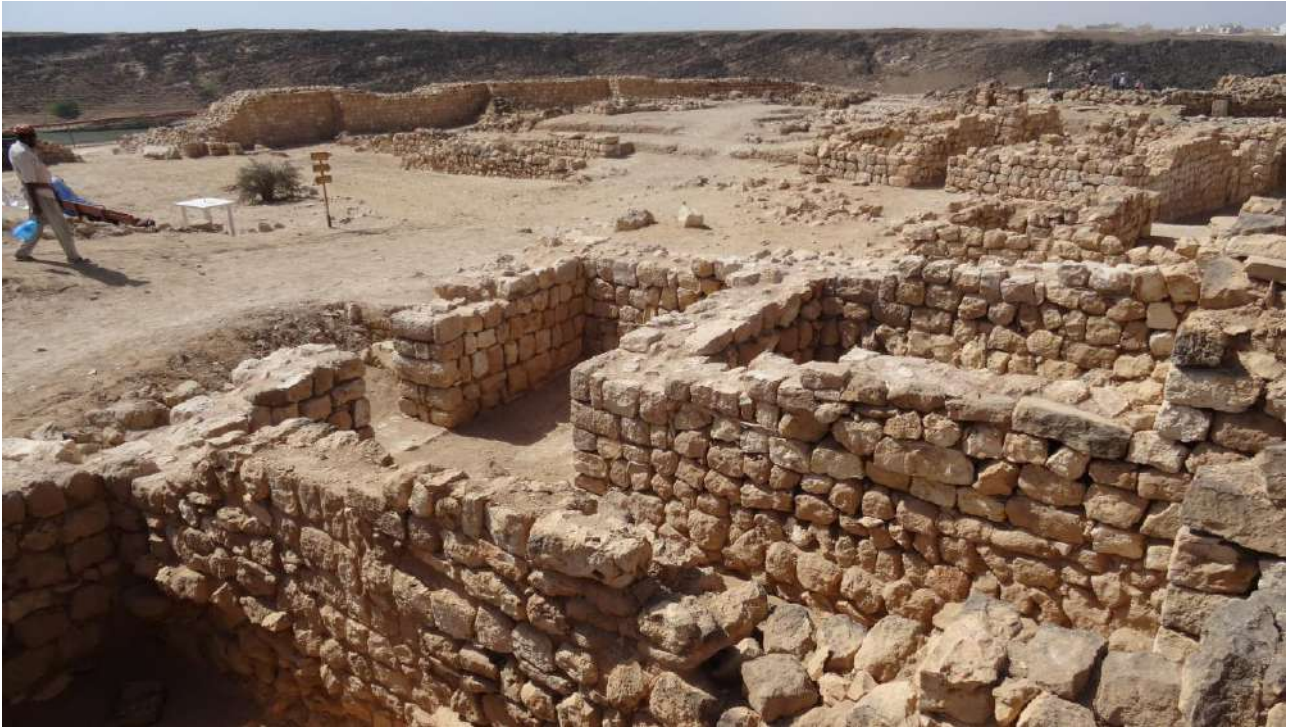
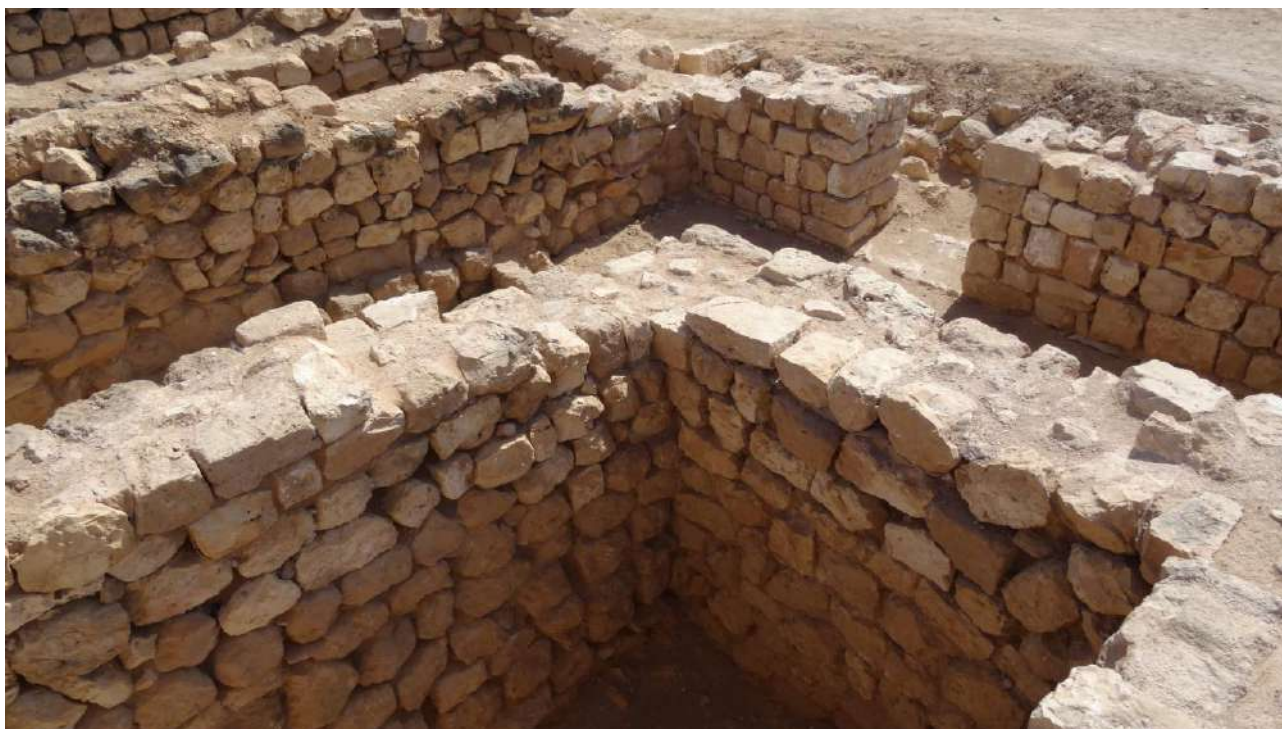
*Fig. 7e – BA12 after the restoration work (view from SW).*

*Fig. 7g – BA12 after the restoration work (view from SE).*

*Fig. 7i – BA12 after the restoration work (view from NE).*

*Fig. 7k – BA12 after the restoration work (view from NW).*

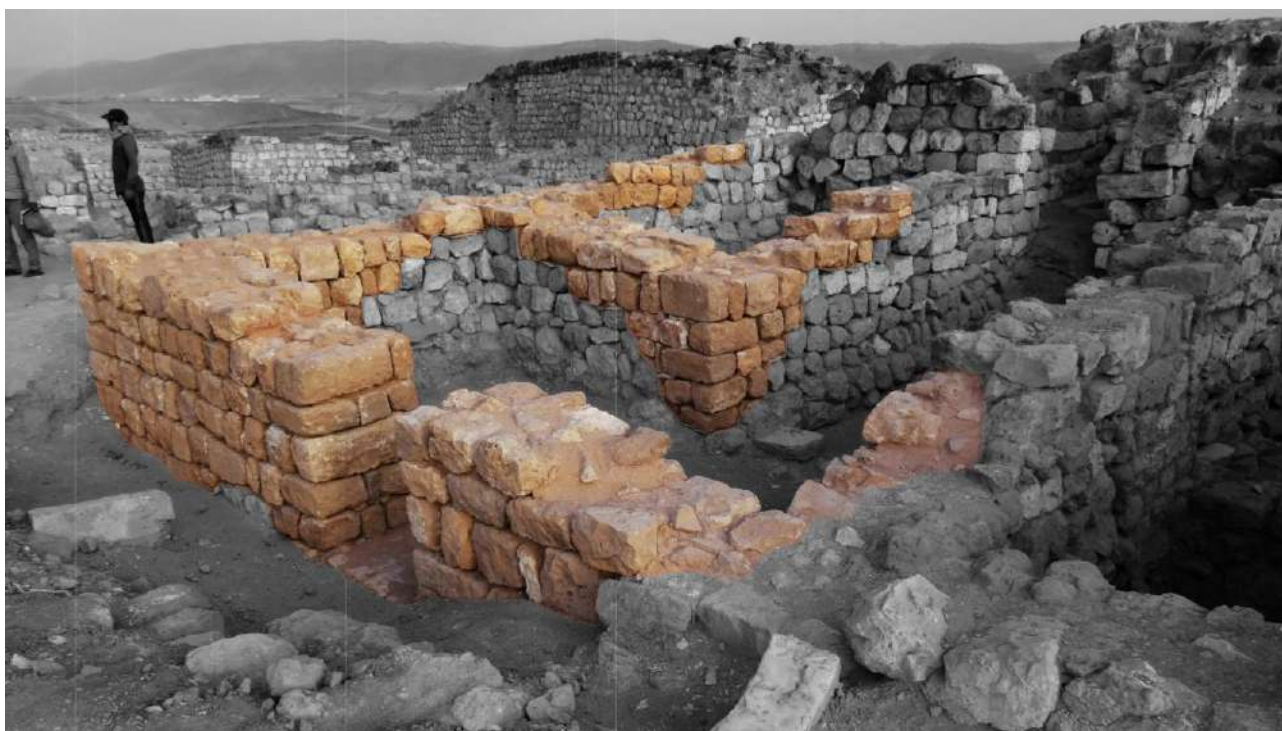
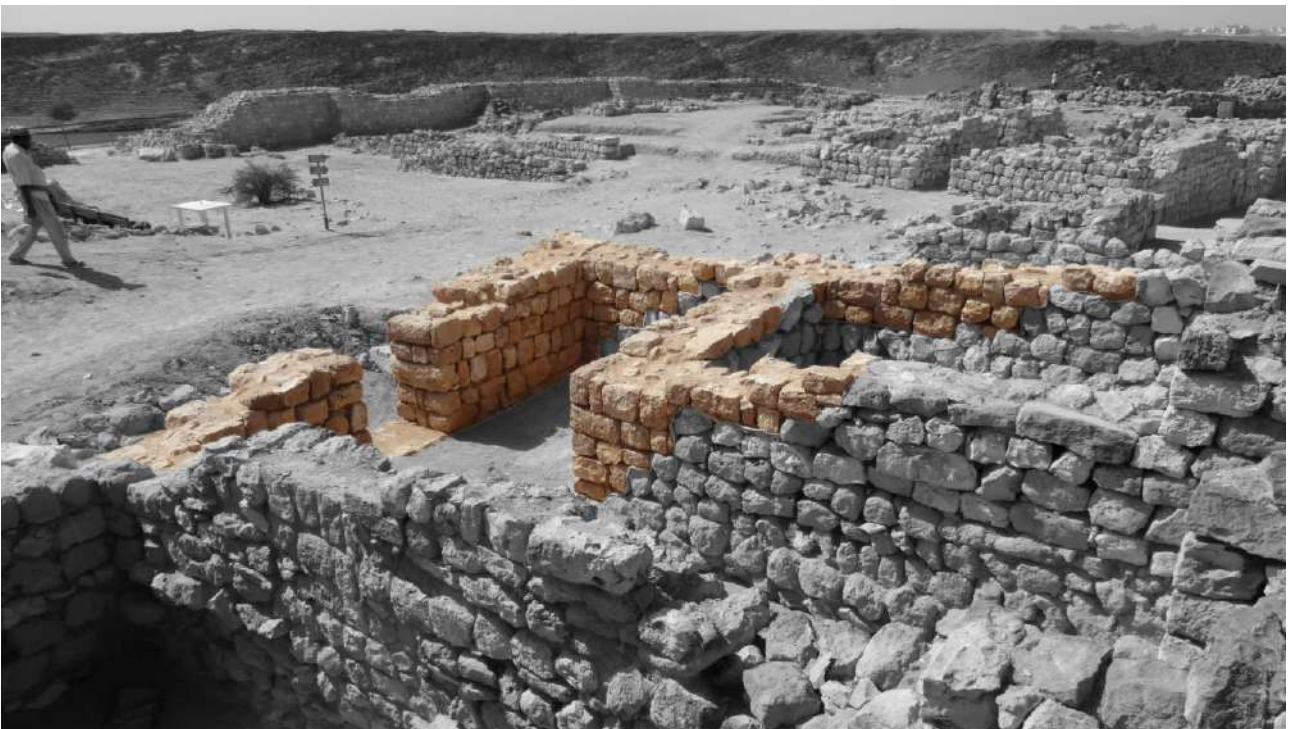
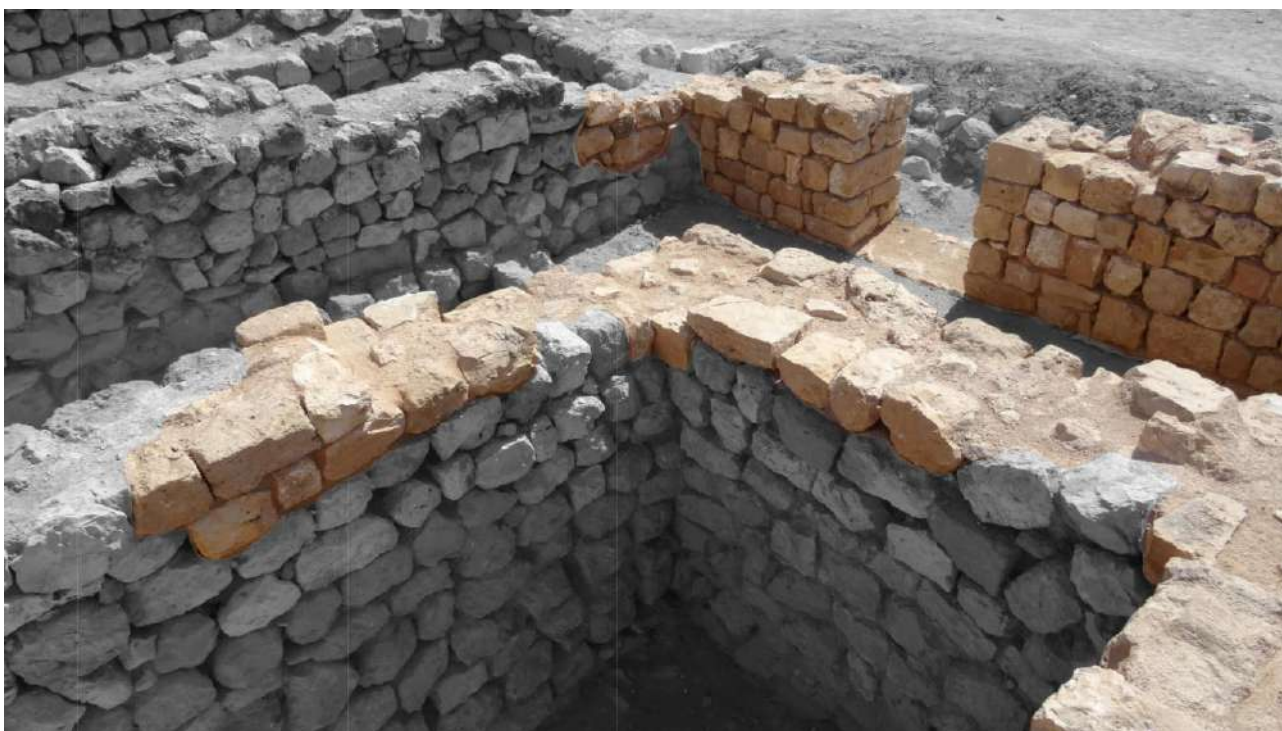
*Fig. 7h – Details of restoration works of BA12 (view from SE).*

*Fig. 7j – Details of restoration works of BA12 (view from NE).*

*Fig. 7l – Details of restoration works of BA12 (view from NW).*

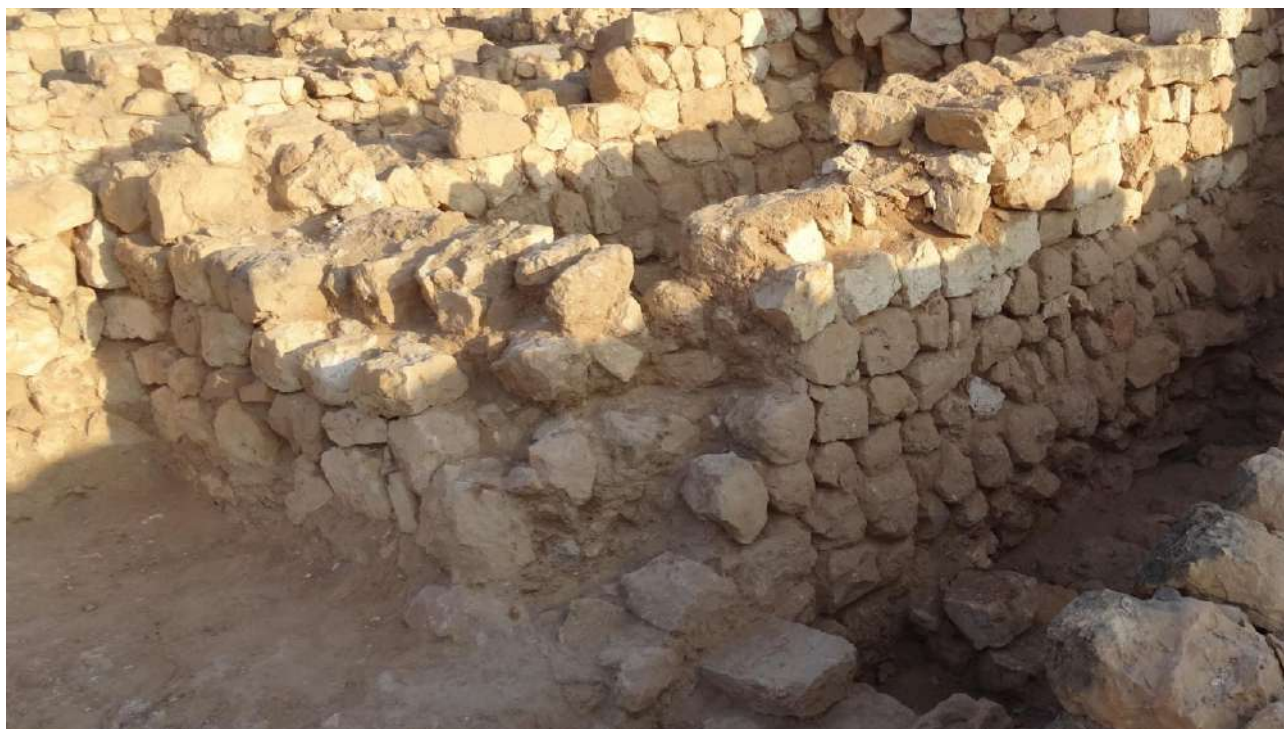
Before the restoration, the corner between the walls M541 and M542 was almost completely collapsed, especially the south and east faces. Before rebuilding the corner, the unstable stones were removed to have a solid foundation for new wall sections. Moreover, as explained in the introduction, the upper surface of the support was abundantly wet and a geotextile layer was placed above the original masonry. The upper surface of the new corner and of the masonries M541 and M542 was reshaped to make it similar to the surrounding ruins, and not similar to that of a new wall (Figs. 8).

*Fig. 8a – BA12, corner between M541 and M542 before the restoration works.*

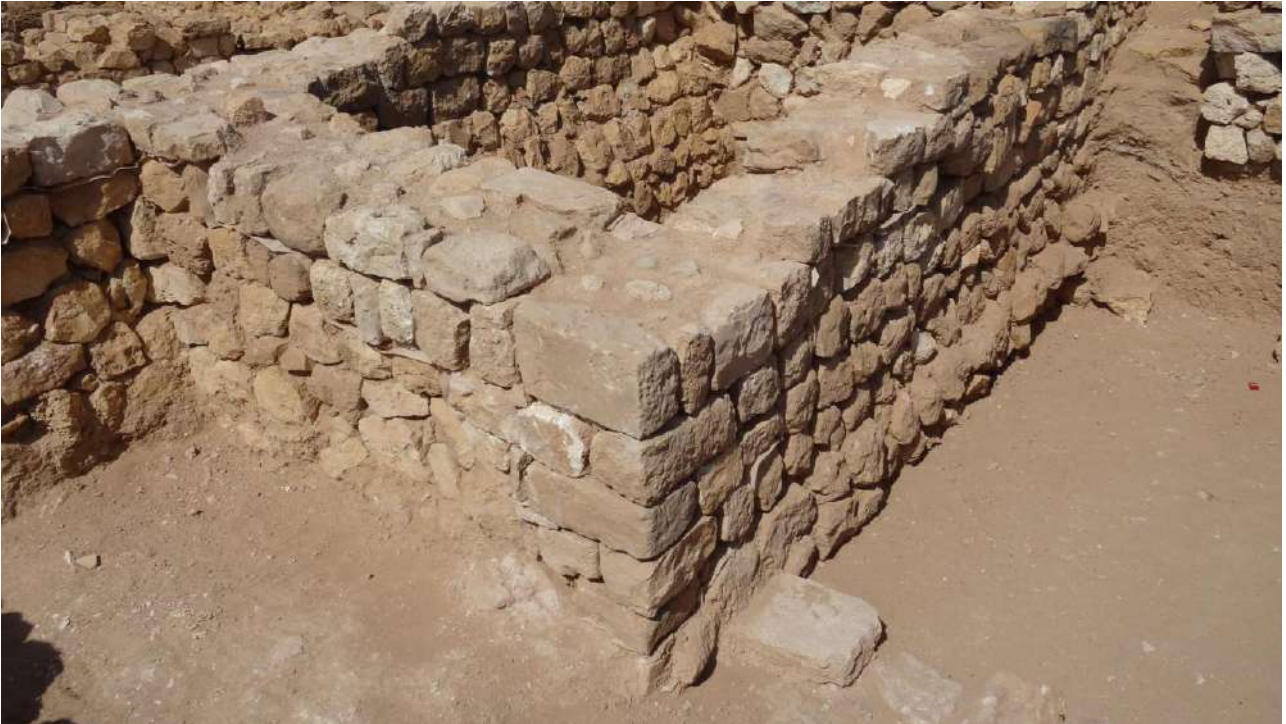
*Fig. 8c – BA12, corner between M541 and M542 after the restoration works (view from SE).*

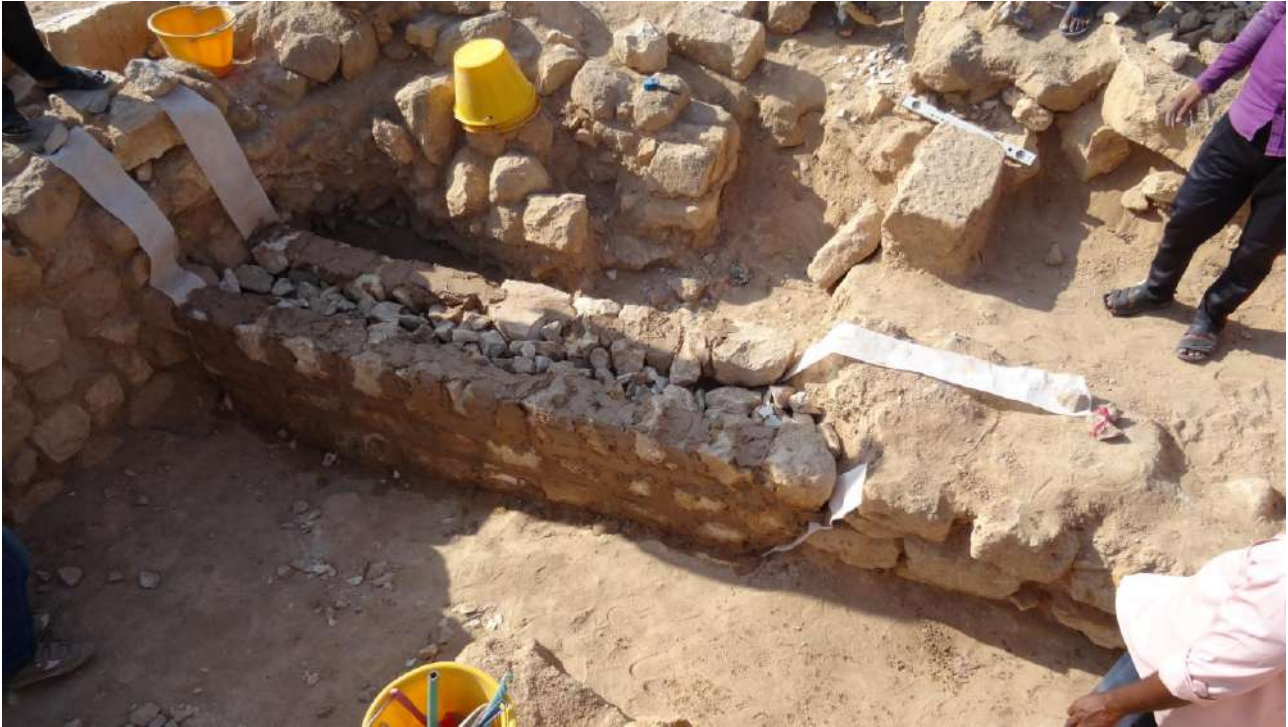
*Fig. 9a – BA12, wall M554 during the restoration works.*

Afterwards, it was rebuilt the wall M554, between the alignments M185 and M550, and the southern part of the wall M185. In order to avoid future subsidences and cracks in the new masonry, the foundation plan was placed about 50 cm below the countryside plan. To reinforce the foundation of the wall, the first two rows were realized with plentiful mortar in joints. Following to the indications of Mr. Sedov, in the middle of the reconstructed part of the wall M554 it was made an opening of about 85 cm (Figs. 9).

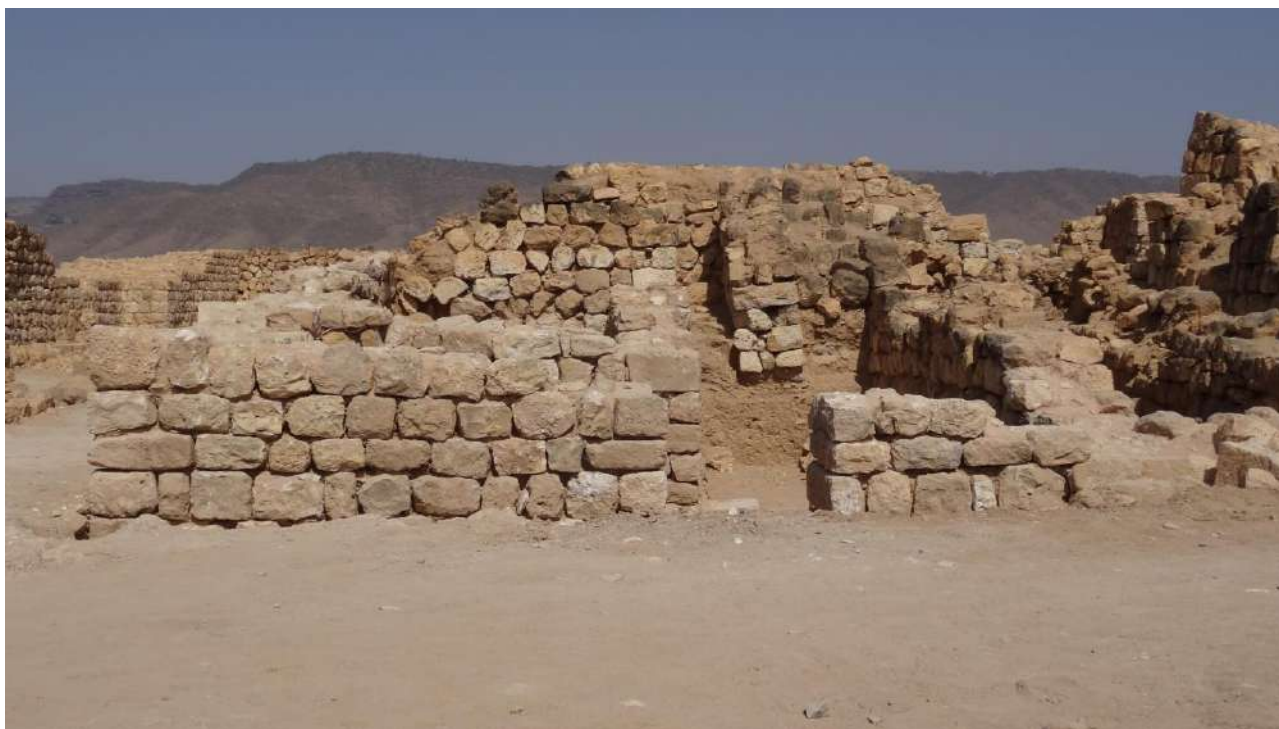
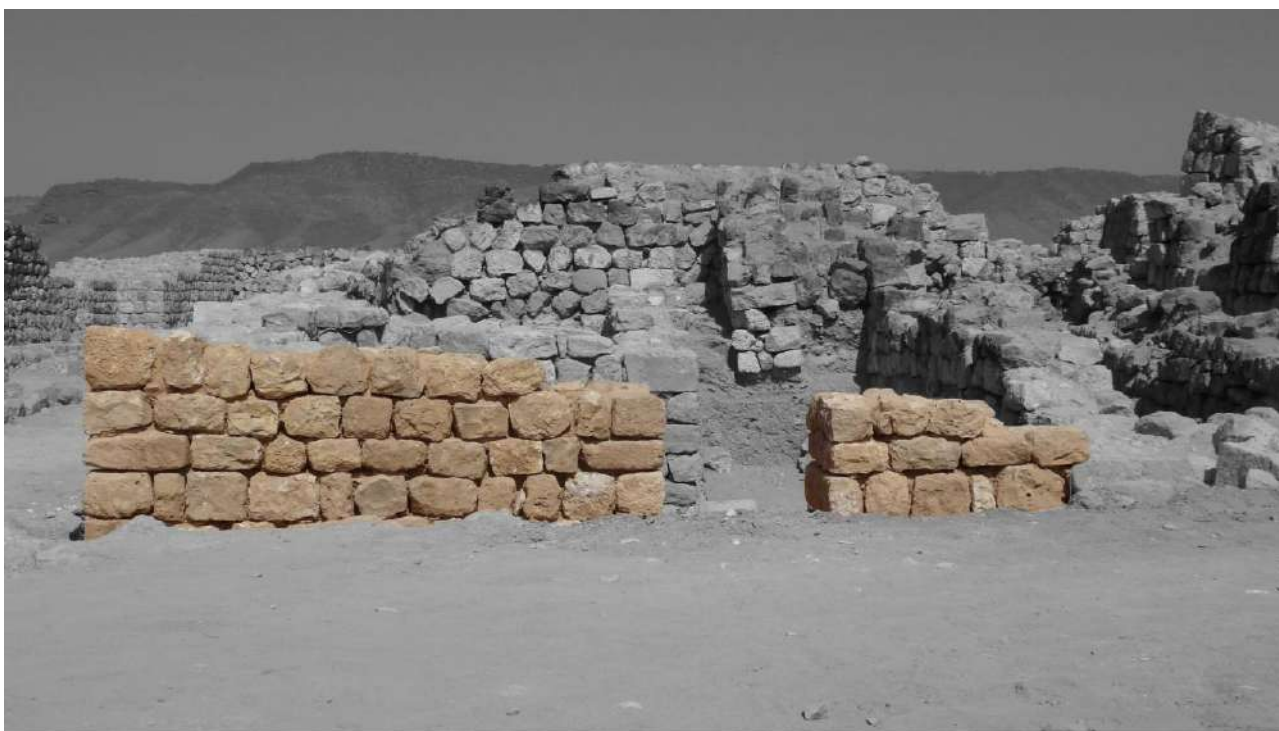
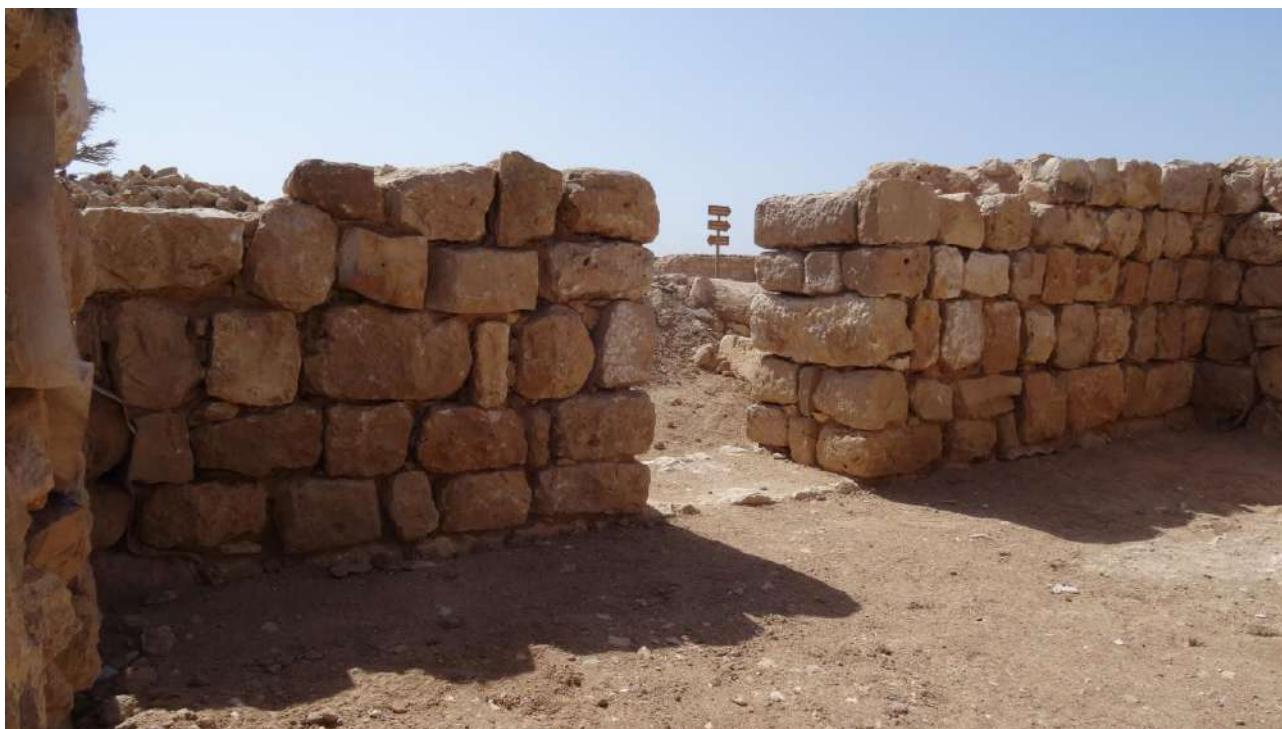
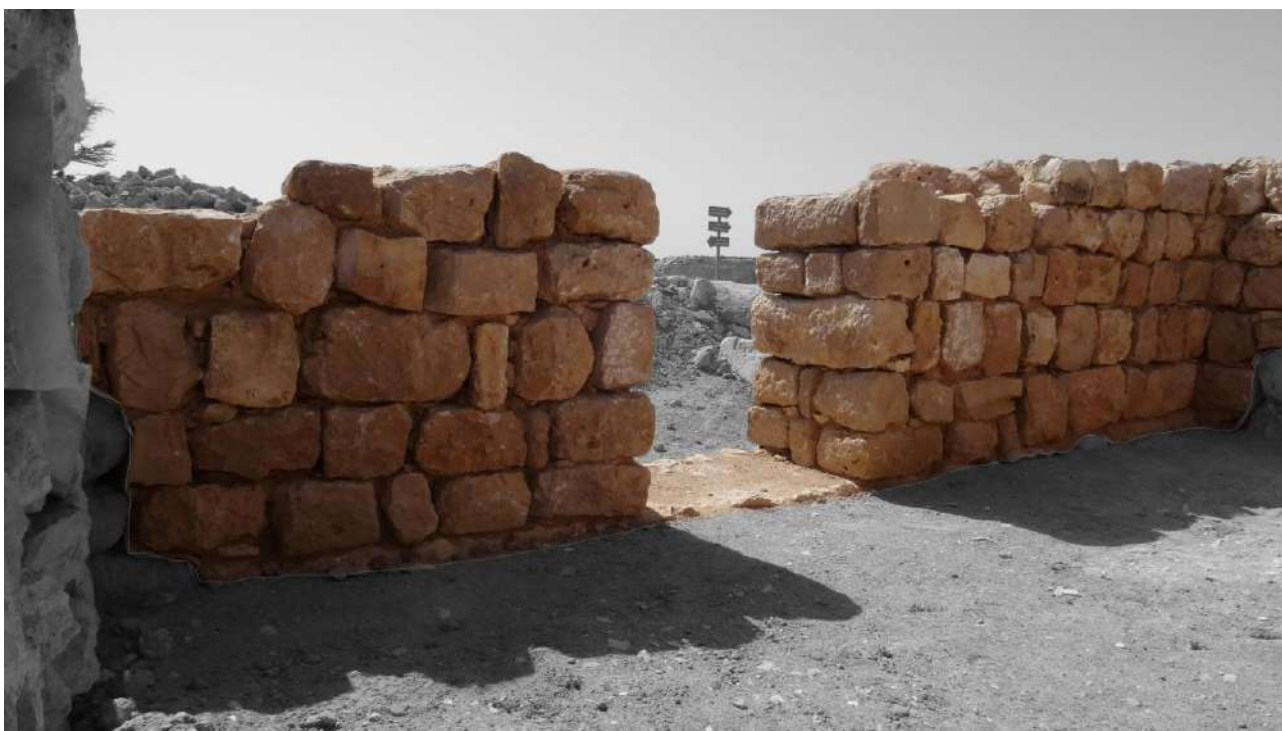
*Fig. 9c – BA12, wall M554 after the restoration works (view from S).*

*Fig. 9d – BA12, details of the restorations works of the wall M554 (view from S).*

*Fig. 9e – BA12, wall M554 after the restoration works (view from N).*

*Fig. 9f – BA12, details of the restorations works of the wall M554 (view from N).*
