**RESTORATION WORKS AT SUMHURAM  
(ARCHAEOLOGICAL PARK OF KHOR RORI)  
(Sultanate of Oman)  
CAMPAIGN October-December 2017**

**Technical Report**  
**16<sup>th</sup> October – 14<sup>th</sup> December 2017**

**Michele Chimienti – Emiliano Mura**  
**ARCHITECTS**

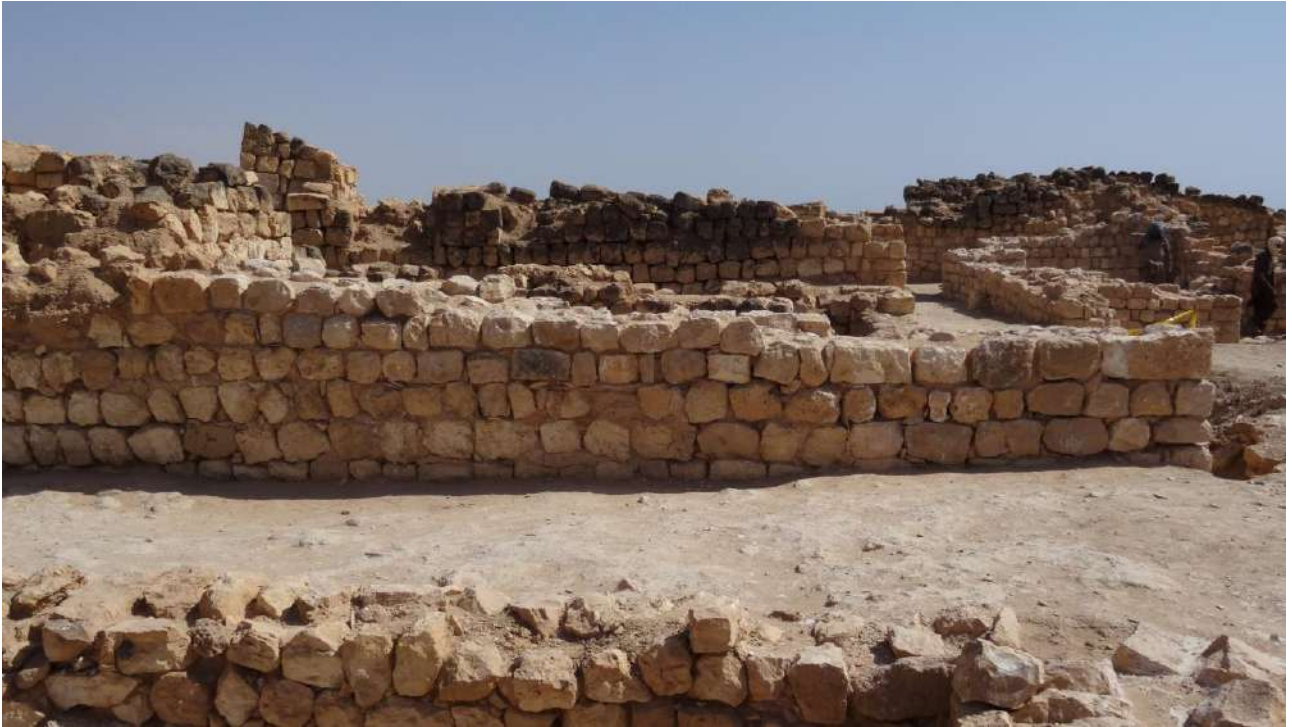
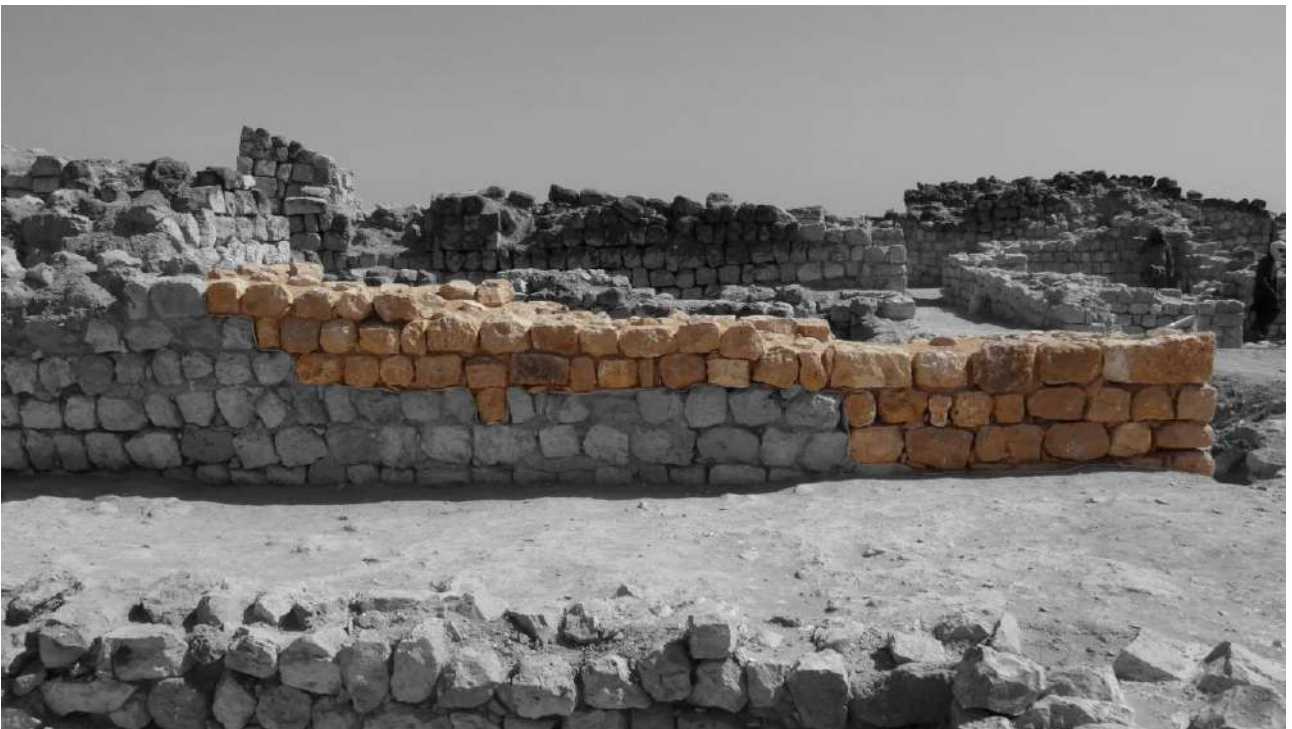
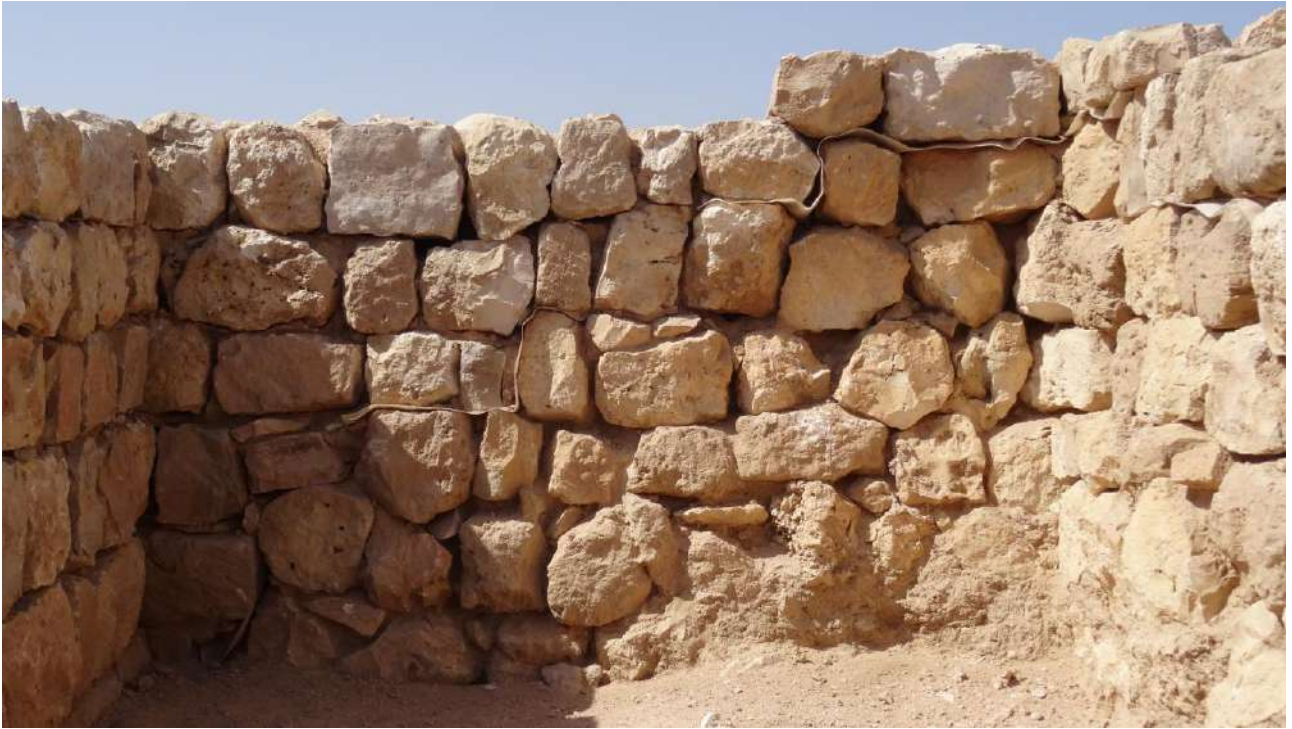
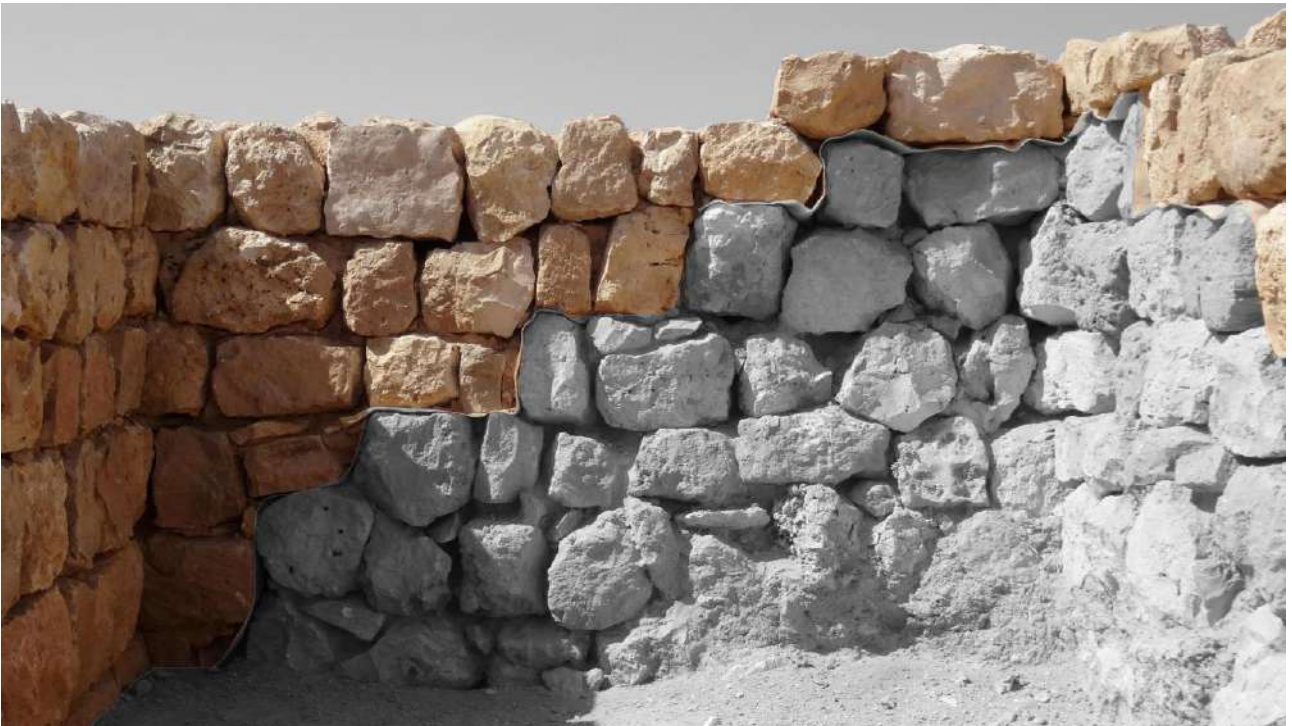
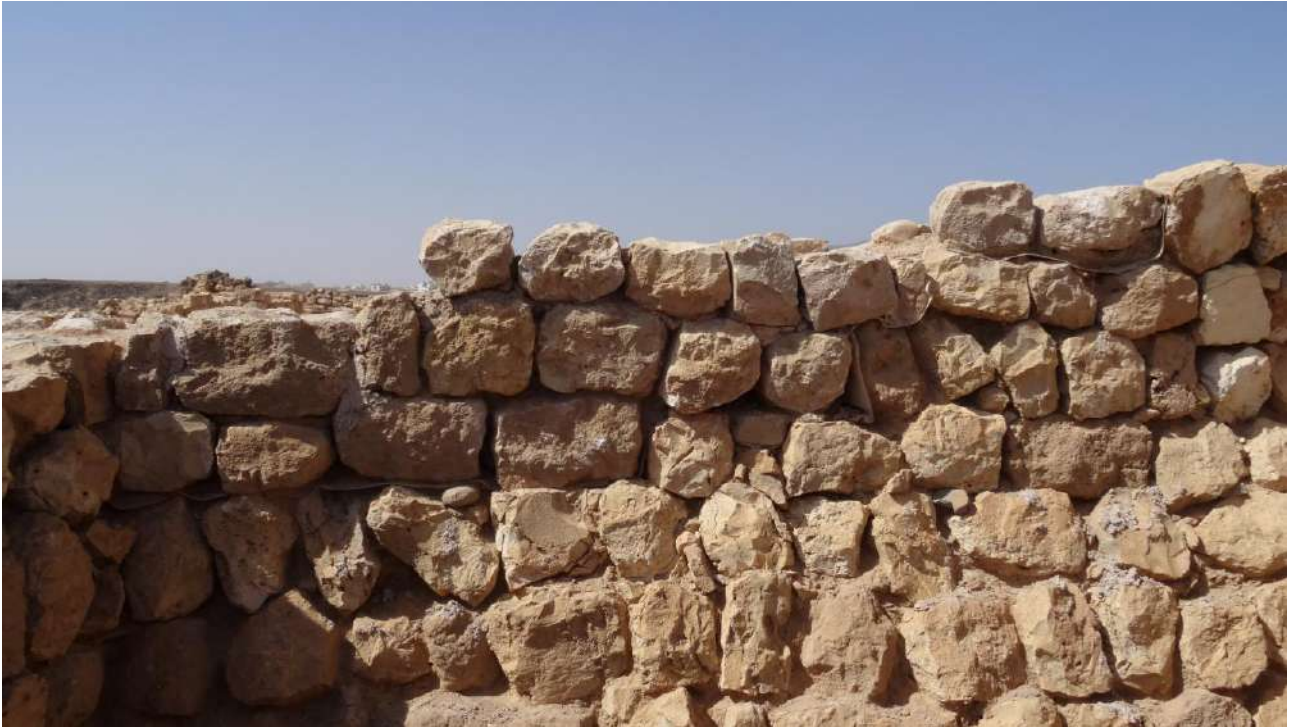
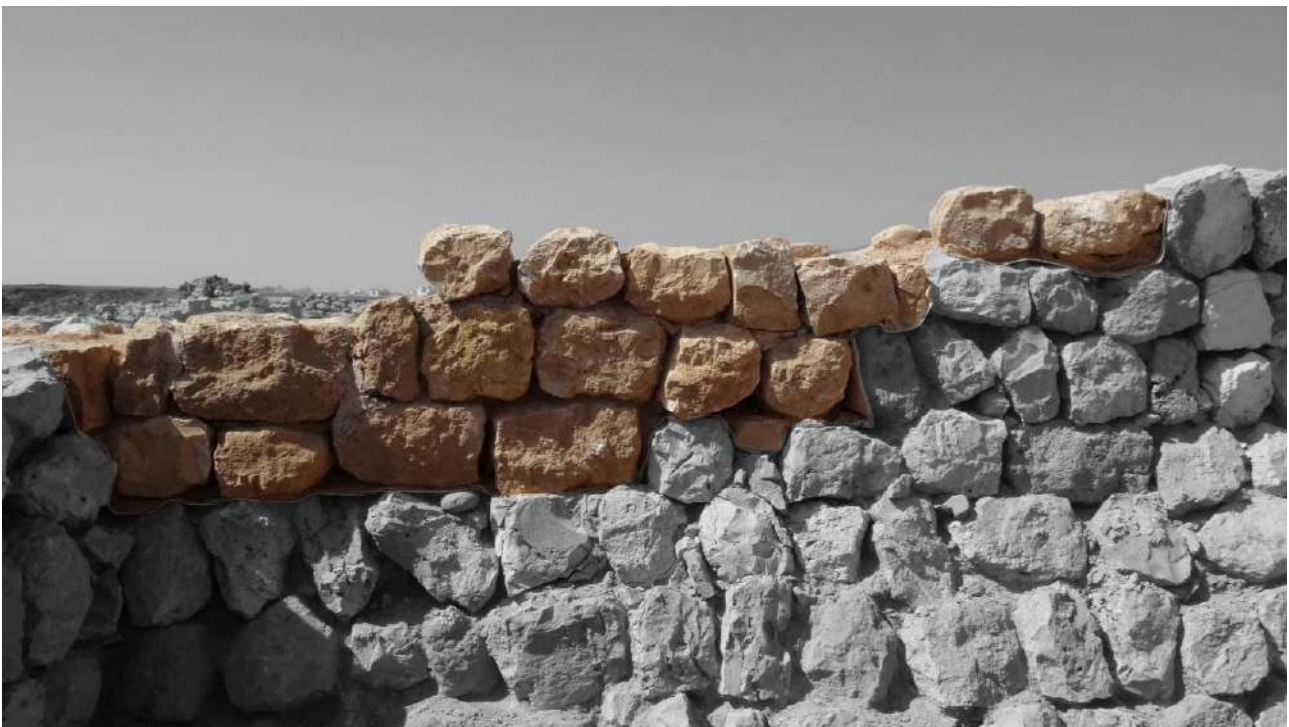
*Fig. 9g – BA12, wall M185 after the restoration works (view from W).*

*Fig. 9h – BA12, details of the restorations works of the wall M185 (view from W).*

*Fig. 9i – BA12, wall M185 (between the alignments M554 and M542) after the restoration works  
(view from E).*

*Fig. 9j – BA12, details of the restorations works of the wall M185 between the alignments M554  
and M542 (view from E).*

*Fig. 9k – BA12, wall M185 (between the alignments M542 and M540) after the restoration works  
(view from E).*

*Fig. 9l – BA12, details of the restorations works of the wall M185 between the alignments M542  
and M540 (view from E).*

Afterwards, it was rebuilt the wall M554, between the alignments M185 and M550, and the southern part of the wall M185. In order to avoid future subsidences and cracks in the new masonry, the foundation plan was placed about 50 cm below the countryside plan. To reinforce the foundation of the wall, the first two rows were realized with plentiful mortar in joints. Following to the indications of Mr. Sedov, in the middle of the reconstructed part of the wall M554 it was made an opening of about 85 cm (Figs. 9).

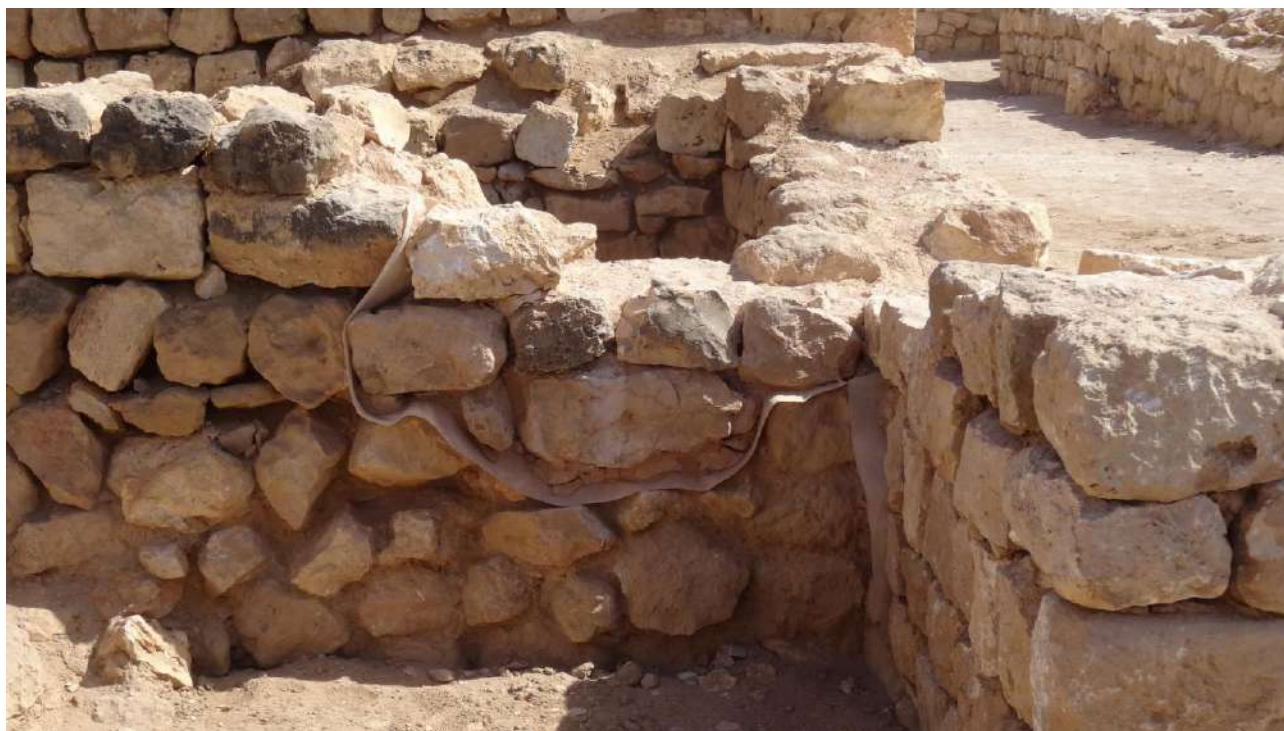
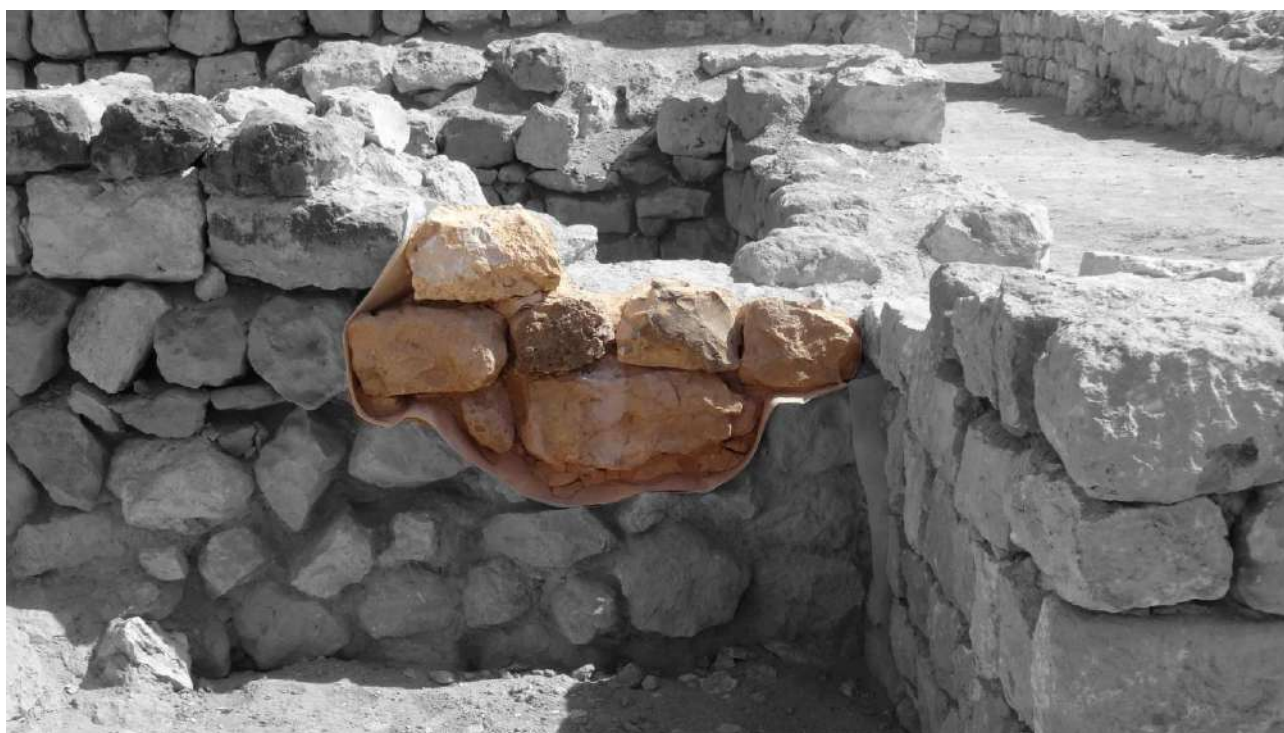
*Fig. 10c – BA12, southern part of the wall M550 after the restoration works (view from W).*

*Fig. 10d – BA12, details of the restoration works of the southern part of the wall M550 (view from W).*

Subsequently, the top of the southern end of the wall M550 was disassembled and reconstructed (Figs. 10).

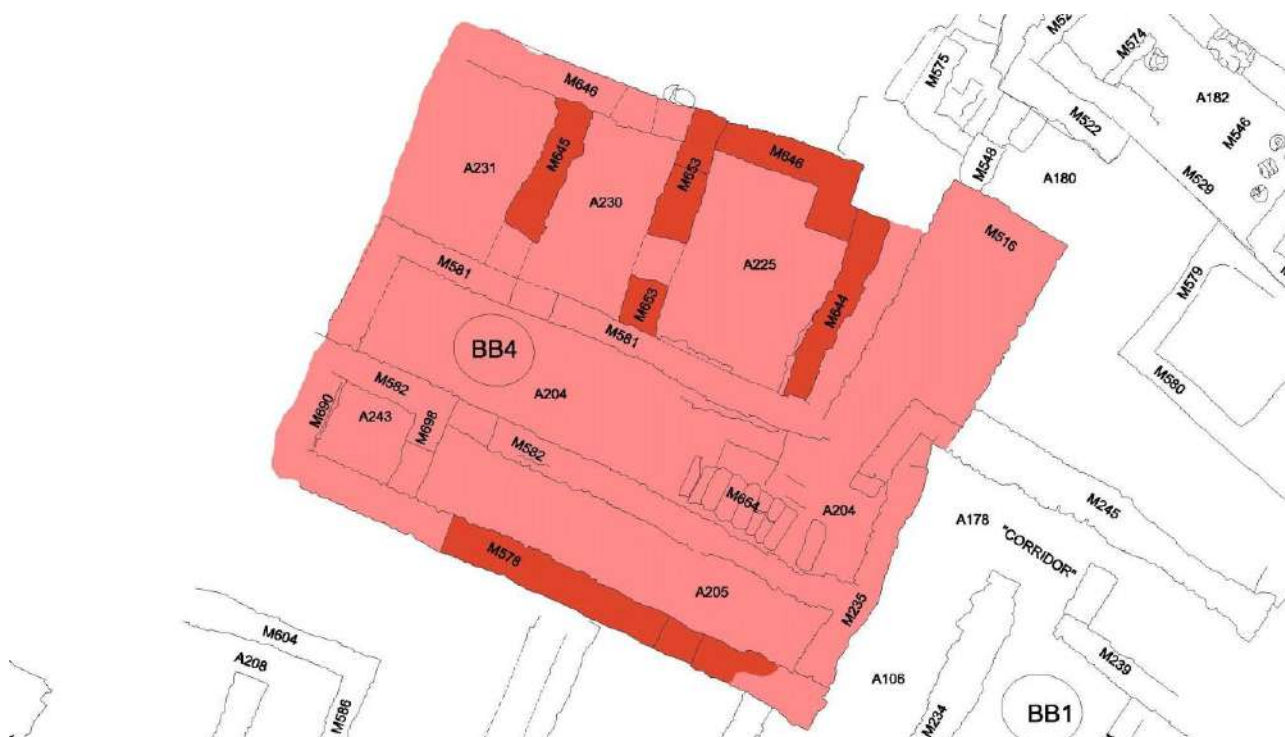
*Fig. 11a – BB4 plan with highlighted the restored walls.*

The second part of the mission was dedicated to the restoration of BB4. In particular, they were rebuilt the walls M645 and M653, a big part of the wall M578, the walls M644 and M646 with the corner between them and it was digged to find the foundation of the west border wall between the walls M581 and M646 (Figs. 11).

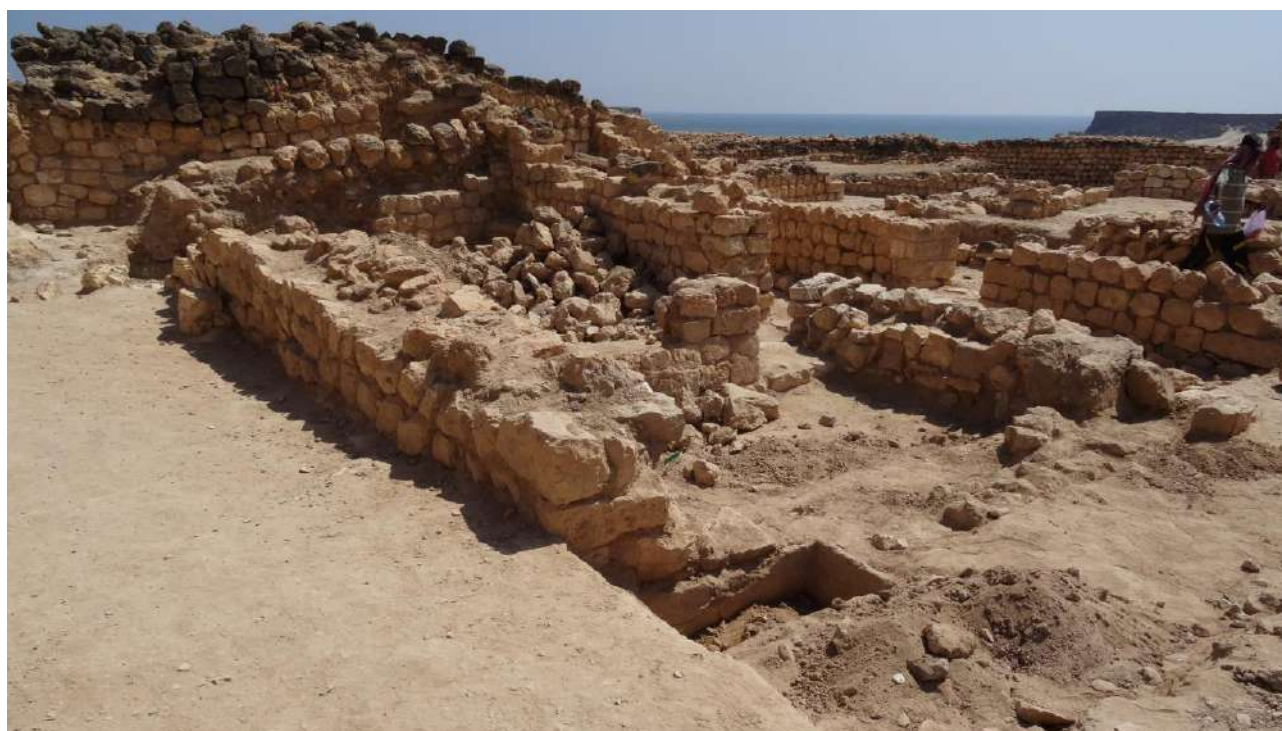
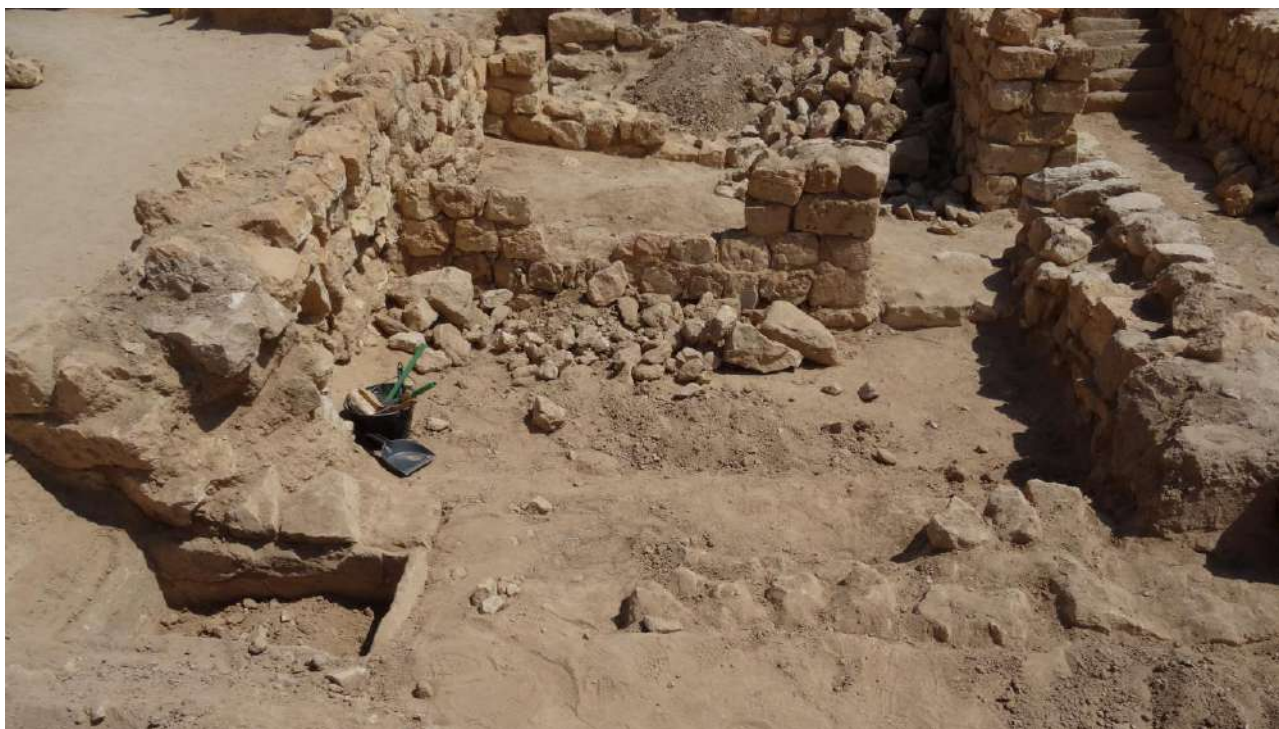
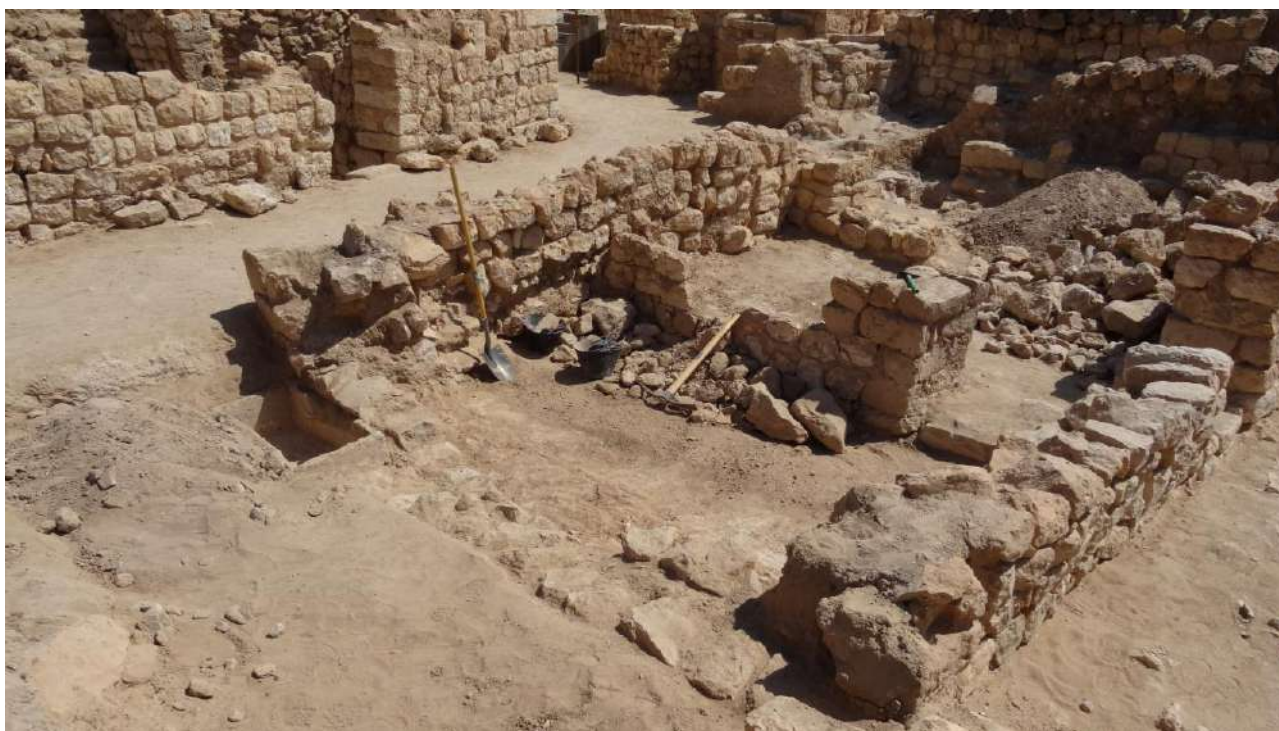
*Fig. 11b – BB4 before the restoration work (view from NW).*

*Fig. 11c – BB4 before the restoration work (view from W).*

*Fig. 11d – BB4 before the restoration work (view from SW).*

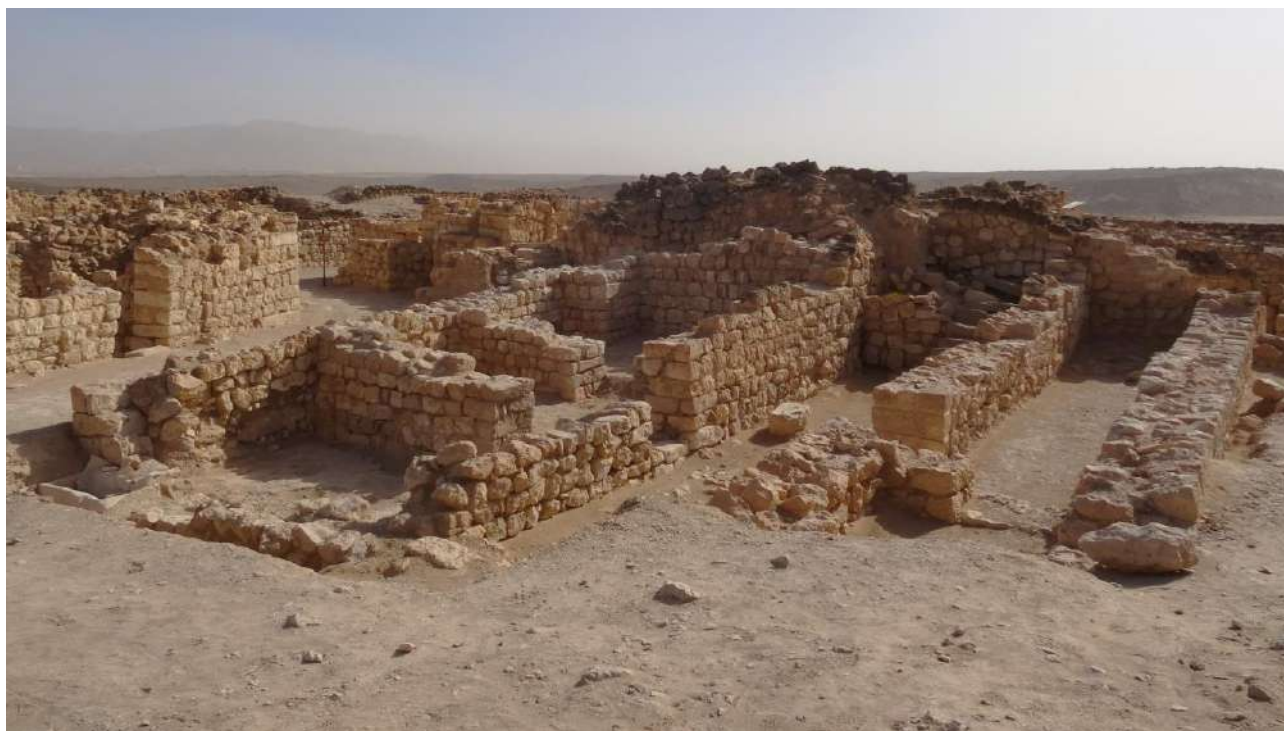
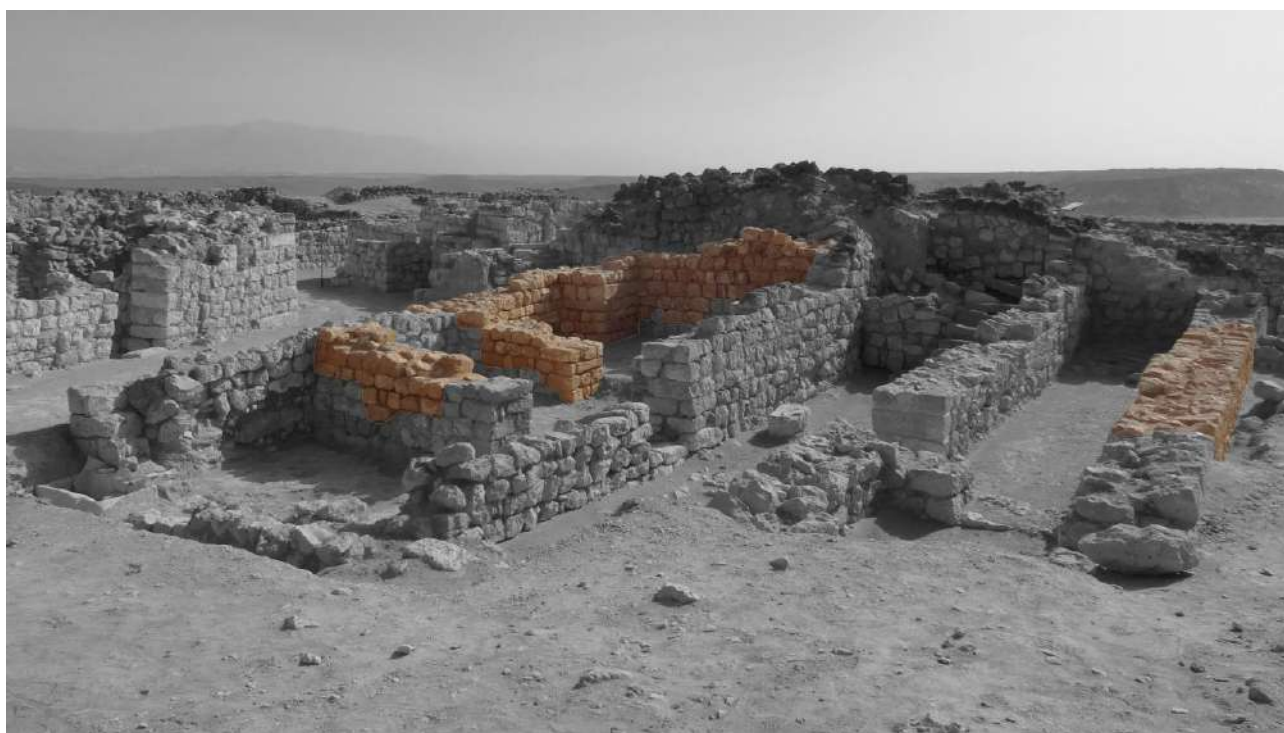
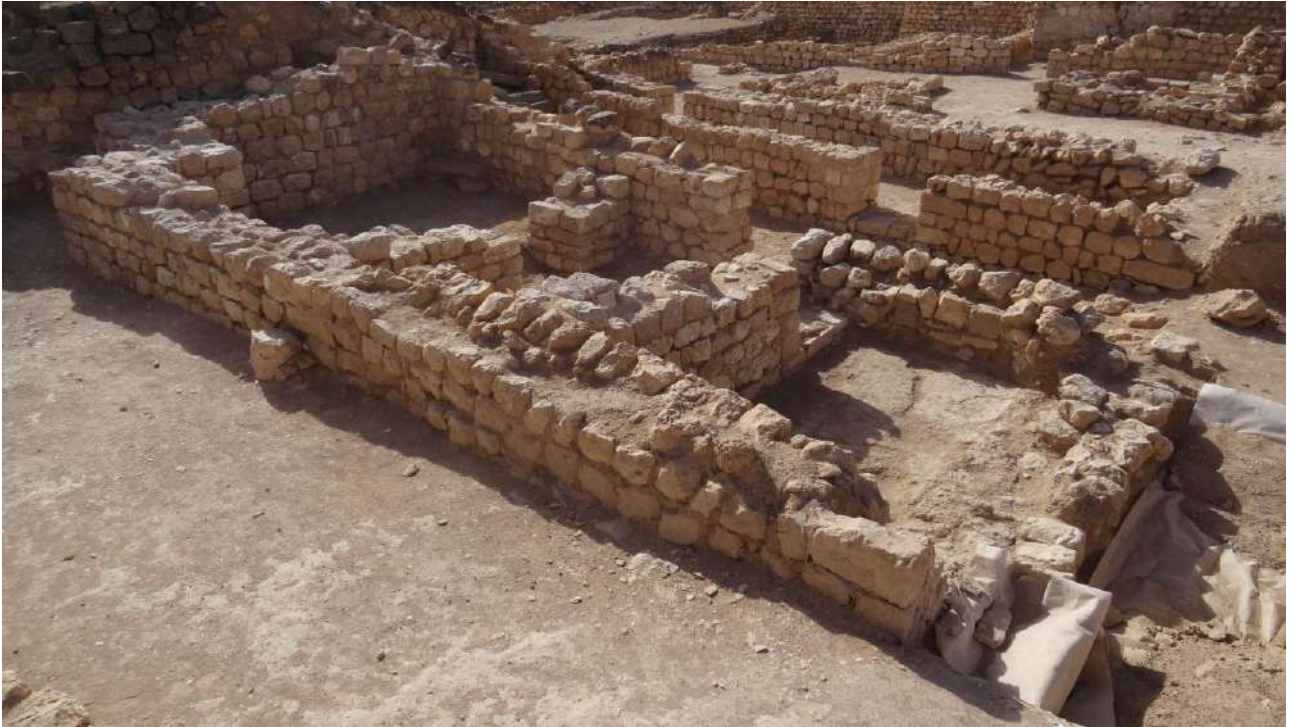
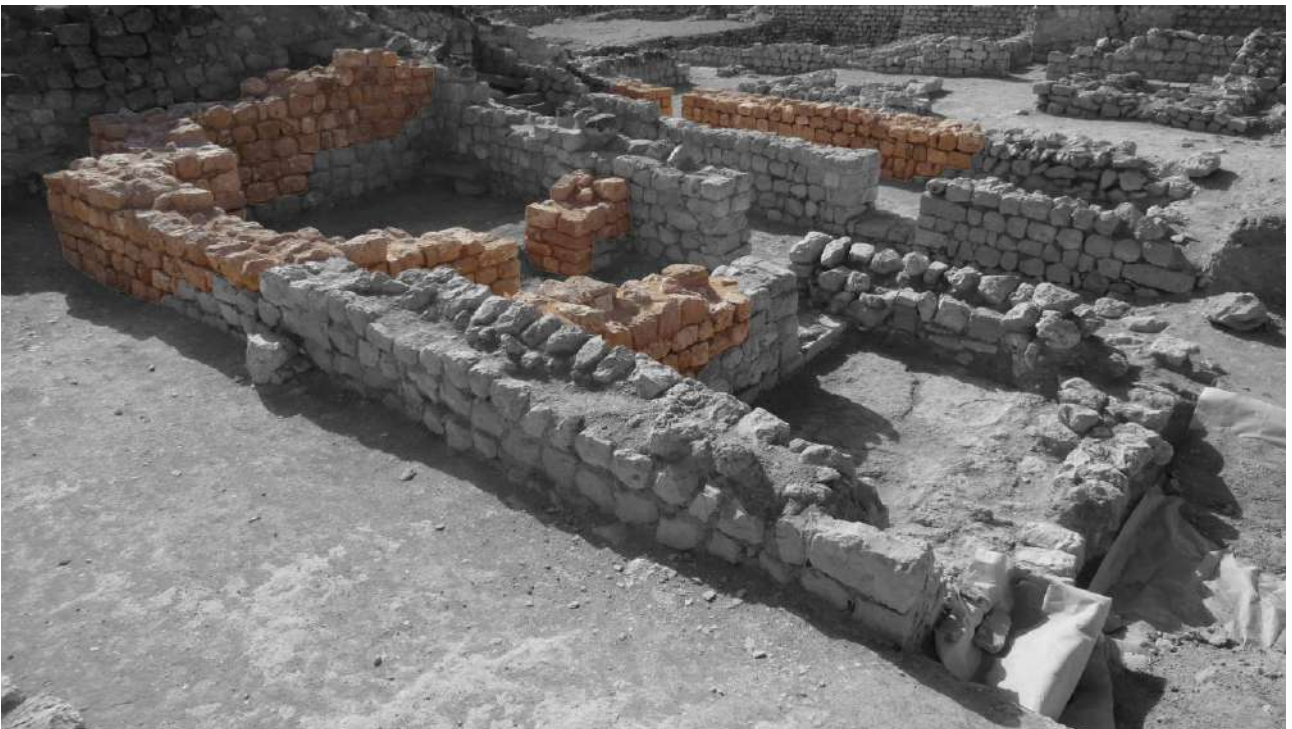
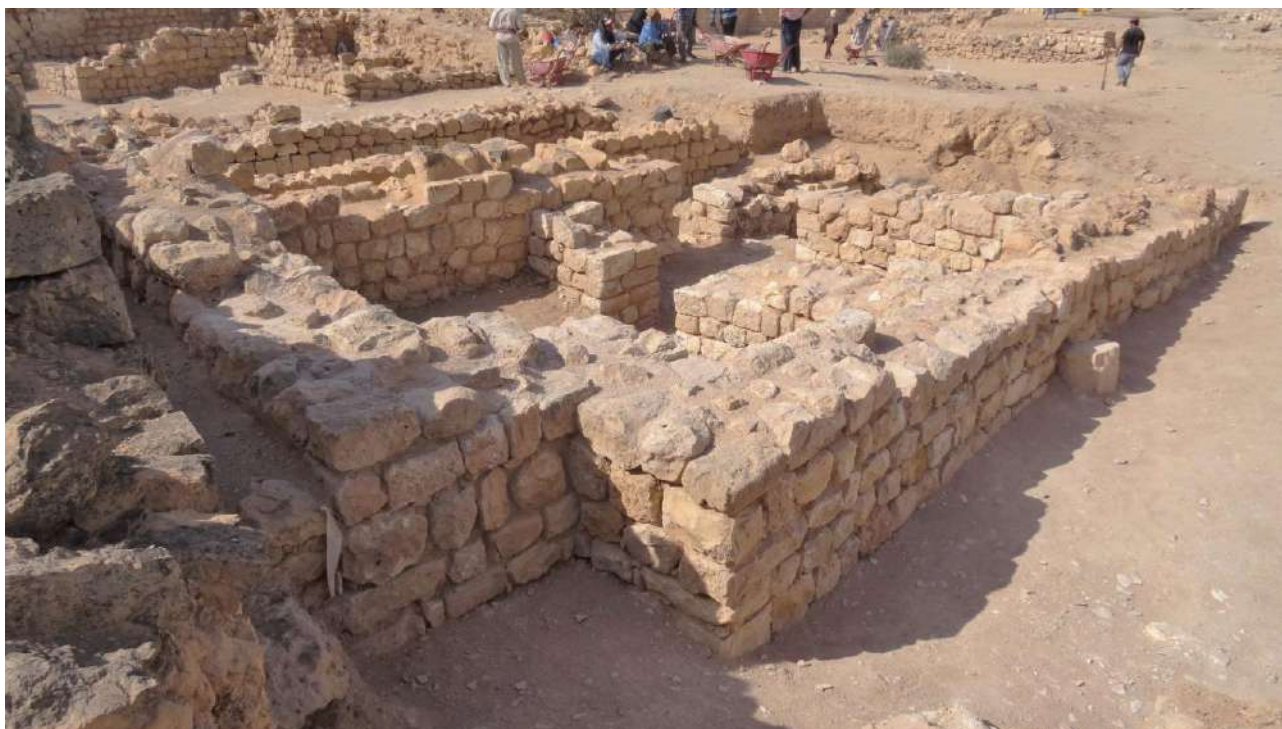
*Fig. 11e – BB4 after the restoration works (view from SW).*

*Fig. 11f – Details of restoration works of BB4 (view from SW).*

*Fig. 11g – BB4 after the restoration works (view from NW).*

*Fig. 11h – Details of restoration works of BB4 (view from NW).*

*Fig. 11i – BB4 after the restoration works (view from NE).*

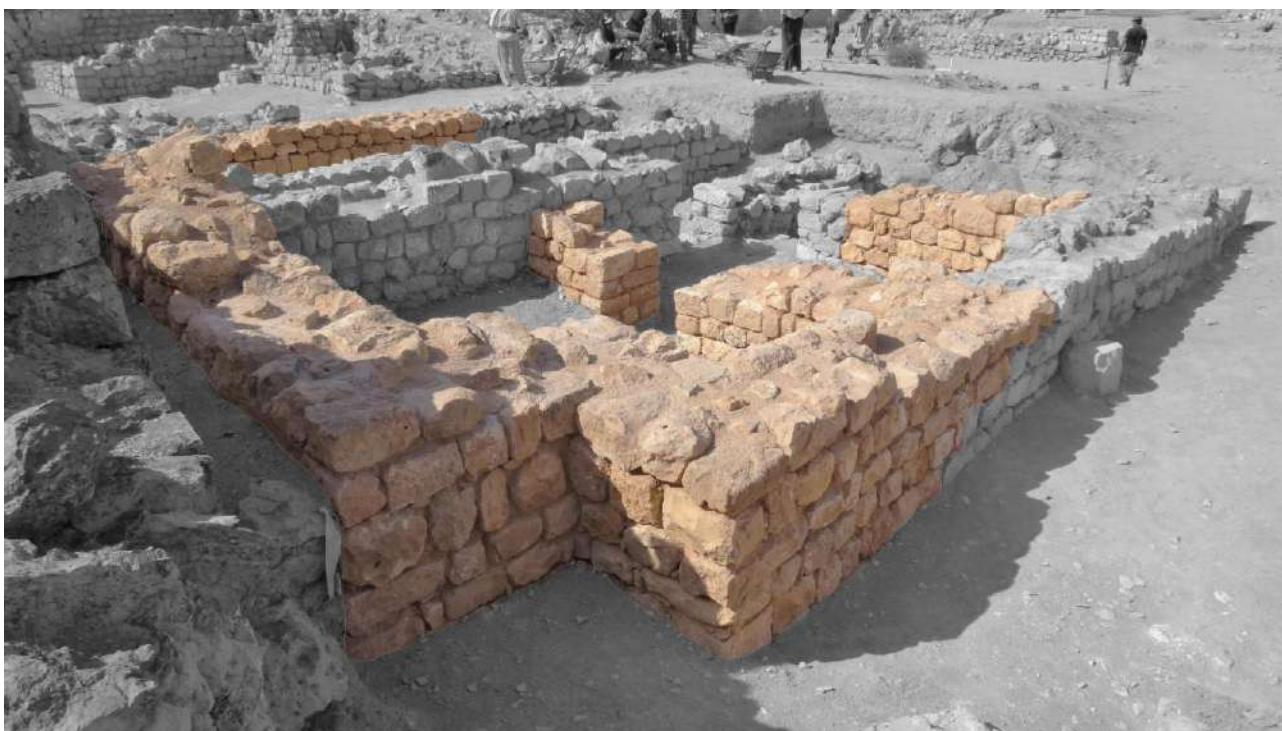
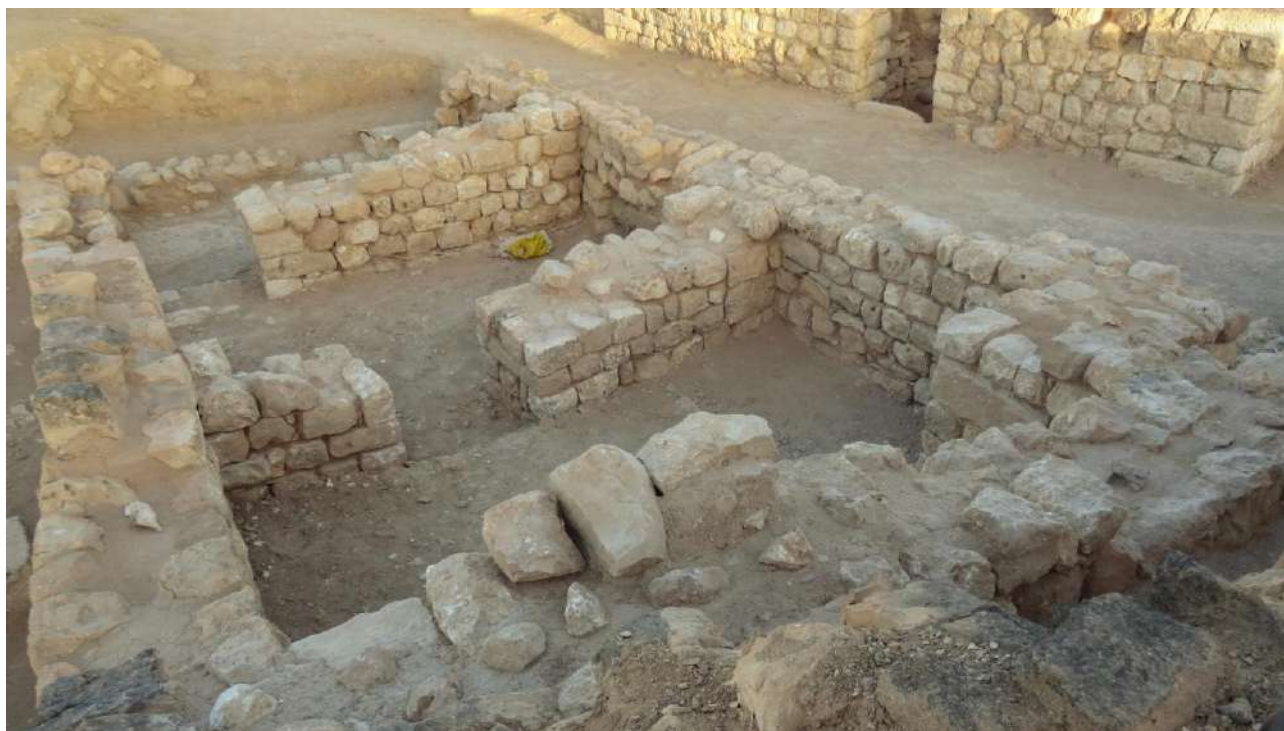
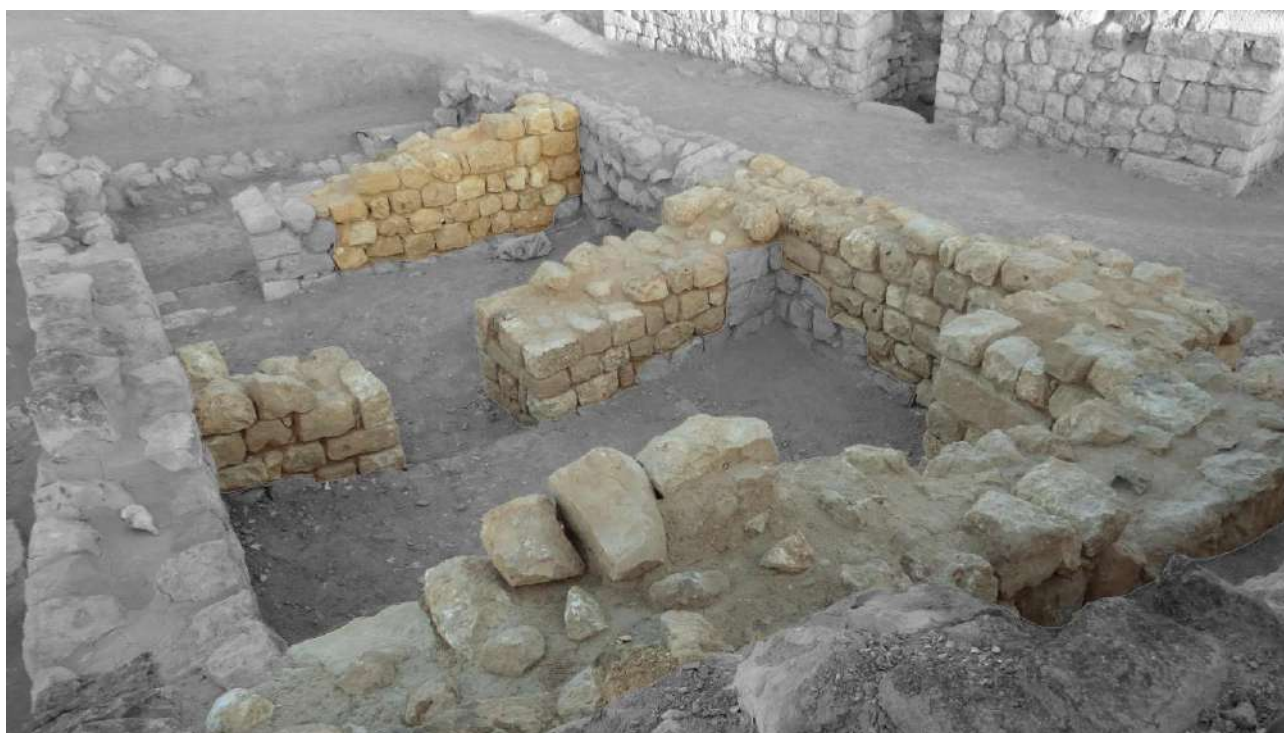
*Fig. 11j – Details of restoration works of BB4 (view from NE).*

*Fig. 11k – BB4 after the restoration works (view from SE).*

*Fig. 11l – Details of restoration works of BB4 (view from SE).*

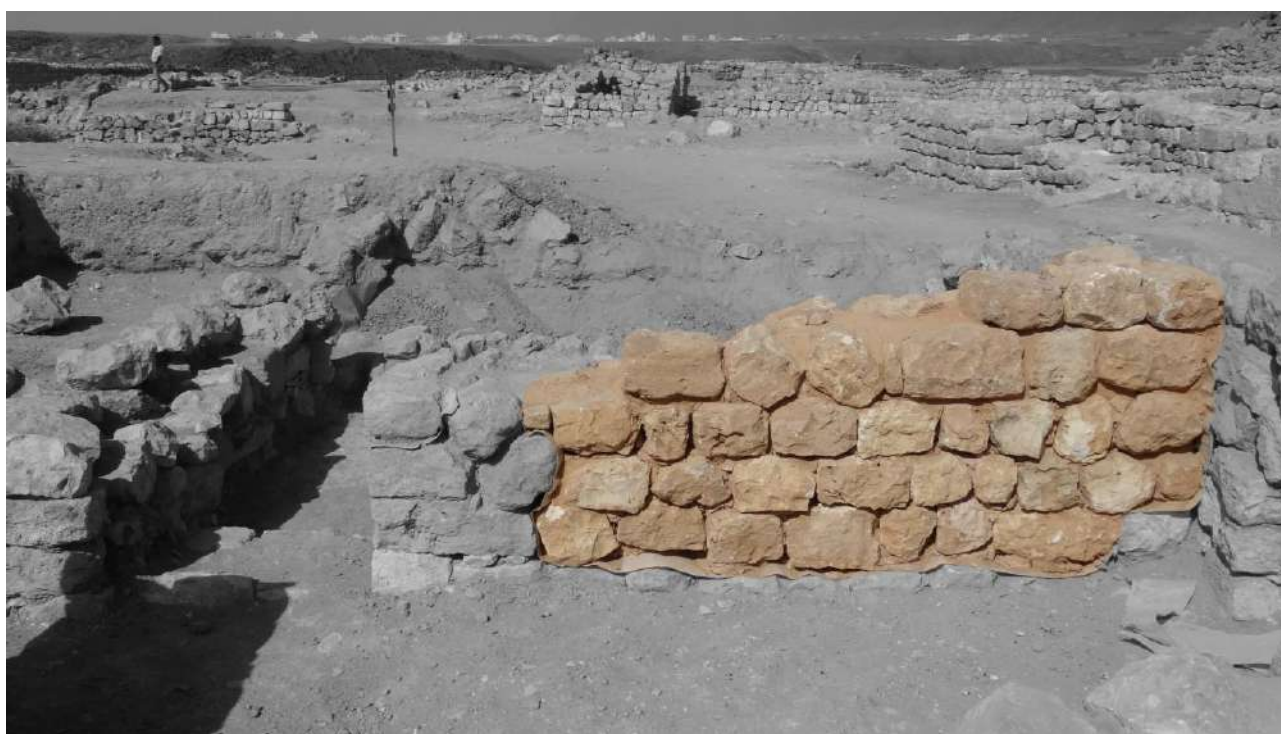
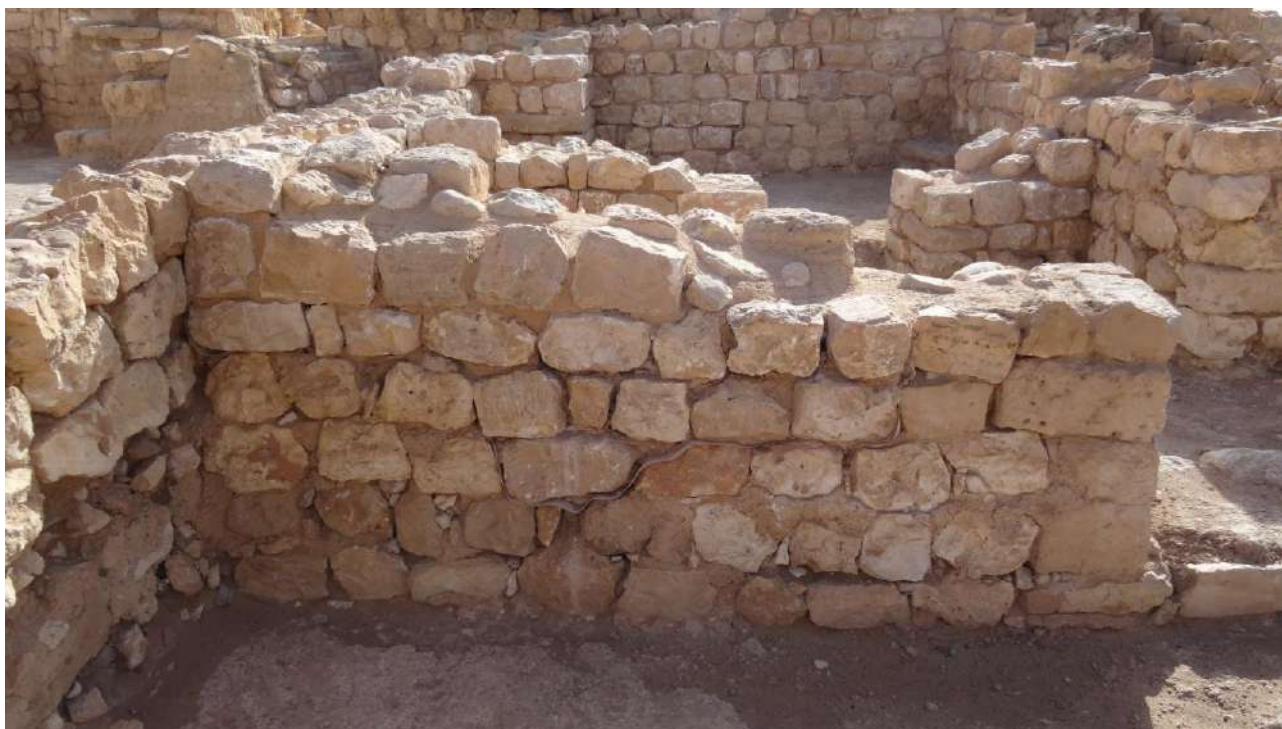
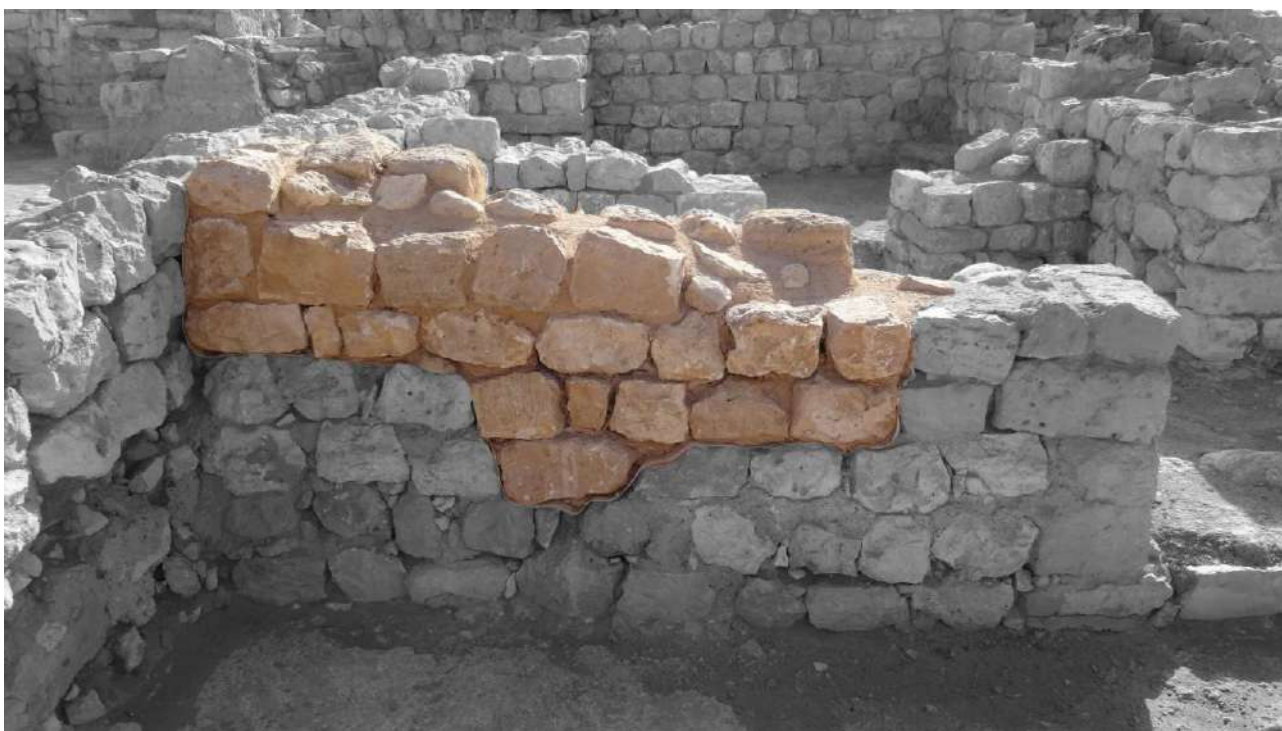
*Fig. 12d – BB4, details of the restoration works of the wall M645 (view from E).*

*Fig. 12e – BB4, wall M645 after the restoration works (view from W).*

*Fig. 12f – BB4, detail of the restoration works of the wall M645 (view from W).*

At first it was restored the wall M645. While the south corner was in good condition, the central part of the wall was widely collapsed. After removing the unstable stones and positioning the geotextile layers, the wall was rebuilt by shaping the top surface as ruin to connect the height of the wall M646 with that of the south end, that was substantially intact (Figs. 12).
