**RESTORATION WORKS AT SUMHURAM  
(ARCHAEOLOGICAL PARK OF KHOR RORI)  
(Sultanate of Oman)  
CAMPAIGN October-December 2017**

**Technical Report**  
**16<sup>th</sup> October – 14<sup>th</sup> December 2017**

**Michele Chimienti – Emiliano Mura**  
**ARCHITECTS**

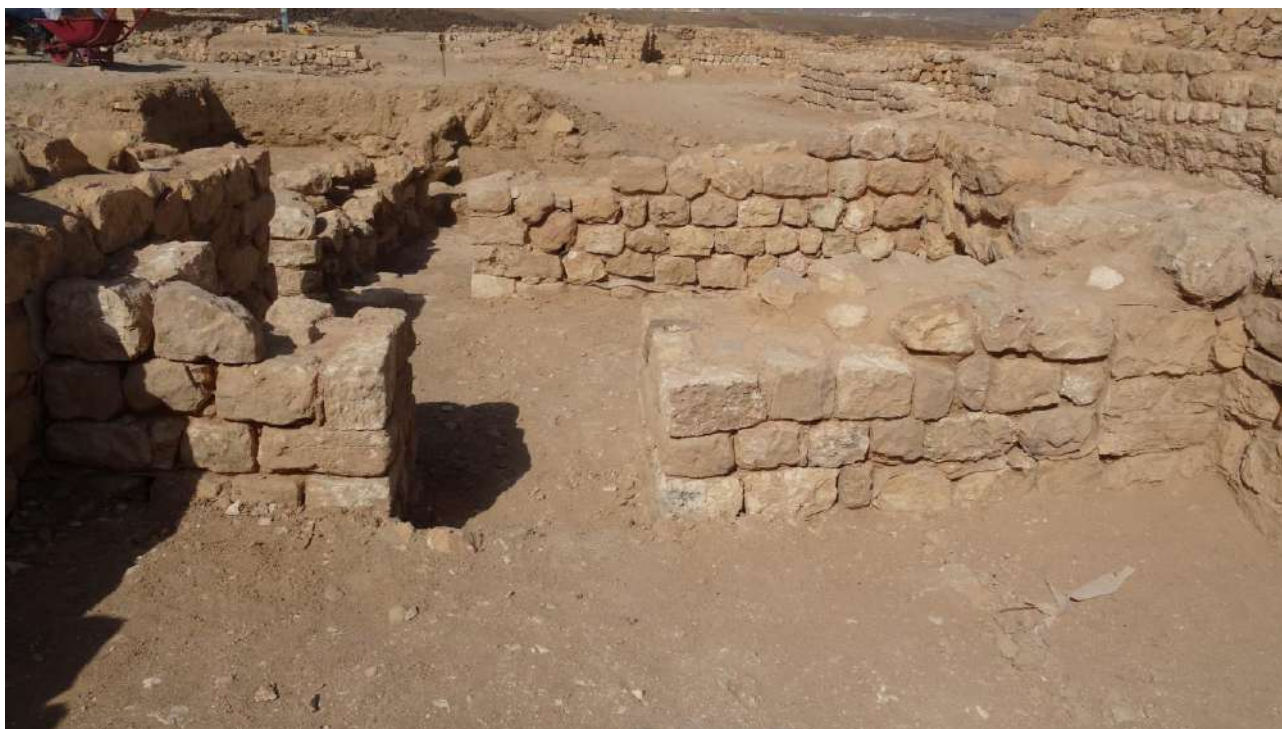
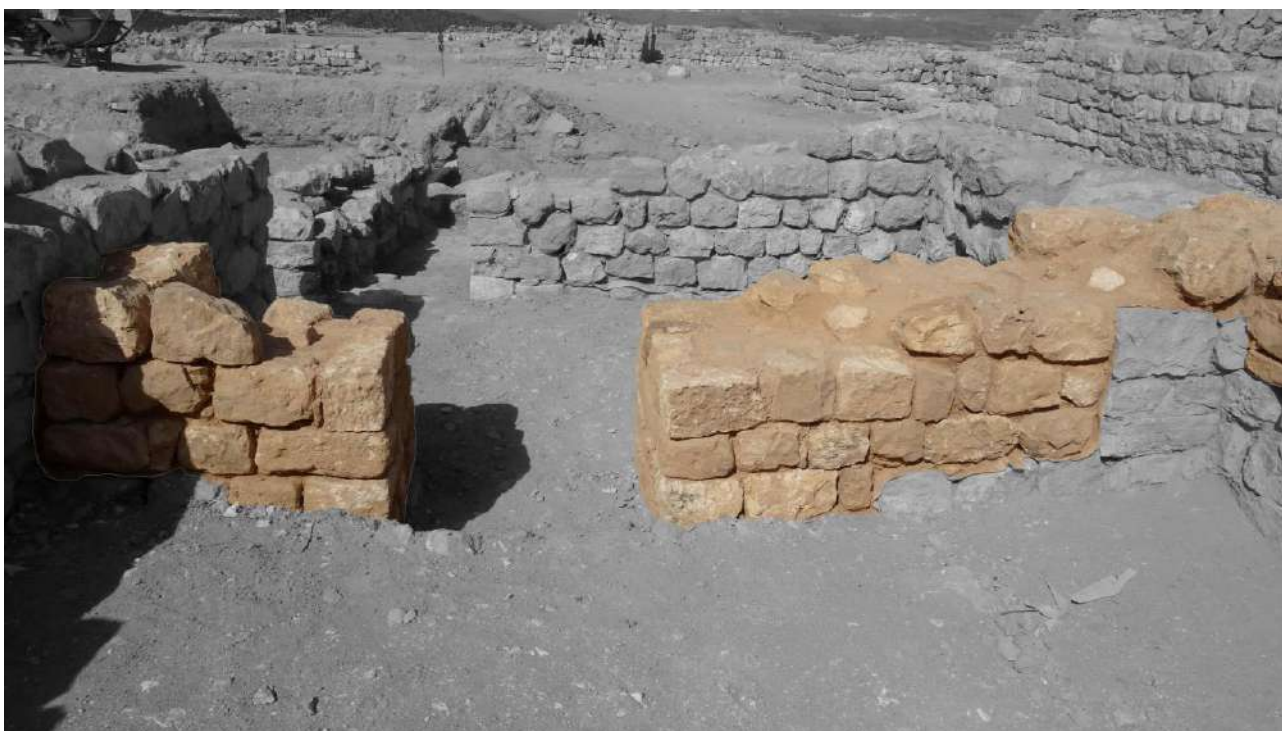
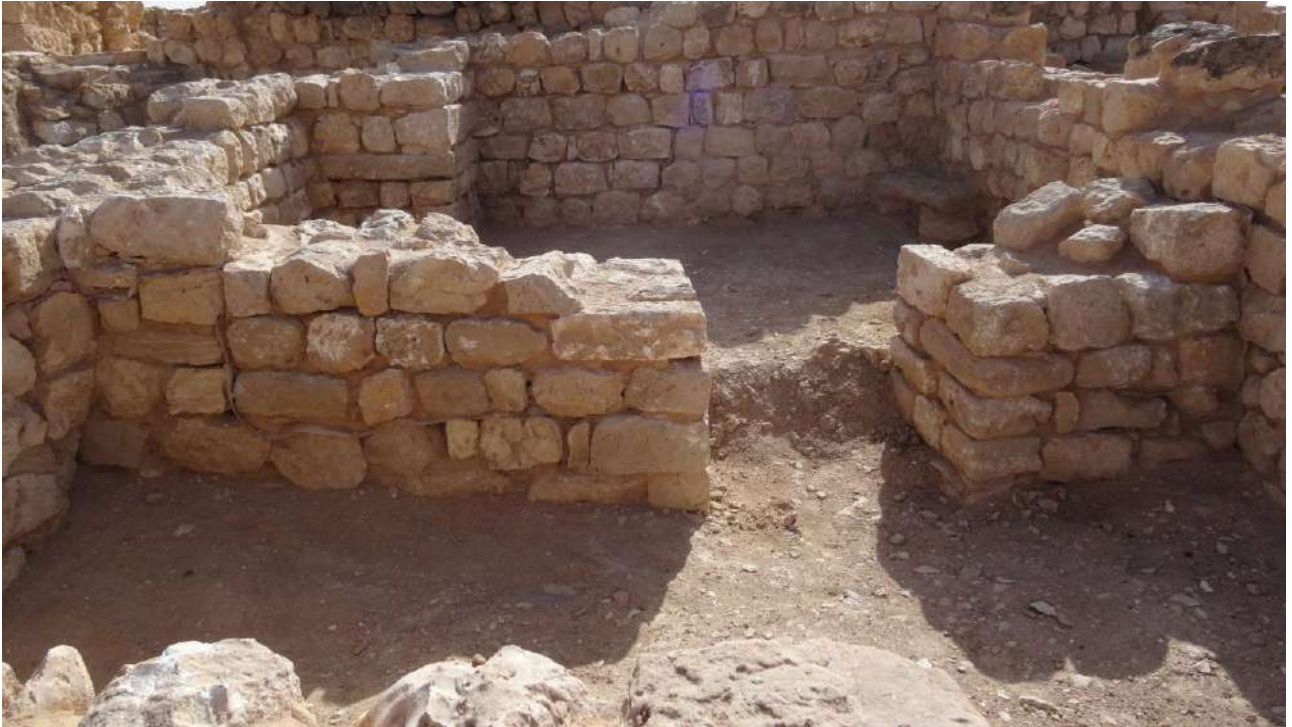
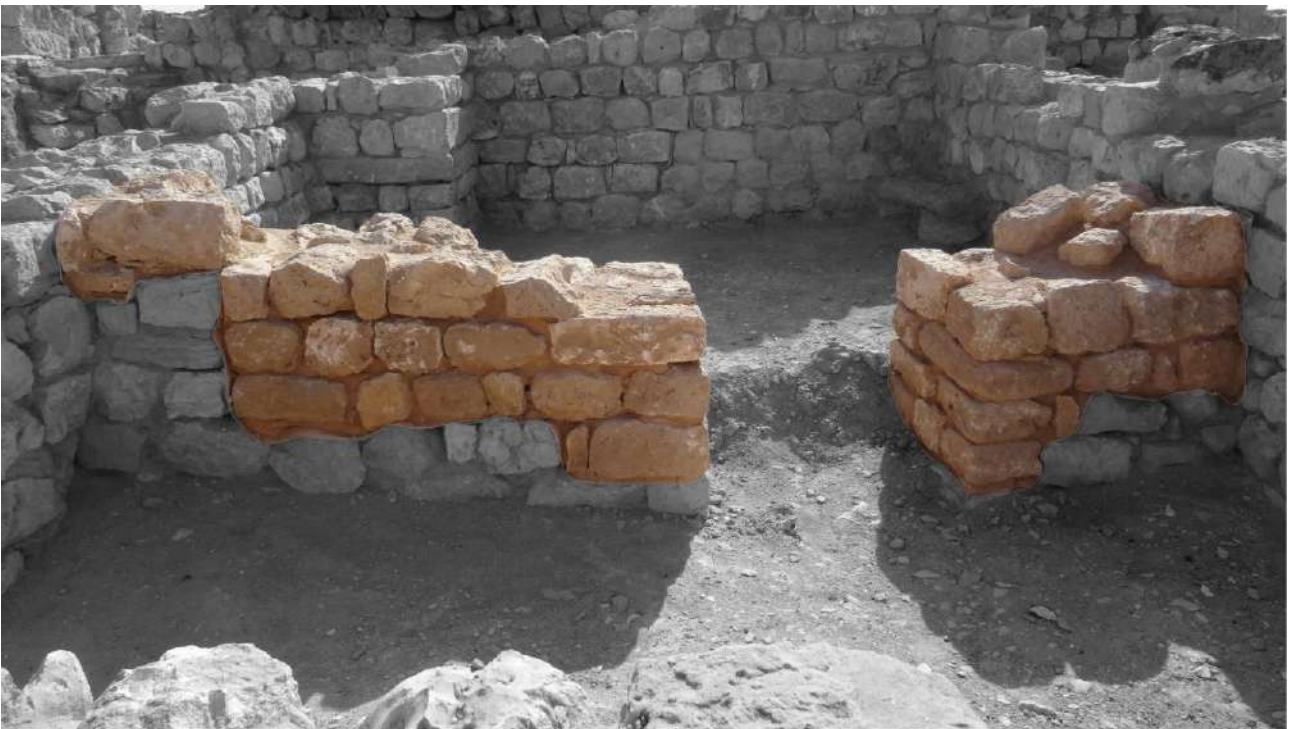
*Fig. 13c – BB4, wall M653 after the restoration works (view from E).*

*Fig. 13d – BB4, details of the restoration works of the wall M653 (view from E).*

*Fig. 13e – BB4, wall M653 after the restoration works (view from W).*

*Fig. 13f – BB4, details of the restoration works of the wall M653 (view from W).*

Afterwards it was rebuilt the wall M653. The southern half of the wall was almost completely collapsed, with the exception of the first row of stones. Therefore it was possible to create the door in its original position, though there was a doubt jamb near the north transversal wall M646. Before rebuilding the masonry, the unsafe stones were removed and the geotextile layer was placed (Figs. 13).

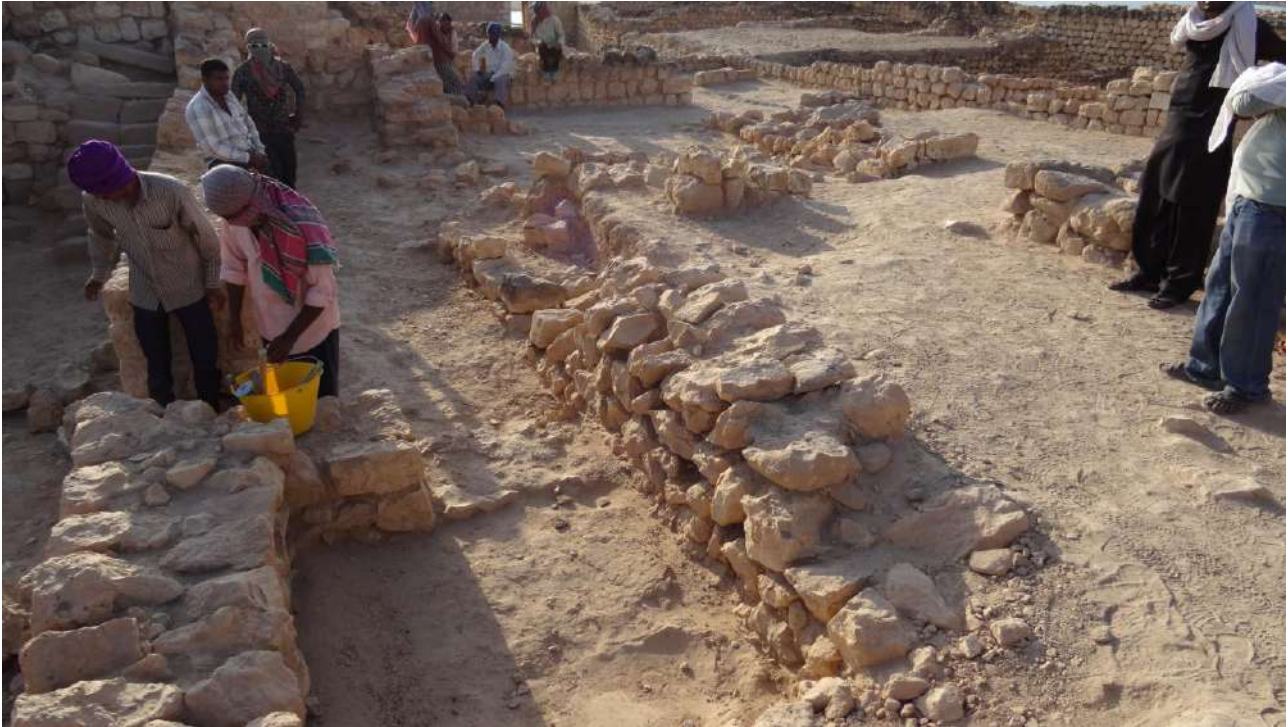
*Fig. 14a – BB4, wall M578 before the restoration work (view from NW).*

During the restoration of the walls M645 and M653, it was also reconstructed the wall M578 between the alignments M698 and M235. After digging to find a solid surface on which to base the wall, all the first row was laid. From the second row on, the rows were interrupted to make an opening in the east part of the wall. Having no trace of the location of that door, it was created in the middle of the room to access (Figs. 14).

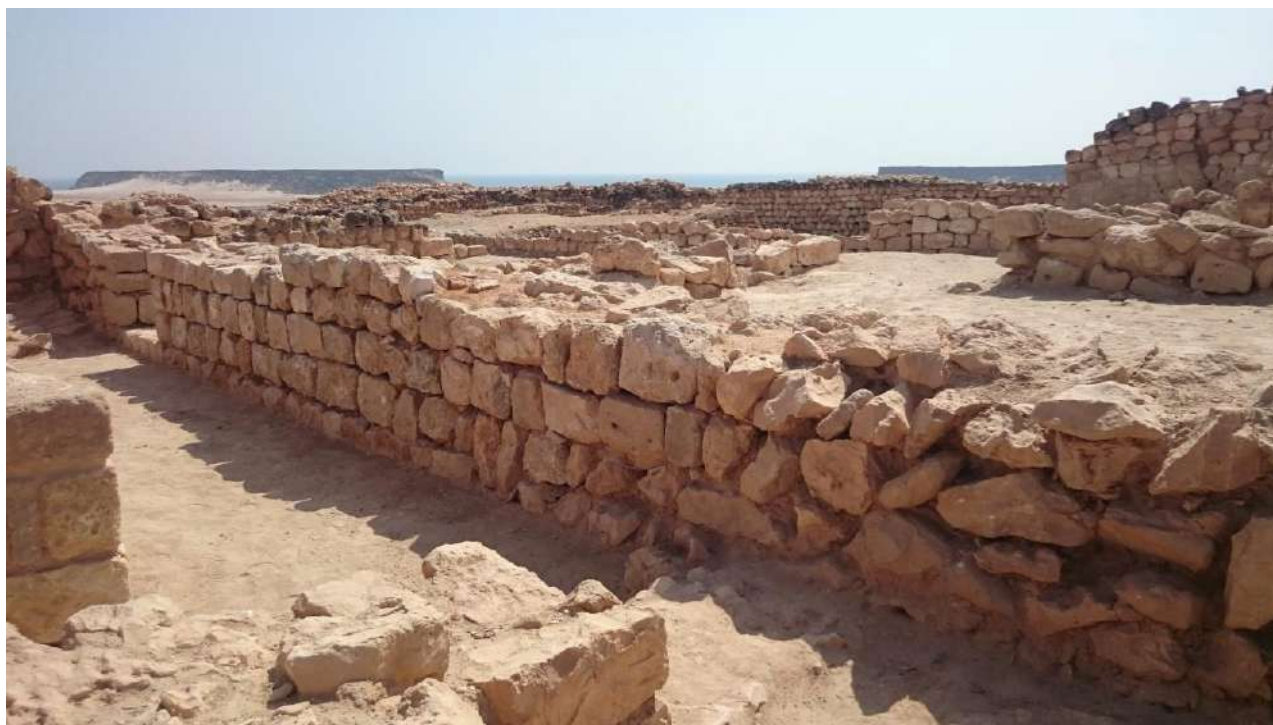
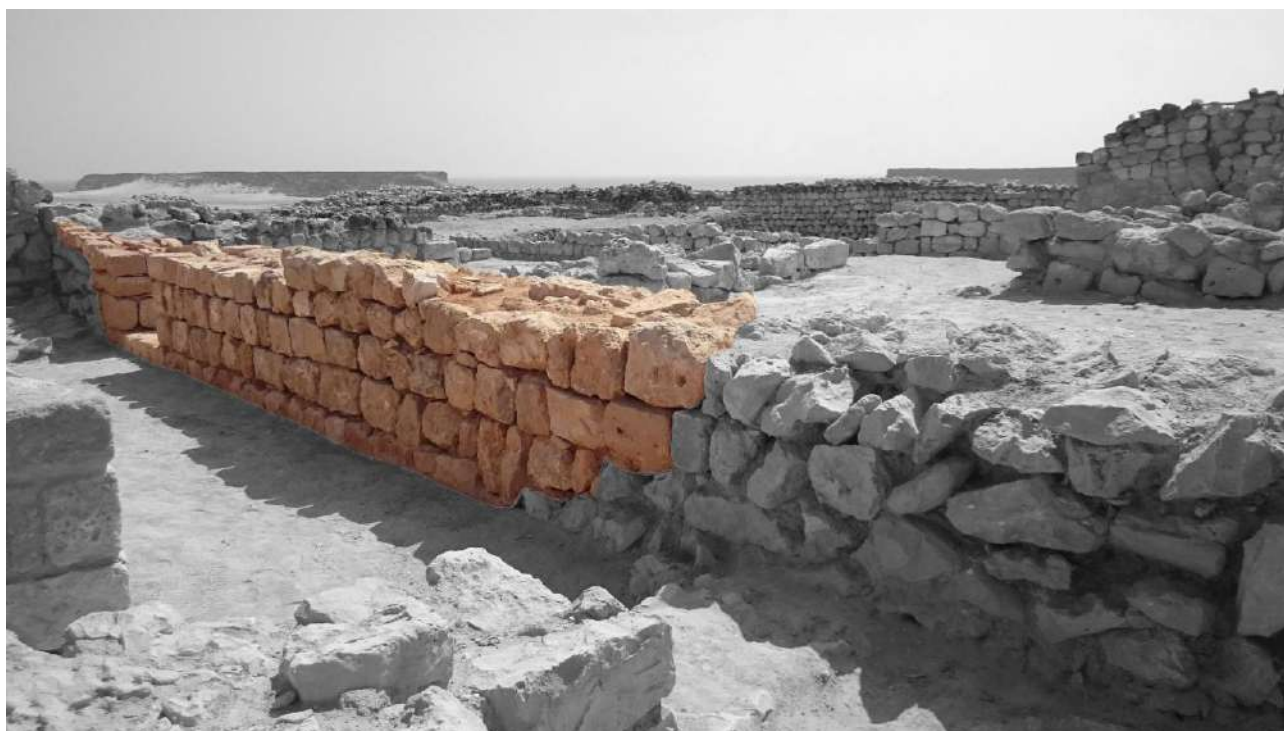
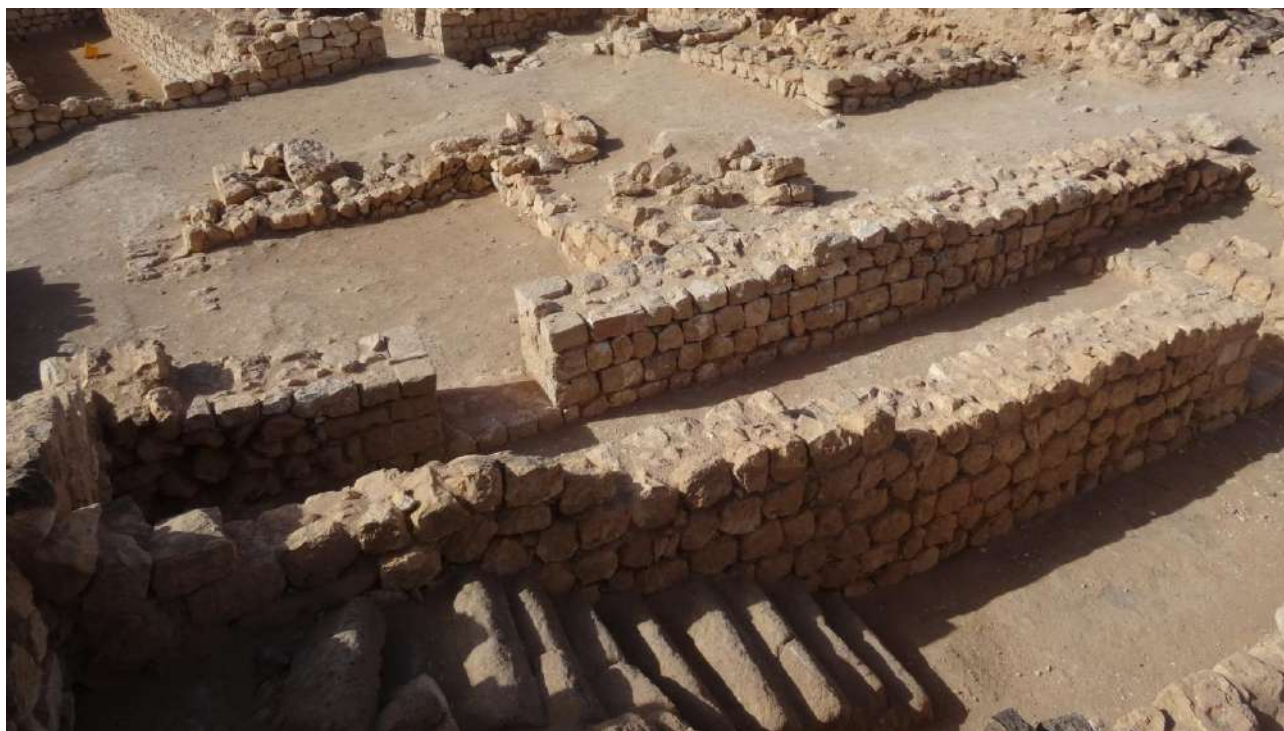
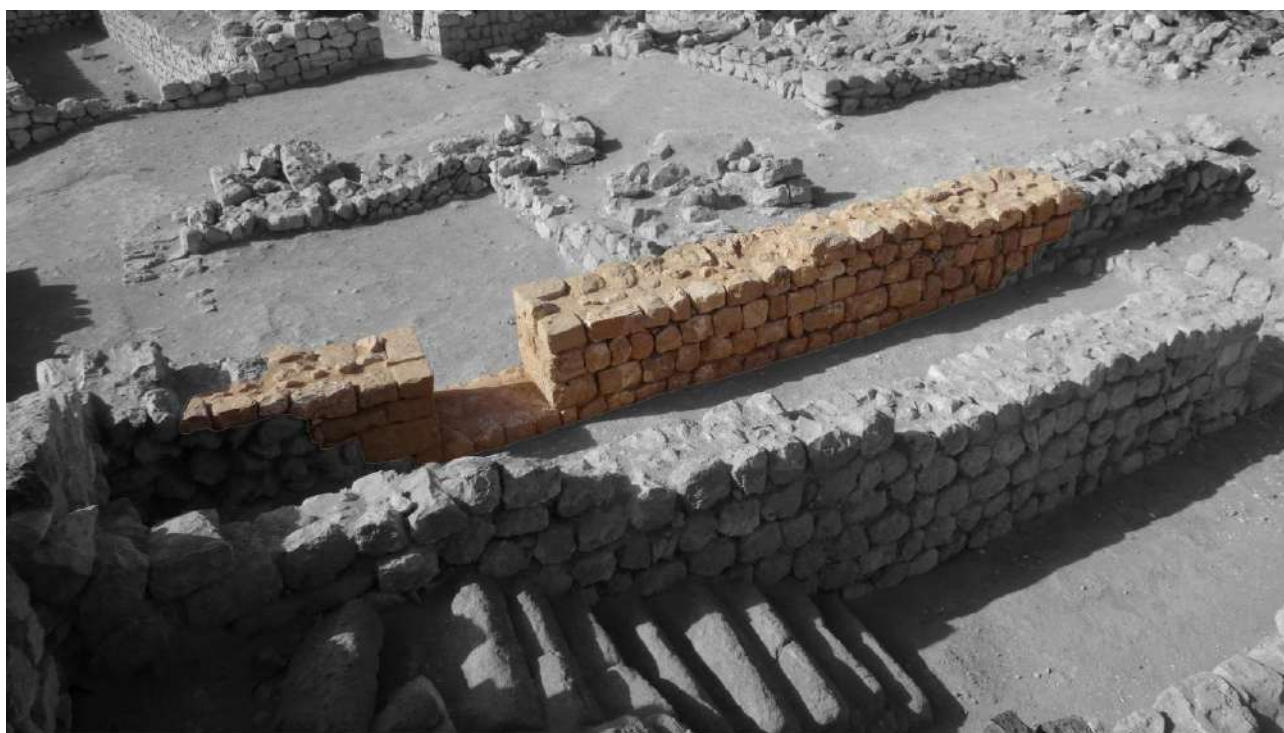
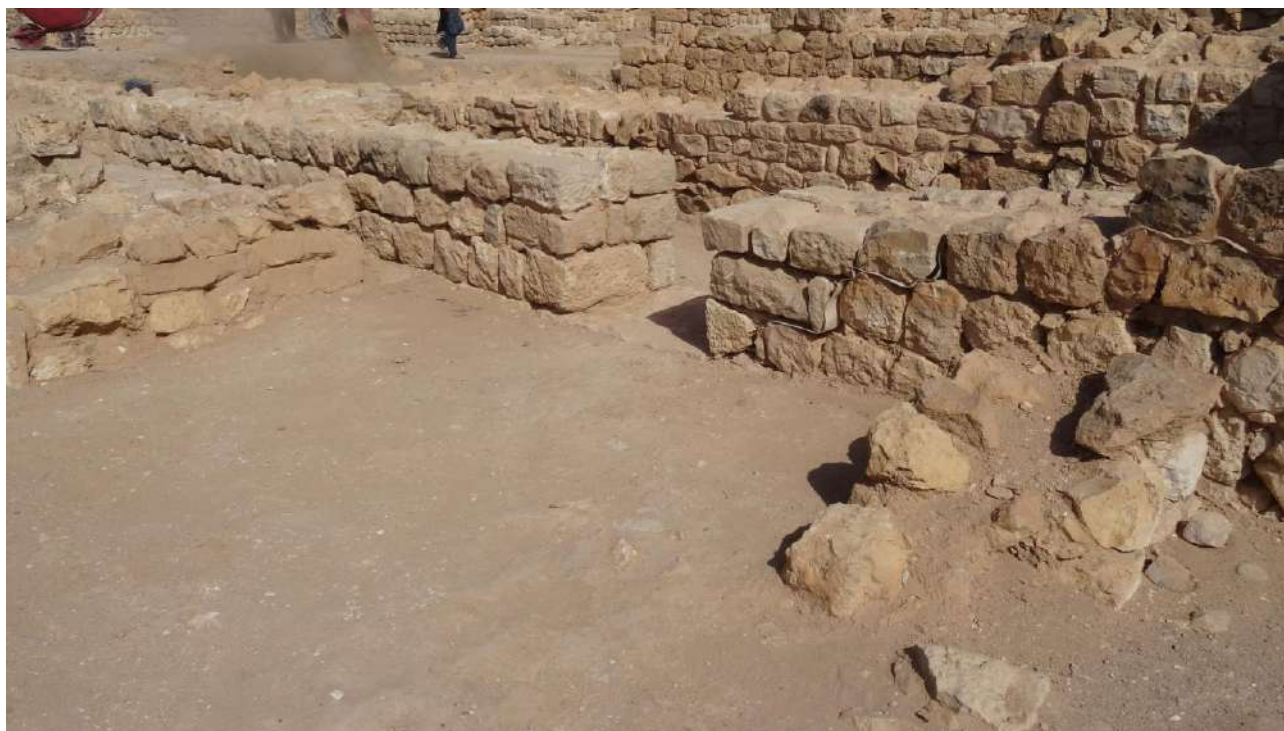
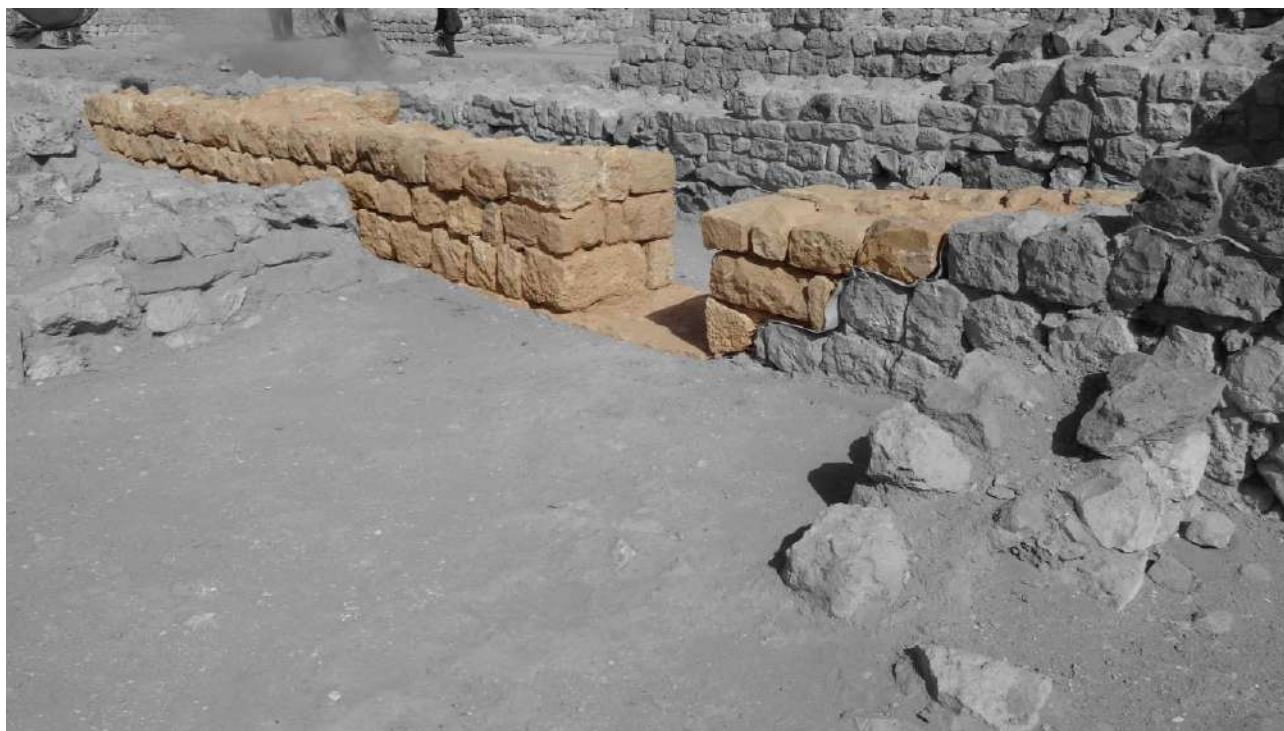
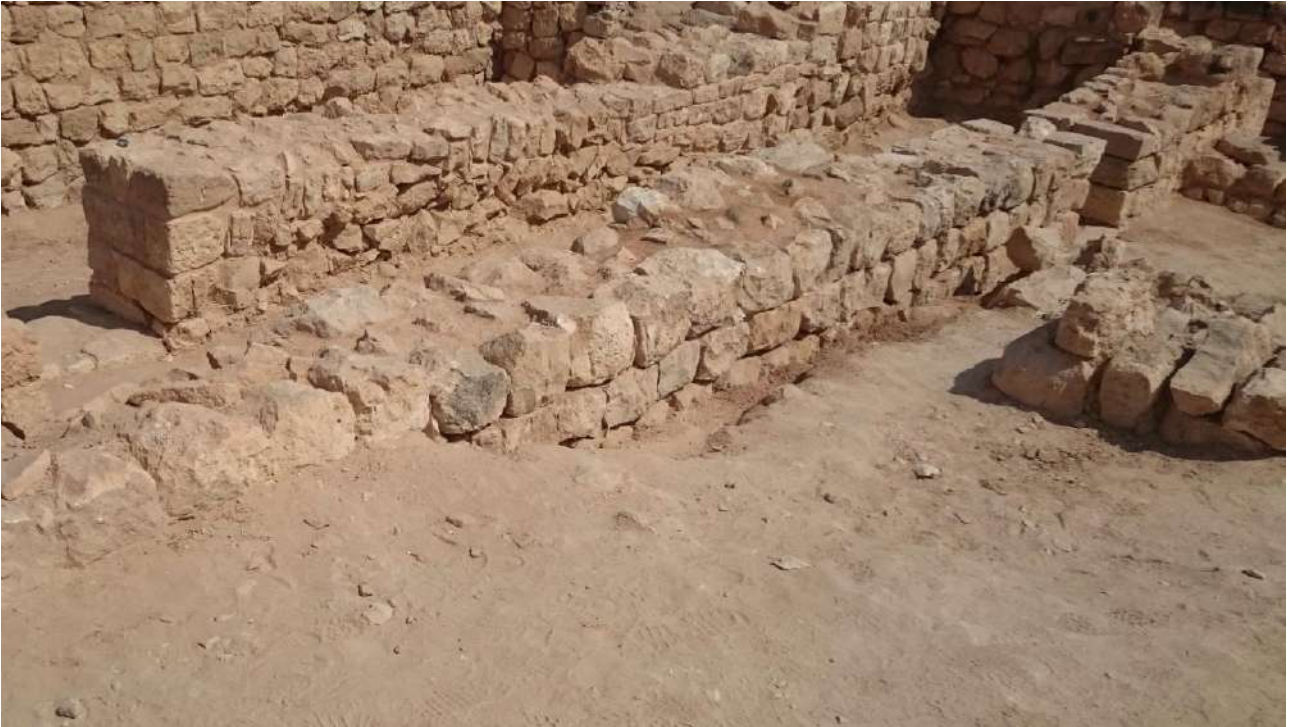
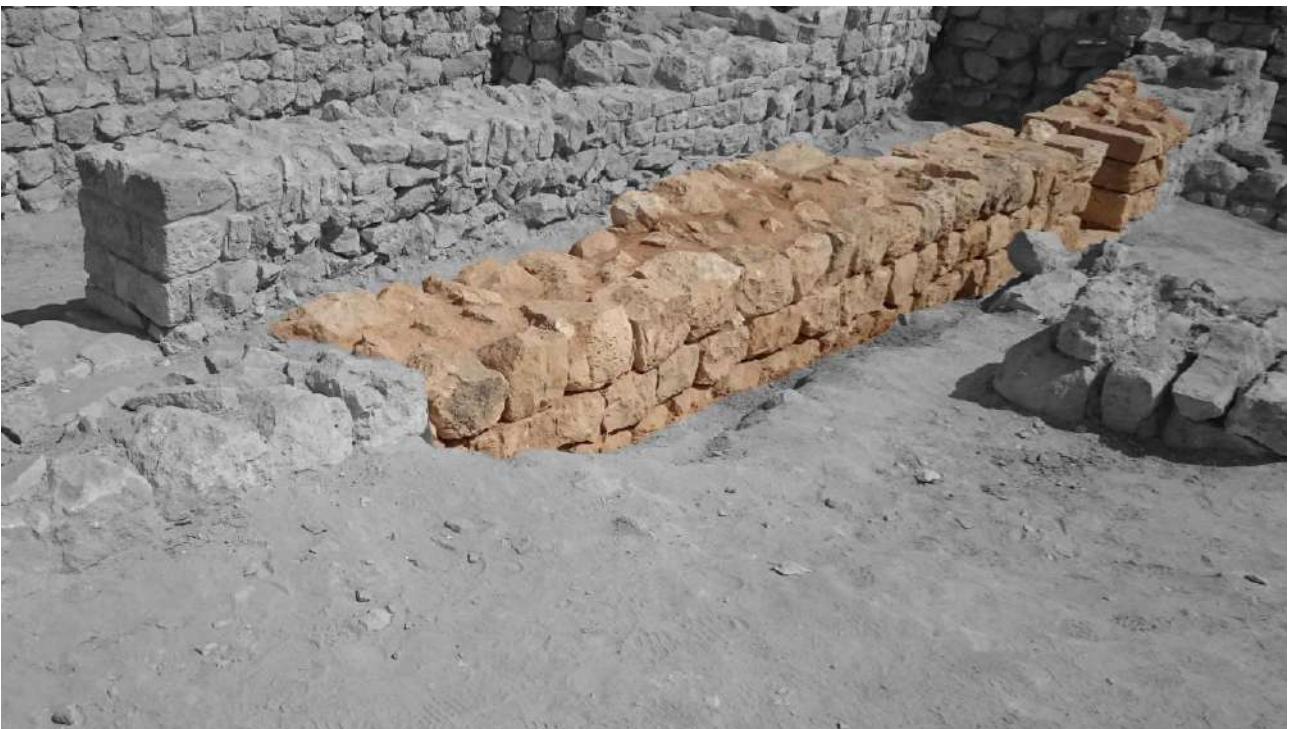
*Fig. 14c – BB4, wall M578 after the restoration works (view from NW).*

*Fig. 14d – BB4, details of the restoration works of the wall M578 (view from NW).*

*Fig. 14e – BB4, wall M578 after the restoration works (view from NE).*

*Fig. 14f – BB4, details of the restoration works of the wall M578 (view from NE).*

*Fig. 14g – BB4, wall M578 after the restoration works (view from SE).*

*Fig. 14h – BB4, details of the restoration works of the wall M578 (view from SE).*

*Fig. 14i – BB4, wall M578 after the restoration works (view from SW).*

*Fig. 14j – BB4, details of the restoration works of the wall M578 (view from SW).*
