**RESTORATION WORKS AT SUMHURAM  
(ARCHAEOLOGICAL PARK OF KHOR RORI)  
(Sultanate of Oman)  
CAMPAIGN October-December 2017**

**Technical Report**  
**16<sup>th</sup> October – 14<sup>th</sup> December 2017**

**Michele Chimienti – Emiliano Mura**  
**ARCHITECTS**

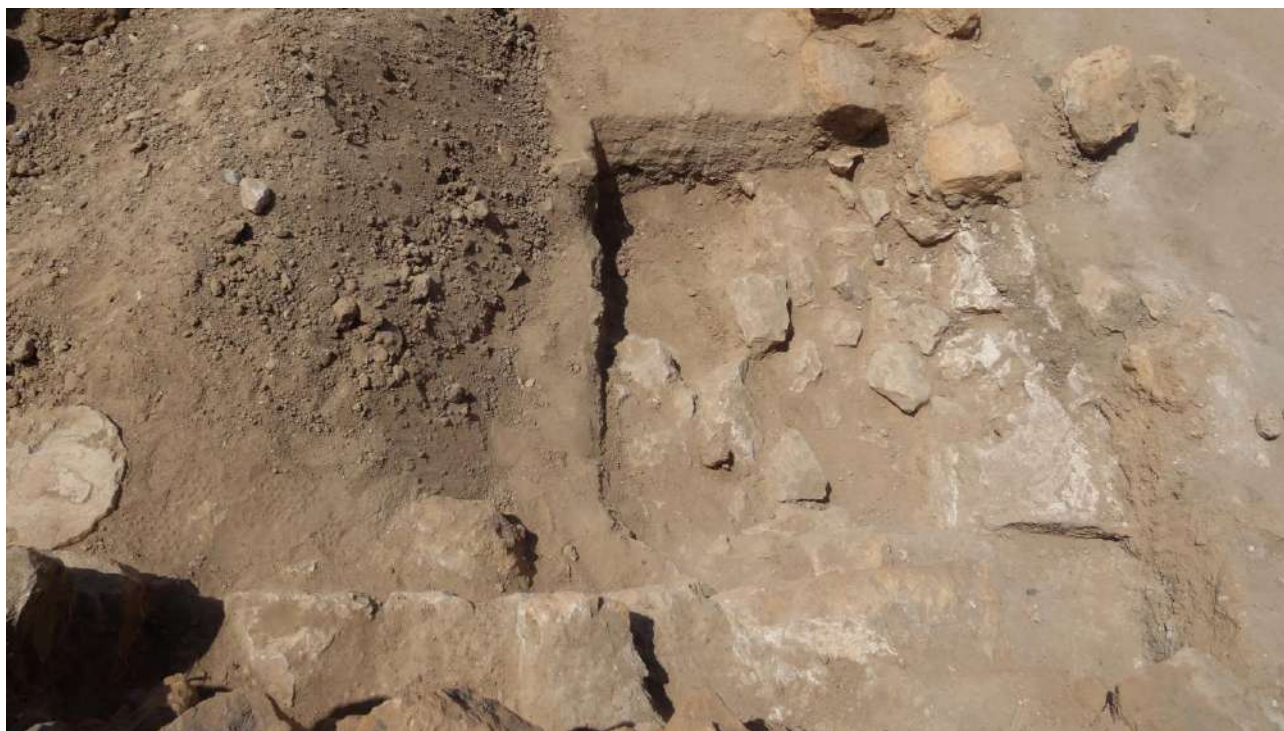
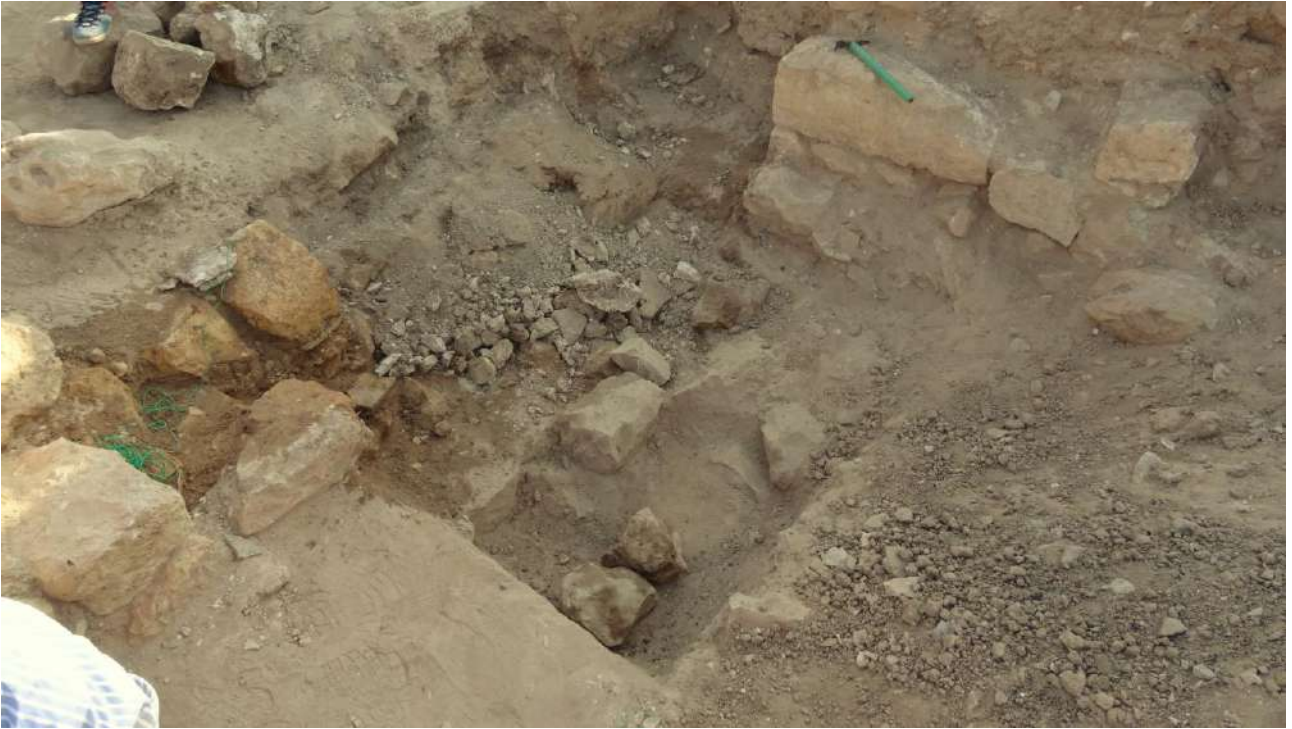
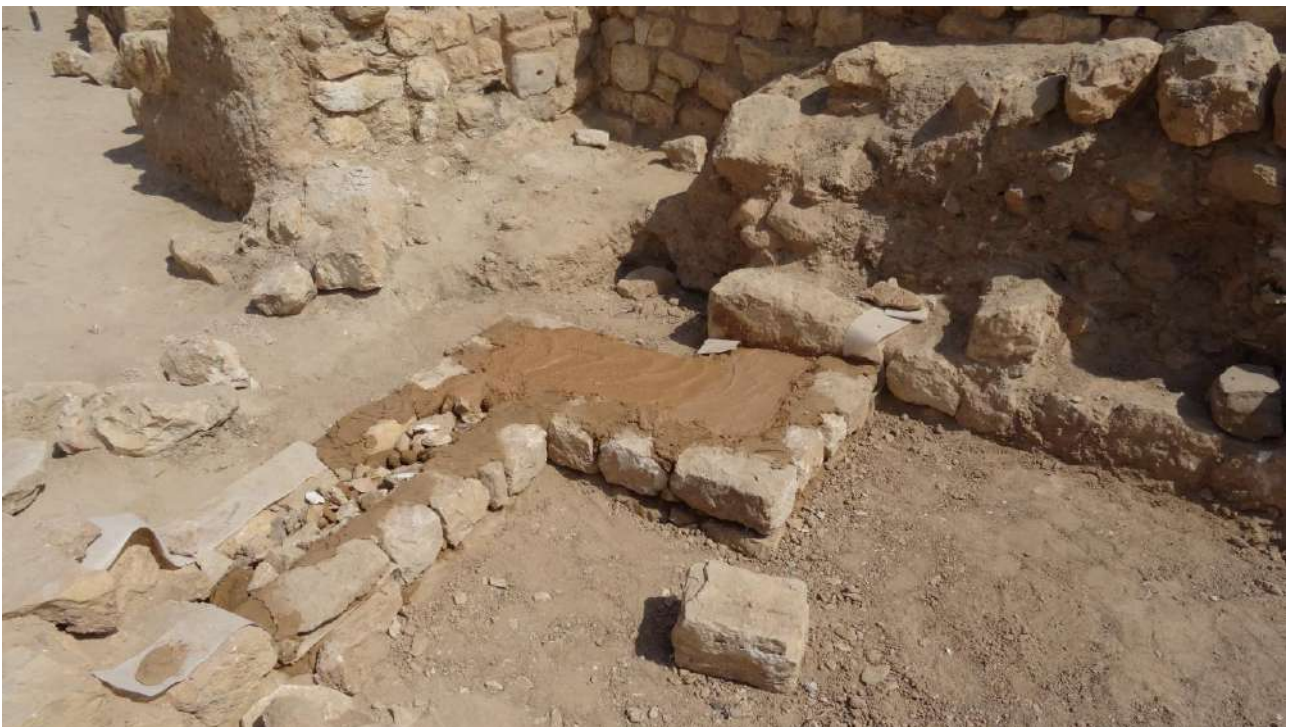
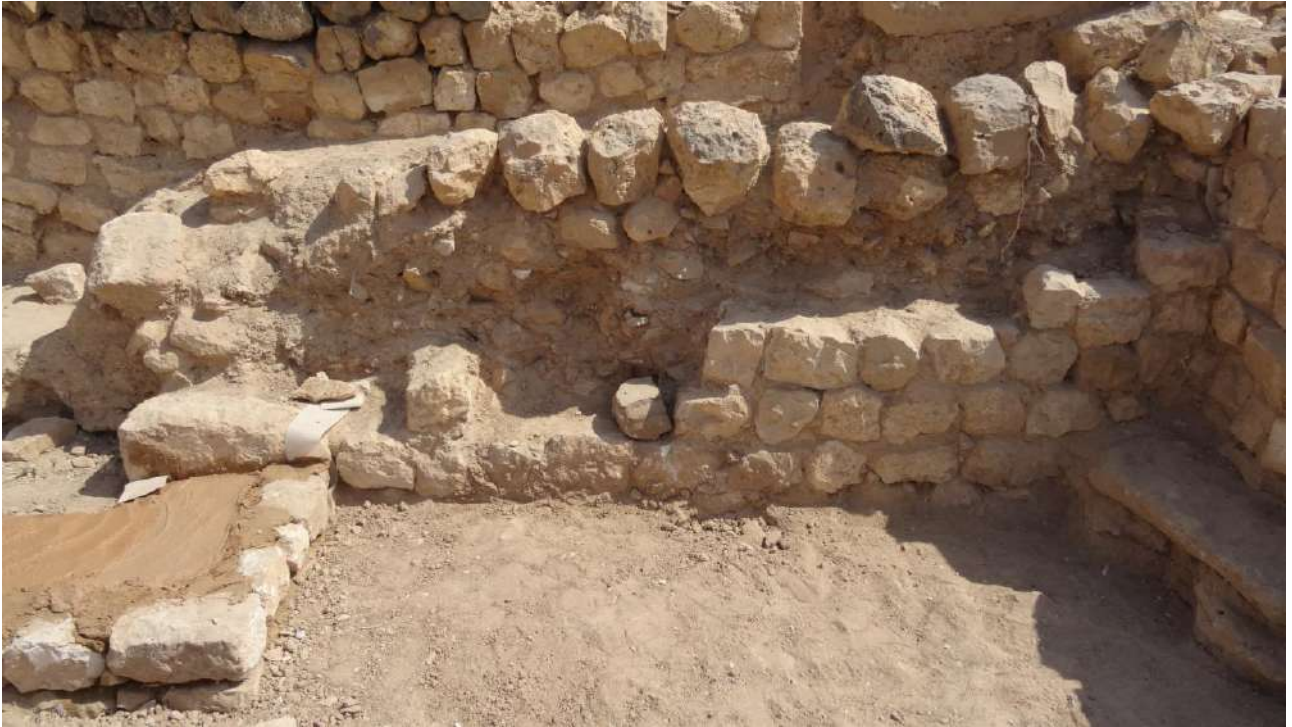
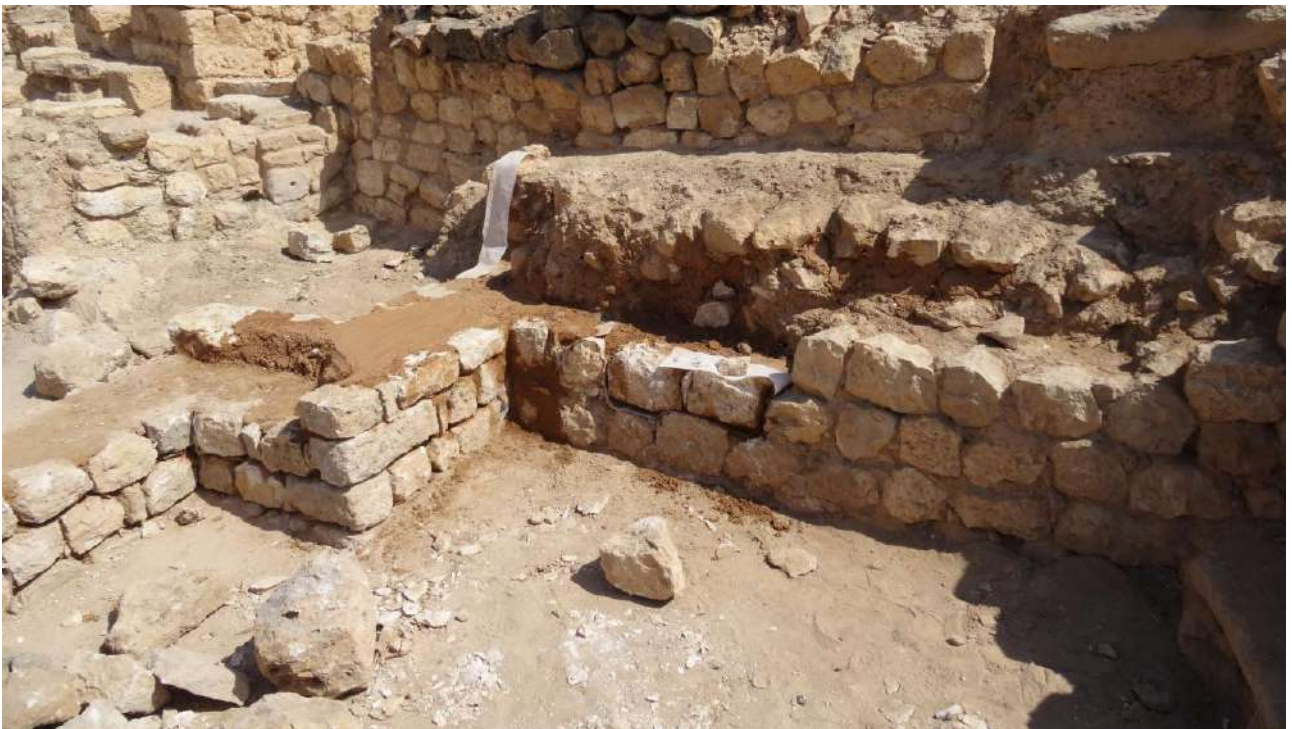
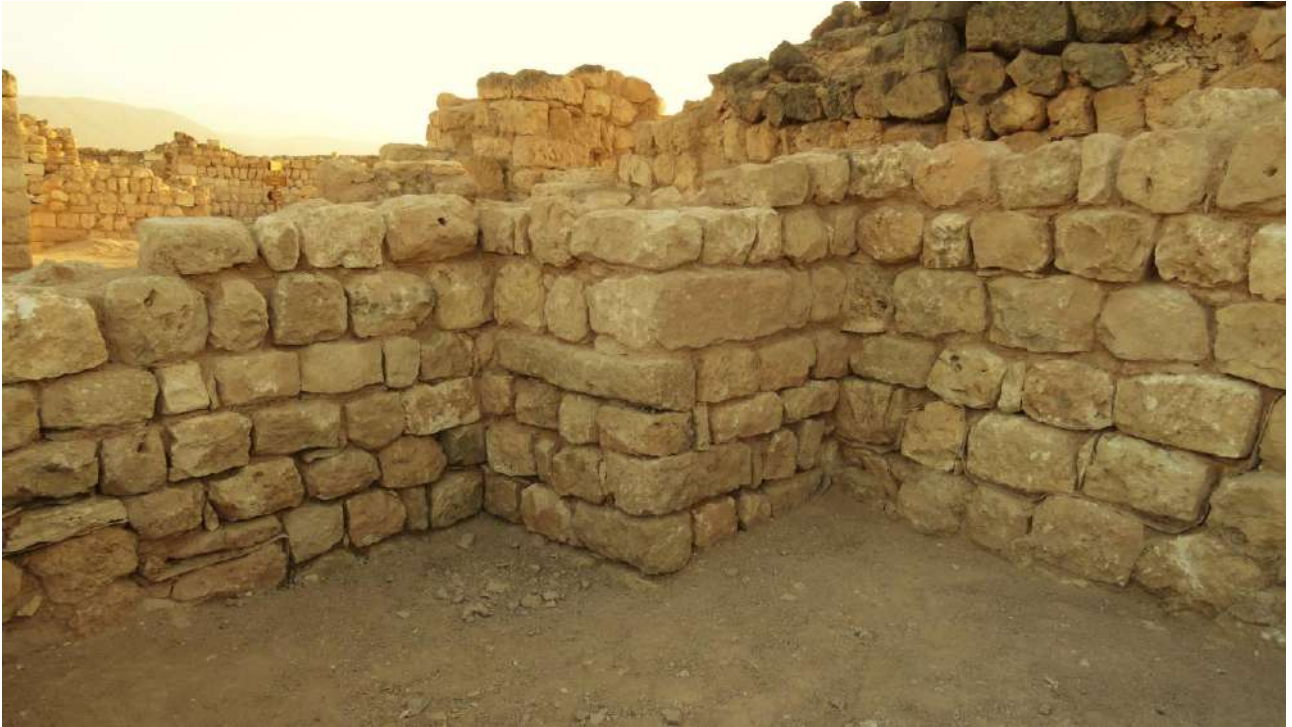
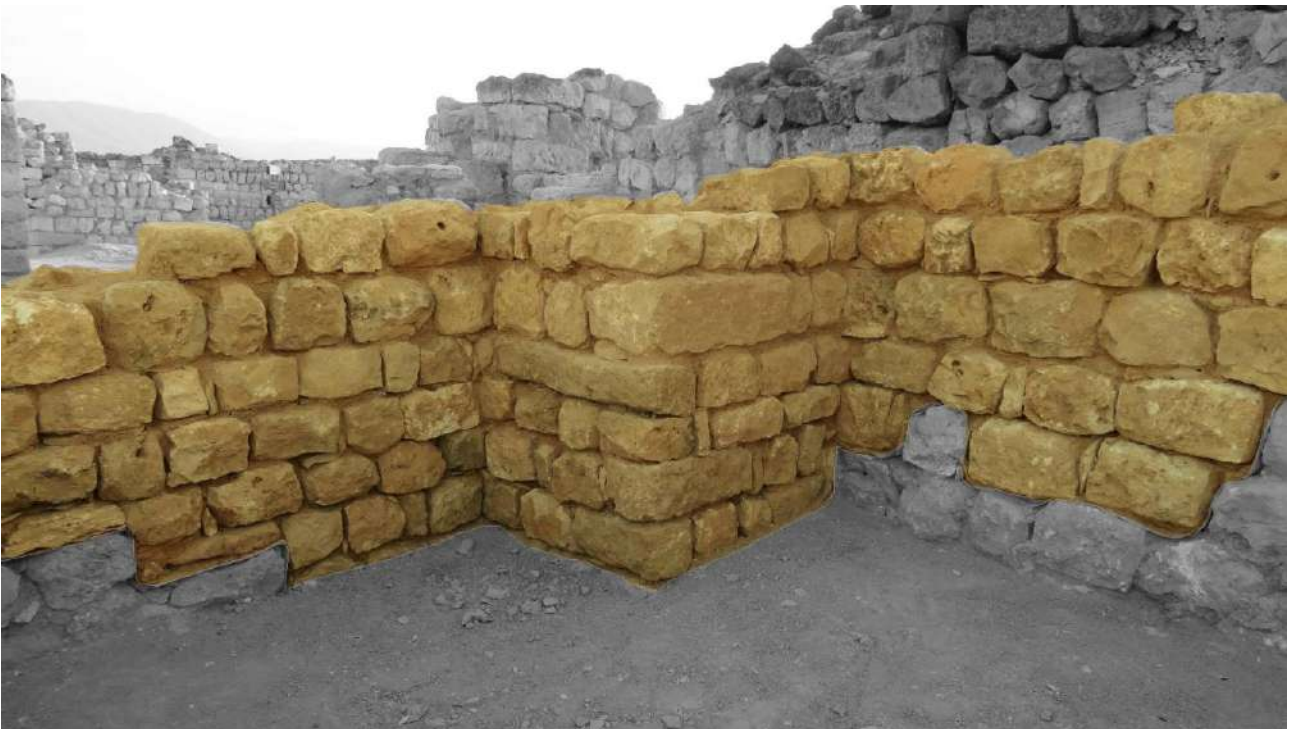
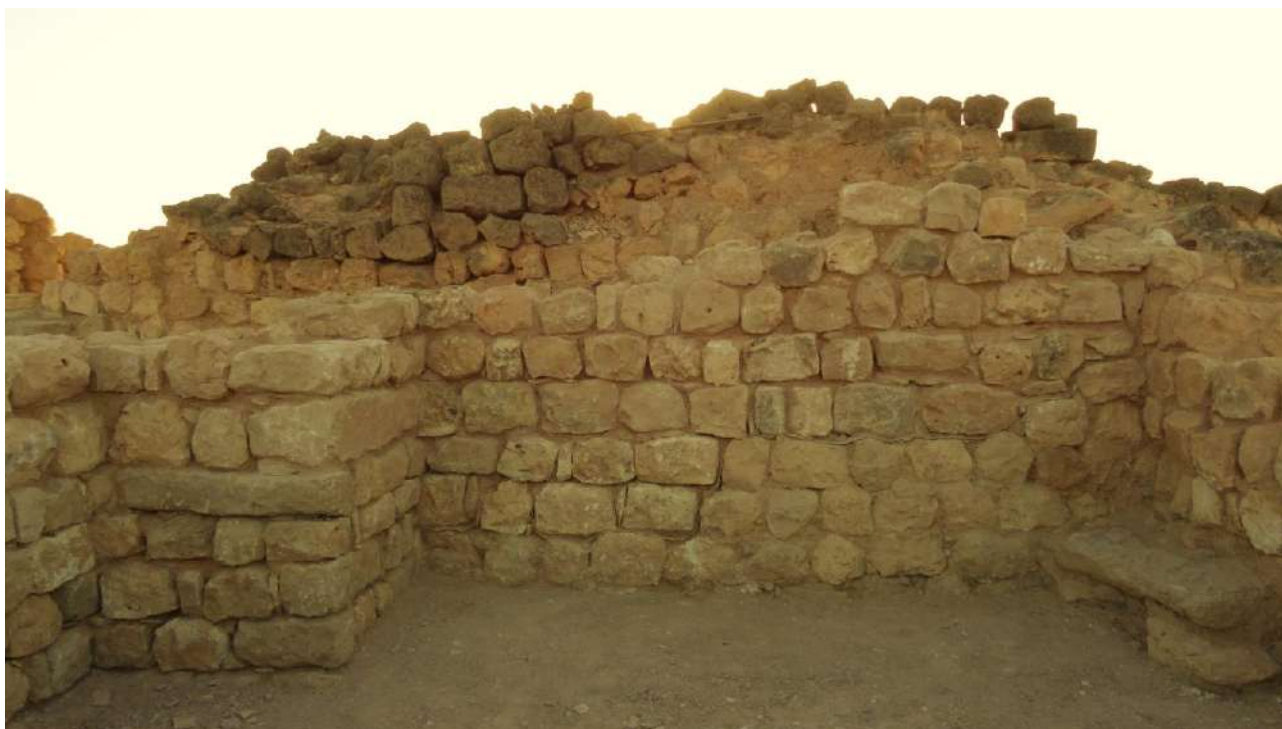
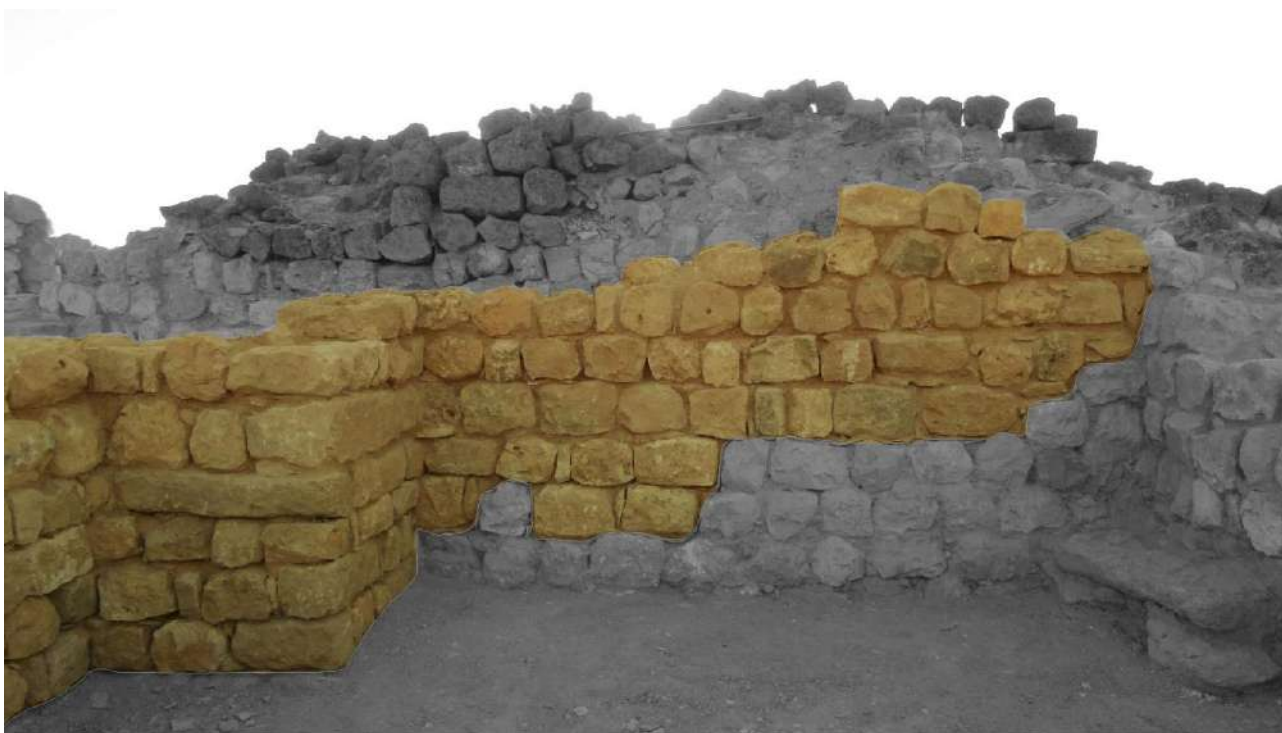
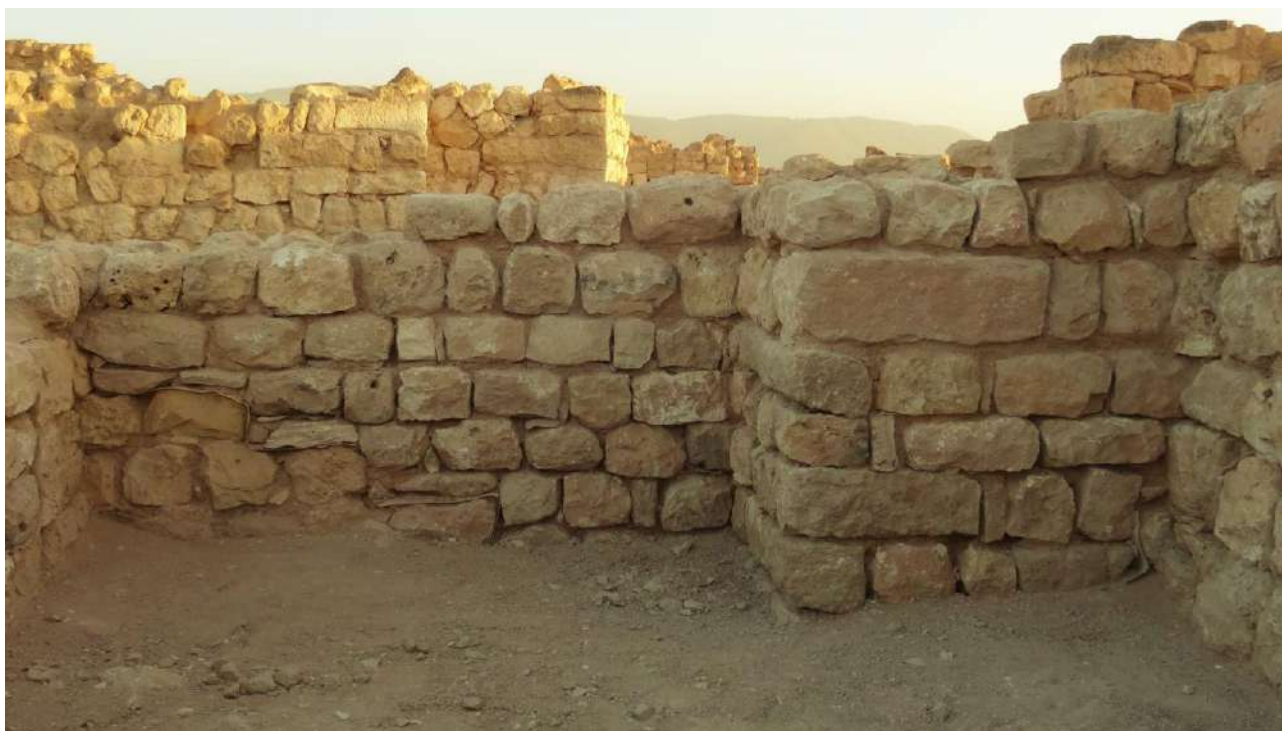
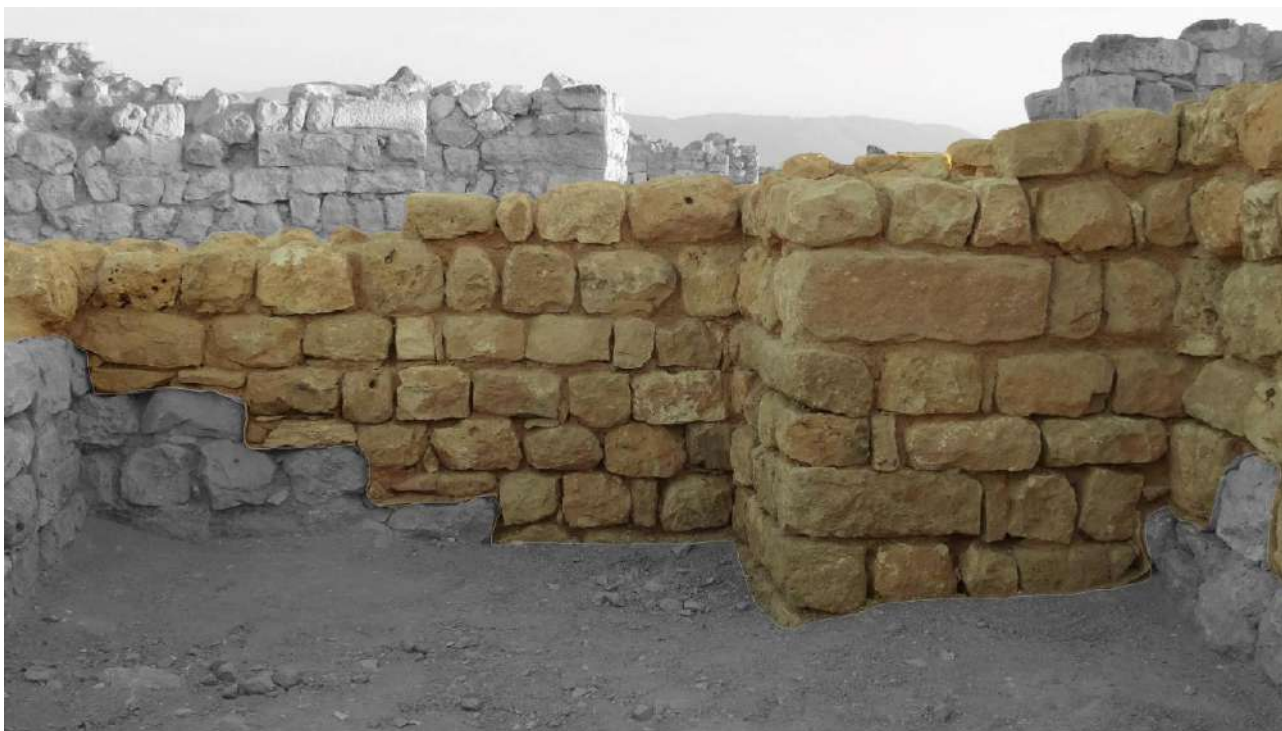
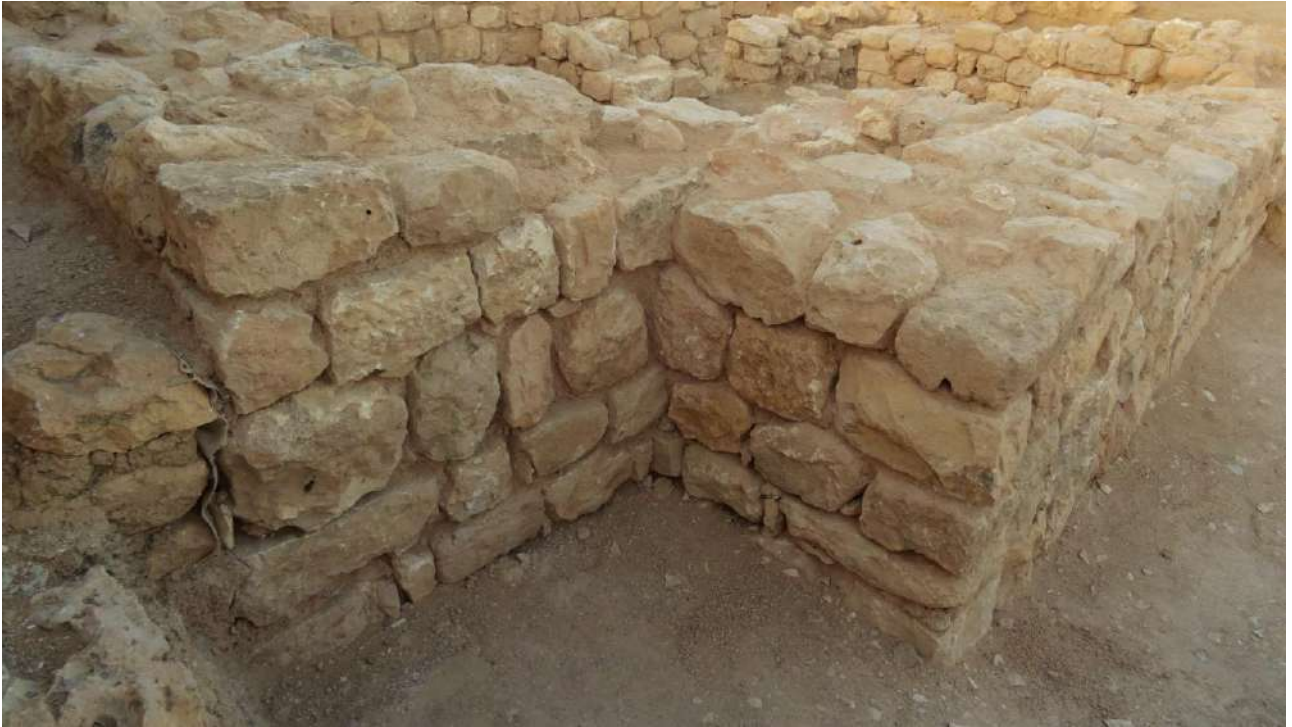
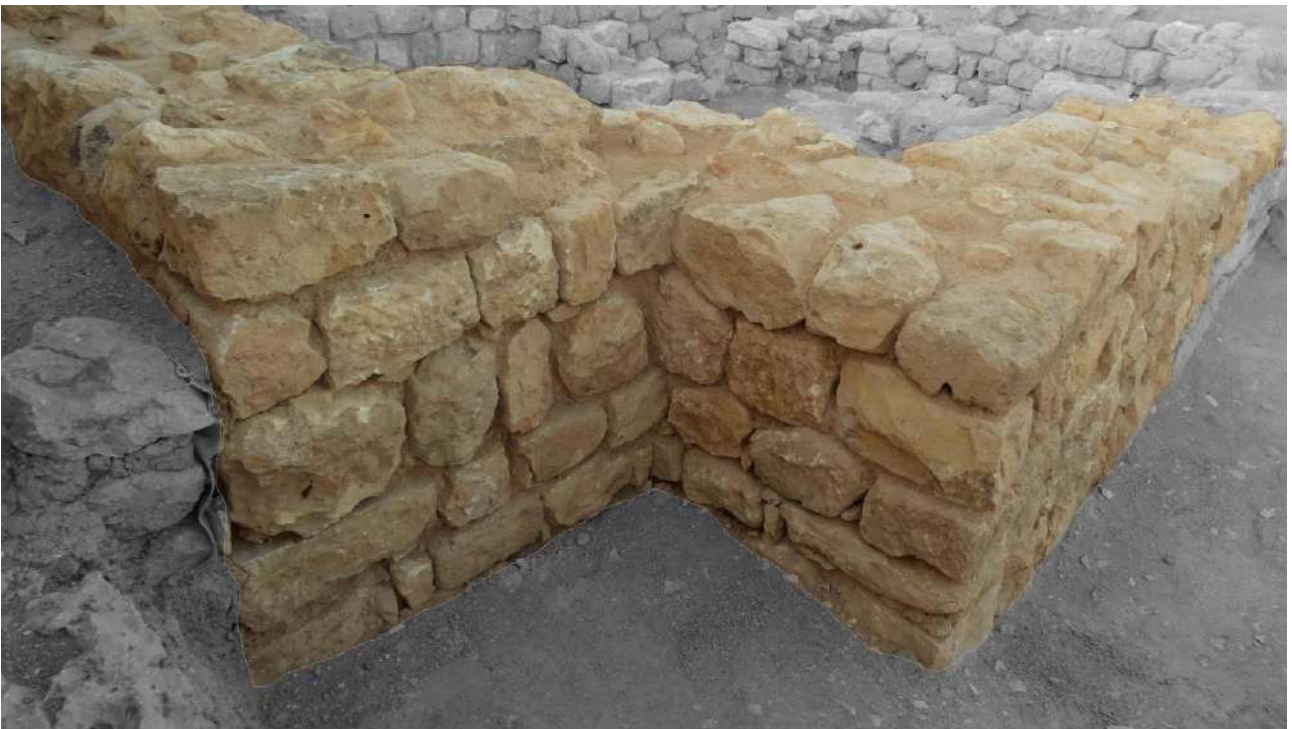
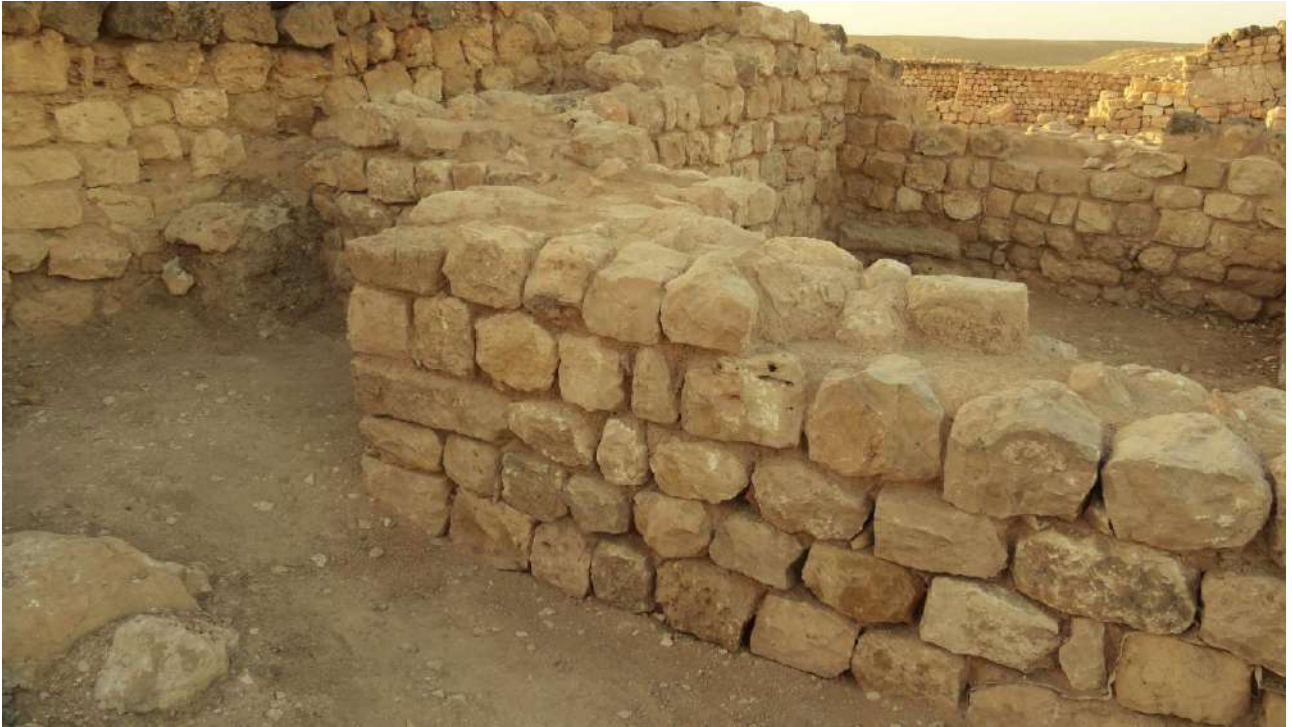
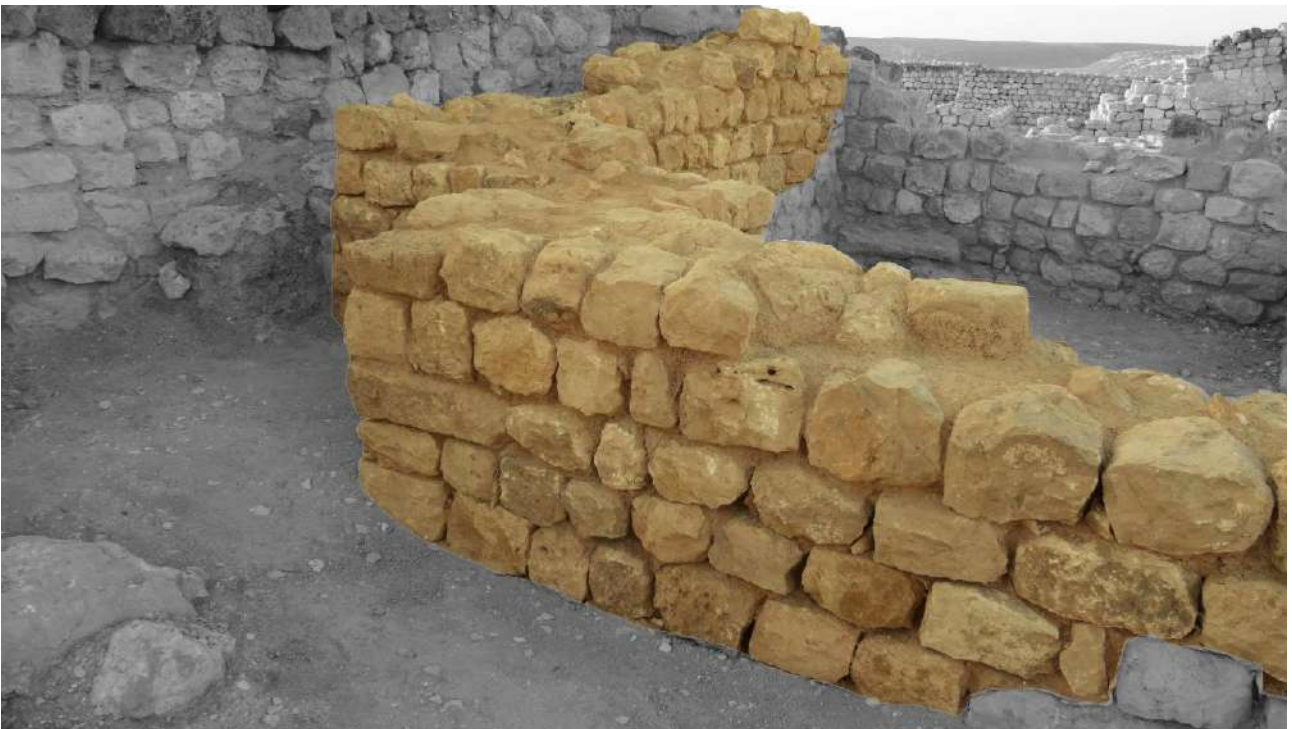
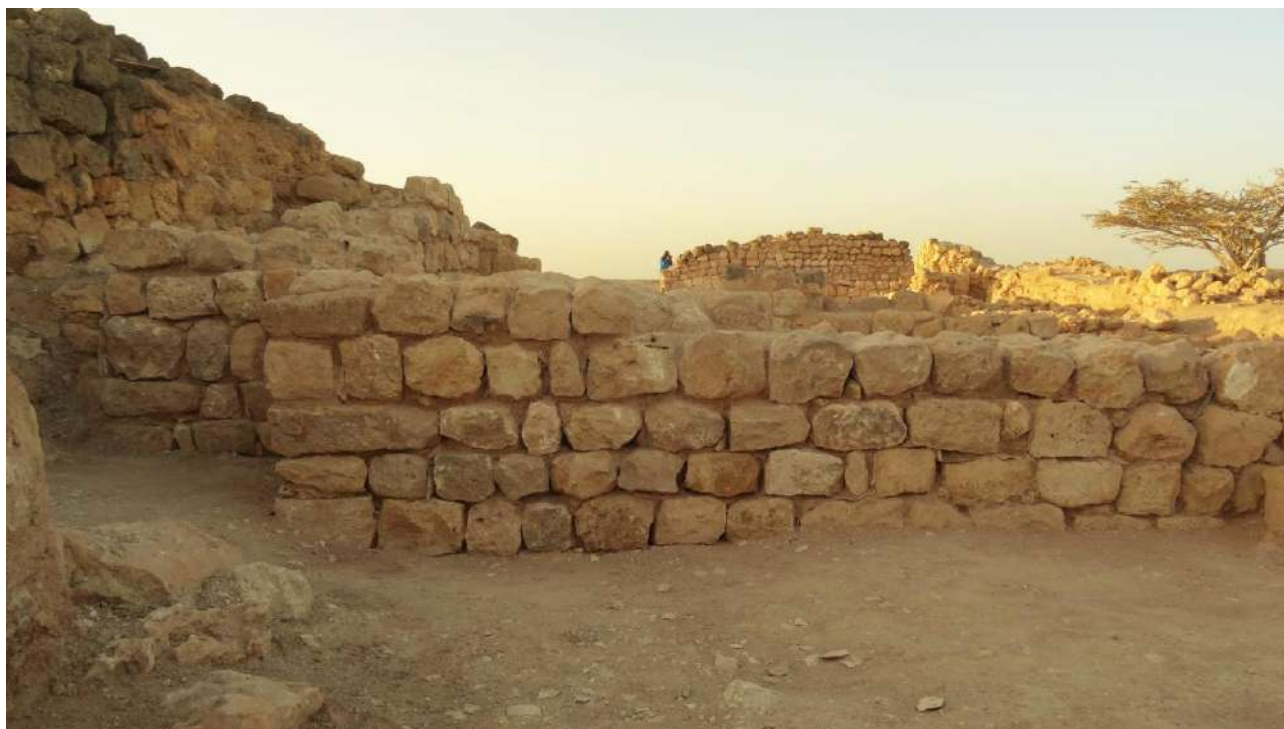
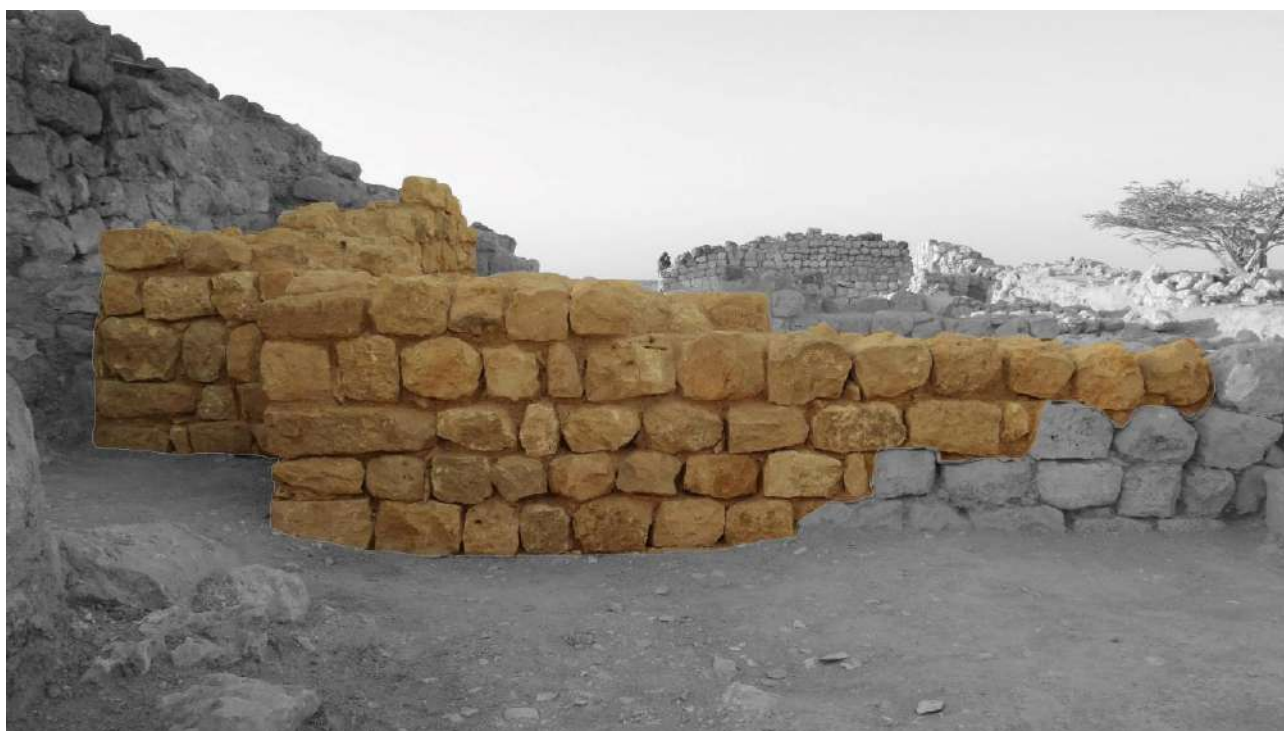
*Fig. 15b – BB4, survey to find the foundation of the corner between walls M644 and M646 (view from E).*

*Fig. 15c – BB4, survey to find the foundation of the corner between walls M644 and M646 (view from SW).*

*Fig. 15d – BB4, corner between walls M644 and M646 during the restoration works (view from SW).*

*Fig. 15e – BB4, wall M644 during the restoration works (view from W).*

*Fig. 15f – BB4, corner between walls M644 and M646 during the restoration works (view from SW).*

*Fig. 15g – BB4, corner between walls M644 and M646 after the restoration works (view from SW).*

*Fig. 15h – BB4, details of the restoration works of the corner between walls M644 and M646 (view from SW).*

*Fig. 15i – BB4, wall M644 after the restoration works (view from W).*

*Fig. 15j – BB4, details of the restoration works of the wall M644 (view from W).*

*Fig. 15k – BB4, wall M646 after the restoration works (view from S).*

*Fig. 15l – BB4, details of the restoration works of the wall M646 (view from S).*

*Fig. 15m – BB4, corner between walls M644 and M646 after the restoration works (view from NE).*

*Fig. 15n – BB4, details of the restoration works of the corner between walls M644 and M646 (view from NE).*

*Fig. 15o – BB4, corner between walls M644 and M646 after the restoration works (view from NW).*

*Fig. 15p – BB4, details of the restoration works of the corner between walls M644 and M646 (view from NW).*

*Fig. 15q – BB4, wall M646 after the restoration works (view from N).*

*Fig. 15r – BB4, details of the restoration works of the wall M646 (view from N).*

Later on, it was restored the corner between the walls M644 and M646, the east end of the wall M646 and all the wall M644. While the corner was completely collapsed, the two walls were at least detectable, with the wall M644 that kept only the first rows of the inner face, while the outer face was 2 meters high. Since from the state of the places it was unclear what was the planimetric shape of the corner, at first it was digged a survey in order to find its foundations and to deduce its shape. With the help of the archaeologists present on the site it was deduced that this was a concave angle (i.e. a W shape). To avoid losing track of the above-mentioned planimetry, the first rows were immediately reconstructed until the high of the wall M646 and of the inner face of the wall M644. After that, the rocking stones of the wall M644 were removed. At this point, the walls M644 and M646 were built simultaneously, with upward trend from west to east and from north to south (Figs. 15).

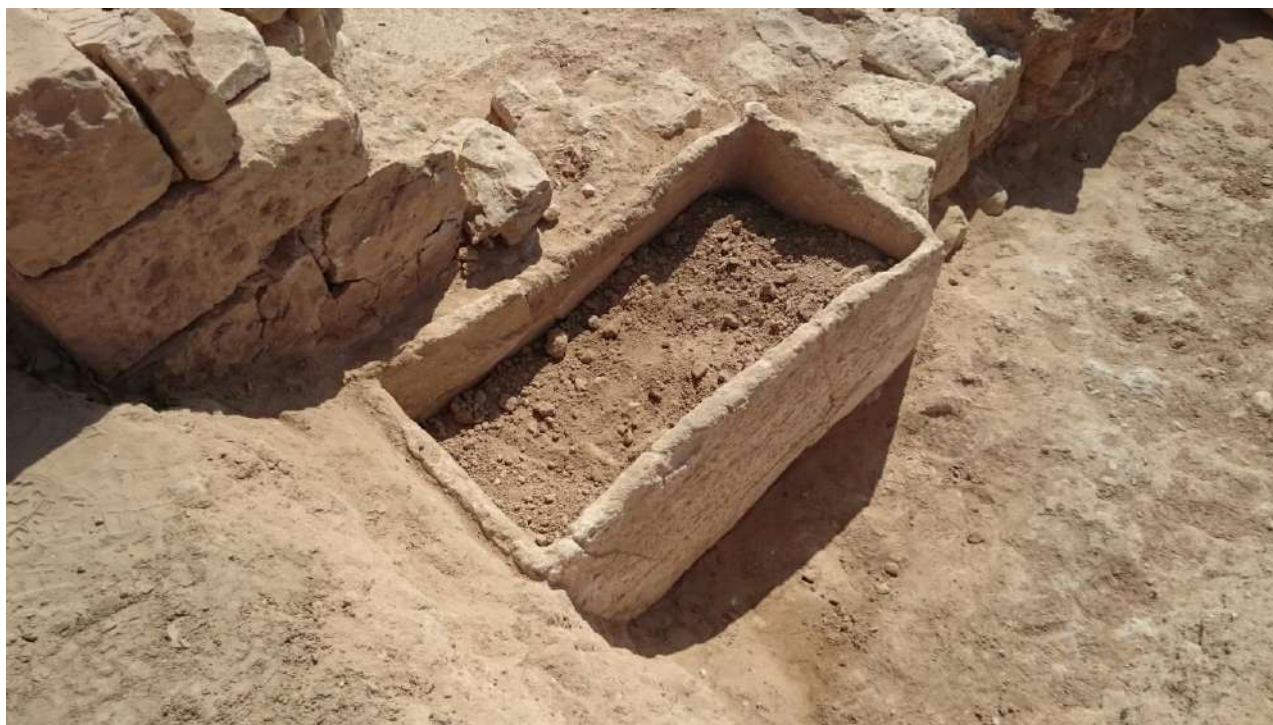
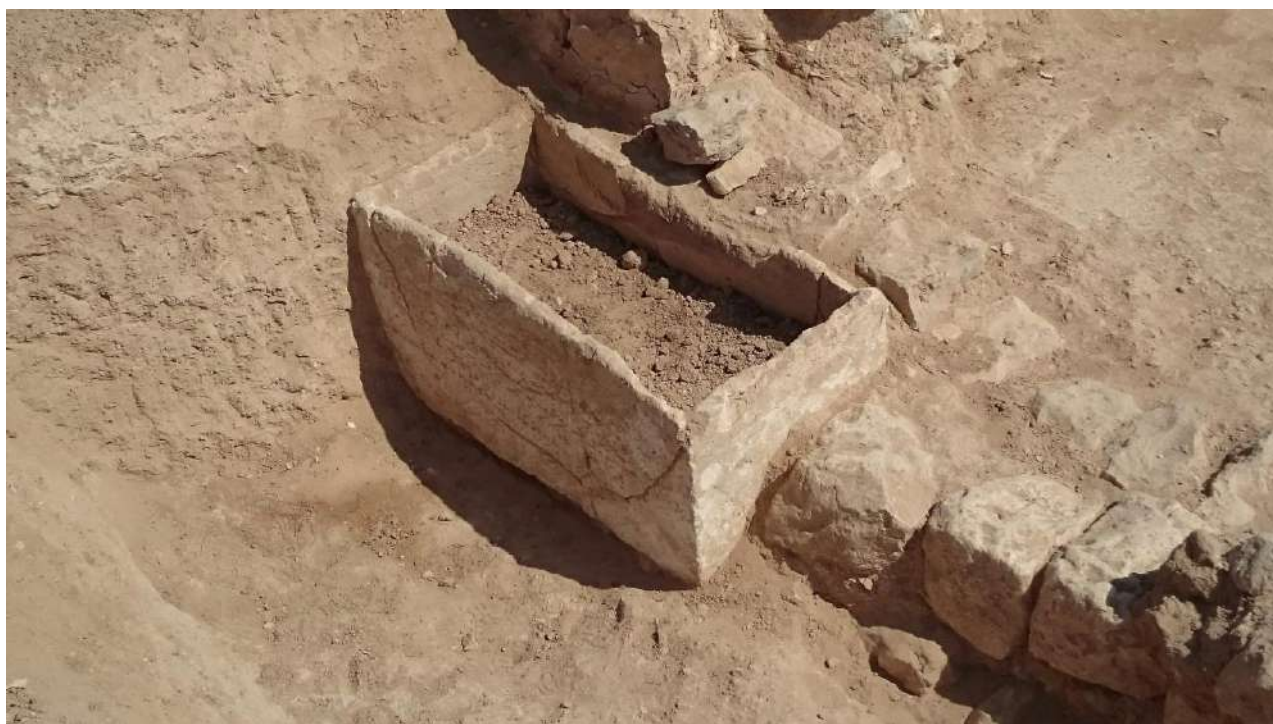
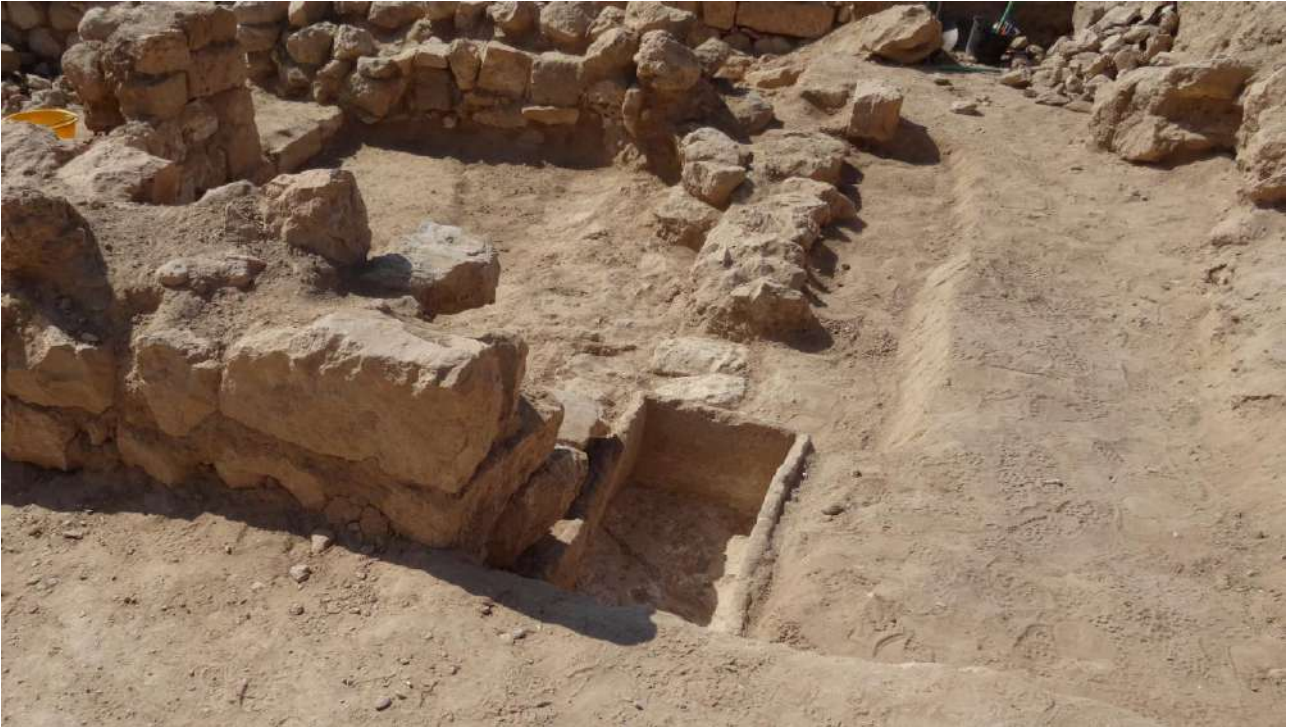
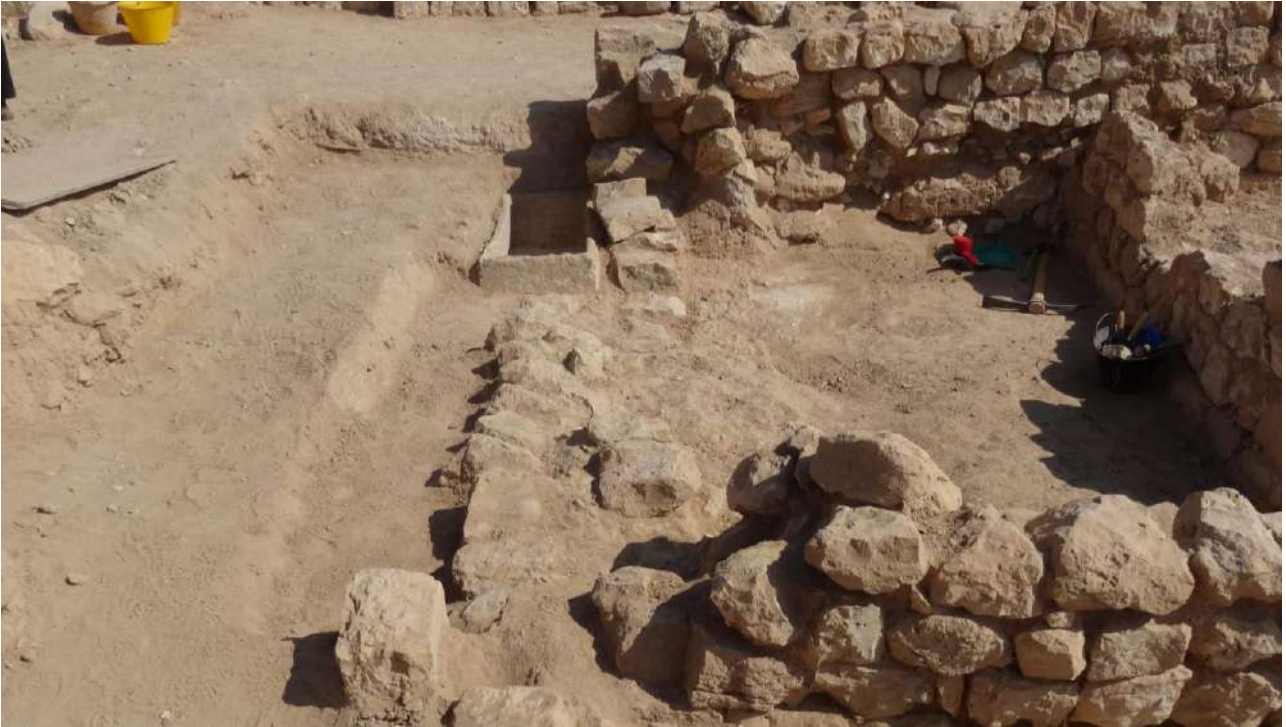
*Fig. 16a – BB4, basin discovered near the NW corner (view from NW).*

*Fig. 16b – BB4, basin discovered near the NW corner (view from SW).*

*Fig. 16c – BB4, west border wall between walls M581 and M646 during the excavation (view from N).*

*Fig. 16e – BB4, west border wall between walls M581 and M646 during the excavation (view from S). It is possible to note the presence of the three wall faces and the fact that the west one (on the left in the picture) is out of the building profile.*

Simultaneously with the aforementioned restoration works, it was dugged around the west border wall between the walls M581 and M646 to discover its foundation or the bedrock. During the excavation a stone basin was found outside the northwest corner of the building. Moreover, it appeared that the masonry consisted of three different faces: the east one in raw earth bricks and the western two in stones. However, analyzing the remains of the three wall faces, it seemed that the exterior stone face was out of the shape of the building, that was perfectly defined by the well preserved northwestern corner. Therefore, it was supposed that originally there were two different masonry: the building boundary wall, made by two faces (the inner in bricks and the exterior in stones), and an exterior wall, made by one stone face. Watching carefully the exterior face, it was noted that some stones adjacent to the stone basin were remarkably smooth. It was therefore conjectured that this was the threshold of an opening. However, the fact that this threshold wasn't present even in the most internal masonry (the two-faced wall) suggested that the two walls were built in two different periods. In order to clarify the situation, it was excavated a width of about 1 m and a depth of about 30 cm on the west of the wall in question, but nothing was found. Therefore, according with Mr. Sedov and with the archaeologists present on site, it was decided to postpone the restoration to a next mission, after enlarging the survey. In any case it was disassembled and temporarily reconstructed the north-west corner that was in precarious equilibrium conditions (Figs. 16).

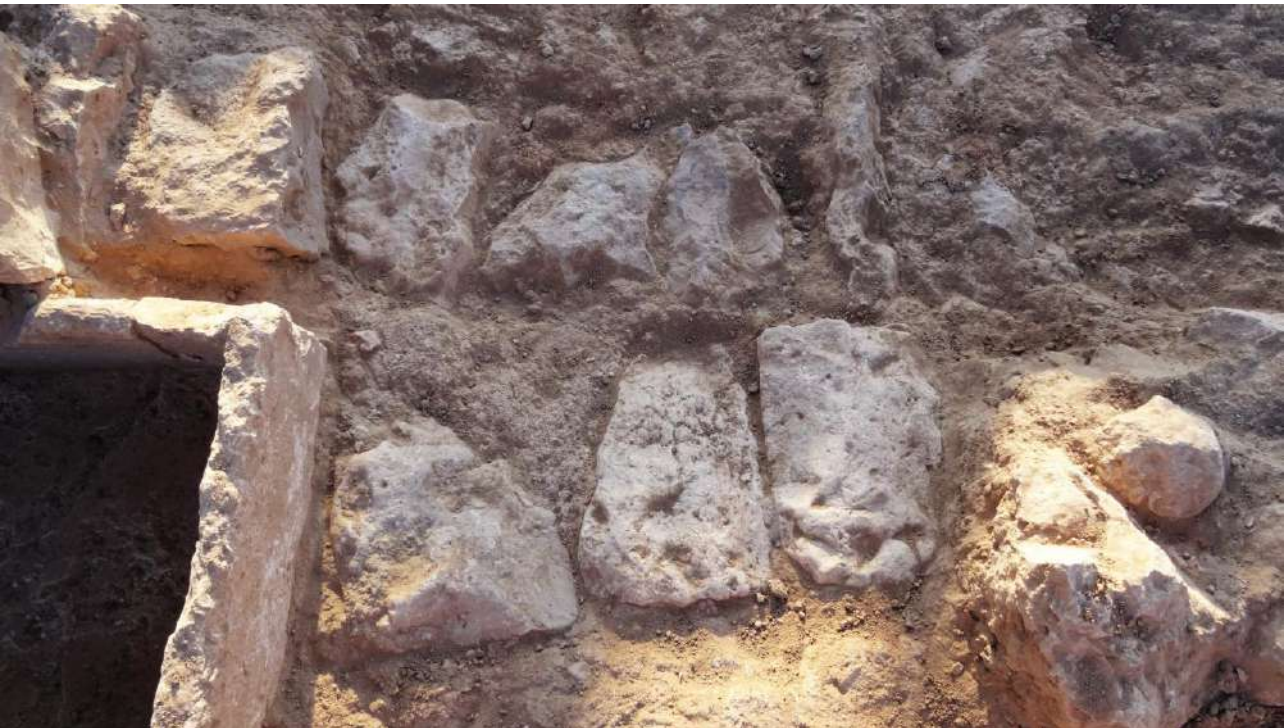
*Fig. 16f – BB4, detail of the three smooth stones near the basin.*
