**RESTORATION WORKS AT SUMHURAM  
(ARCHAEOLOGICAL PARK OF KHOR RORI)  
(Sultanate of Oman)  
CAMPAIGN October-December 2017**

**Technical Report**  
**16<sup>th</sup> October – 14<sup>th</sup> December 2017**

**Michele Chimienti – Emiliano Mura**  
**ARCHITECTS**

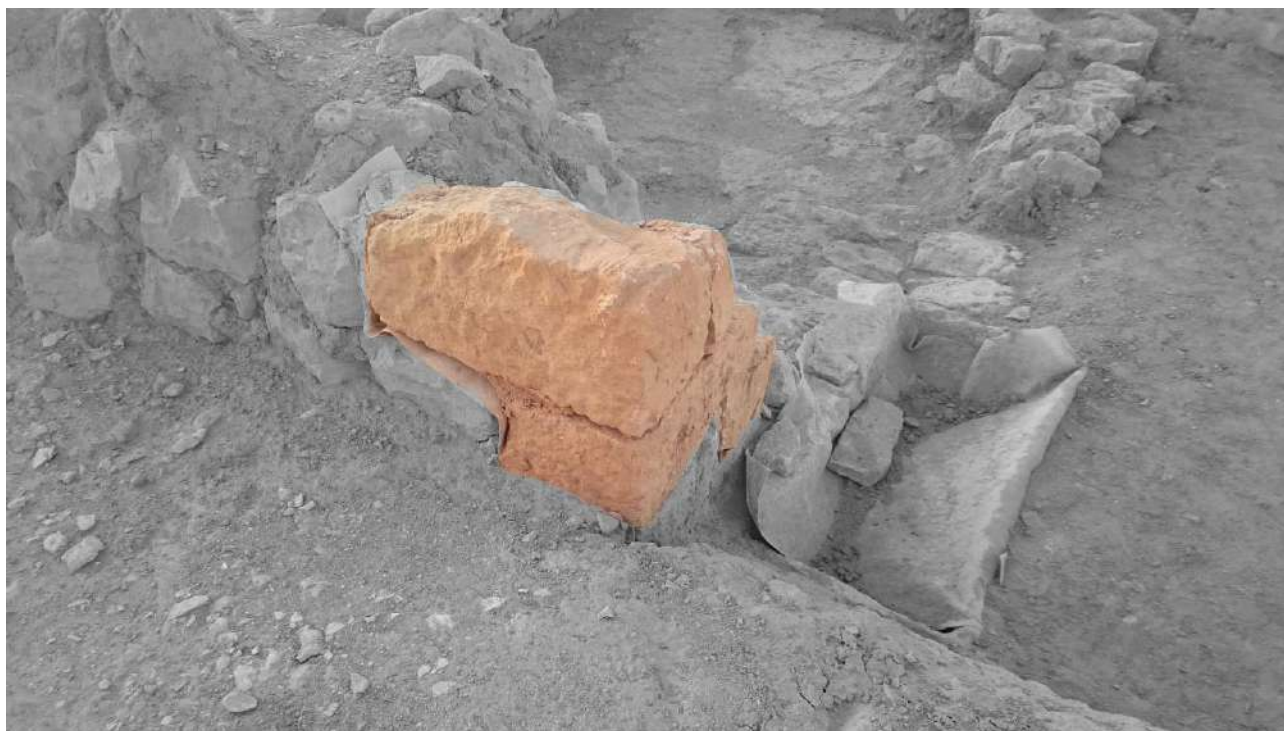
Simultaneously with the aforementioned restoration works, it was dugged around the west border wall between the walls M581 and M646 to discover its foundation or the bedrock. During the excavation a stone basin was found outside the northwest corner of the building. Moreover, it appeared that the masonry consisted of three different faces: the east one in raw earth bricks and the western two in stones. However, analyzing the remains of the three wall faces, it seemed that the exterior stone face was out of the shape of the building, that was perfectly defined by the well preserved northwestern corner. Therefore, it was supposed that originally there were two different masonry: the building boundary wall, made by two faces (the inner in bricks and the exterior in stones), and an exterior wall, made by one stone face. Watching carefully the exterior face, it was noted that some stones adjacent to the stone basin were remarkably smooth. It was therefore conjectured that this was the threshold of an opening. However, the fact that this threshold wasn't present even in the most internal masonry (the two-faced wall) suggested that the two walls were built in two different periods. In order to clarify the situation, it was excavated a width of about 1 m and a depth of about 30 cm on the west of the wall in question, but nothing was found. Therefore, according with Mr. Sedov and with the archaeologists present on site, it was decided to postpone the restoration to a next mission, after enlarging the survey. In any case it was disassembled and temporarily reconstructed the north-west corner that was in precarious equilibrium conditions (Figs. 16).

*Fig. 16h – BB4, details of the restoration works of the north-west corner.*

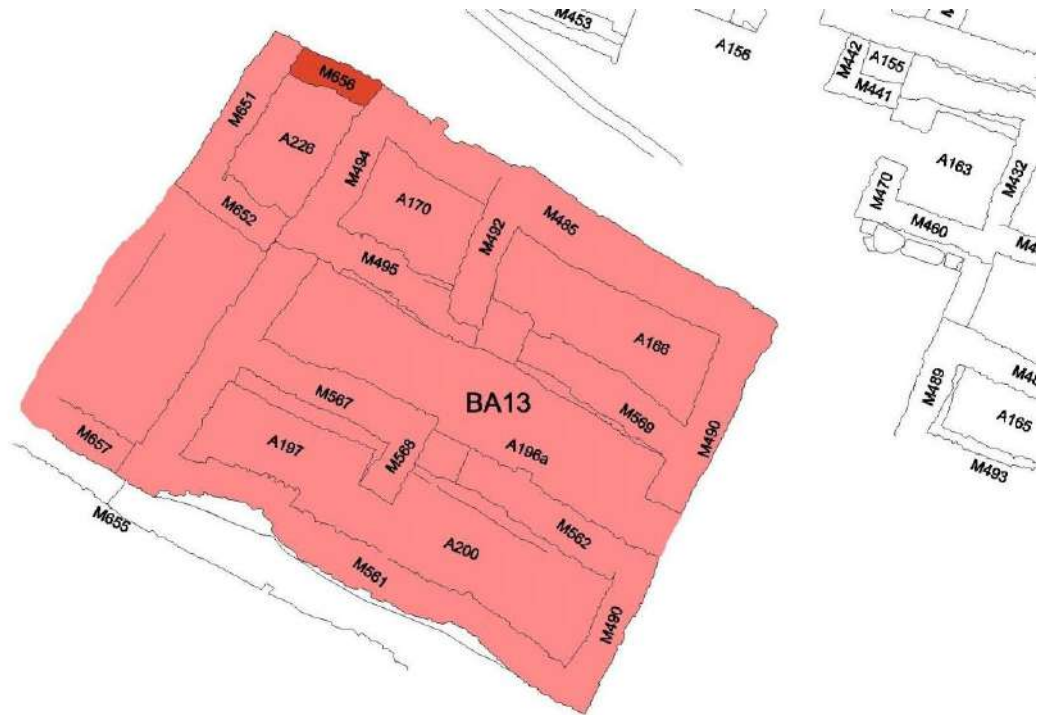
A little part of the mission was dedicated to the restoration of BA13. In particular, it was just disassembled and reconstructed the wall M656 (Fig. 17).

*Fig. 17 – BA13 plan with highlighted the restored wall.*

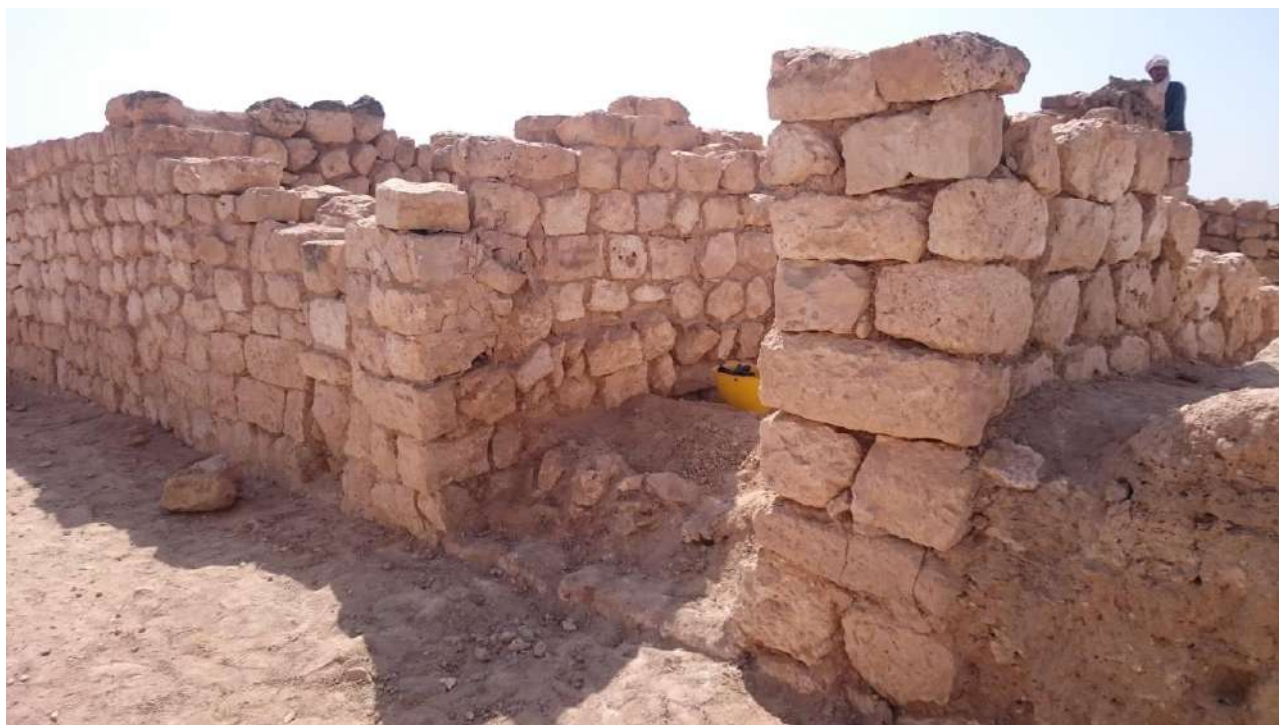
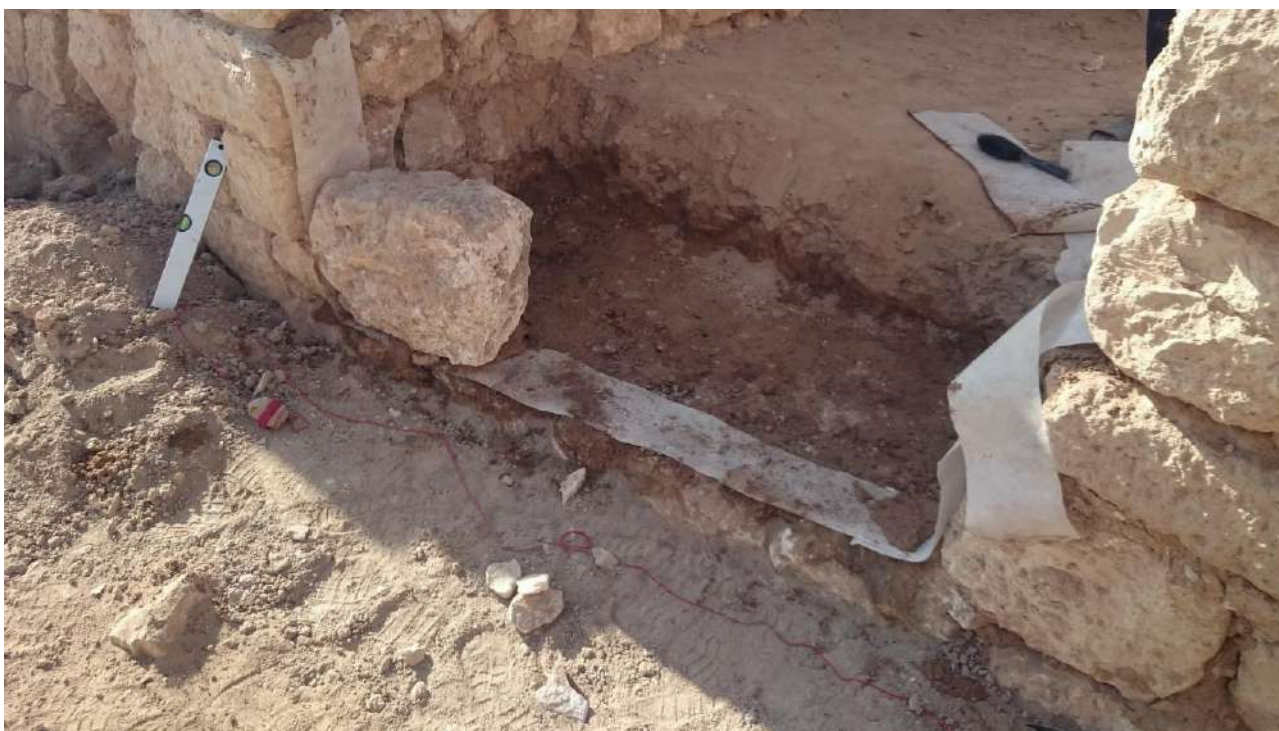
Before the restoration works, the wall M656 appeared in precarious equilibrium conditions, showing an evident collapse towards the north. Therefore, for the safety of tourists, the aforementioned wall was disassembled and rebuilt with the same stones. Moreover, in agreement with the archaeologists present on site, the wall was rebuilt lower to facilitate a future disassembly of the same in order to investigate thoroughly the environment of BA13 closed by the wall M656 and the road at north of it (Figs. 18).

*Fig. 18c – BA13, wall M656 during the restoration works (view from NW).*

*Fig. 18d – BA13, wall M656 during the restoration works (view from NW).*

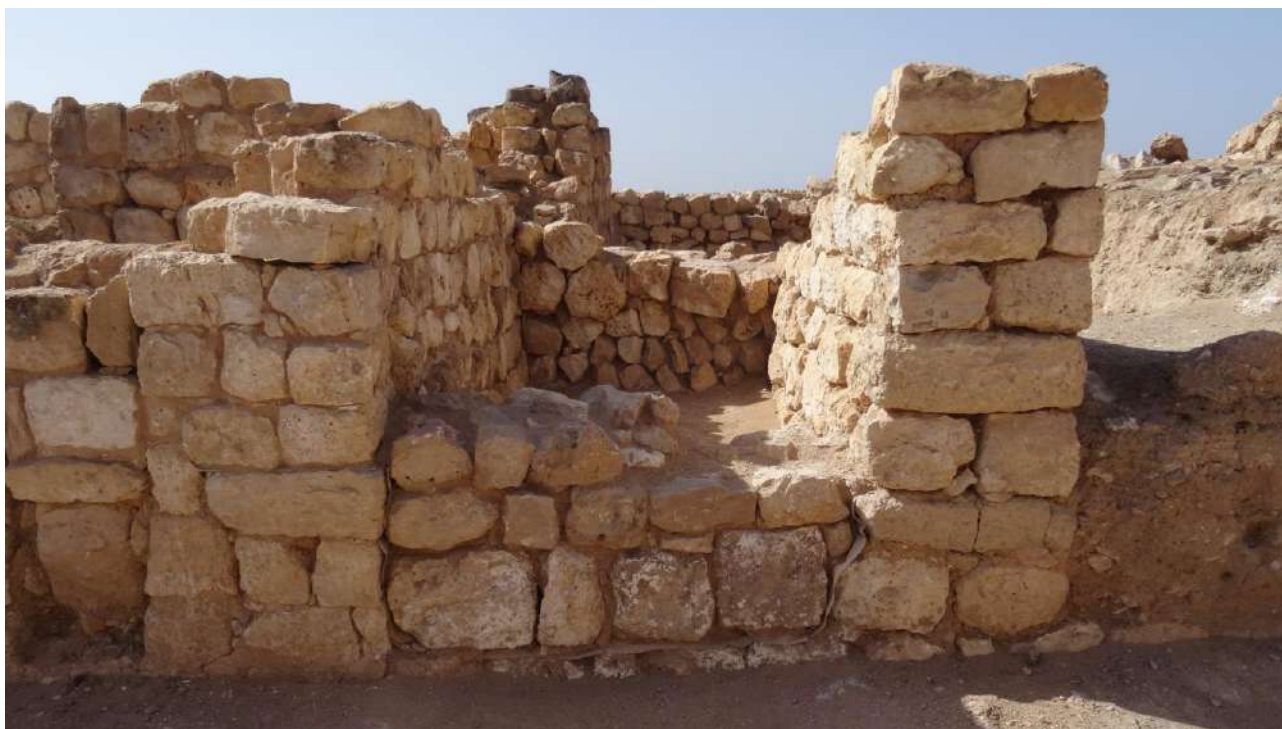
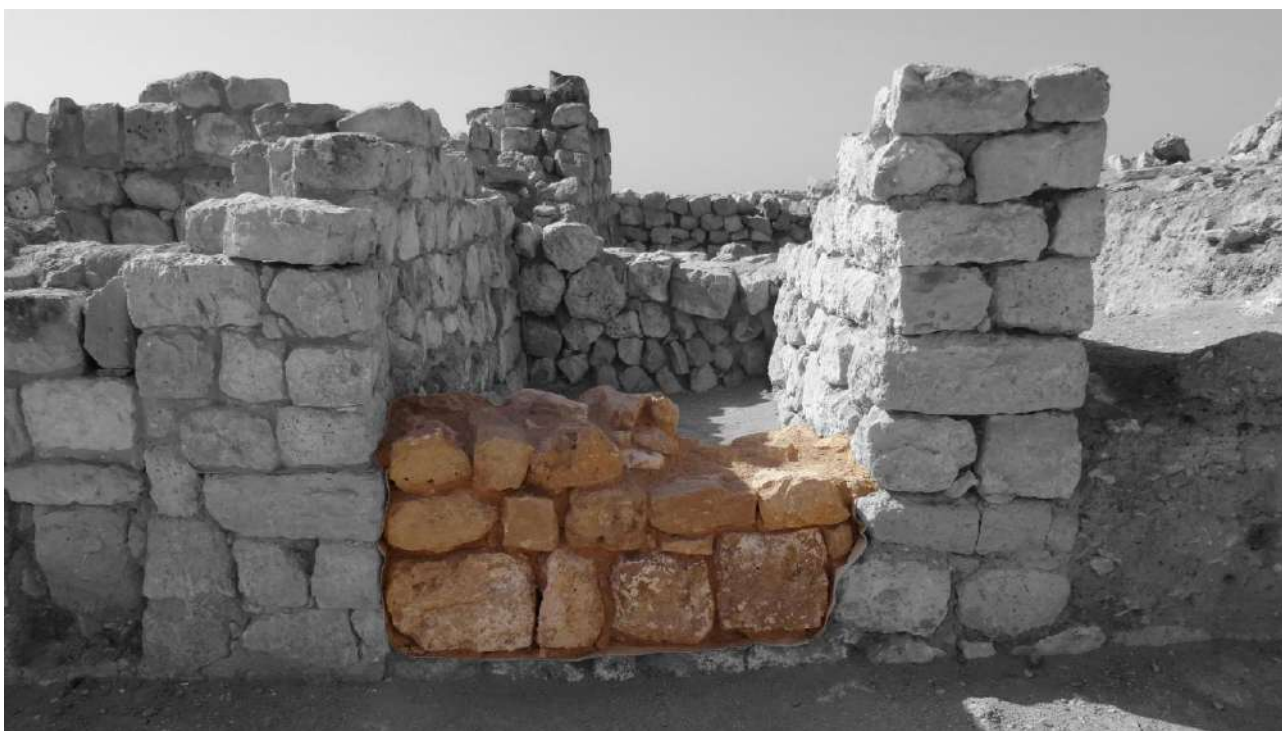
*Fig. 18e – BA13, wall M656 after the restoration works (view from N).*

*Fig. 18f – Details of the restoration works of the wall M656 (view from N).*

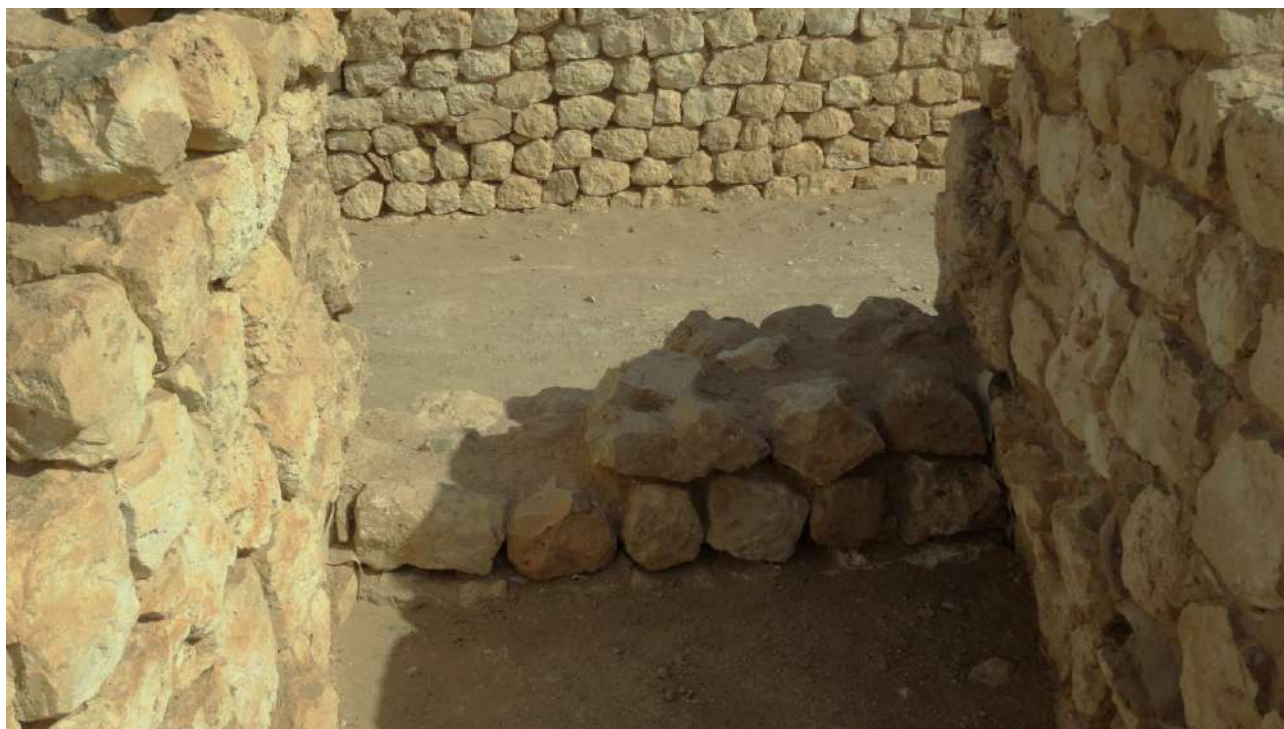
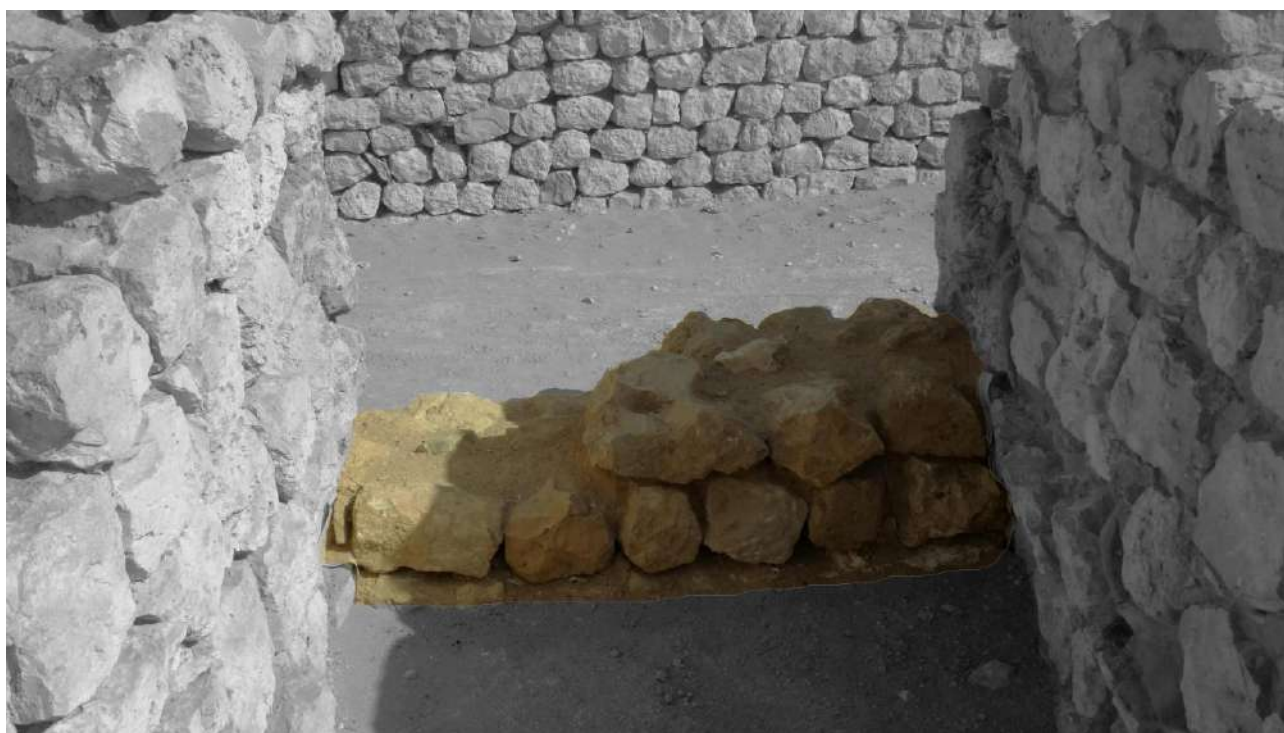
*Fig. 18g – BA13, wall M656 after the restoration works (view from S).*

*Fig. 18h – Details of the restoration works of the wall M656 (view from S).*
