**RESTORATION WORKS AT SUMHURAM
(ARCHAEOLOGICAL PARK OF KHOR RORI)
(Sultanate of Oman)
CAMPAIGN February-March 2016**

**Technical Report
06th February – 24th March 2016**

RESTORATION WORKS AT HAMR AL-SHARQIYA

Technical Report
06th February – 24th March 2016

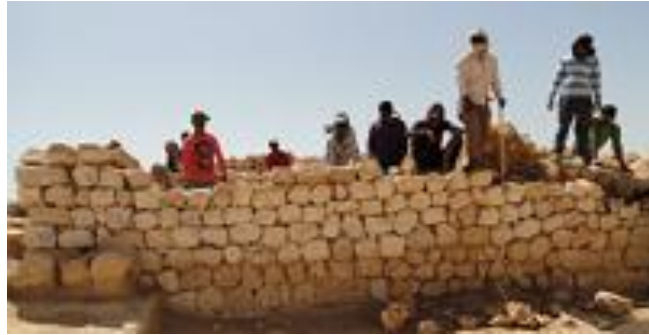
M485, south front wall, after the restoration.

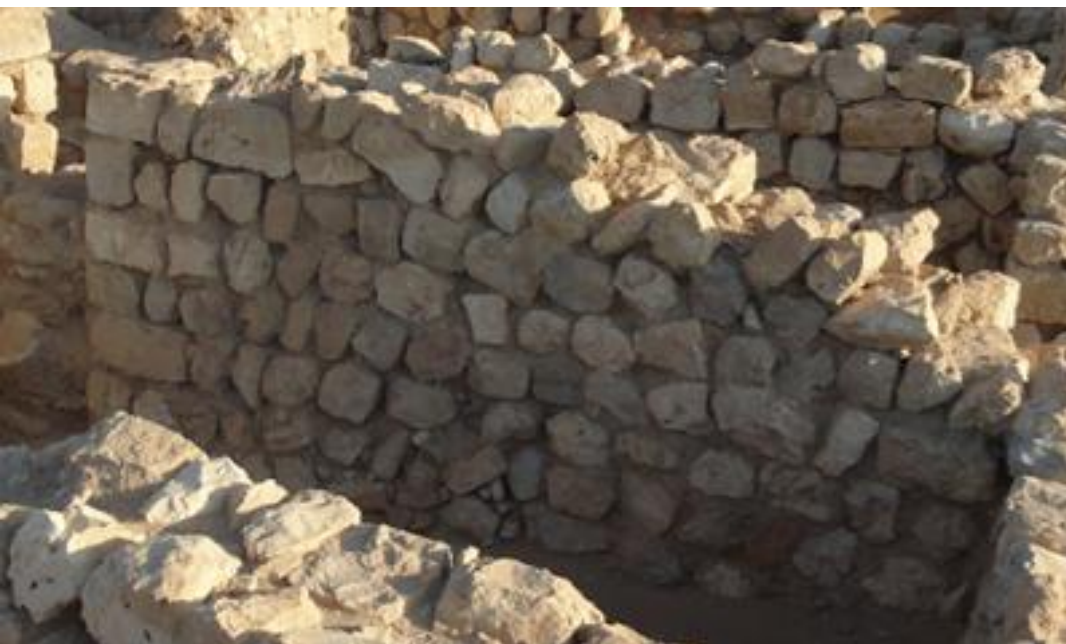
M562, north front wall, before the restoration.

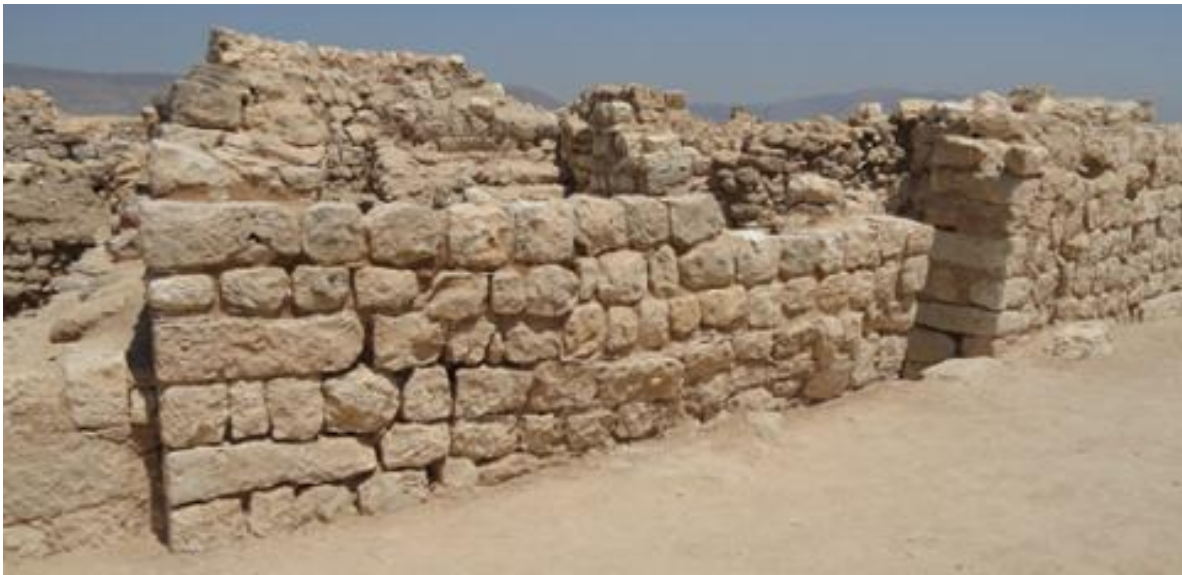
M635, south front wall, after the restoration

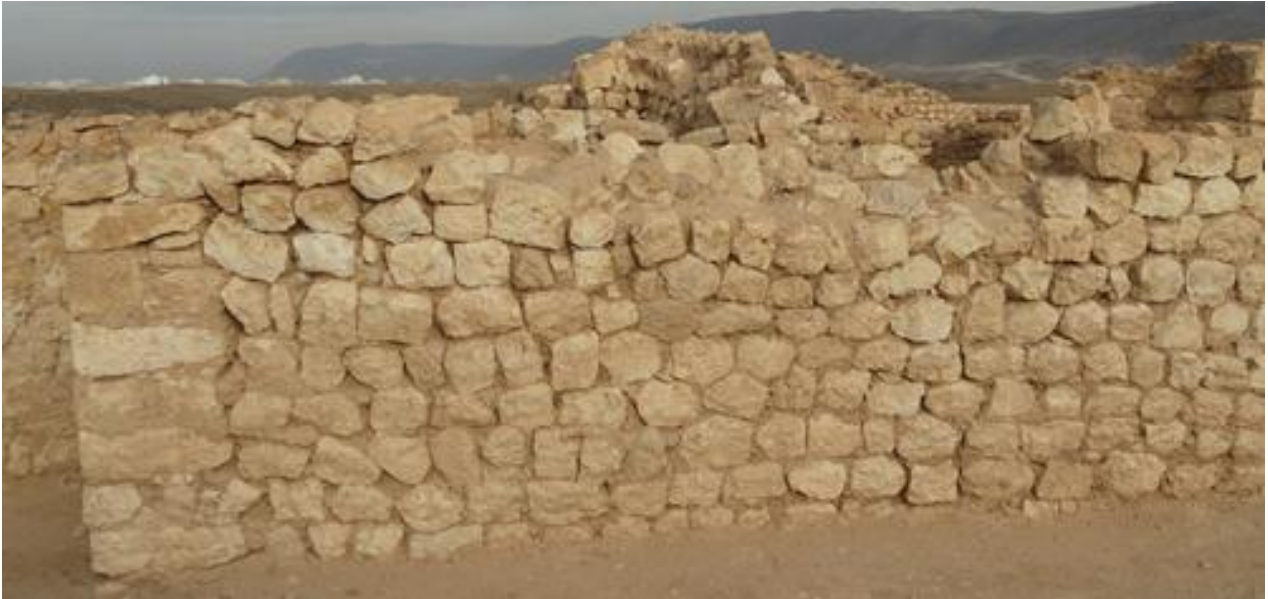
M484, east front wall, before the restoration.

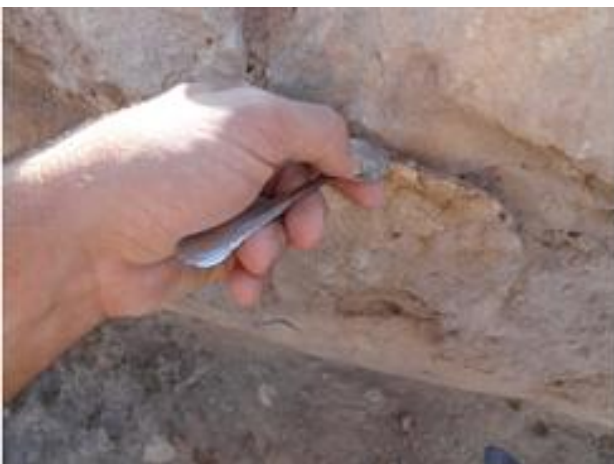
Dust removal

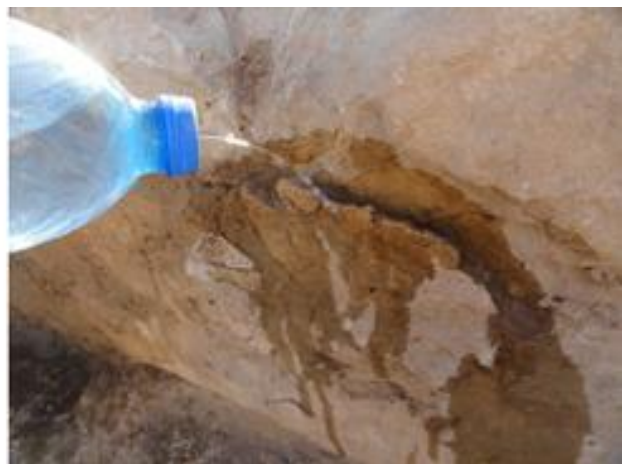
Cleaning

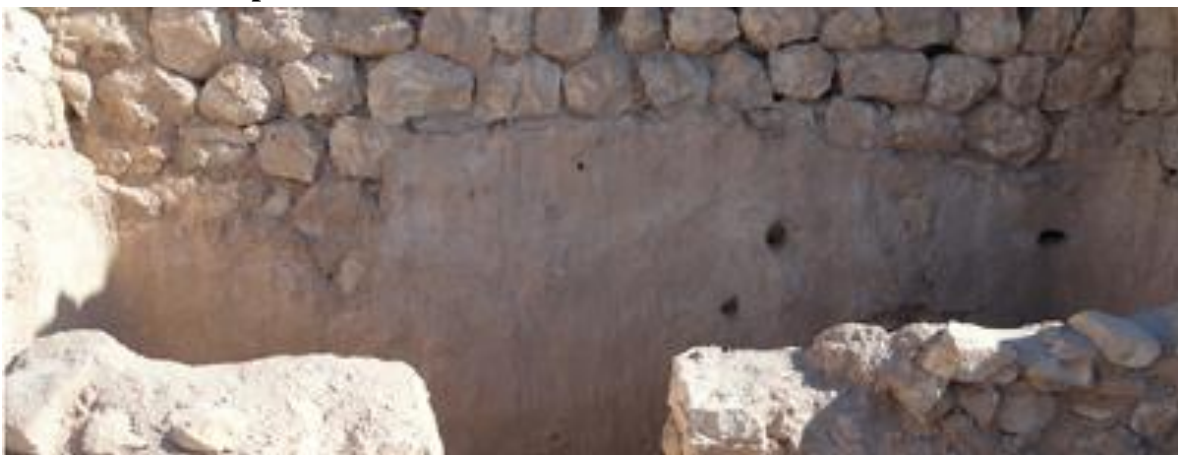
M17 (A121), south wall, façade. before the restoration

Restoration of the plaster wall M17

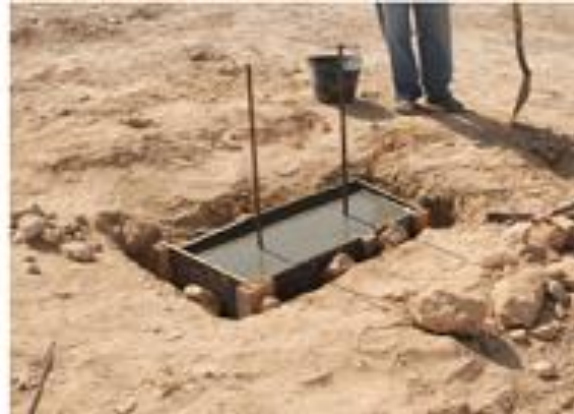
New foundation

For this mission we decided to make only the monolite base, made by the means of white concrete adding yellow and brown oxide colours in order to get the sand colour. To make the monolite stronger we used steel for reinforcement. This operation will be finished during the next mission.

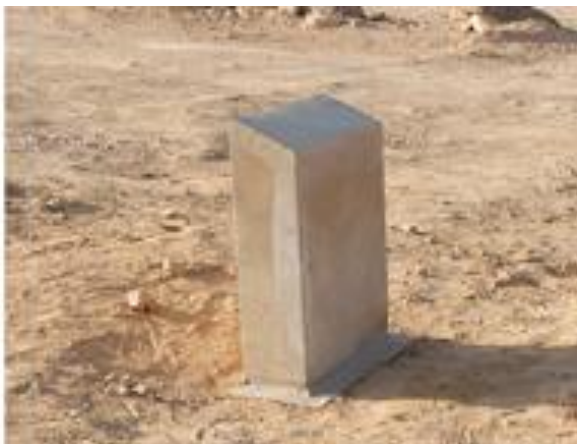
Monolite made by couloured concrete

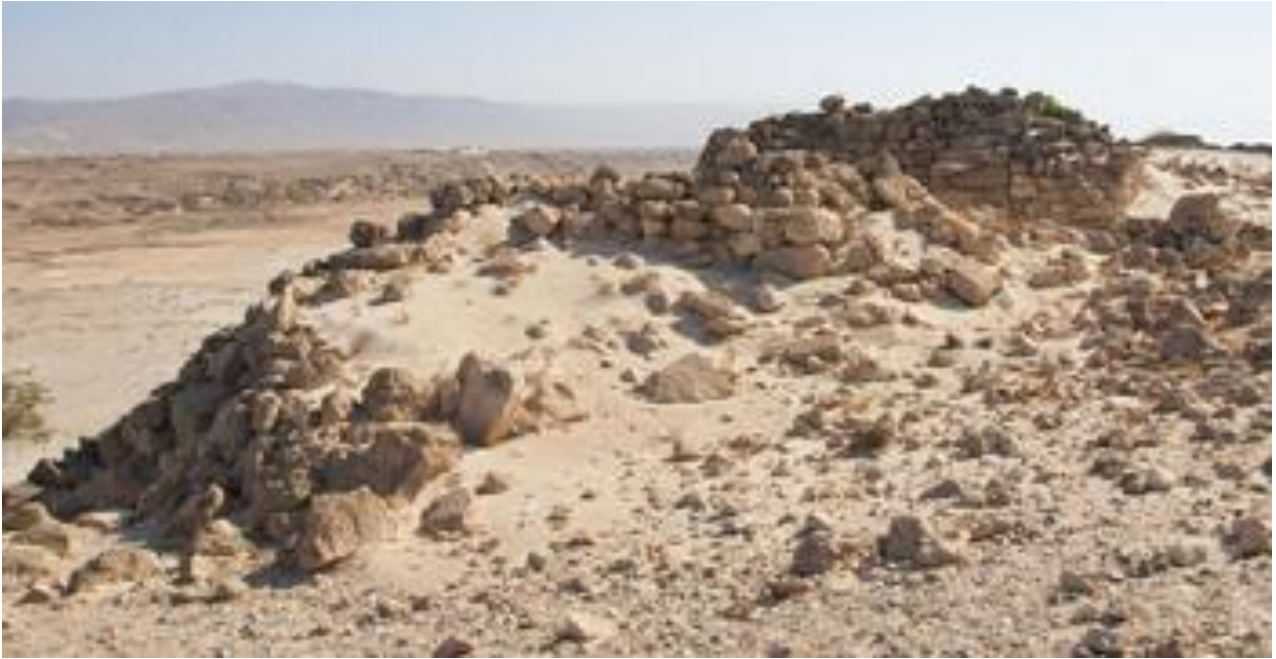
The west tower is in poor condition, there are many collapses and many unsafe and unstable stones.

West tower, south-west side

It is necessary a step of removing the stones of collapse, a consolidation of unstable stones, a thorough cleaning and finally restore four front walls with the restoration of the original part.

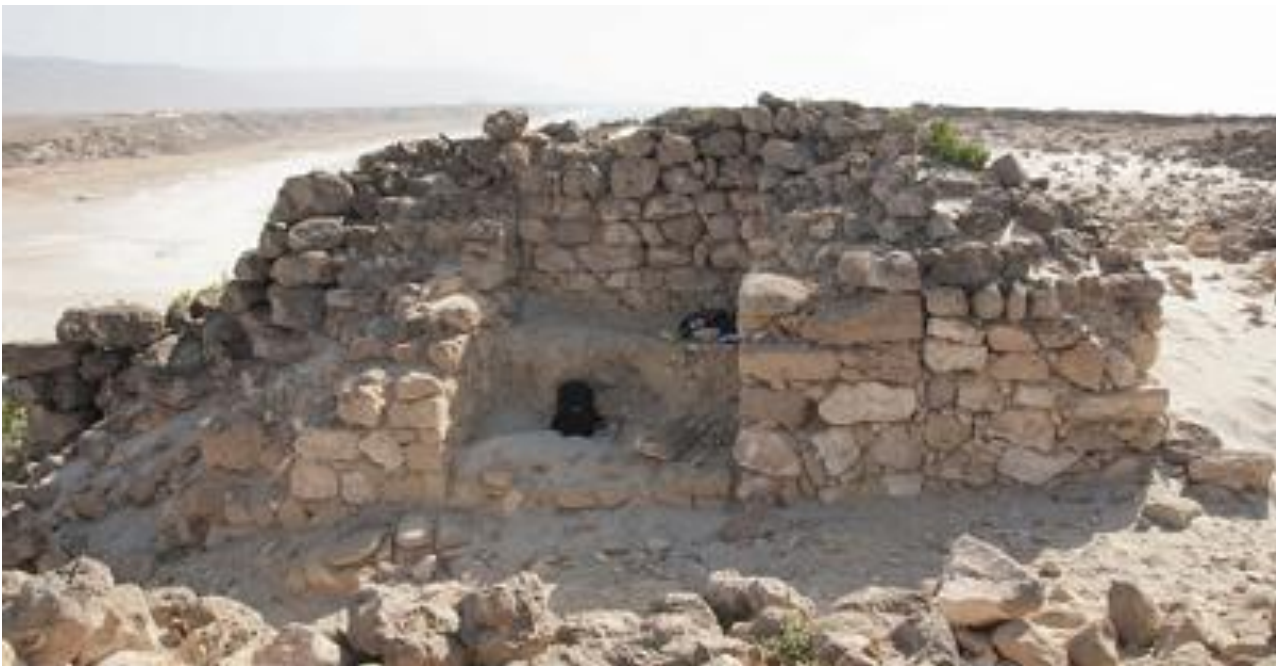
The east tower is in the best storage conditions, despite being required many interventions of consolidation, the wall portions have the most stable and best preserved. Inside the tower there are many debris and a lot of wind sand.

East tower, west side

It is necessary a consolidation of unstable stones, a thorough cleaning, the partial re-building the four face walls and restoration of corner and original stonework.

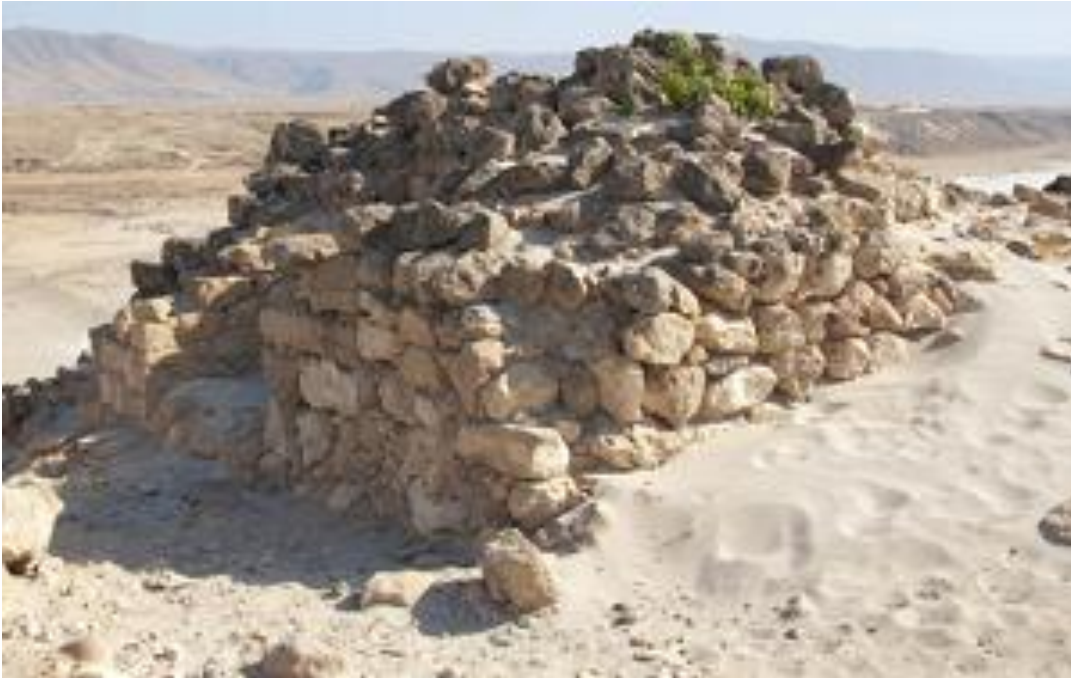
East tower, south side

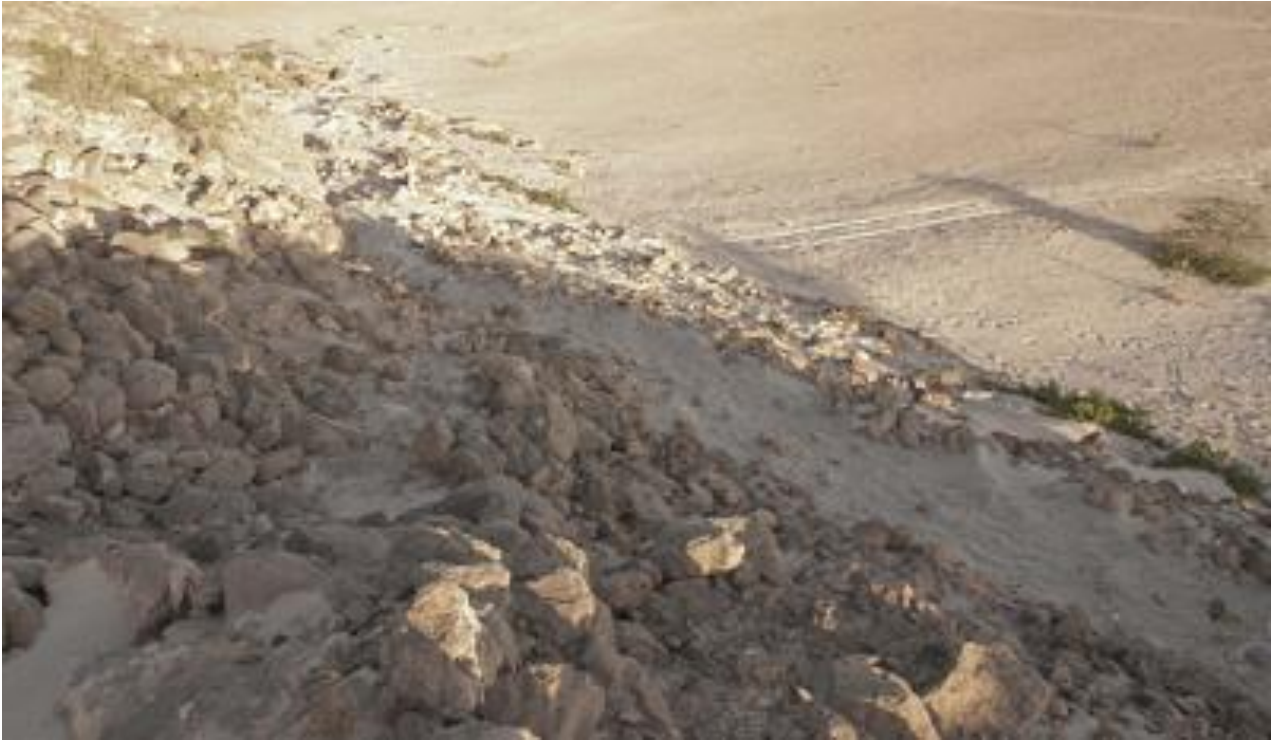
Street before

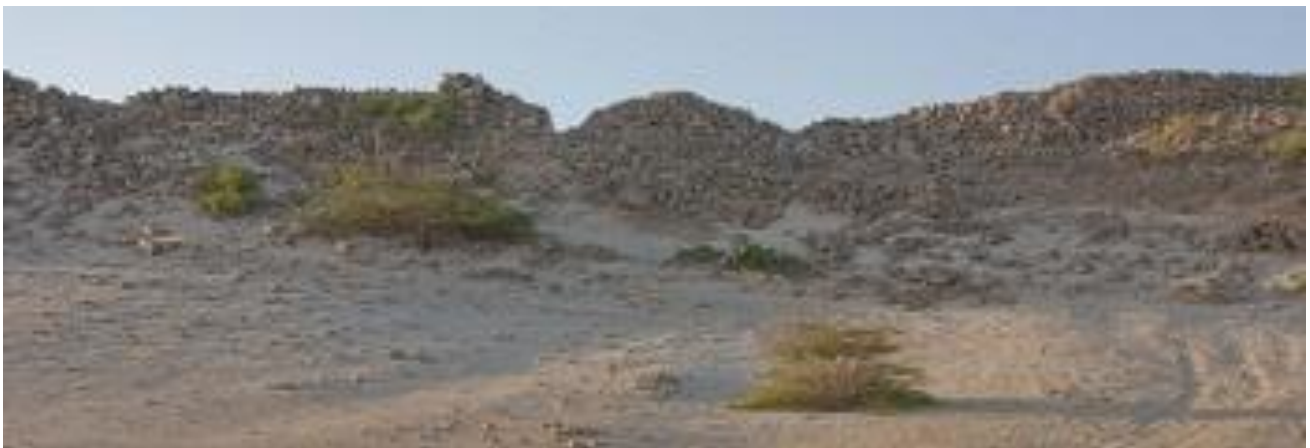
View on the down street before restoration

The restoration of the tower was carried out using the technique of dry wall , with a filling of different grain of stones and ground.

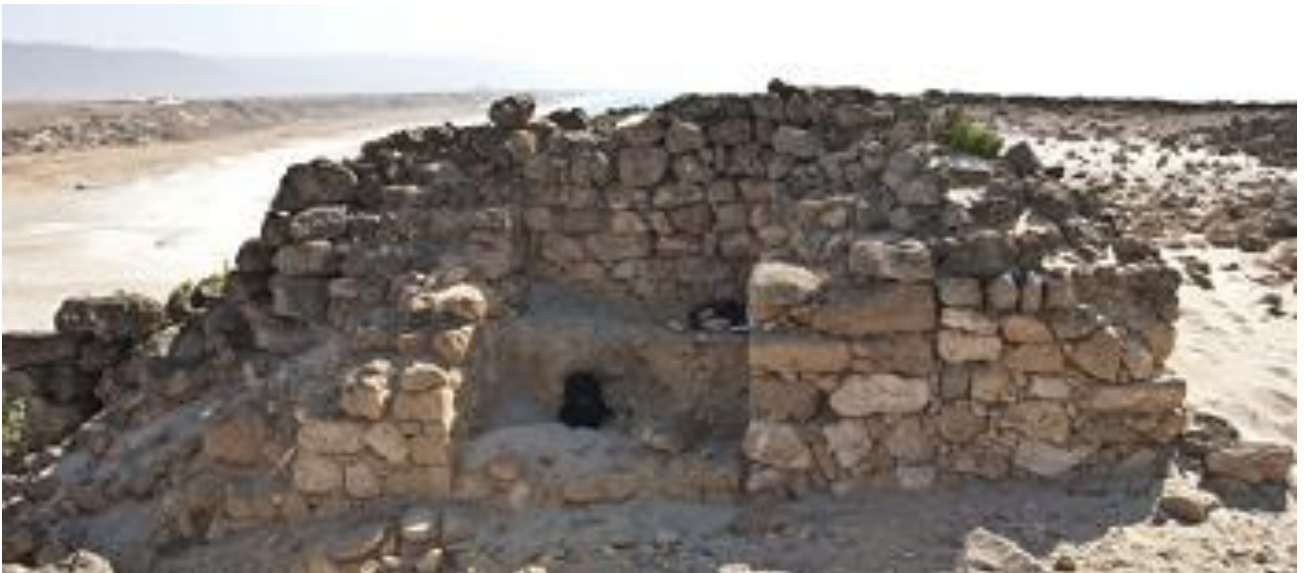
View east side before restoration

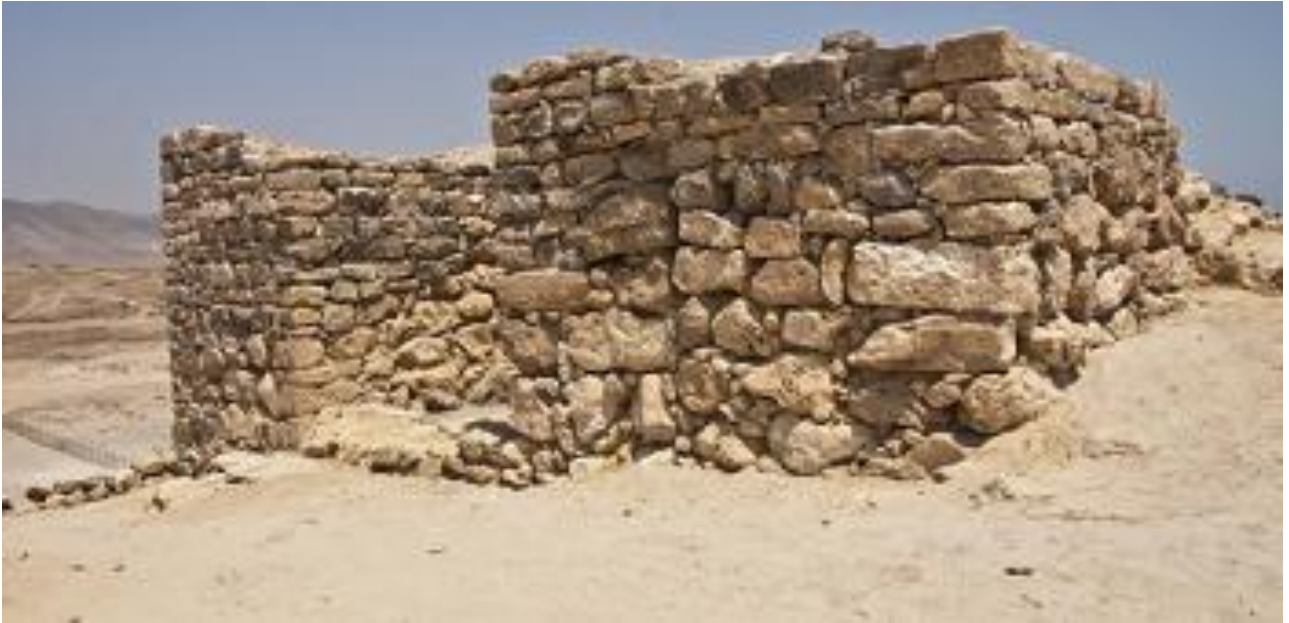
View east-south side after restoration

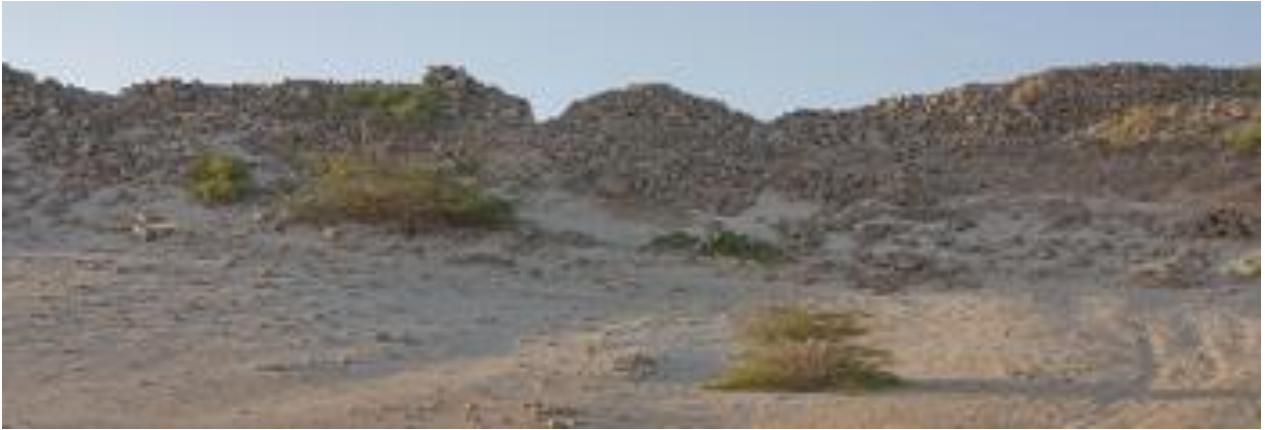
The West tower is in bad condition.

View on the down street before restoration

The restoration of the tower was carried out using the technique of dry wall , with a filling of different grain of stones and ground.

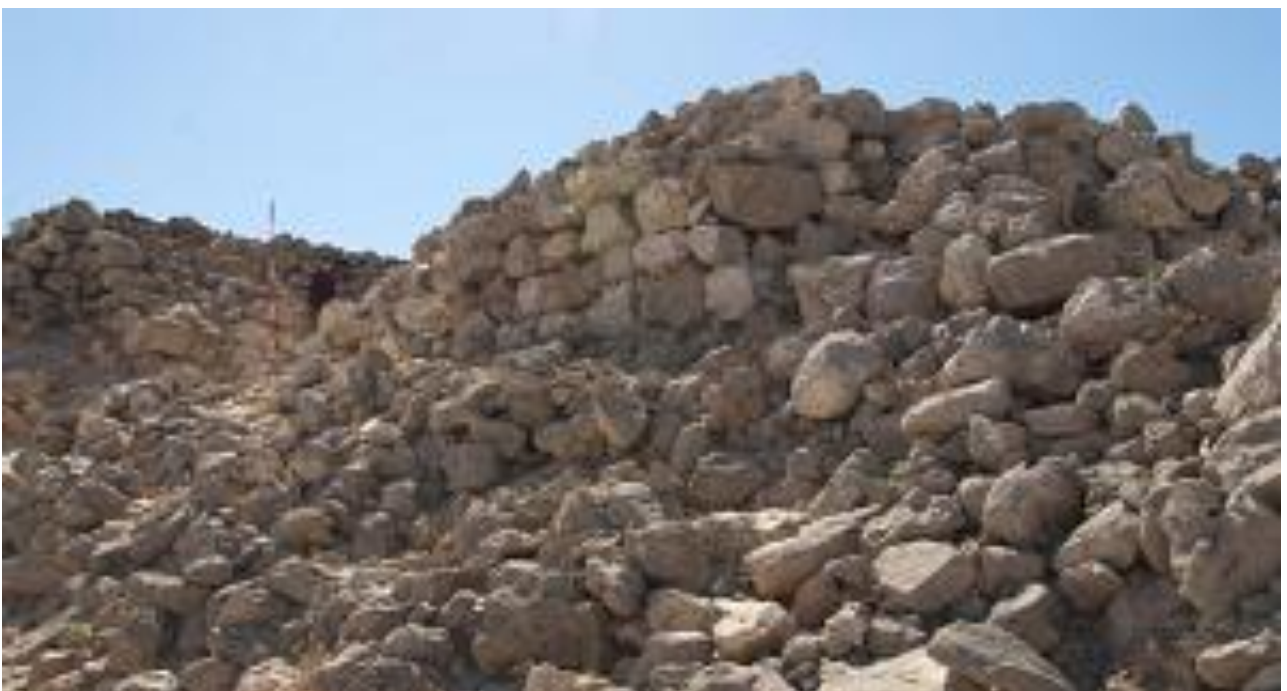
View on the up street before restoration

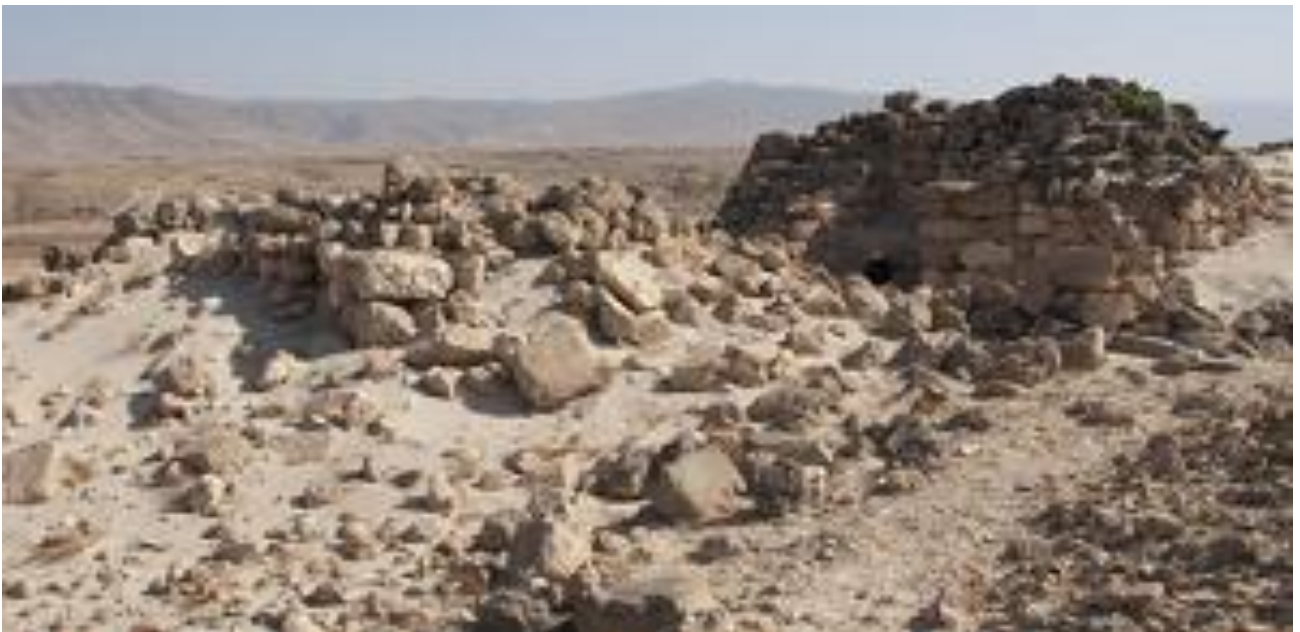
South - East side before restoration

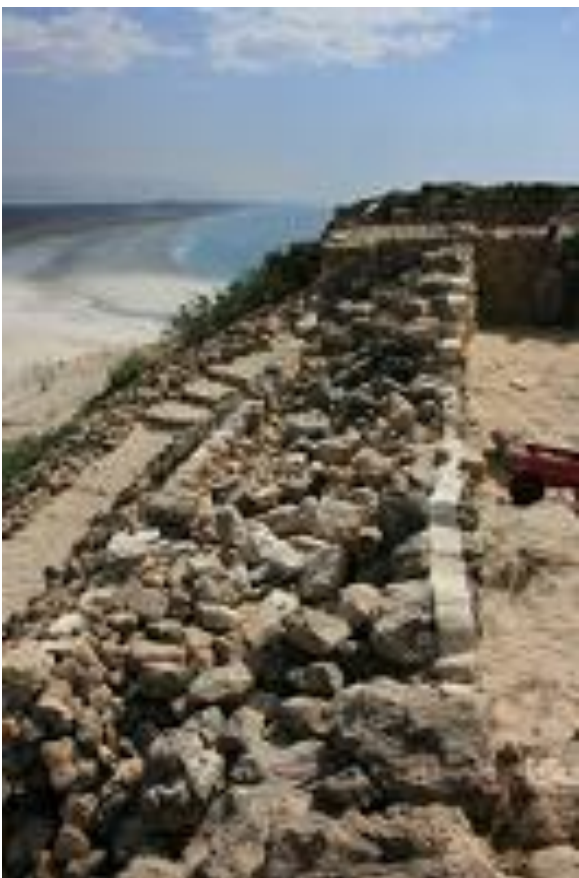
Geo-textile pose

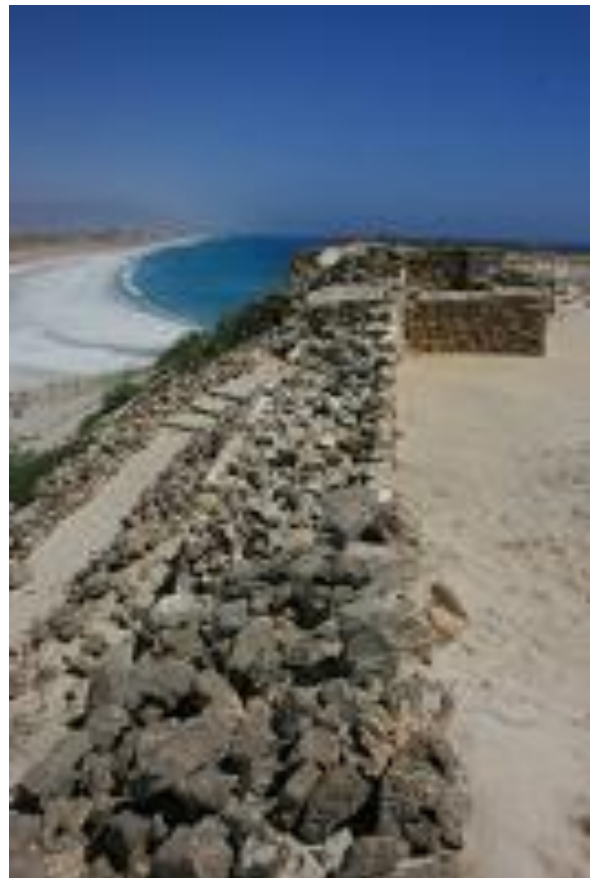
Filling

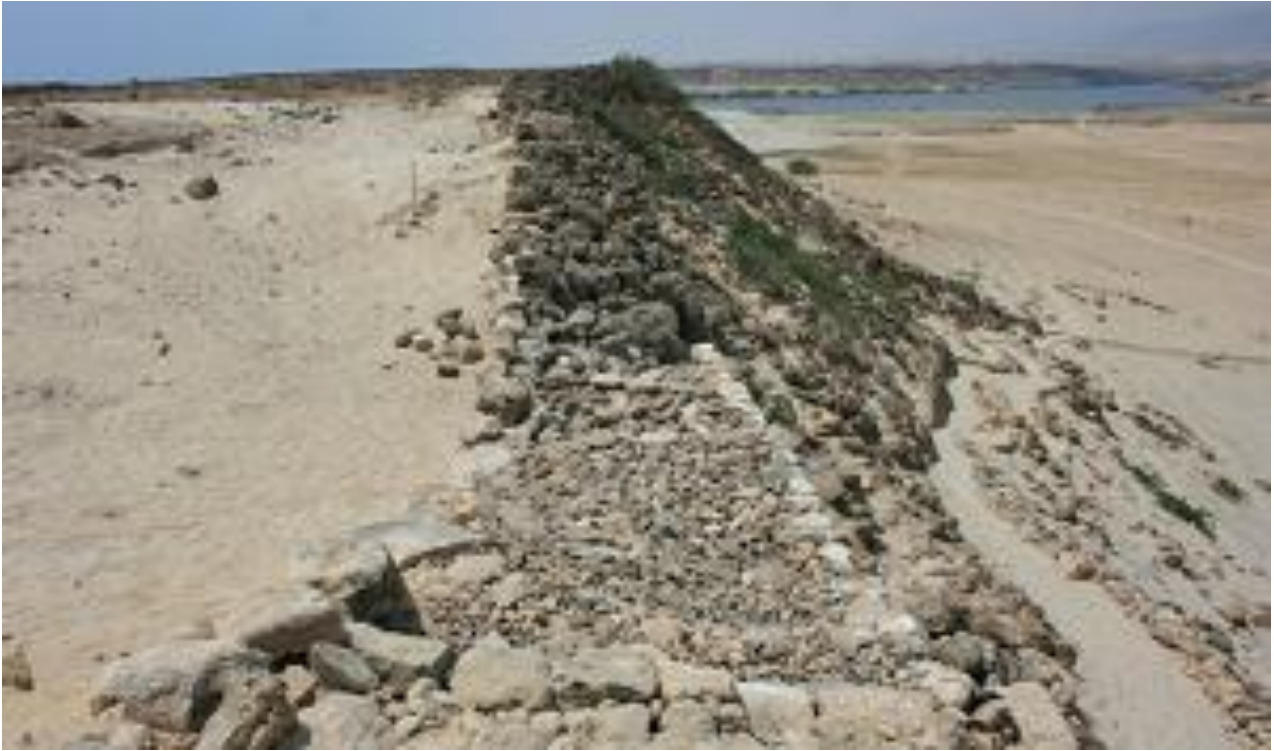
East view, first half complete

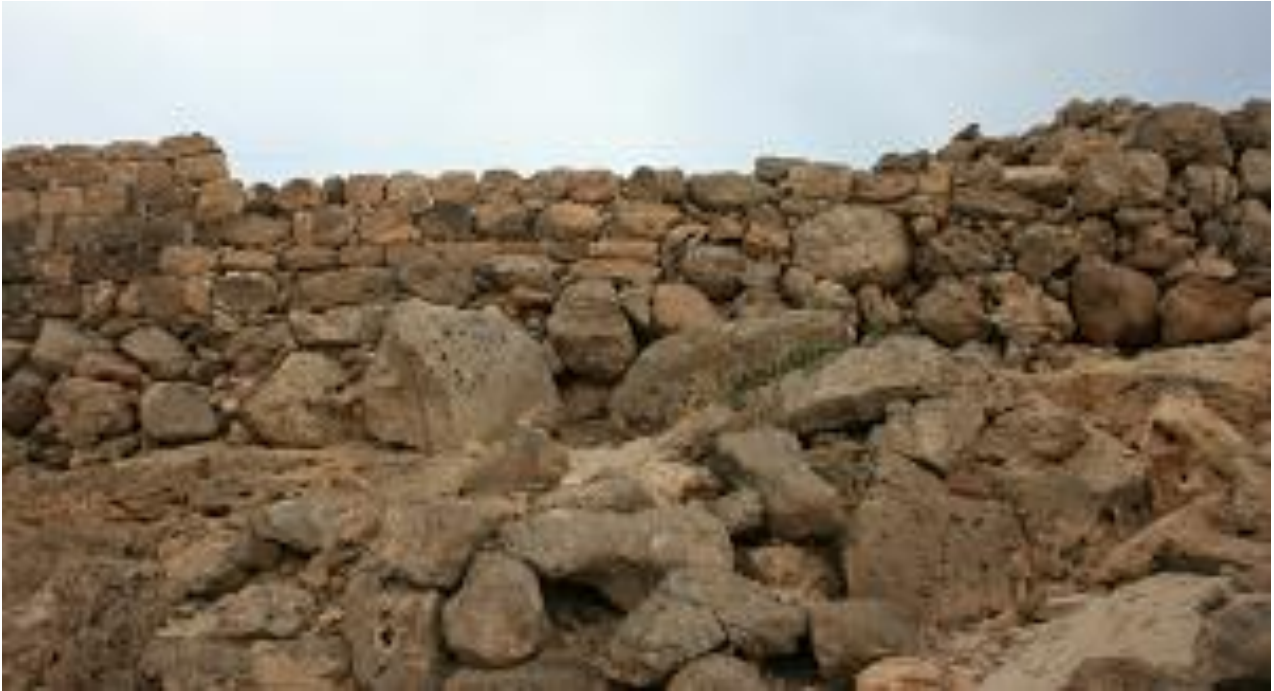
Northern face

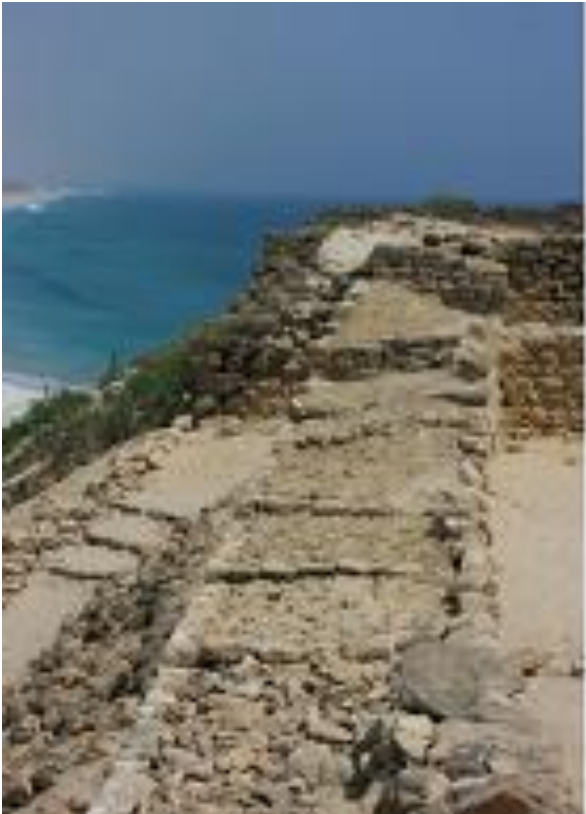
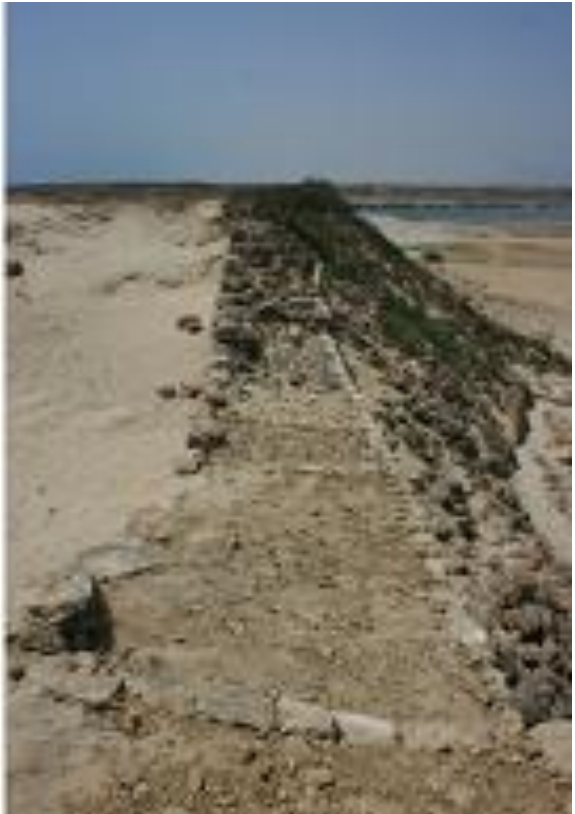
Finish the filling with the soil

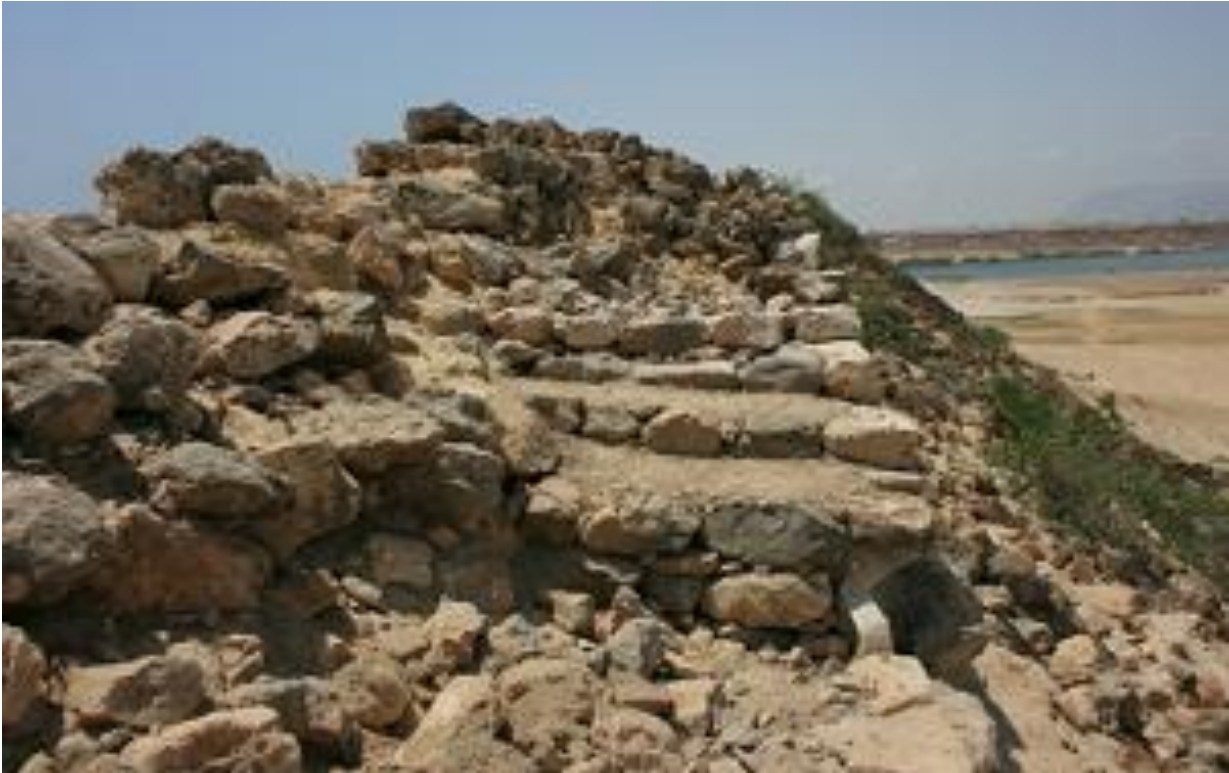
Terraced steps towards the walls better preserved

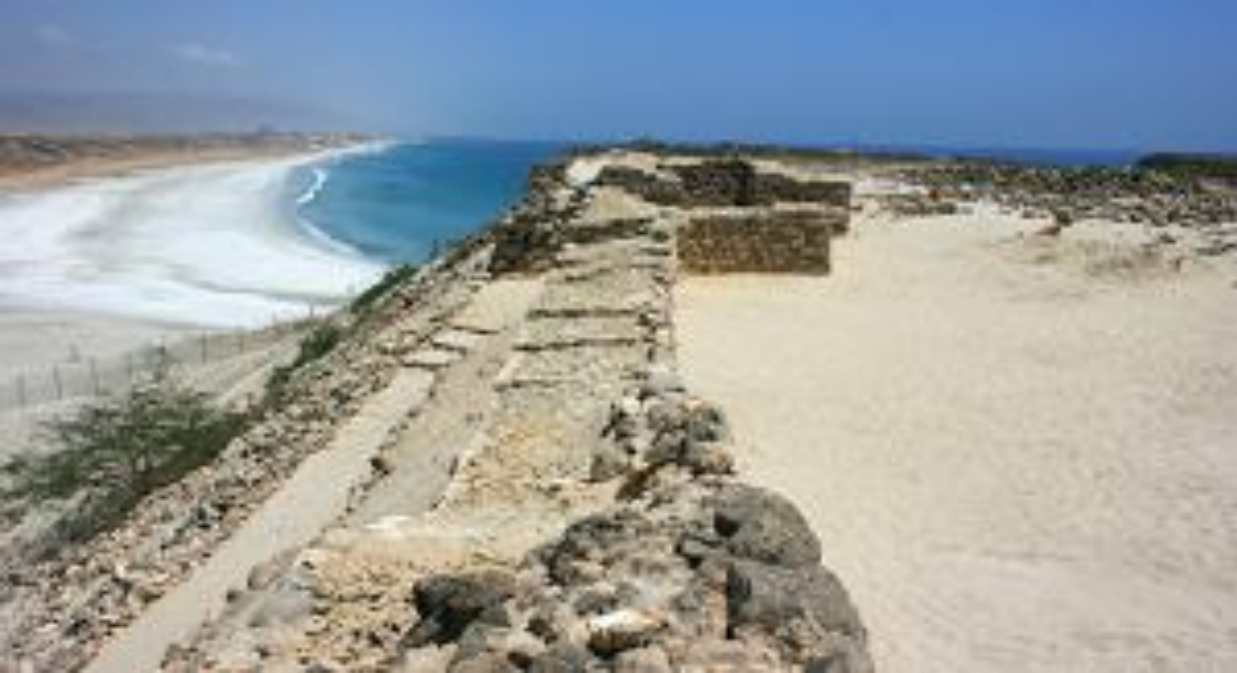
Project area after cleaning north side

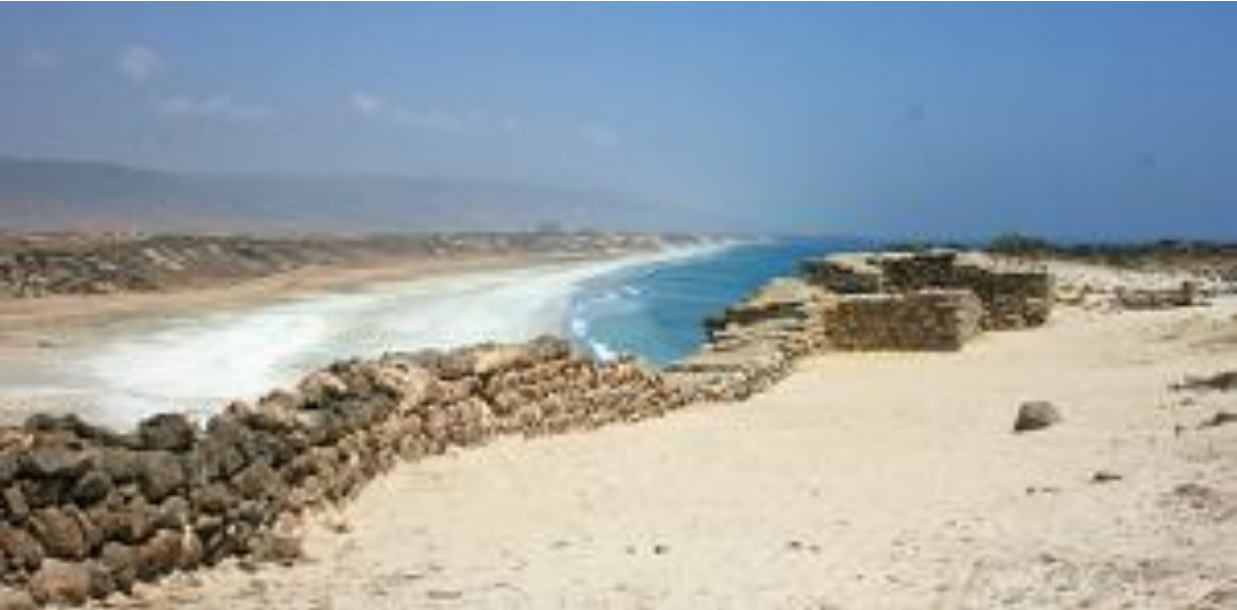
South side, the wall and the towers

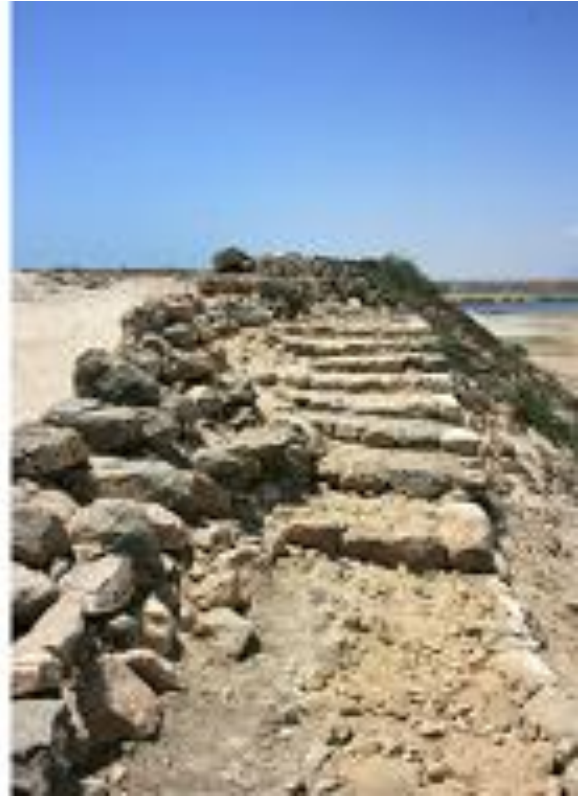
Connection with tower
